## Technical Memorandum

Project Name: Mill E Site

Subject: Mill E 2012 Ground Water Monitoring Summary

# FIELD REPORT

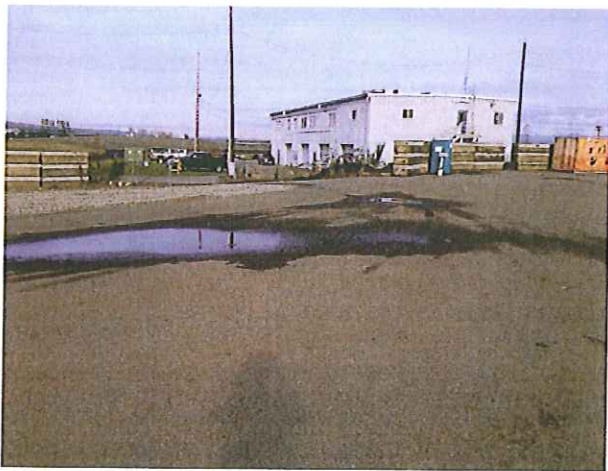
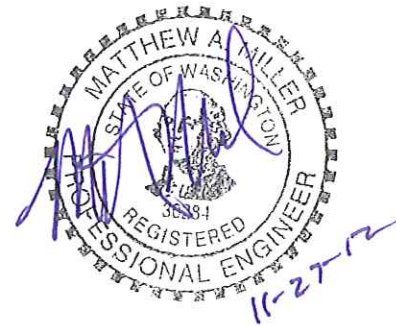
Matthew A. Miller, PE a professional engineer with our firm was on site and performed site observations. The property is currently being used to recycle wood debris into wood chips and similar shredded wood products. The site contains several stock piles of wood debris and wood chips in the central portion of the asphalt cap. During our site visit, the asphalt cap was observed to be in serviceable condition with no obvious signs of cracking, fissures, or pumping. However there was an area near the entrance that has developed a low point for standing water to collect. This is located near the entrance where two "birdbaths" have developed since our last visit. We recommend that these areas be saw cut and replaced or leveled to allow drainage in the area. See Photo below:

AESI should be contacted if additional indications of pavement distress are observed before our next scheduled site visit.

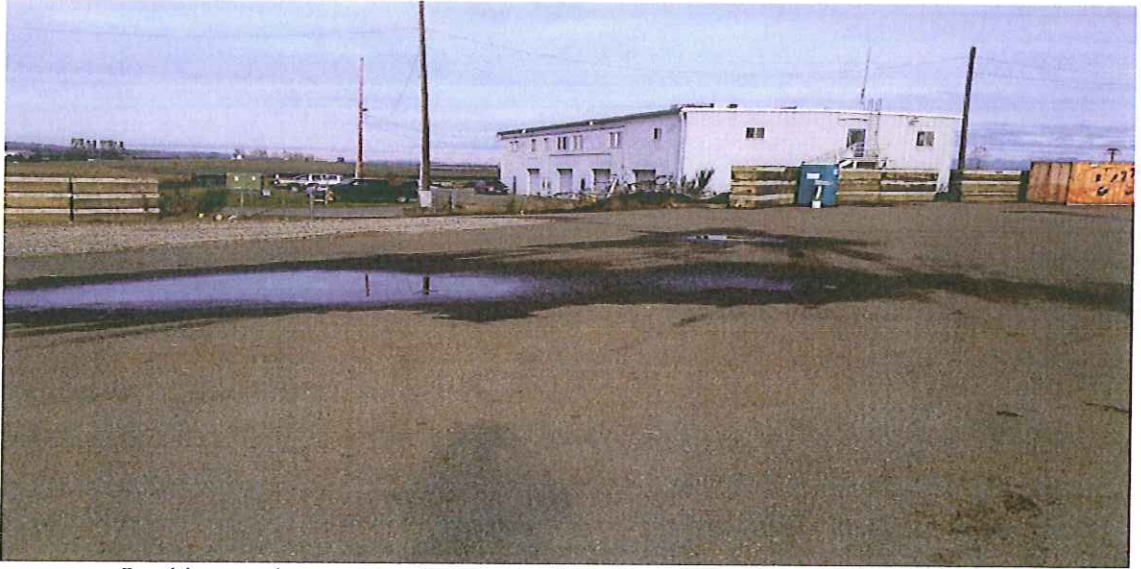
Looking northwest towards entry road. Areas of ponded water on pavement.

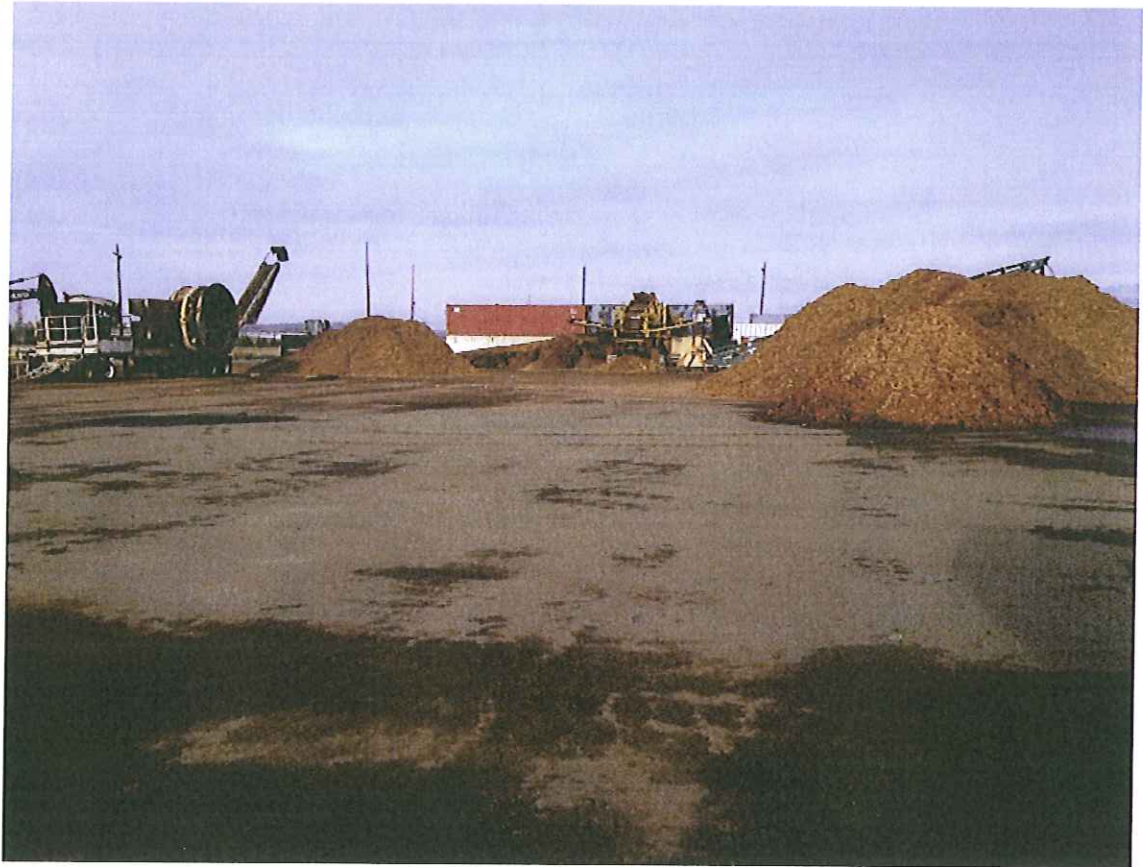
Looking north at operations
