Limited Underground Storage Tank Site Assessment/Decommissioning Report

10 East Bruneau Street
Kennewick, Washington 99336

October 2007
Project No.: 61768.00

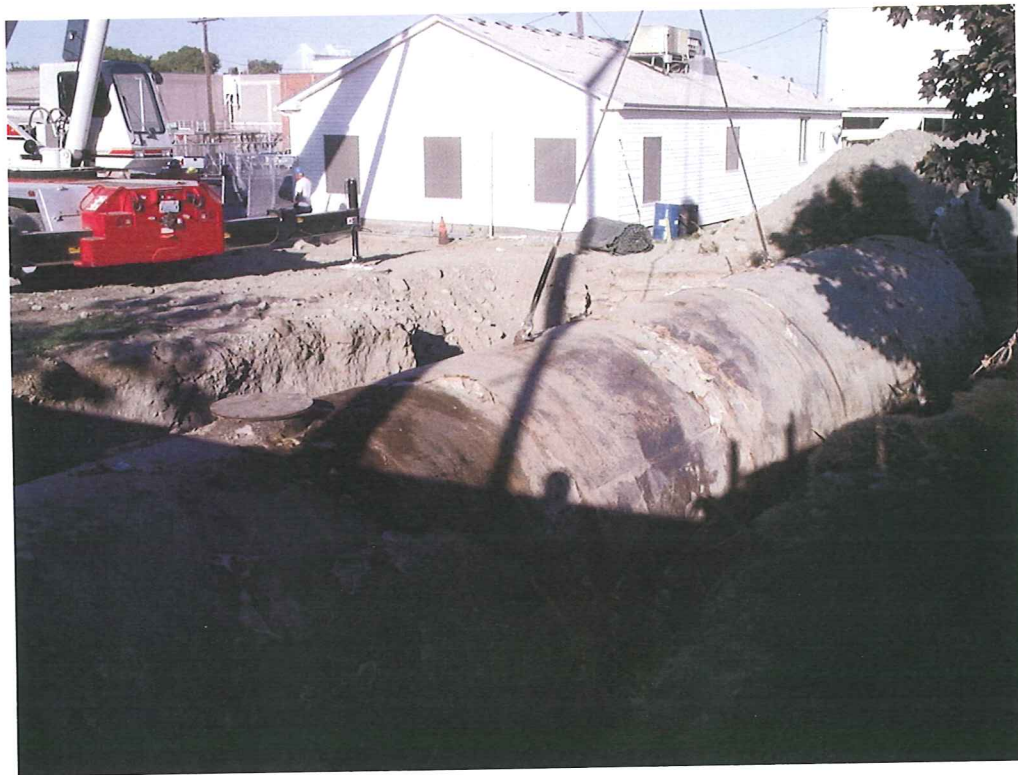
PHOTO 1: BEGINNING THE LIFT TO REMOVE TANK, LOOKING NORTH EAST

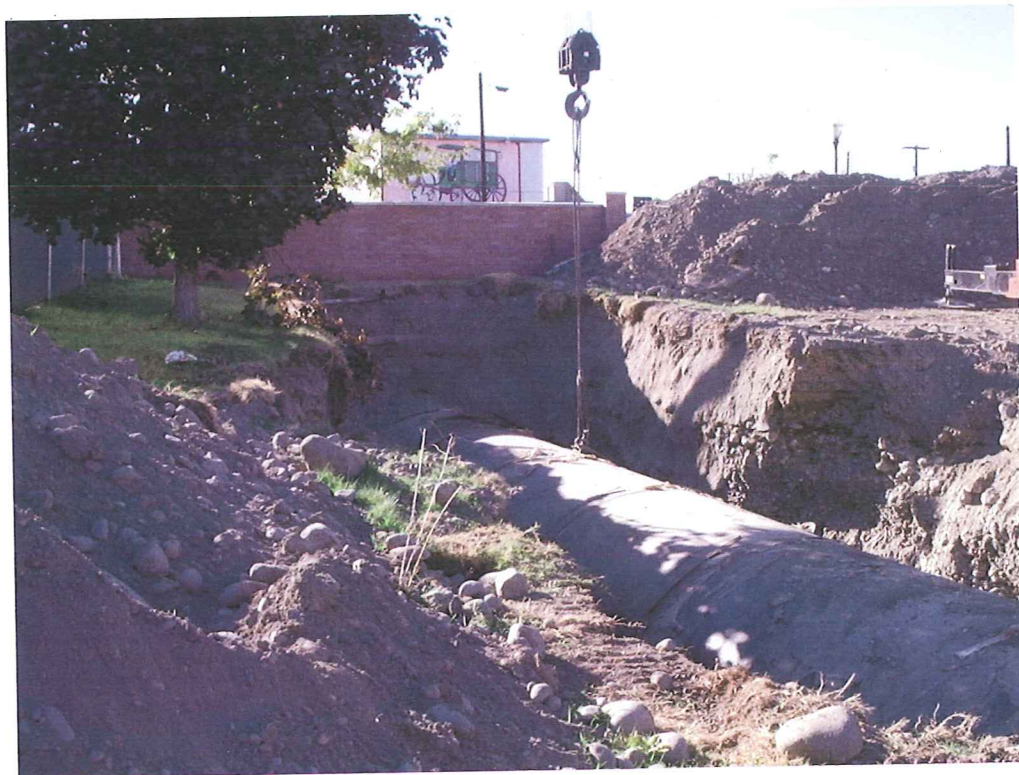
The 50,000 gallon UST had the dimensions of 78 feet in length by 26 feet in diameter. The tank was steel, with no corrosion control infrastructure. Some slight rusting was observed on the tank at the time of decommissioning. The plastic covering originally covering the tank exterior was still in place at the time of UST removal. No indications of holes were observed in the tank.

PHOTO 2: LOOKING NORTH WEST AT TANK IN TANK BASIN

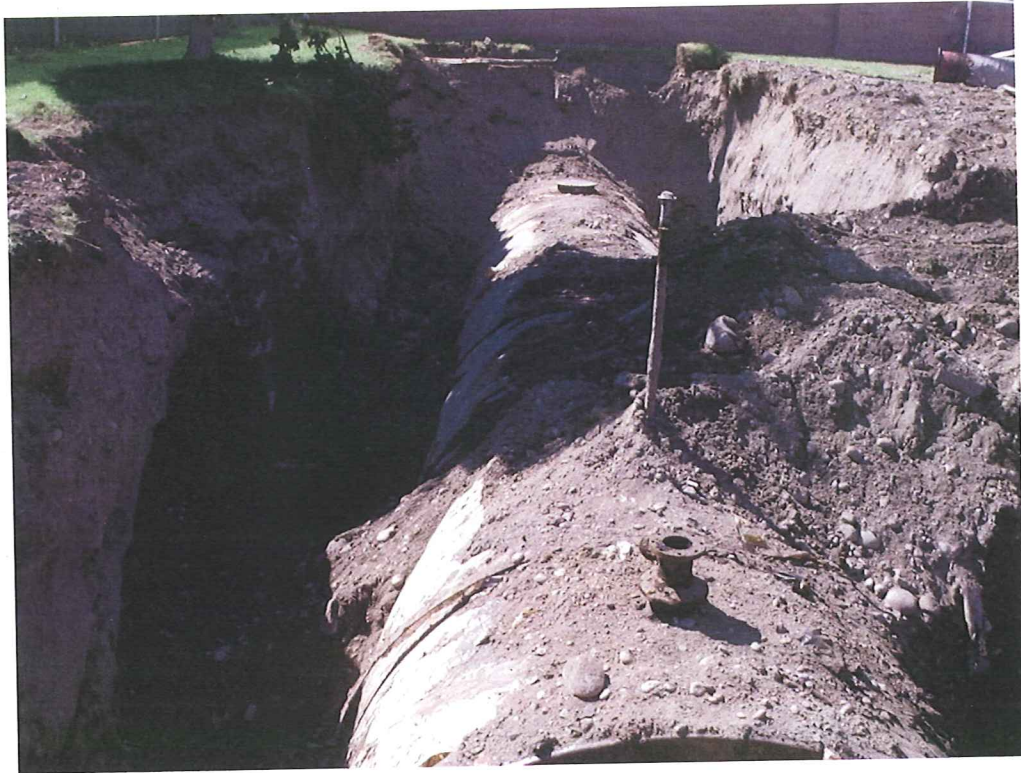
PHOTO 3: TOP OF TANK SHOWING UPPER CONNECTIONS

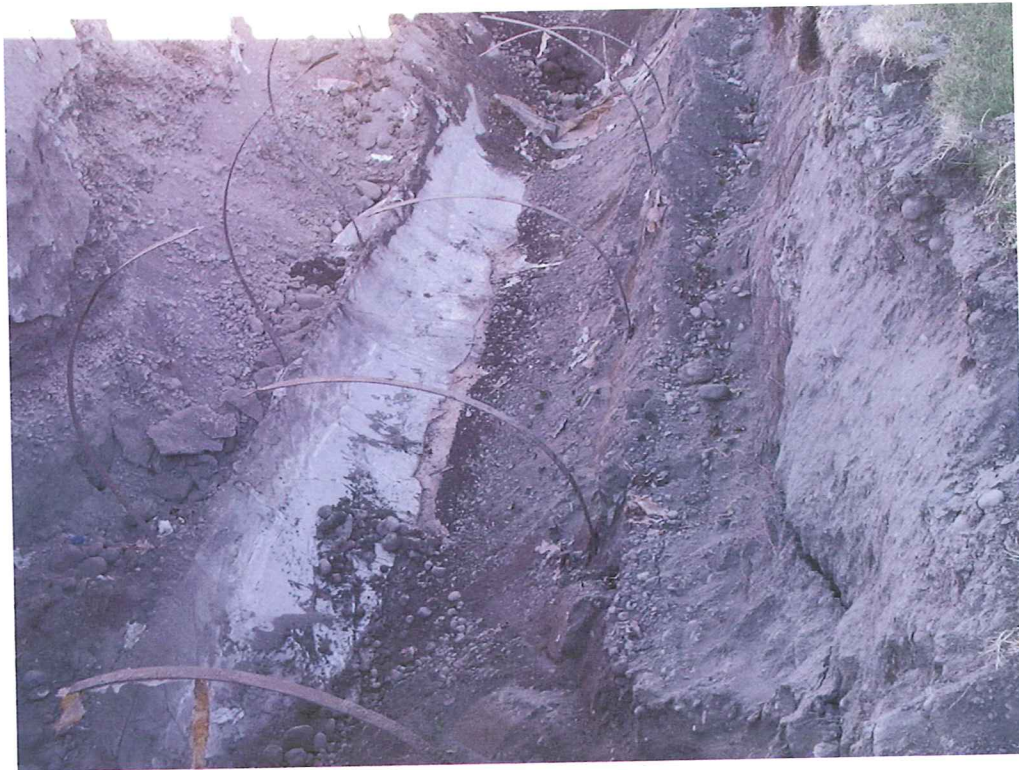
The soils encountered consisted of variable amounts of sand and gravel with some cobbles. There were no field indications of soil contamination. All of the samples collected from the base, sidewall and stockpile locations were non-detect for petroleum product.

PHOTO 4: PIT BASE AFTER REMOVING TANK
