## ASP GERMAN CAR REPAIR UST CLEANUP REPORT

Project #AGCRUST96

Prepared for  
ASP German Car Repair  
17704 Fifteenth Avenue, North East  
Seattle, WA 98155

31 July 1996

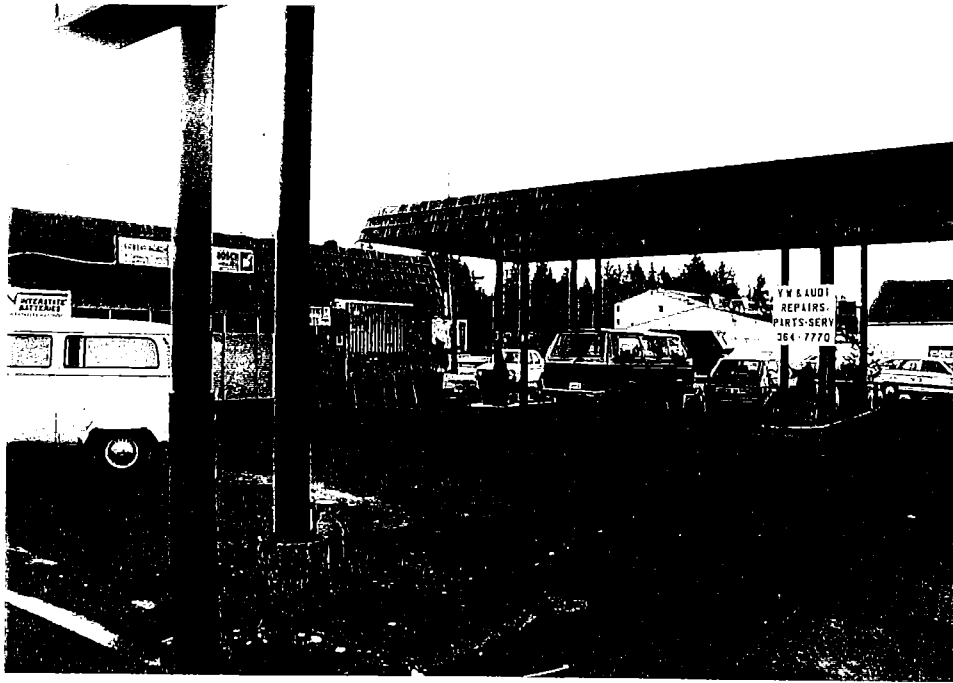
Photograph 1. Property view facing Southeast. Fluorescent cones indicate former UST site.

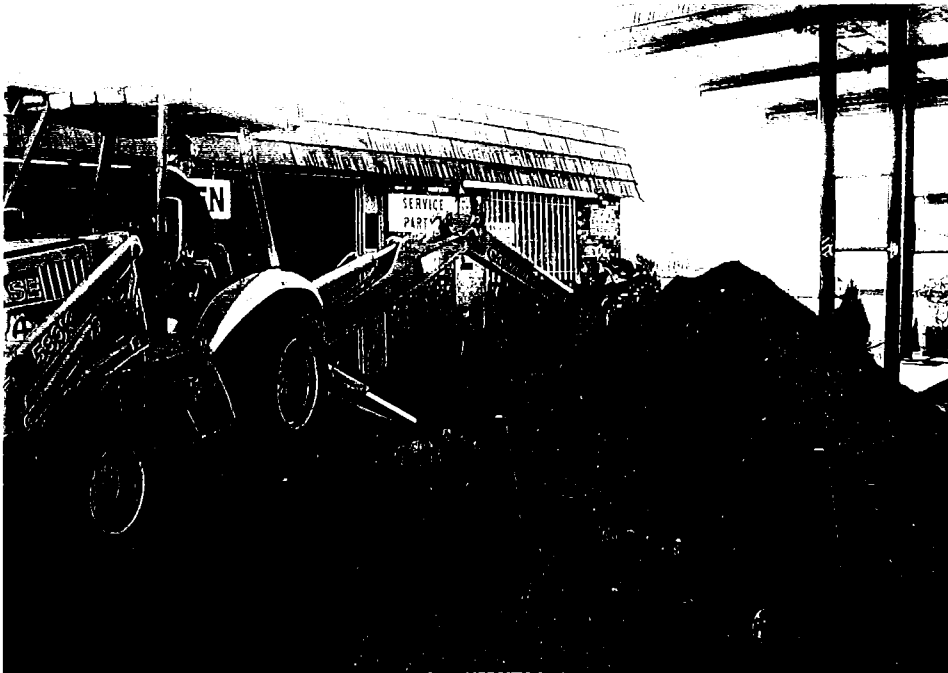
Photograph 2. Impacted soils excavation activities by AEL.

During UST decommissioning, initial AEL sample results reported impacted soils within the former UST excavation. Approximately 40 cubic yards of soil were excavated from the ground surrounding the area of the former UST placement. Subsequent AEL sample results reportedly indicate appropriate impacted soils excavation. Test Pit Logs (Appendix A) were performed on 17 November 1994 by AEL during excavation activities. These Test Pit Logs report the presence of multi-colored gravelly sands at various levels to a maximum depth of 12 feet. At no time did AEL report encountering groundwater. The excavation was subsequently replaced with back-fill provided by AEL. The surface contour was then finished and brought to grade by ASP German Car Repair personnel.

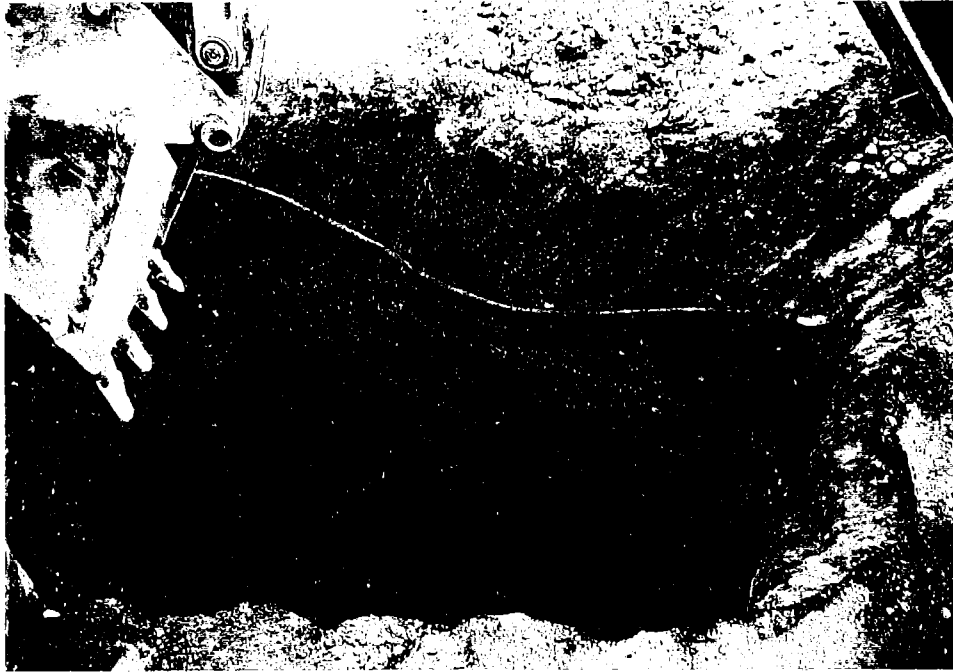
Photograph 3. Excavation interior during impacted soils removal by AEL

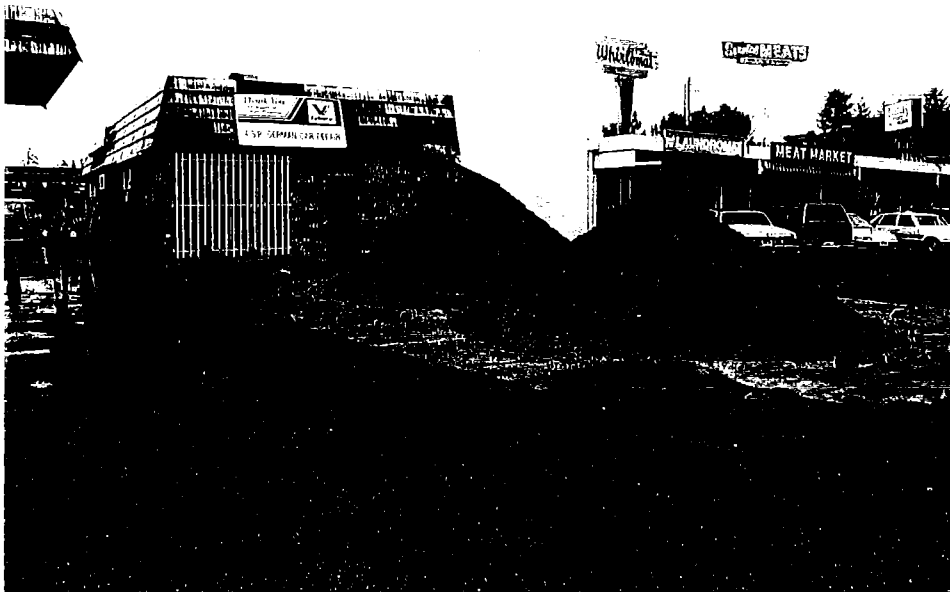
Photograph 4. Property view facing North by Northeast. Impacted soils staged by AEL

Petroleum impacted soils were encountered during UST decommissioning activities performed by AEL. AEL reportedly transferred these soils to an area directly South of the main property building, and placed them upon a protective plastic liner. An additional plastic barrier was placed over the top of soils. These impacted soils were held at this staging area for subsequent off-site transport and treatment.

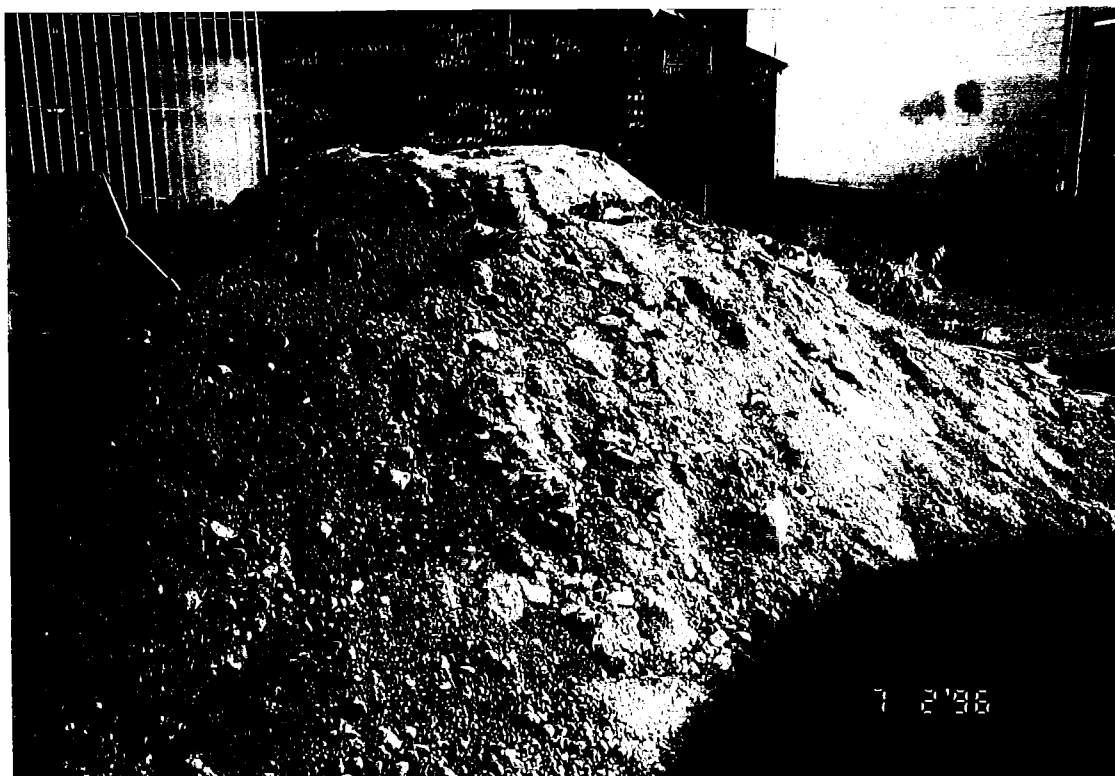
Photograph 5. Staged soils pile, view facing North.

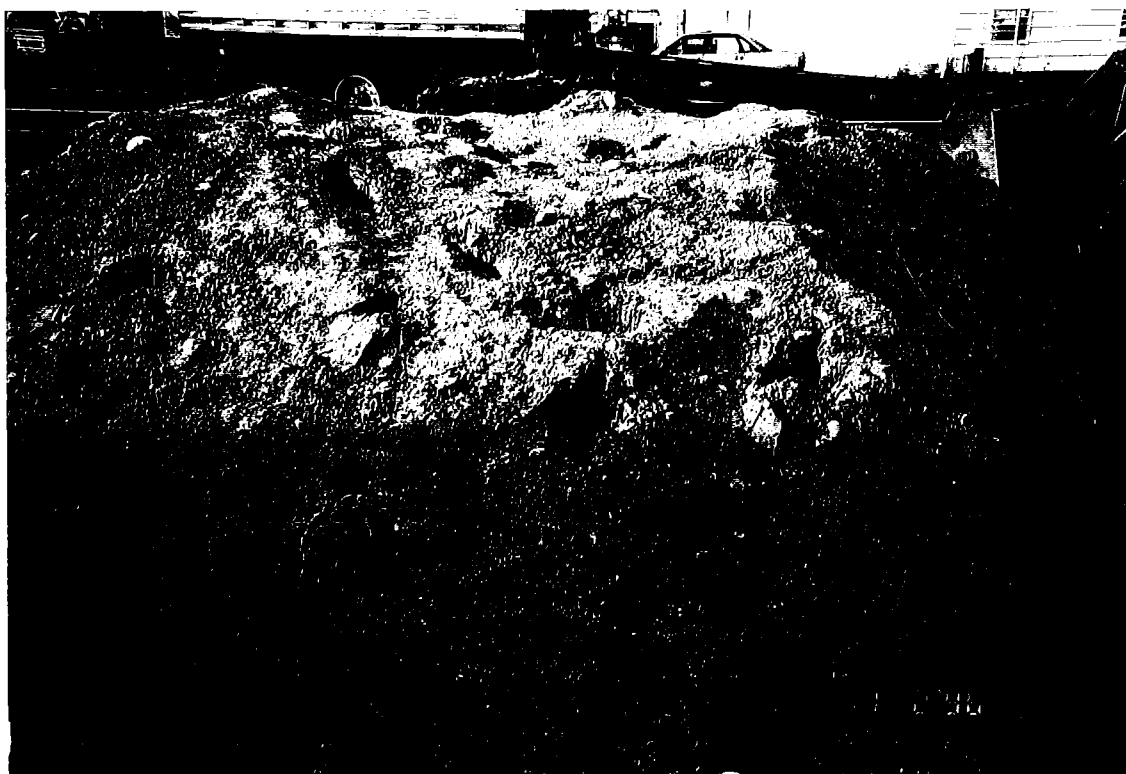
Photograph 6. Staged soils pile, view facing South.
