INITIAL INVESTIGATION FIELD REPORT

ERTS # 621303
 County Kitsap
 Parcel # 272502-4-006-2000
 FS ID # 15438

Site Name: Strawberry Plant

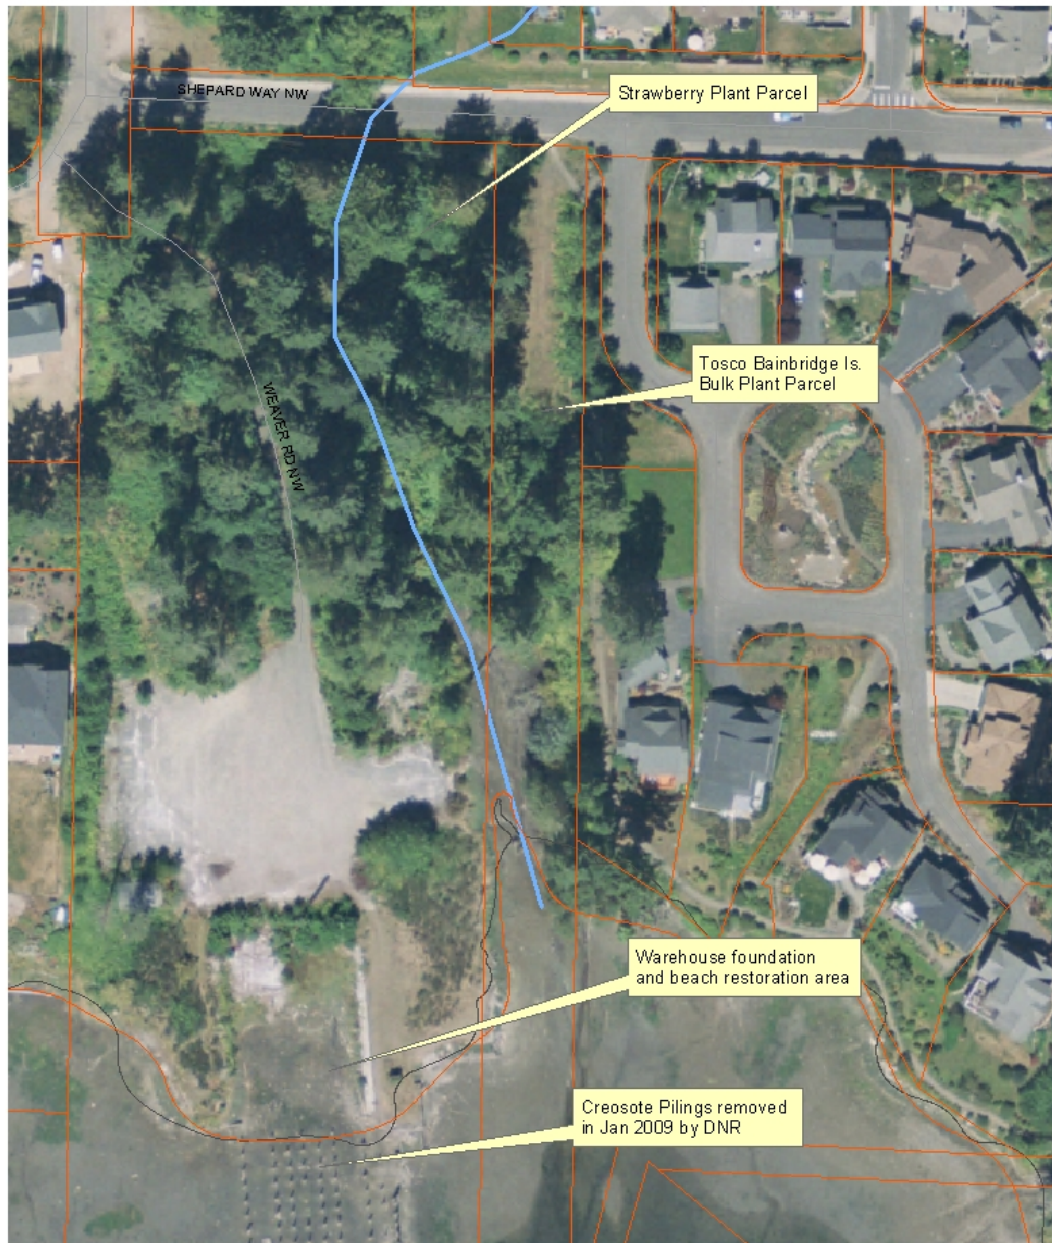
SITE MAP/DIAGRAM

Description: The site is a shoreline parcel of approximately 4.1 acres. The shoreline has a concrete foundation and slabs in various locations. There is a large asphalt parking lot in the center of the parcel. The site extends upland into a wooded area. A stream runs south down the property line on the east side. A small house also remains on the site near the shore and adjacent to the asphalt parking lot. The surrounding parcels are mostly residential. Several monitoring wells are on the Strawberry Plant site in the asphalt parking lot.

Strawberry Plant Parcel
