# **Remedial Investigation Work Plan for the Former Eatonville Landfill**

Ecology Facility Site ID No. 85933

September 2021

**GSI Water Solutions, Inc.**

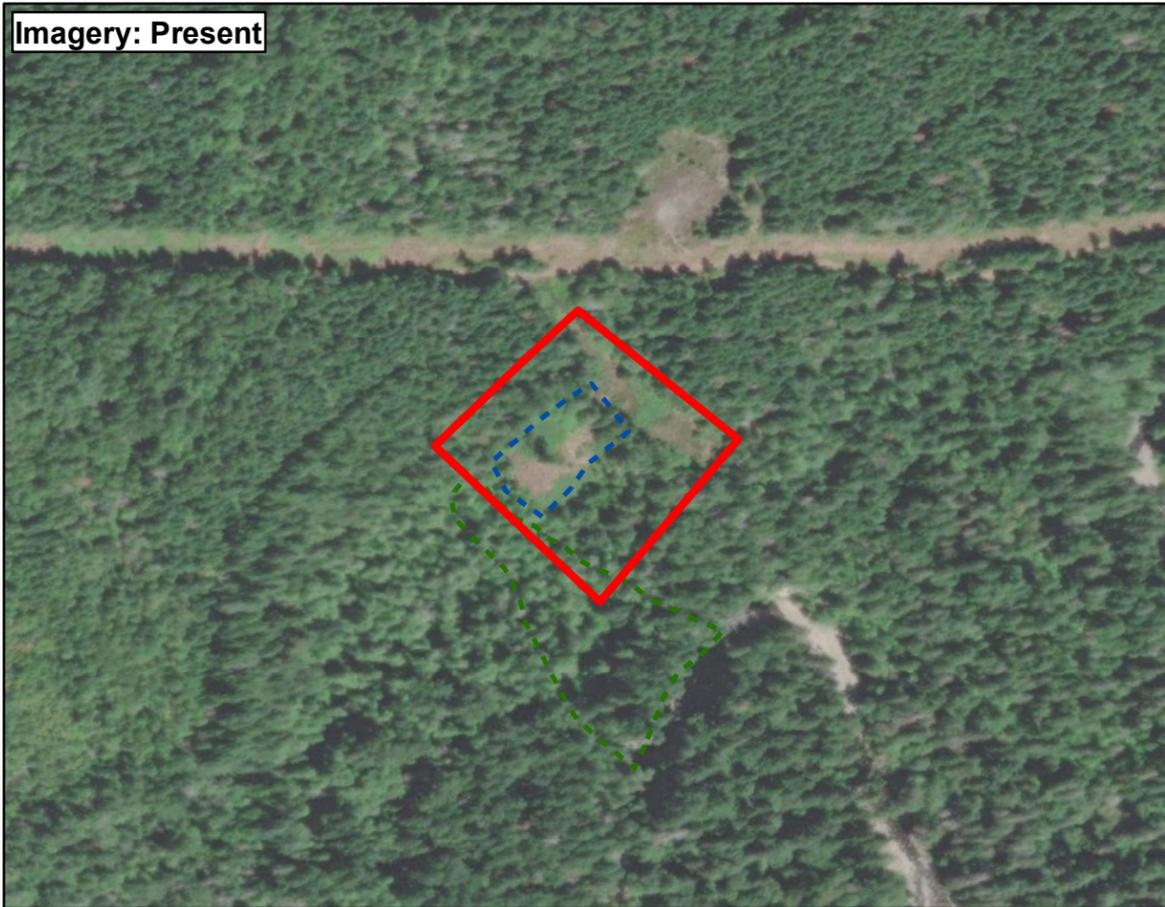
**FIGURE 3**  
Former Eatonville Landfill  
Aerial Imagery Showing  
Former Landfill Footprint  
Eatonville, Washington

Imagery: 1941

Imagery: 1957

Imagery: 1980

Imagery: Present

A review of historical aerial photographs from Google Earth and the University of Washington Libraries indicates that the Site and surrounding areas have not changed considerably since the 1950s. Prior to operating the landfill, the area was undisturbed. Throughout the landfill period and until today, the surrounding forest has remained mostly intact. Figure 3 provides historical aerial representations of the Site over time. As shown on the 1957 and 1980 aerial photos included in Figure 3, the access road to the landfill is highly eroded and leads to the landfill area. The wastes were dumped down a steep slope on the northeastern side of the former landfill area. The toe of the landfill is located at the southwestern side of the landfill outline.
