**Geotechnical Field Investigation and
Bench Scale Treatability Study**
USG Interiors Highway 99 Site
Milton, Washington

GEOTECHNICAL FIELD INVESTIGATION AND BENCH SCALE TREATABILITY STUDY
USG INTERIORS HIGHWAY 99 SITE
MILTON, WASHINGTON

CDM Smith Project No. 19921.251008

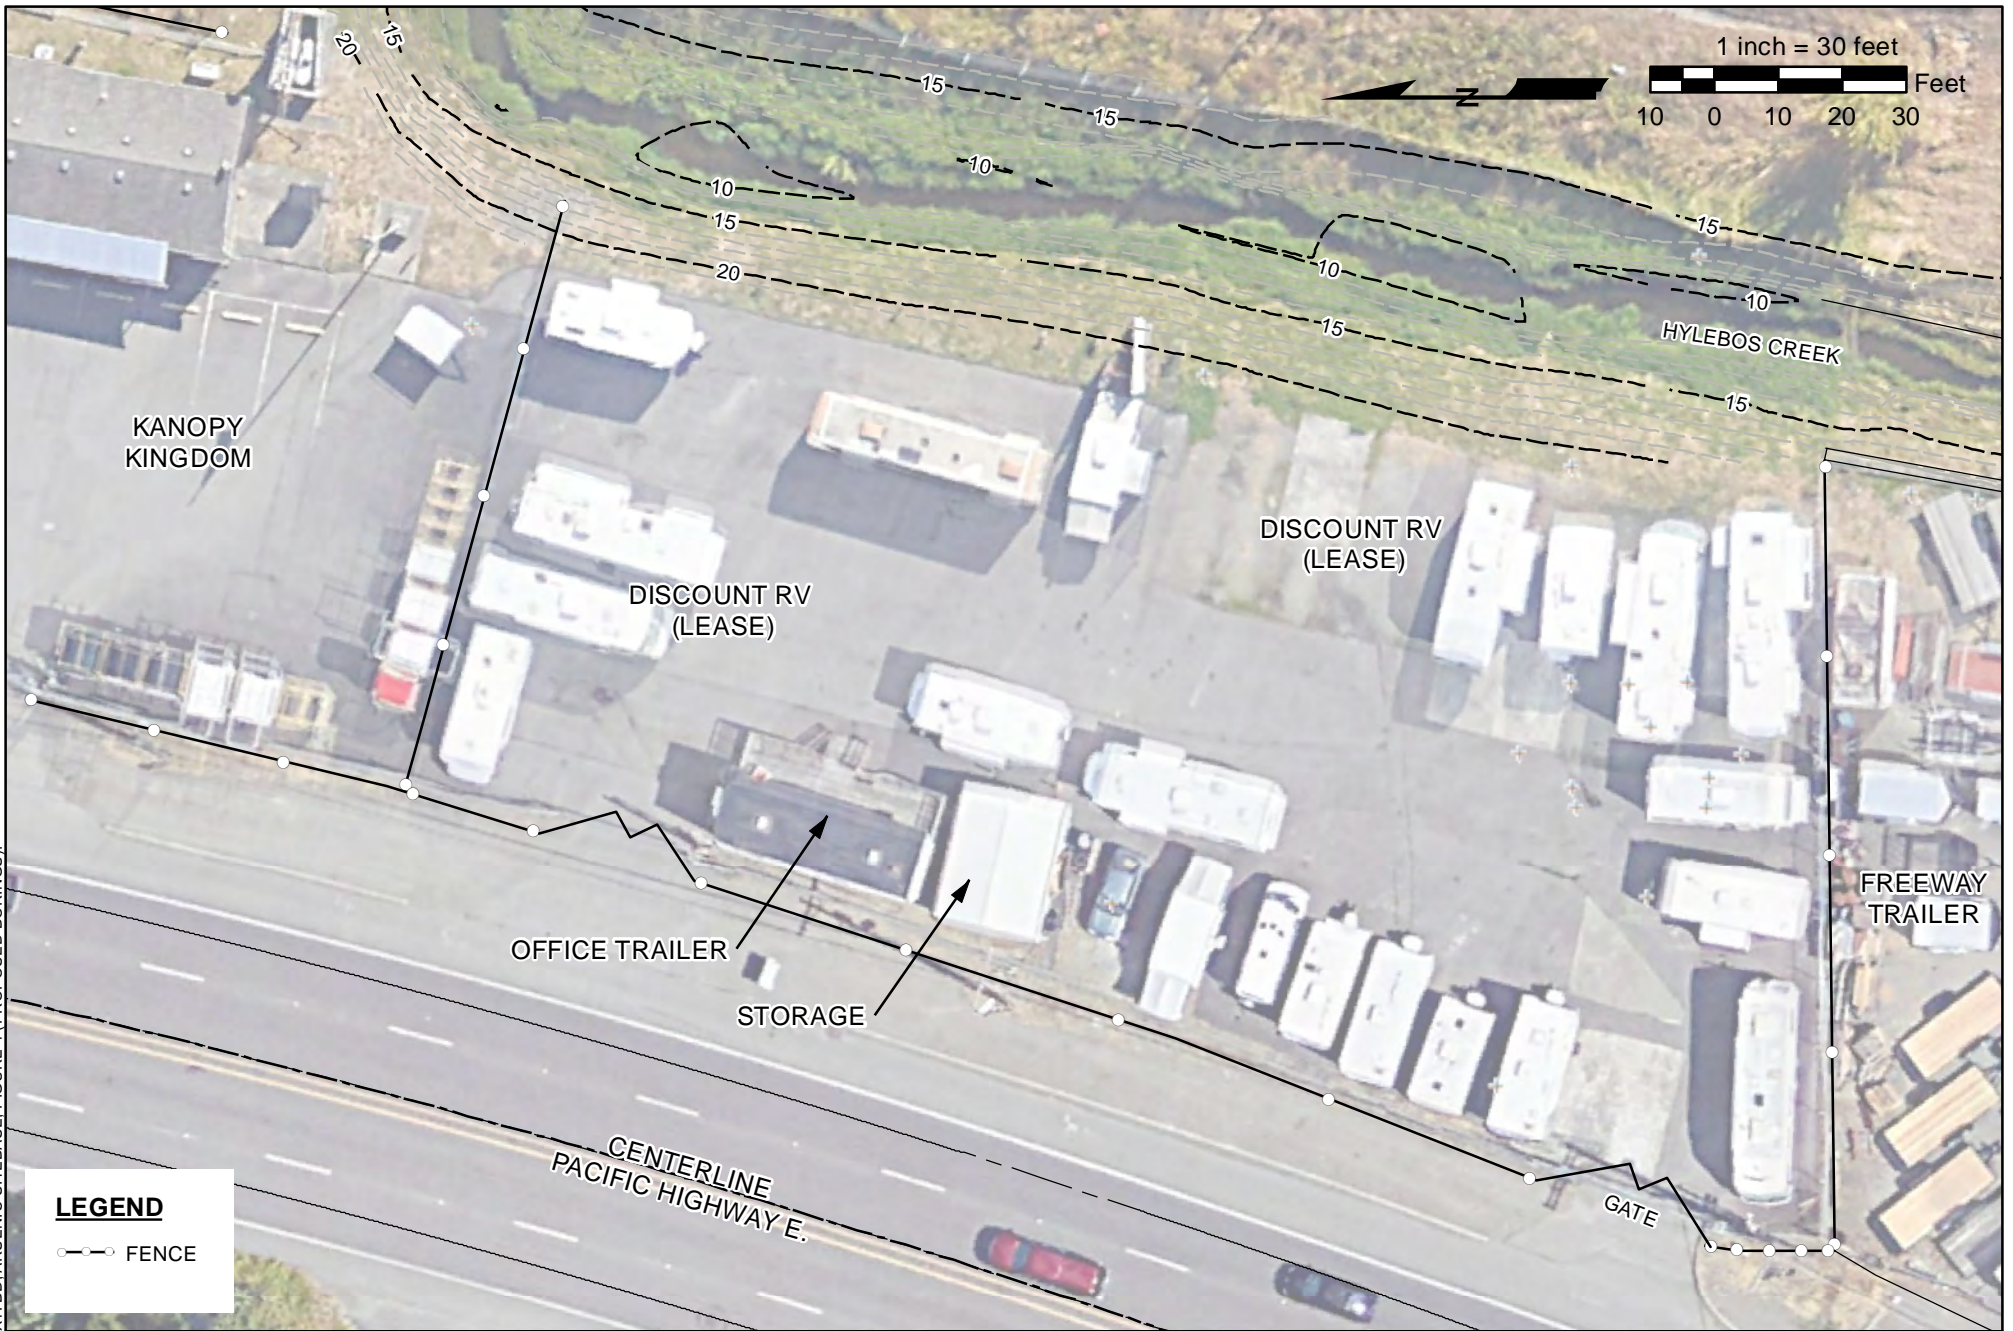
Figure 2
Site Plan

The USGI Highway 99 site is between Pacific Highway East and Interstate 5 (**Figure 1**). It is in a commercial area situated along the east side of Pacific Highway East and is addressed as 7110 Pacific Highway East. Commercial businesses are located to the north and south and residences are located west of the property across Pacific Highway East. The relatively level site is asphalt-paved and is presently occupied by a recreational vehicle (RV) dealership, Discount RV. A mobile office building and a small storage building are situated on the west side of the site. The remainder of the property serves as a lot for RVs. The site plan is presented on **Figure 2**.

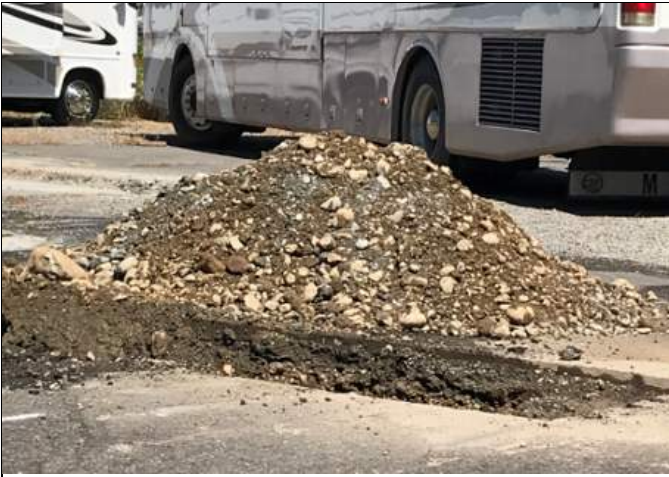
Picture Date:	Wednesday 07/29/2020
Picture Taken By:	Haley Provinsal
Picture Location:	Milton, Washington
Project Name:	USG Highway 99 Site
Description:	99-TP-1 Top 3 ft of material

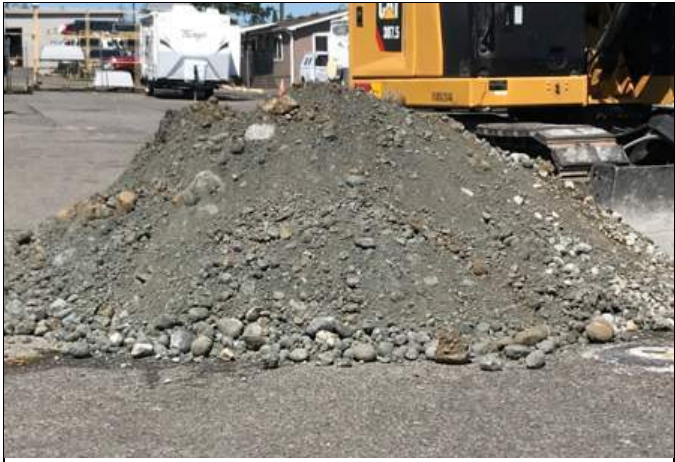
Picture Date:	Wednesday 07/29/2020
Picture Taken By:	Haley Provinsal
Picture Location:	Milton, Washington
Project Name:	USG Highway 99 Site
Description:	99-TP-1 Material from 3 to 8.5 ft bgs

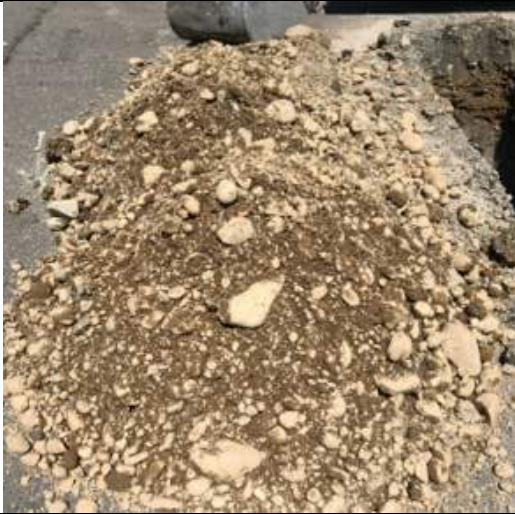
Picture Date:	Wednesday 07/29/2020
Picture Taken By:	Haley Provinsal
Picture Location:	Milton, Washington
Project Name:	USG Highway 99 Site
Description:	99-TP-2 Top 3 ft of material

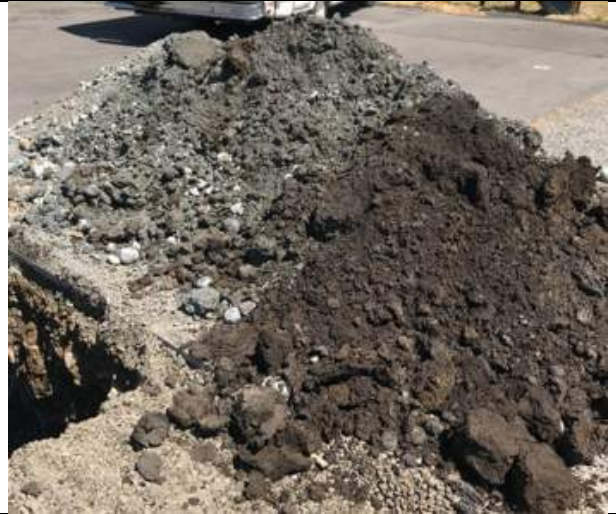
Picture Date:	Wednesday 07/29/2020
Picture Taken By:	Haley Provinsal
Picture Location:	Milton, Washington
Project Name:	USG Highway 99 Site
Description:	99-TP-2 Material from 3 ft to 11 ft bgs

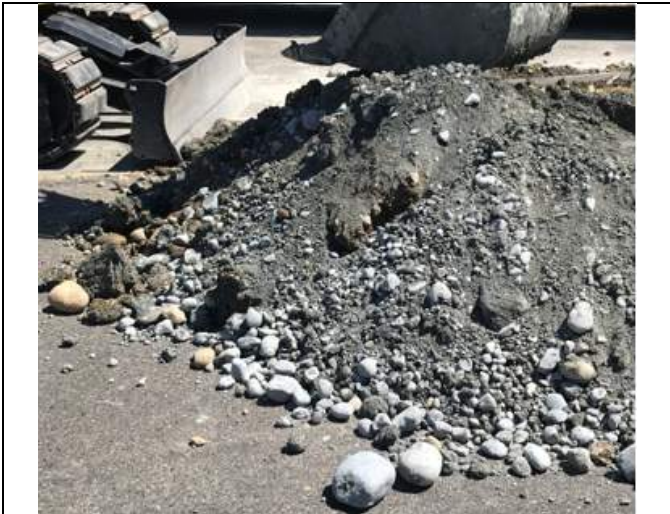
Picture Date:	Wednesday 07/29/2020
Picture Taken By:	Haley Provinsal
Picture Location:	Milton, Washington
Project Name:	USG Highway 99 Site
Description:	Material from 99-TP-3

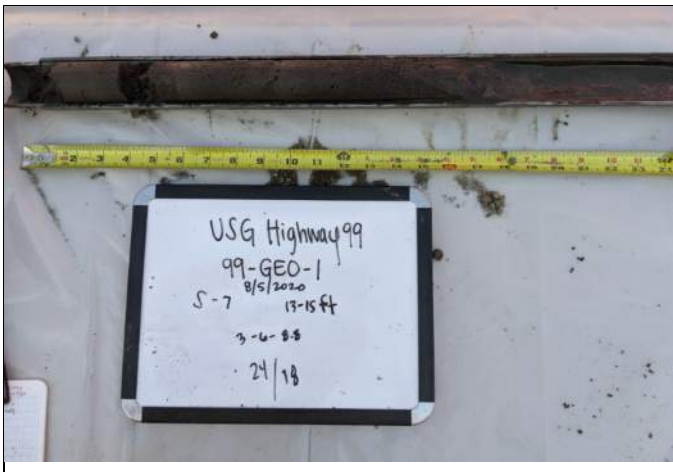
Picture Date:	Wednesday 08/5/2020
Picture Taken By:	Haley Provinsal
Picture Location:	Milton, Washington
Project Name:	USG Highway 99 Site
Description:	99-GEO-1, S-7 (13-15 ft bgs)

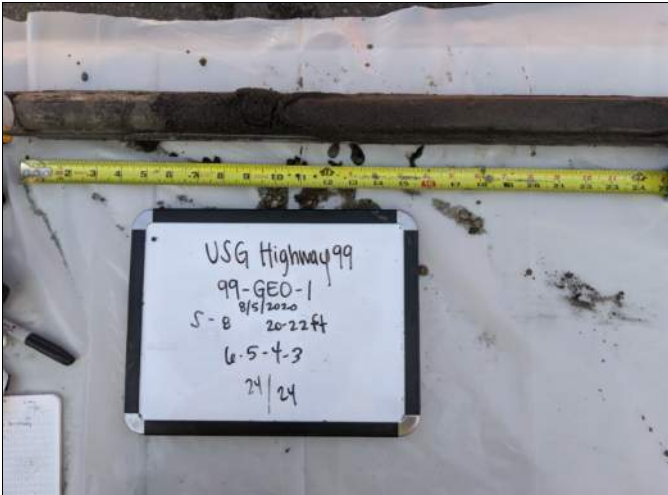
Picture Date:	Wednesday 08/5/2020
Picture Taken By:	Haley Provinsal
Picture Location:	Milton, Washington
Project Name:	USG Highway 99 Site
Description:	99-GEO-1, S-8 (20-22 ft bgs)

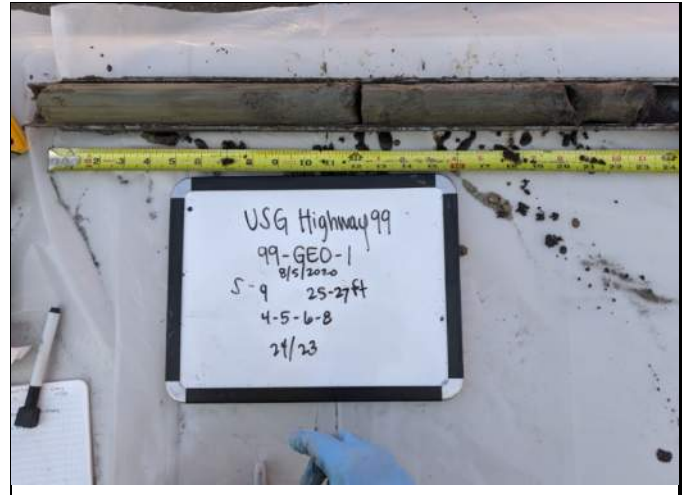
Picture Date:	Wednesday 08/5/2020
Picture Taken By:	Haley Provinsal
Picture Location:	Milton, Washington
Project Name:	USG Highway 99 Site
Description:	99-GEO-1,S-9 (25-27 ft bgs)

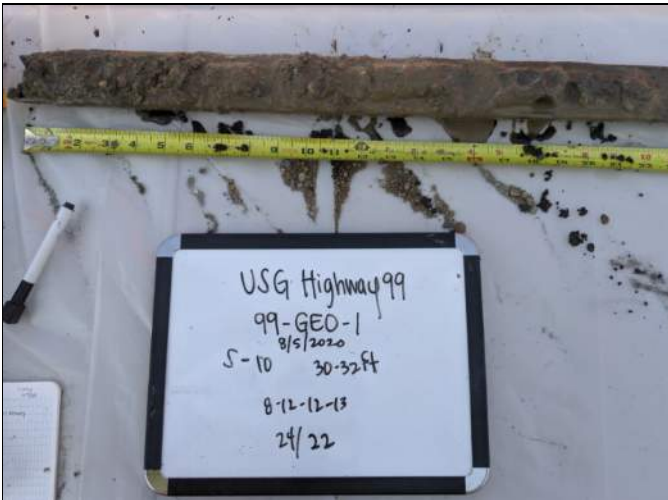
Picture Date:	Wednesday 08/5/2020
Picture Taken By:	Haley Provinsal
Picture Location:	Milton, Washington
Project Name:	USG Highway 99 Site
Description:	99-GEO-1, S-10 (30-32 ft bgs)

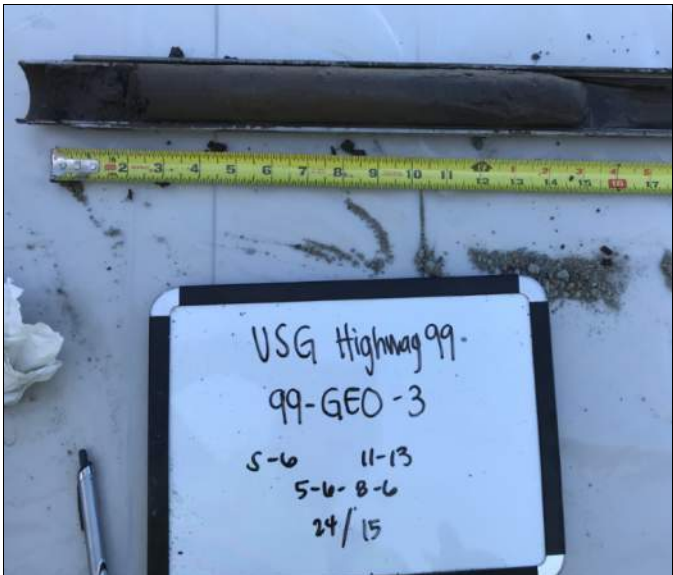
Picture Date:	Tuesday 08/4/2020
Picture Taken By:	Haley Provinsal
Picture Location:	Milton, Washington
Project Name:	USG Highway 99 Site
Description:	99-GEO-3, S-6 (11-13 ft bgs)

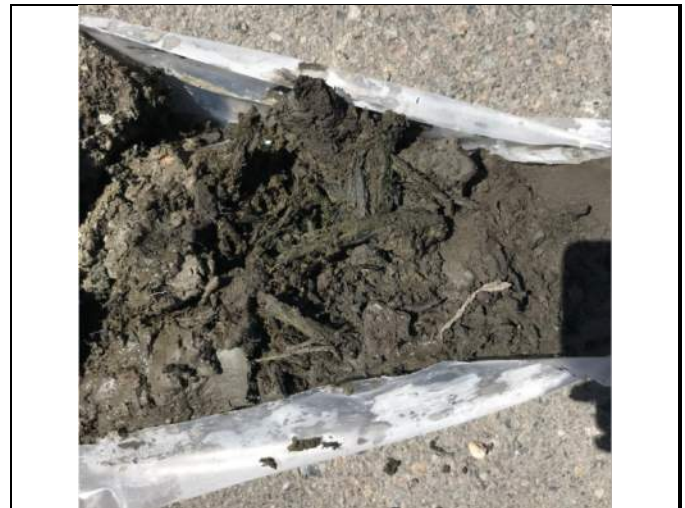
Picture Date:	Friday 08/7/2020
Picture Taken By:	Haley Provinsal
Picture Location:	Milton, Washington
Project Name:	USG Highway 99 Site
Description:	99-BS-1, C-4 wood debris

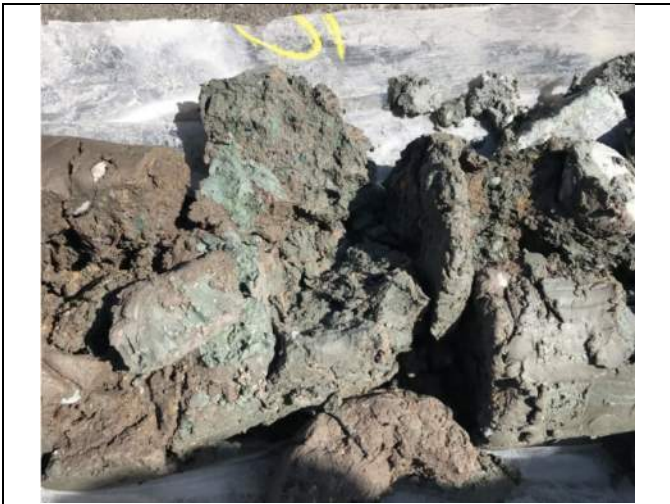
Picture Date:	Friday 08/7/2020
Picture Taken By:	Haley Provinsal
Picture Location:	Milton, Washington
Project Name:	USG Highway 99 Site
Description:	99-BS-3, C-3 coloration

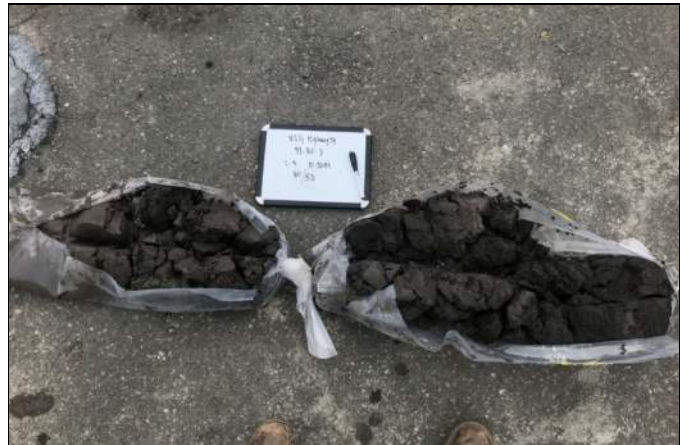
Picture Date:	Friday 08/7/2020
Picture Taken By:	Haley Provinsal
Picture Location:	Milton, Washington
Project Name:	USG Highway 99 Site
Description:	99-BS-3, C-4 (15-20 ft bgs)

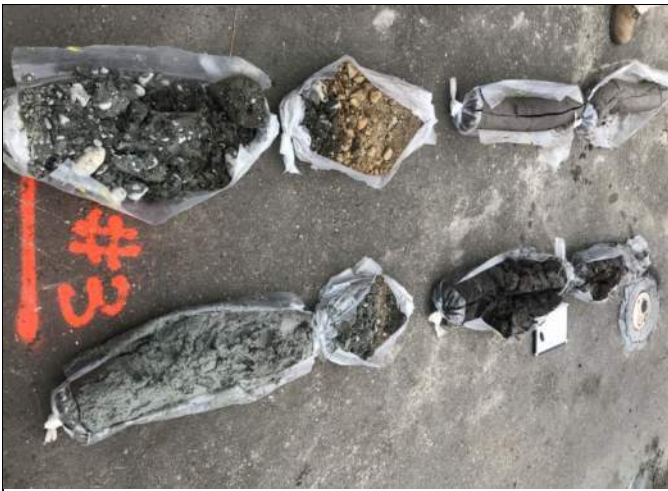
Picture Date:	Friday 08/7/2020
Picture Taken By:	Haley Provinsal
Picture Location:	Milton, Washington
Project Name:	USG Highway 99 Site
Description:	99-BS-3

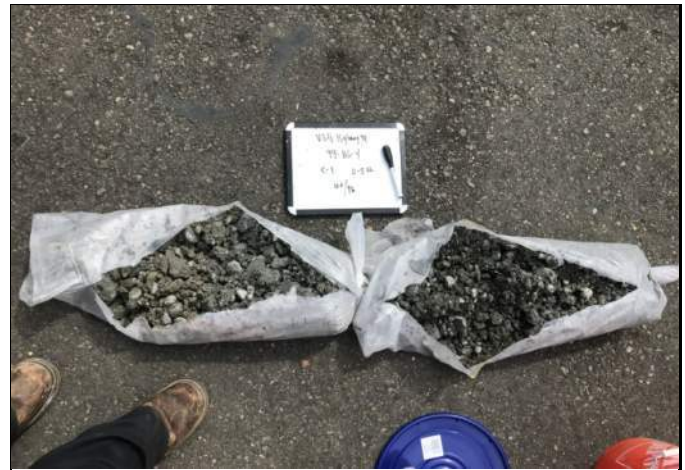
Picture Date:	Friday 08/7/2020
Picture Taken By:	Haley Provinsal
Picture Location:	Milton, Washington
Project Name:	USG Highway 99 Site
Description:	99-BS-4, C-1 (0-5 ft bgs)

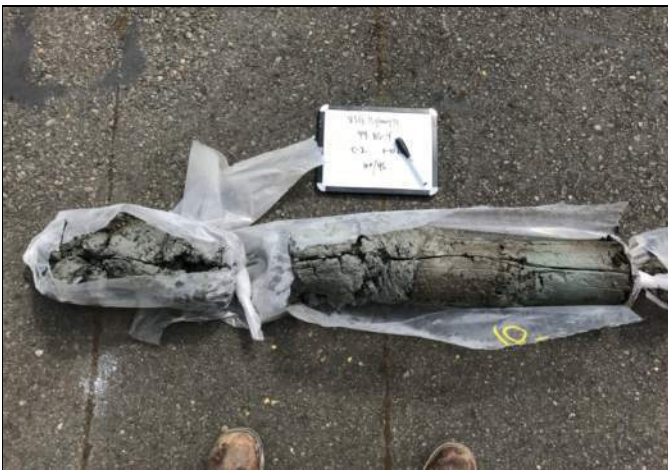
Picture Date:	Friday 08/7/2020
Picture Taken By:	Haley Provinsal
Picture Location:	Milton, Washington
Project Name:	USG Highway 99 Site
Description:	99-BS-4, C-2 (5-10 ft bgs)

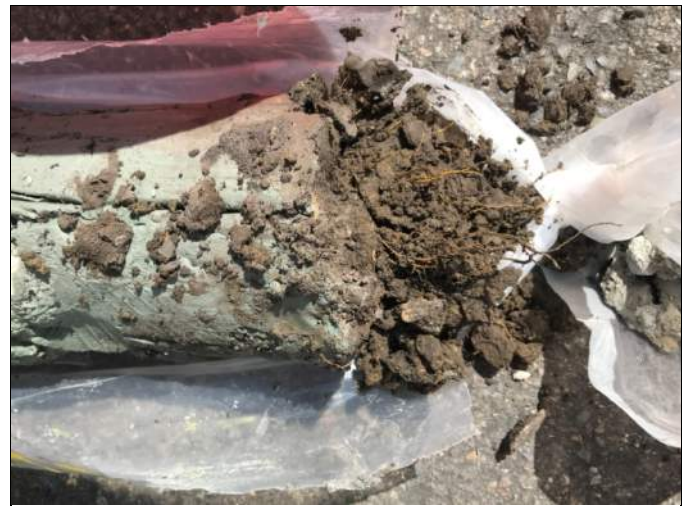
Picture Date:	Friday 08/7/2020
Picture Taken By:	Haley Provinsal
Picture Location:	Milton, Washington
Project Name:	USG Highway 99 Site
Project Description:	99-BS-4, C-2 roots and coloration

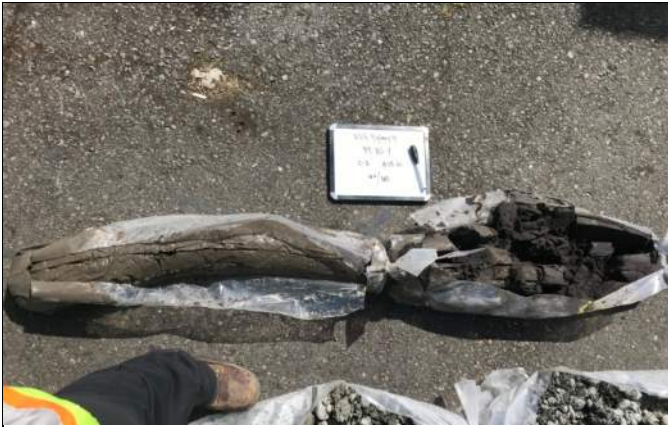
Picture Date:	Friday 08/7/2020
Picture Taken By:	Haley Provinsal
Picture Location:	Milton, Washington
Project Name:	USG Highway 99 Site
Description:	99-BS-4, C-3 (10-15 ft bgs)

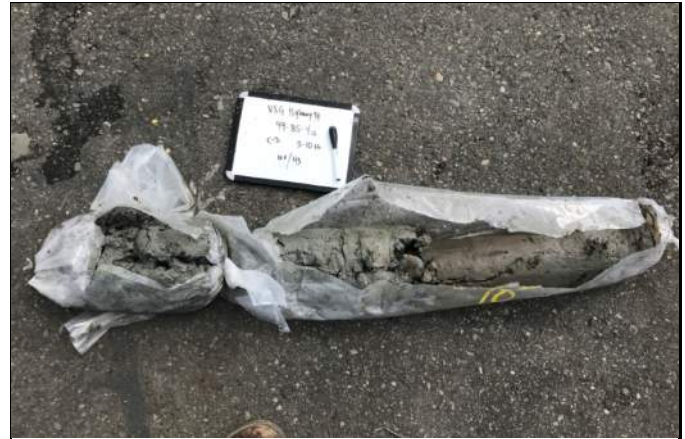
Picture Date:	Friday 08/7/2020
Picture Taken By:	Haley Provinsal
Picture Location:	Milton, Washington
Project Name:	USG Highway 99 Site
Description:	99-BS-4a, C-1 (5-10 ft bgs) (misabeled in picture)

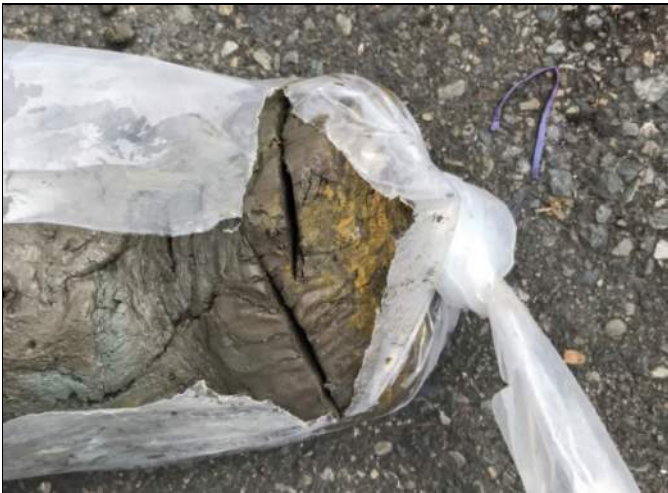
Picture Date:	Friday 08/7/2020
Picture Taken By:	Haley Provinsal
Picture Location:	Milton, Washington
Project Name:	USG Highway 99 Site
Description:	99-BS-4a, C-2 coloration

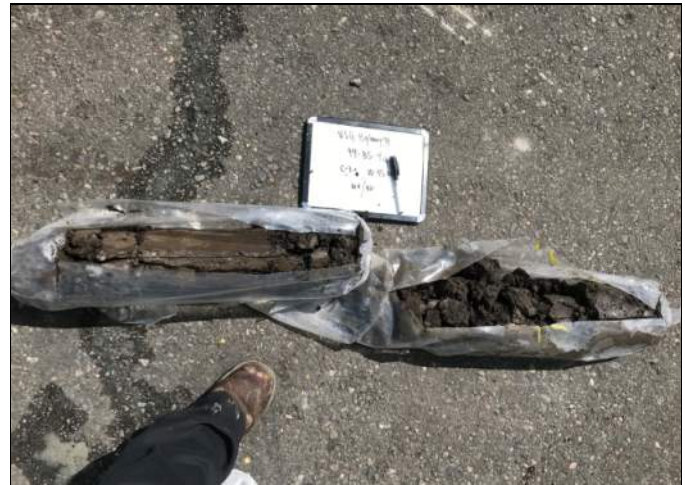
Picture Date:	Friday 08/7/2020
Picture Taken By:	Haley Provinsal
Picture Location:	Milton, Washington
Project Name:	USG Highway 99 Site
Description:	99-BS-4a, C-2 (10-15 ft bgs) (misabeled in picture)

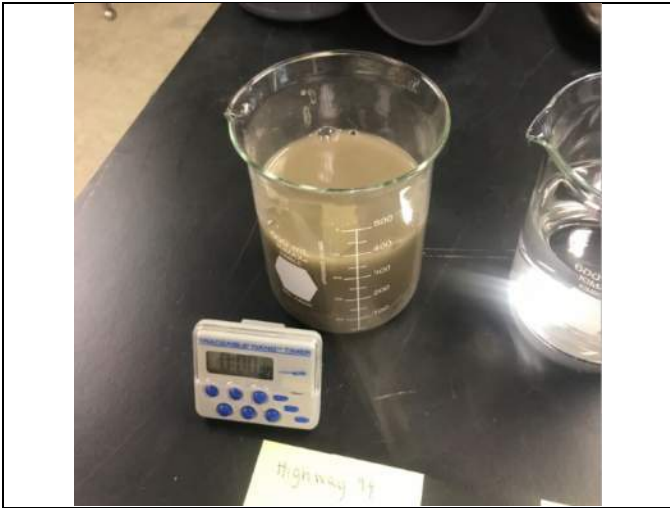
Picture Date:	Tuesday 08/11/2020
Picture Taken By:	Haley Provinsal
Picture Location:	Bellevue, Washington
Project Name:	USG Highway 99/Puyallup Sites
Project Description:	Highway 99 Site Initial Activation with Portland Cement and site water

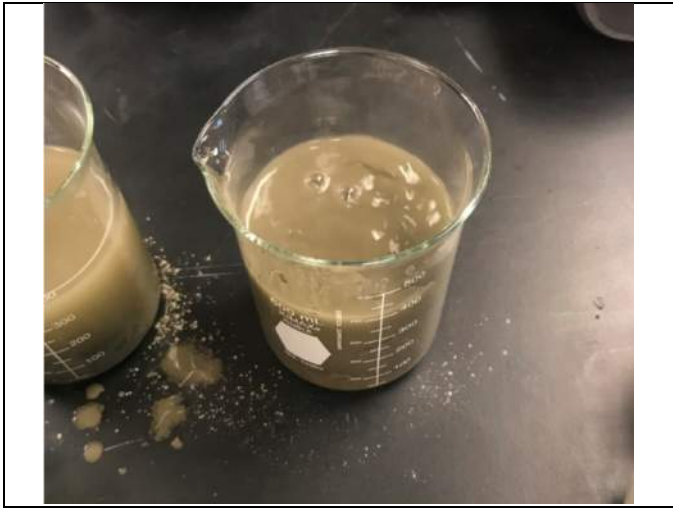
Picture Date:	Tuesday 08/11/2020
Picture Taken By:	Haley Provinsal
Picture Location:	Bellevue, Washington
Project Name:	USG Highway 99/Puyallup Sites
Project Description:	Puyallup Site Initial Activation with Portland Cement and site water

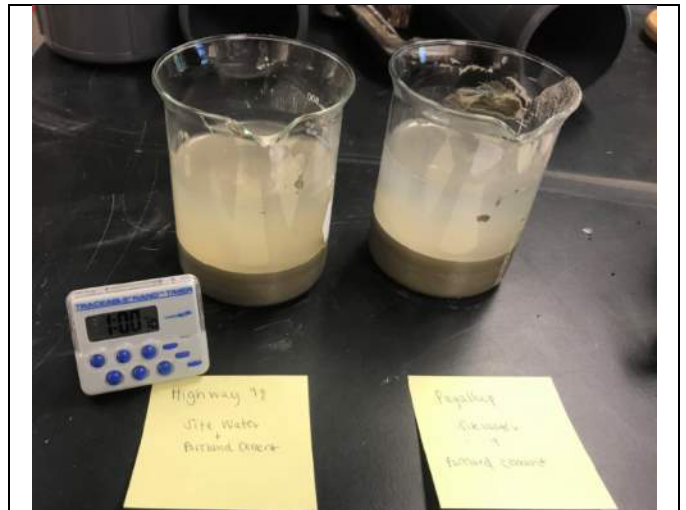
Picture Date:	Tuesday 08/11/2020
Picture Taken By:	Haley Provinsal
Picture Location:	Bellevue, Washington
Project Name:	USG Highway 99/Puyallup Sites
Project Description:	Time Passed = 1 hour Portland Cement and site water

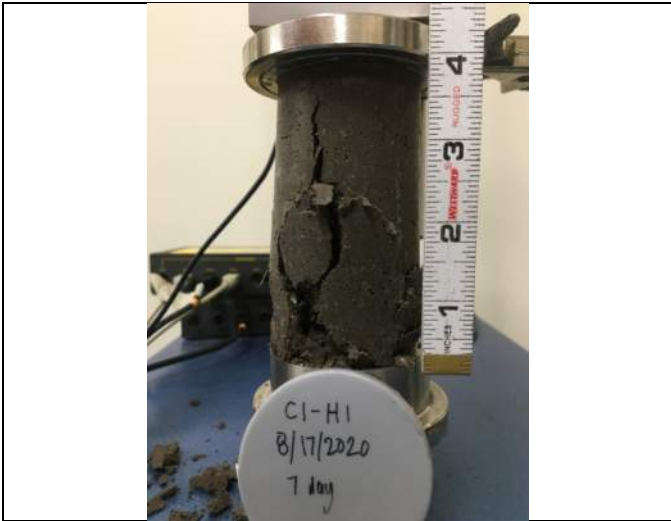
Picture Date:	Monday 08/24/2020
Picture Taken By:	Matt Polsky
Picture Location:	Chelmsford, Massachusetts
Project Name:	USG Highway 99 Site
Project Description:	C1-H1 UCS 7-day break

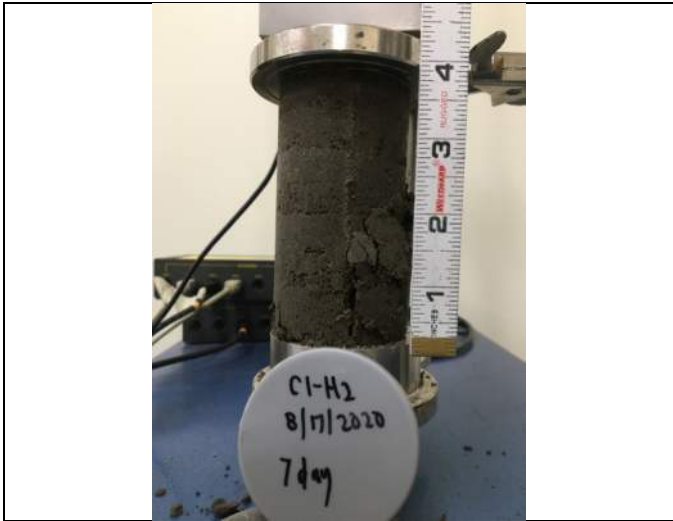
Picture Date:	Monday 08/24/2020
Picture Taken By:	Matt Polsky
Picture Location:	Chelmsford, Massachusetts
Project Name:	USG Highway 99 Site
Project Description:	C1-H2 UCS 7-day break

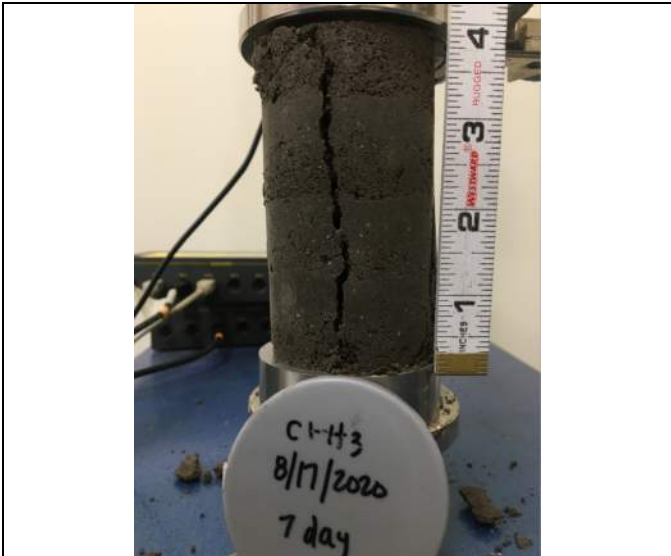
Picture Date:	Monday 08/24/2020
Picture Taken By:	Matt Polsky
Picture Location:	Chelmsford, Massachusetts
Project Name:	USG Highway 99 Site
Project Description:	C1-H3 UCS 7-day break

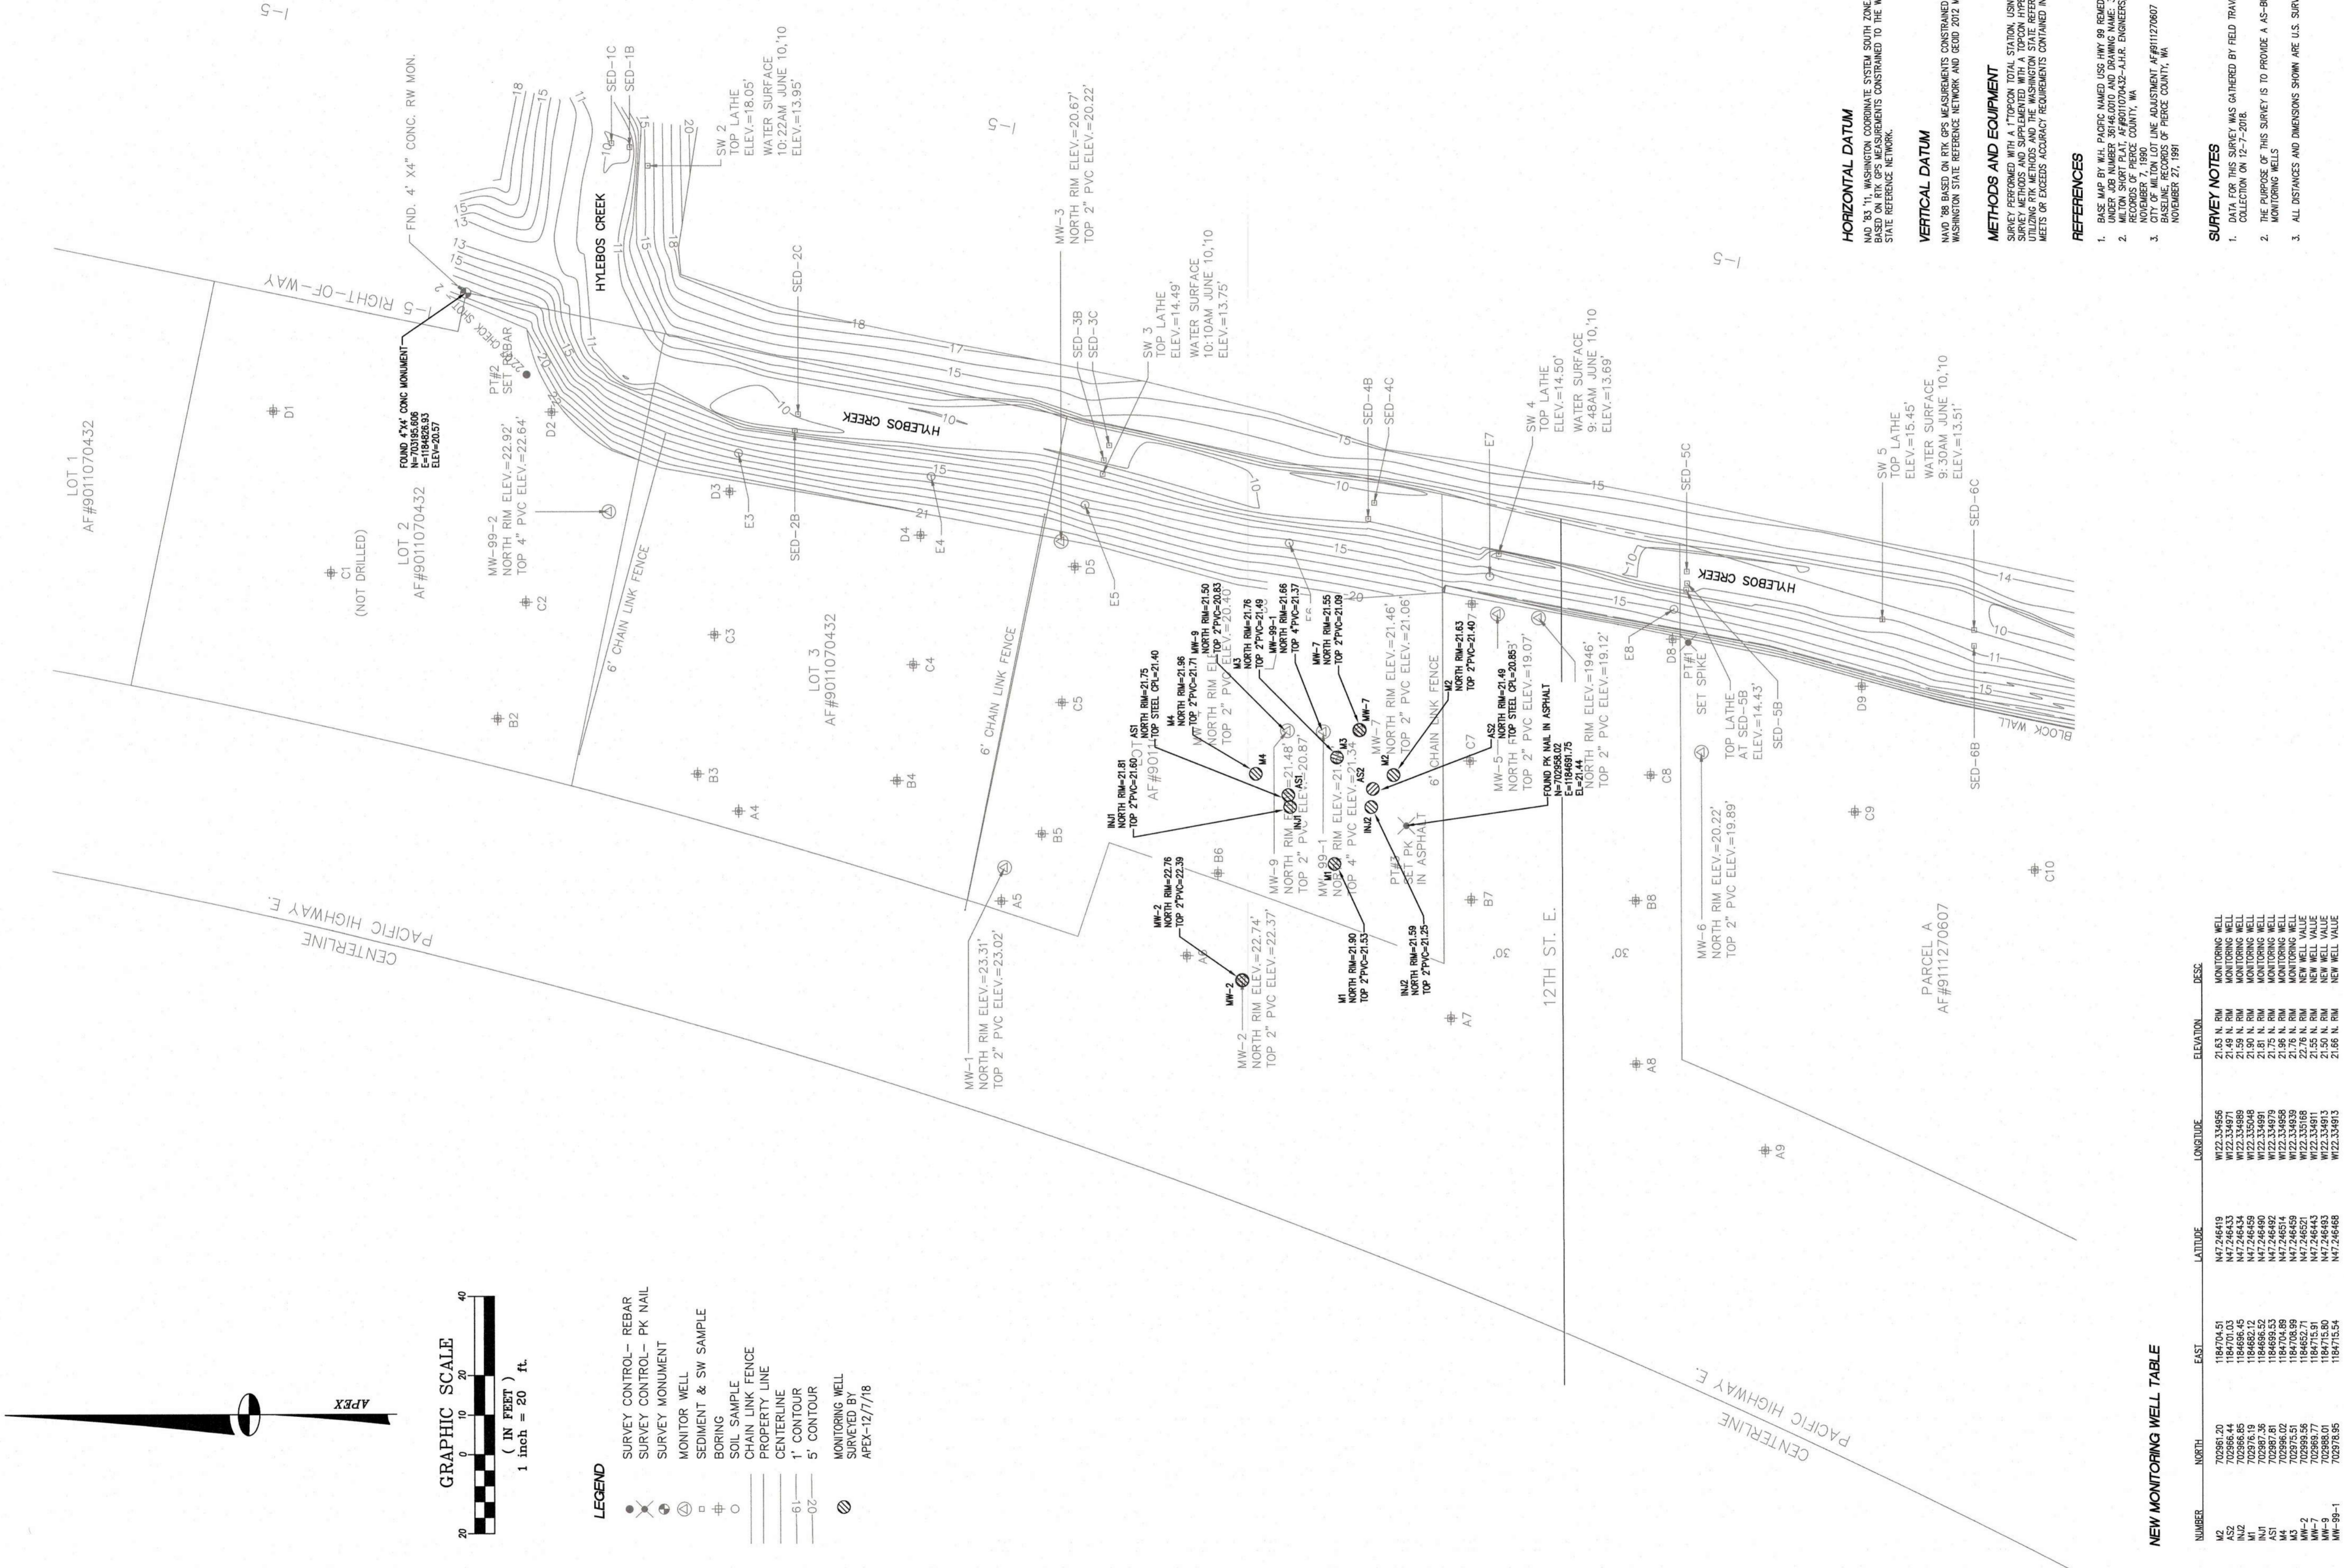
THE NORTHWEST QUARTER AND THE SOUTHWEST QUARTER OF THE SOUTHWEST QUARTER OF SECTION 5, TOWNSHIP 20 NORTH, RANGE 04 EAST, W.M.
PIERCE COUNTY, WASHINGTON

An updated site survey was performed by APEX Engineering in Tacoma, Washington on August 5, 2020. The updated site survey is shown in **Appendix C**. Elevations noted herein are in feet and referenced to the North America Vertical Datum 1988 (NAVD88).
