EMERGENCY ACTIONS - EMERGENCY ACTION REPORT

REMEDIAL ACTION UNIT 3

**CAMP BONNEVILLE
VANCOUVER, WASHINGTON**

February 2007

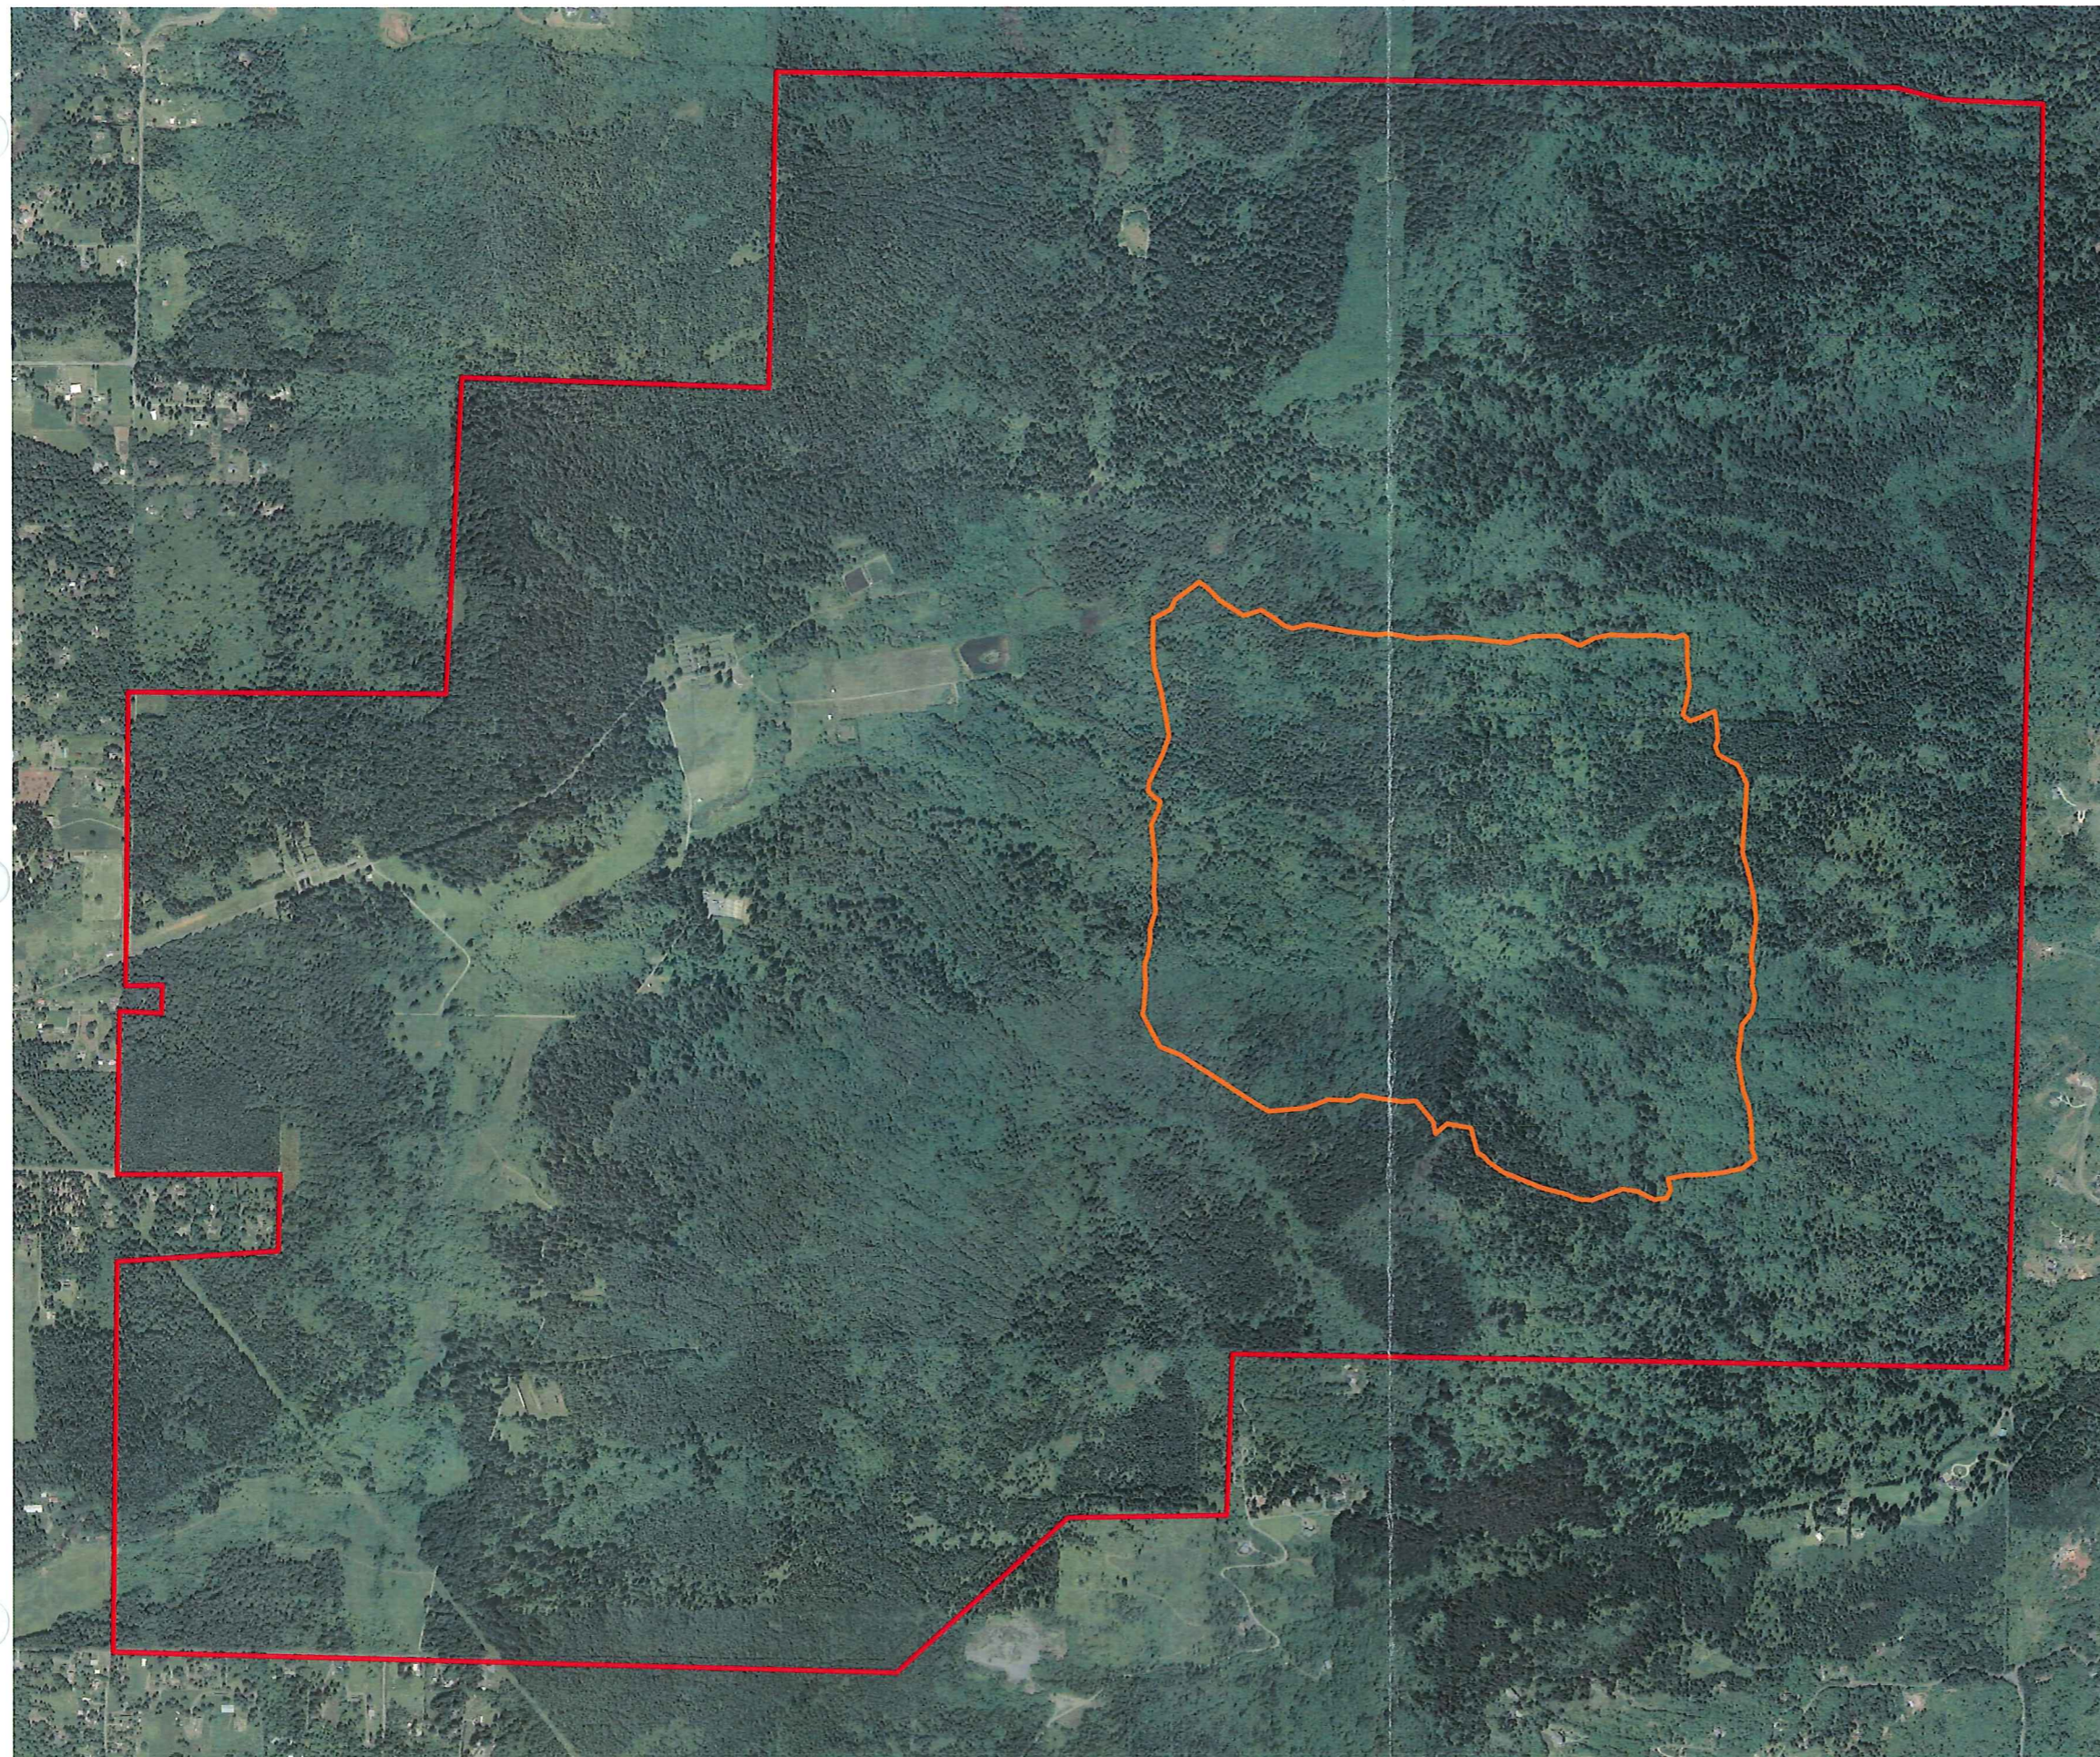
Figure 1-2. Perimeter/CITA for
Emergency Actions

For the emergency actions, the investigation area was established as an area 10 feet wide area along the exterior of the CITA perimeter. This area differed from the specified area in the PPCD, which was a 10 feet wide area along the interior side of the CITA perimeter. This deviation was approved by WDOE because of public safety and ease of fence repair. The CITA boundary extends approximately 3.6 miles. **Figure 3-1** shows the CITA perimeter. All grids were completed around the CITA perimeter.

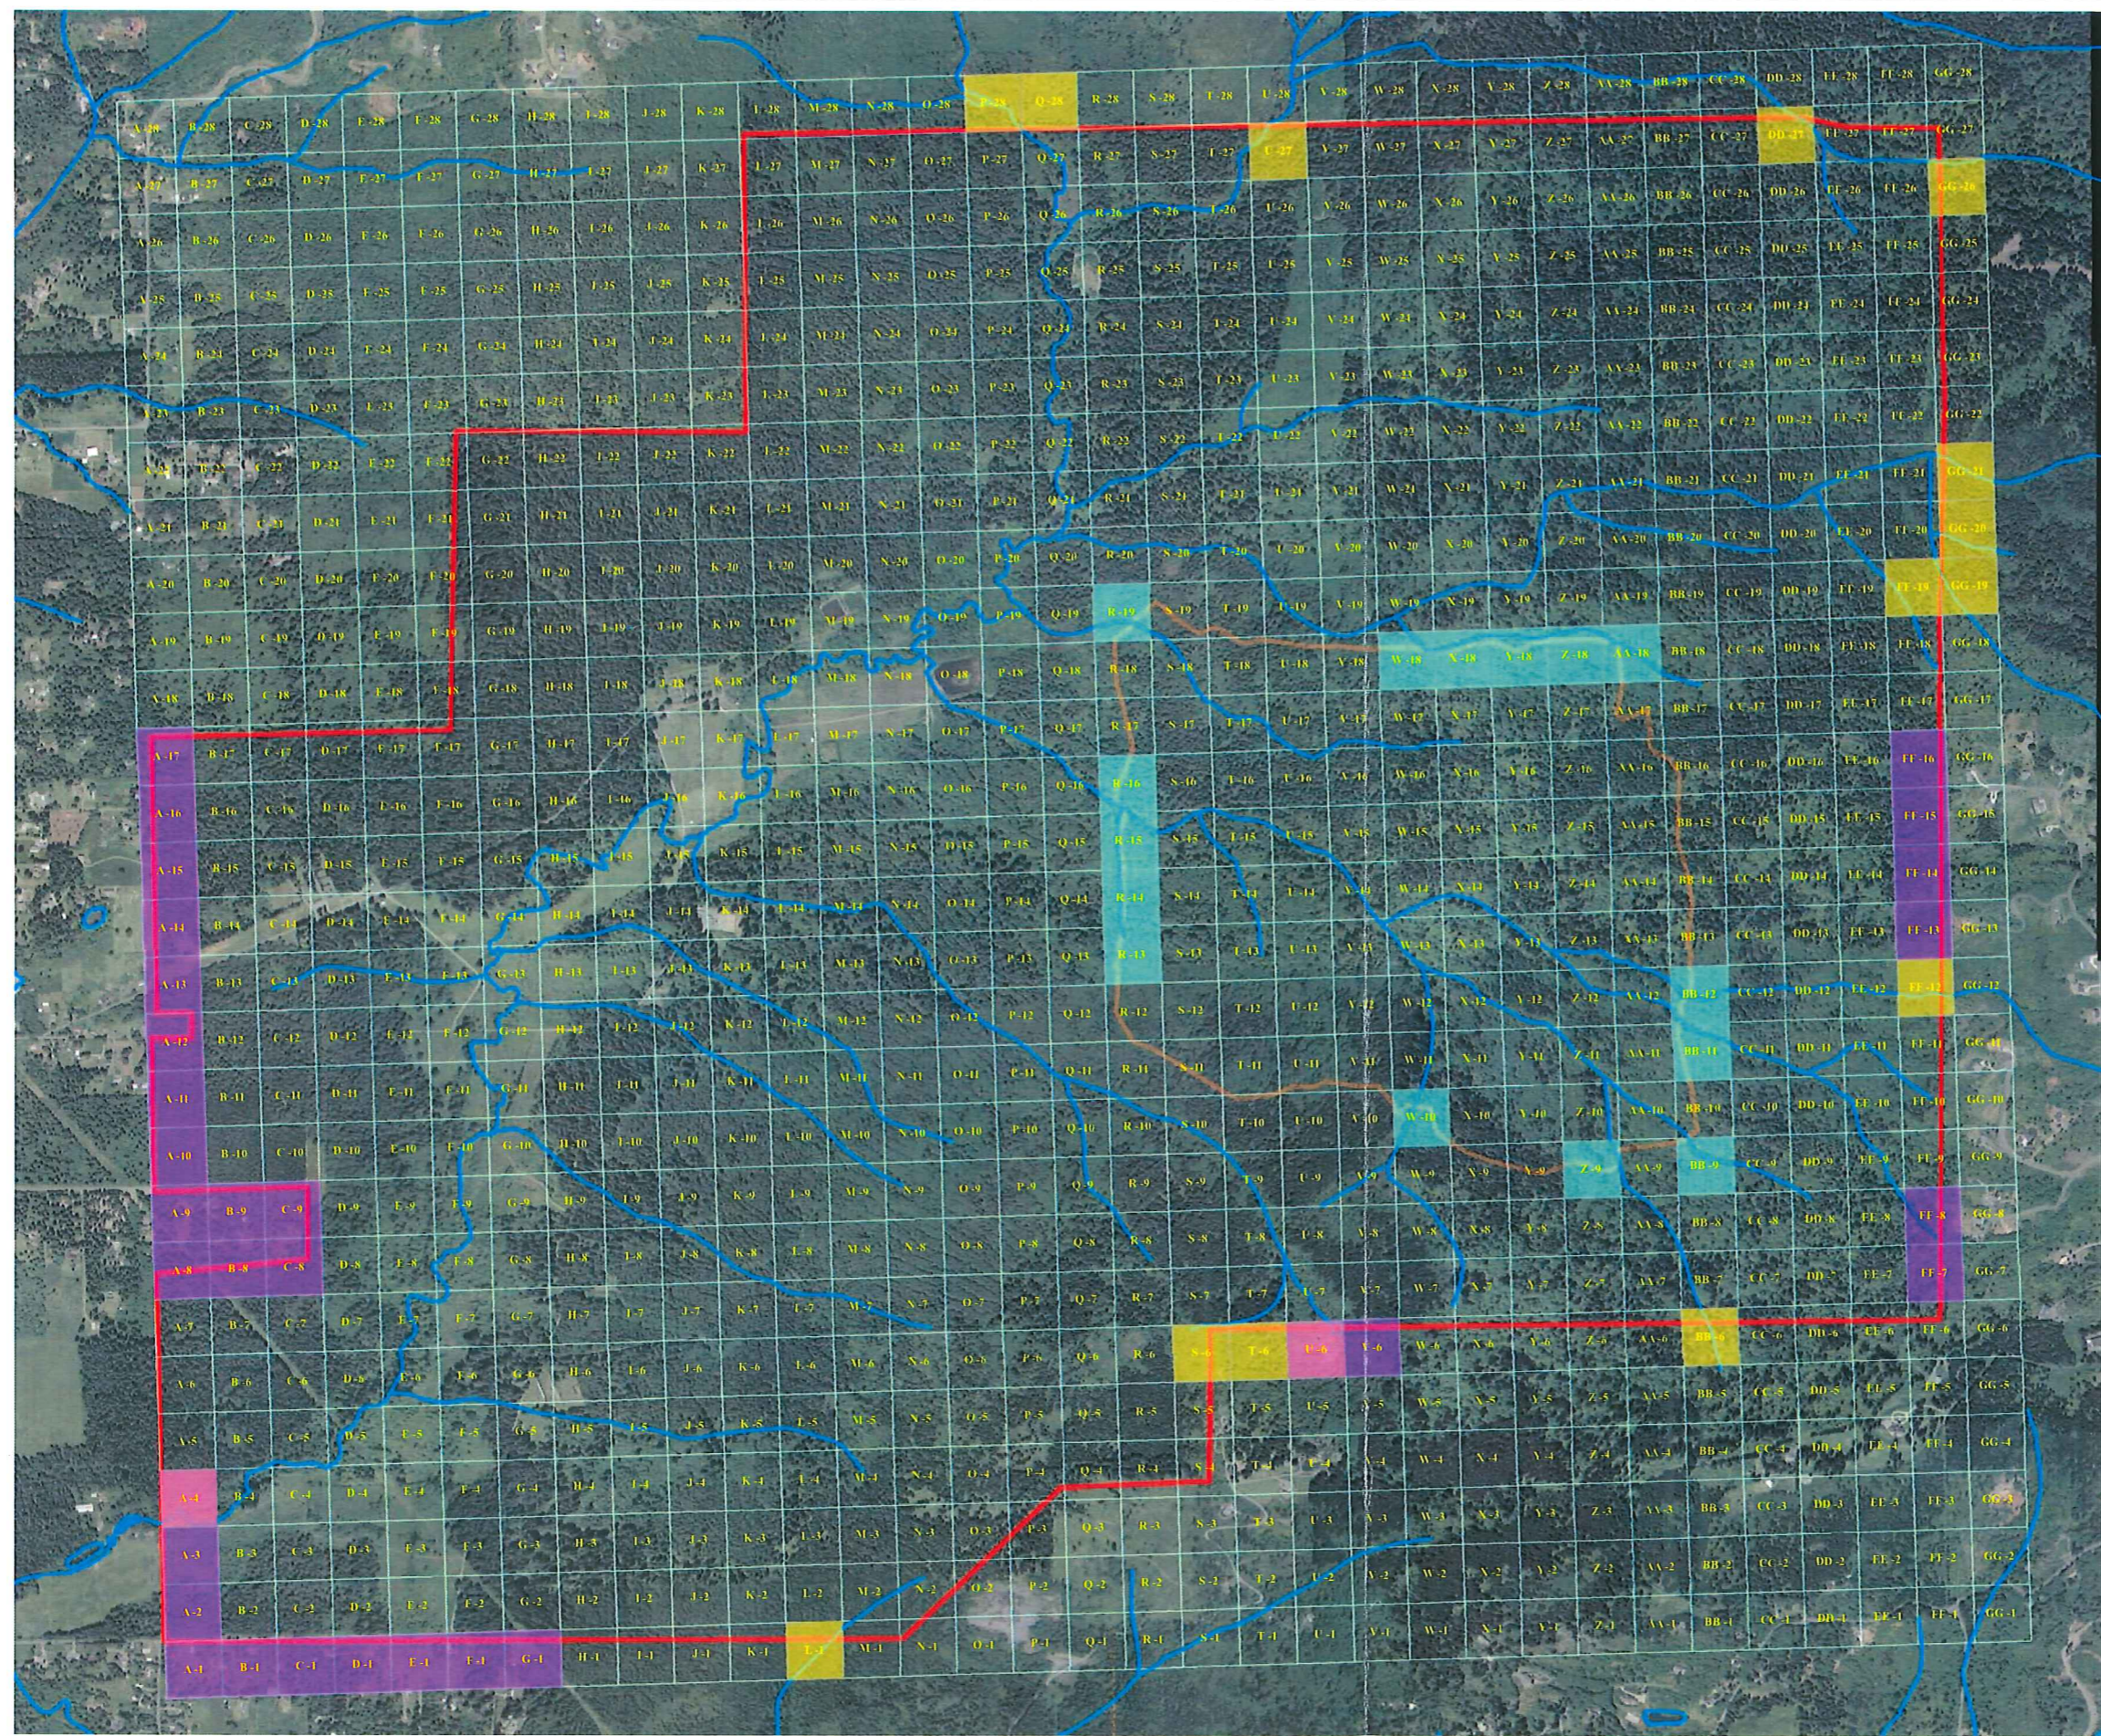
FIGURE 3-2. Camp Bonneville Military Reservation Sensitive Ecological Areas / Exclusion Grids

- Boundary
- CITA
- Creeks
- Grids (500x500)
- Exclusion Area Grids
- Sensitive Area Grids on CITA
- Sensitive Area Grids on Perimeter
- Combined Exclusion and Sensitive Area Grids

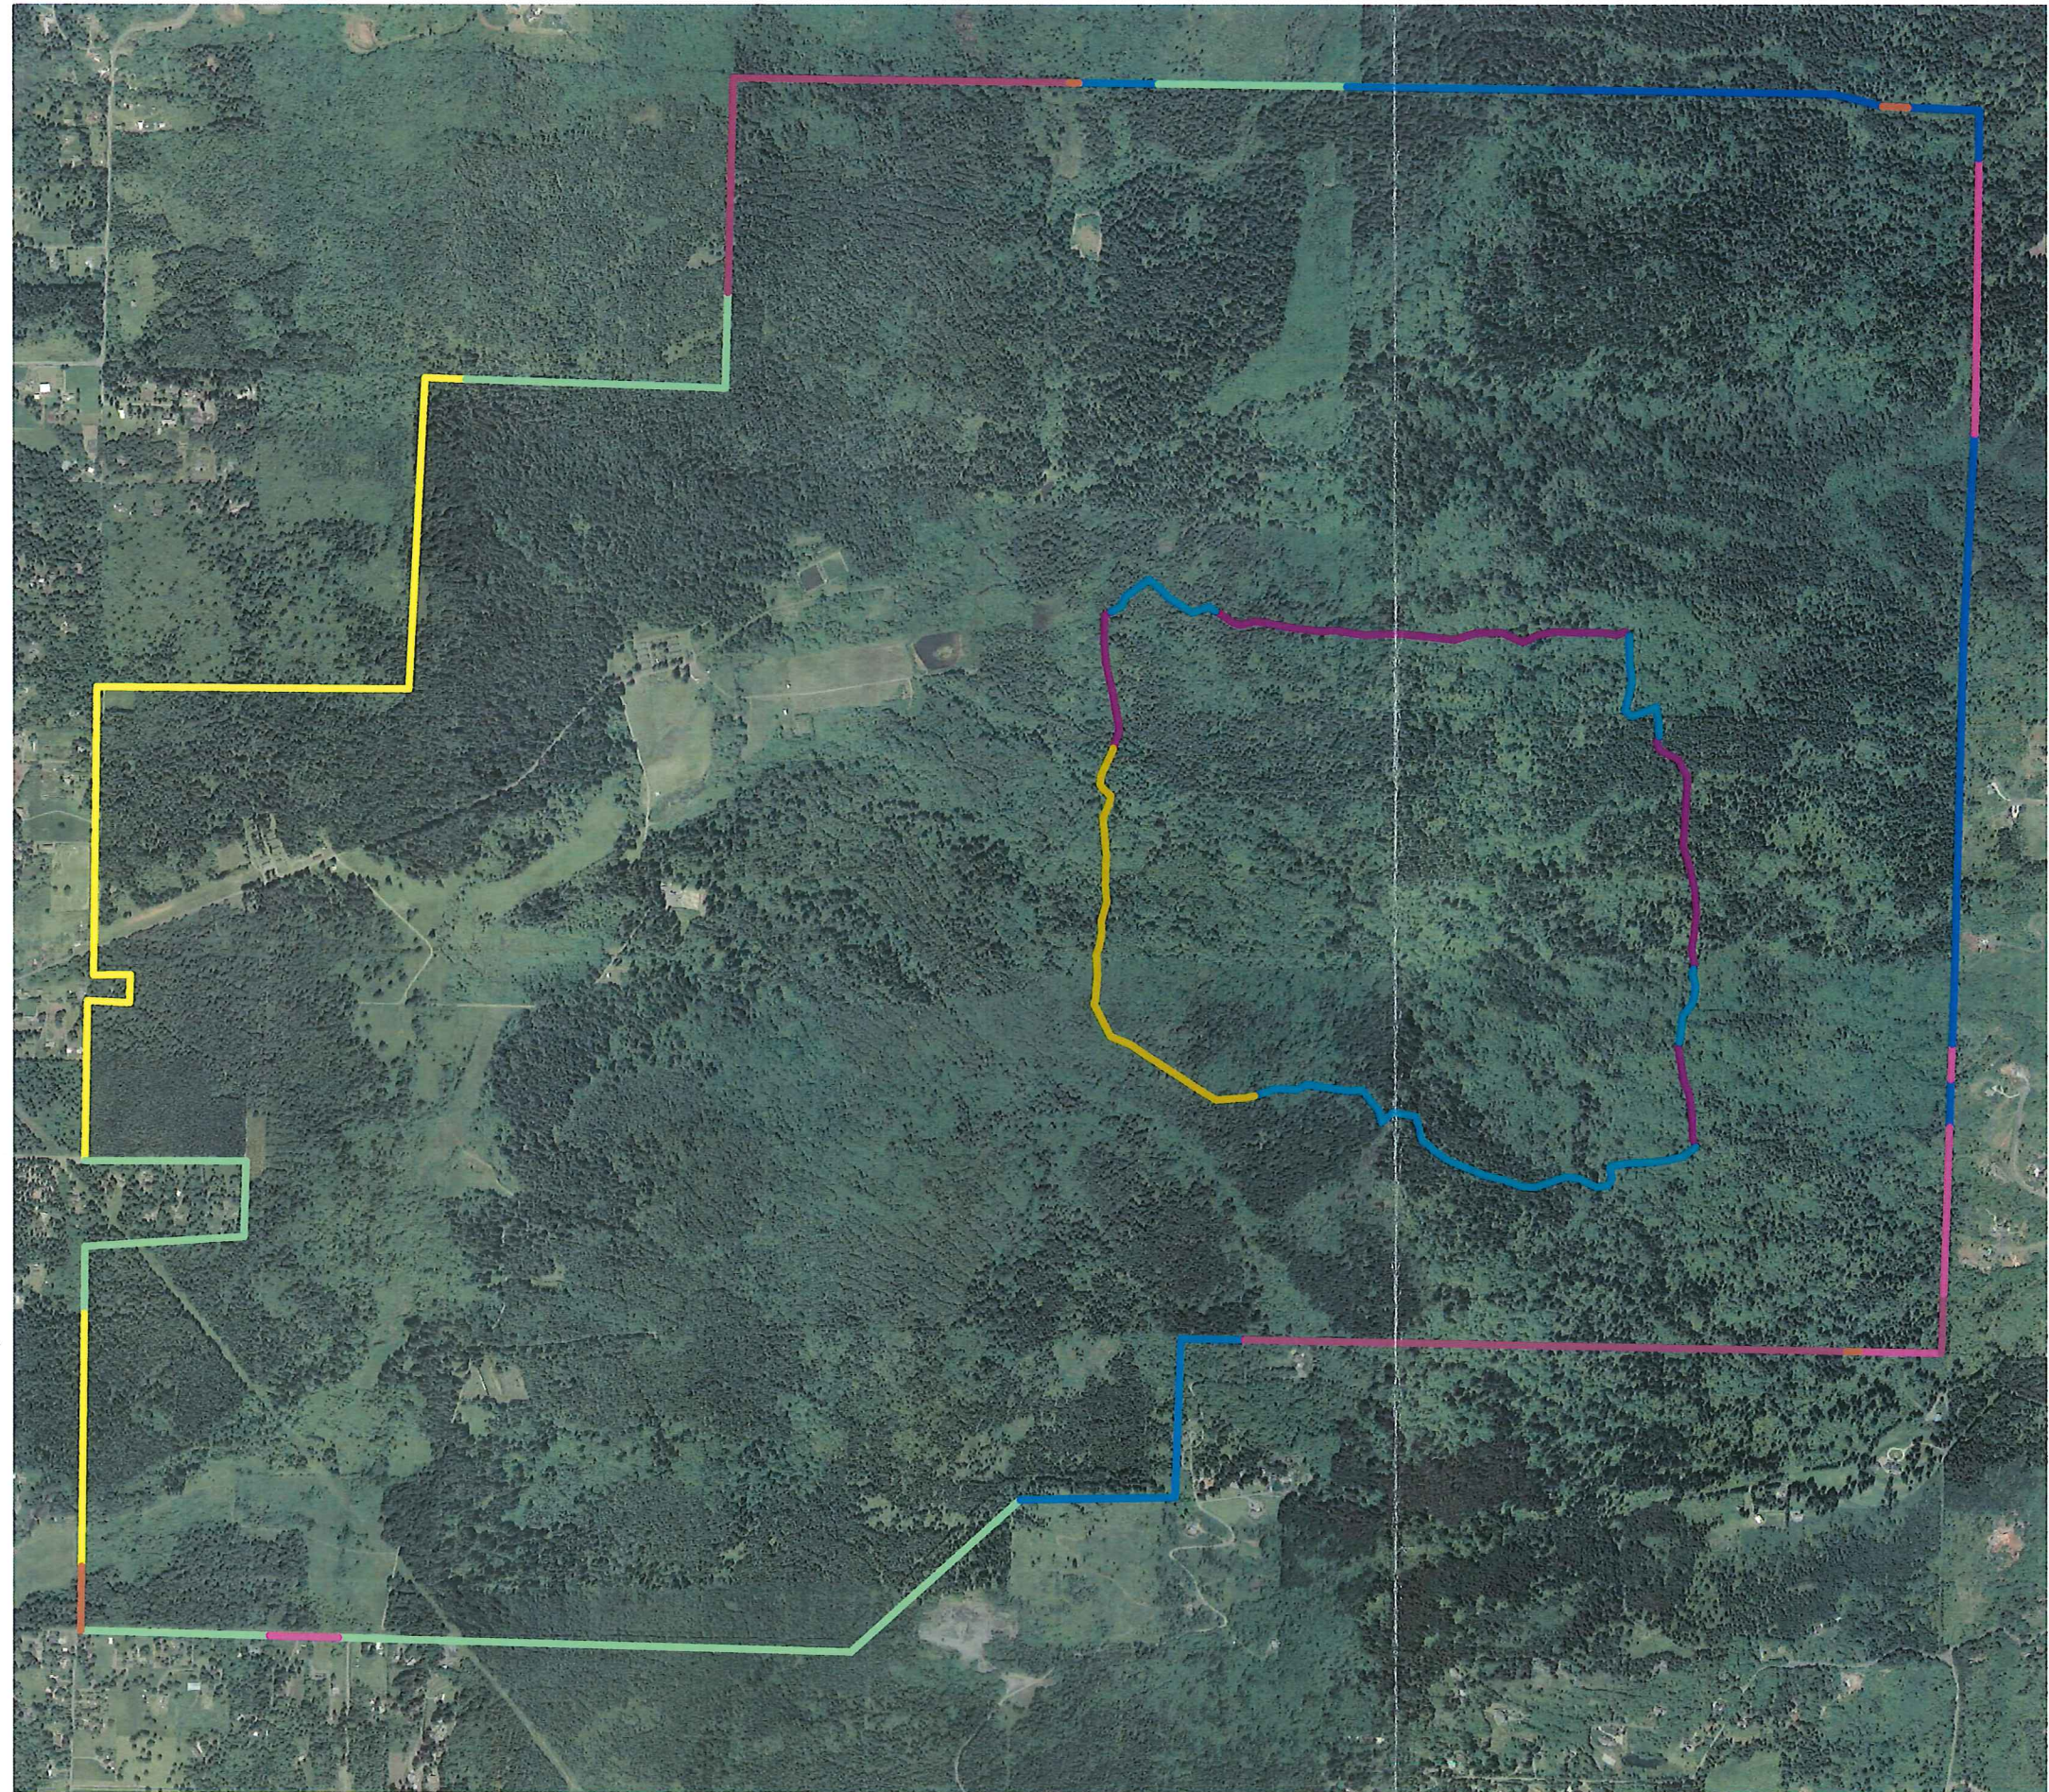
FIGURE 3-3. Vegetation Clearance Map

Weekly Tracking

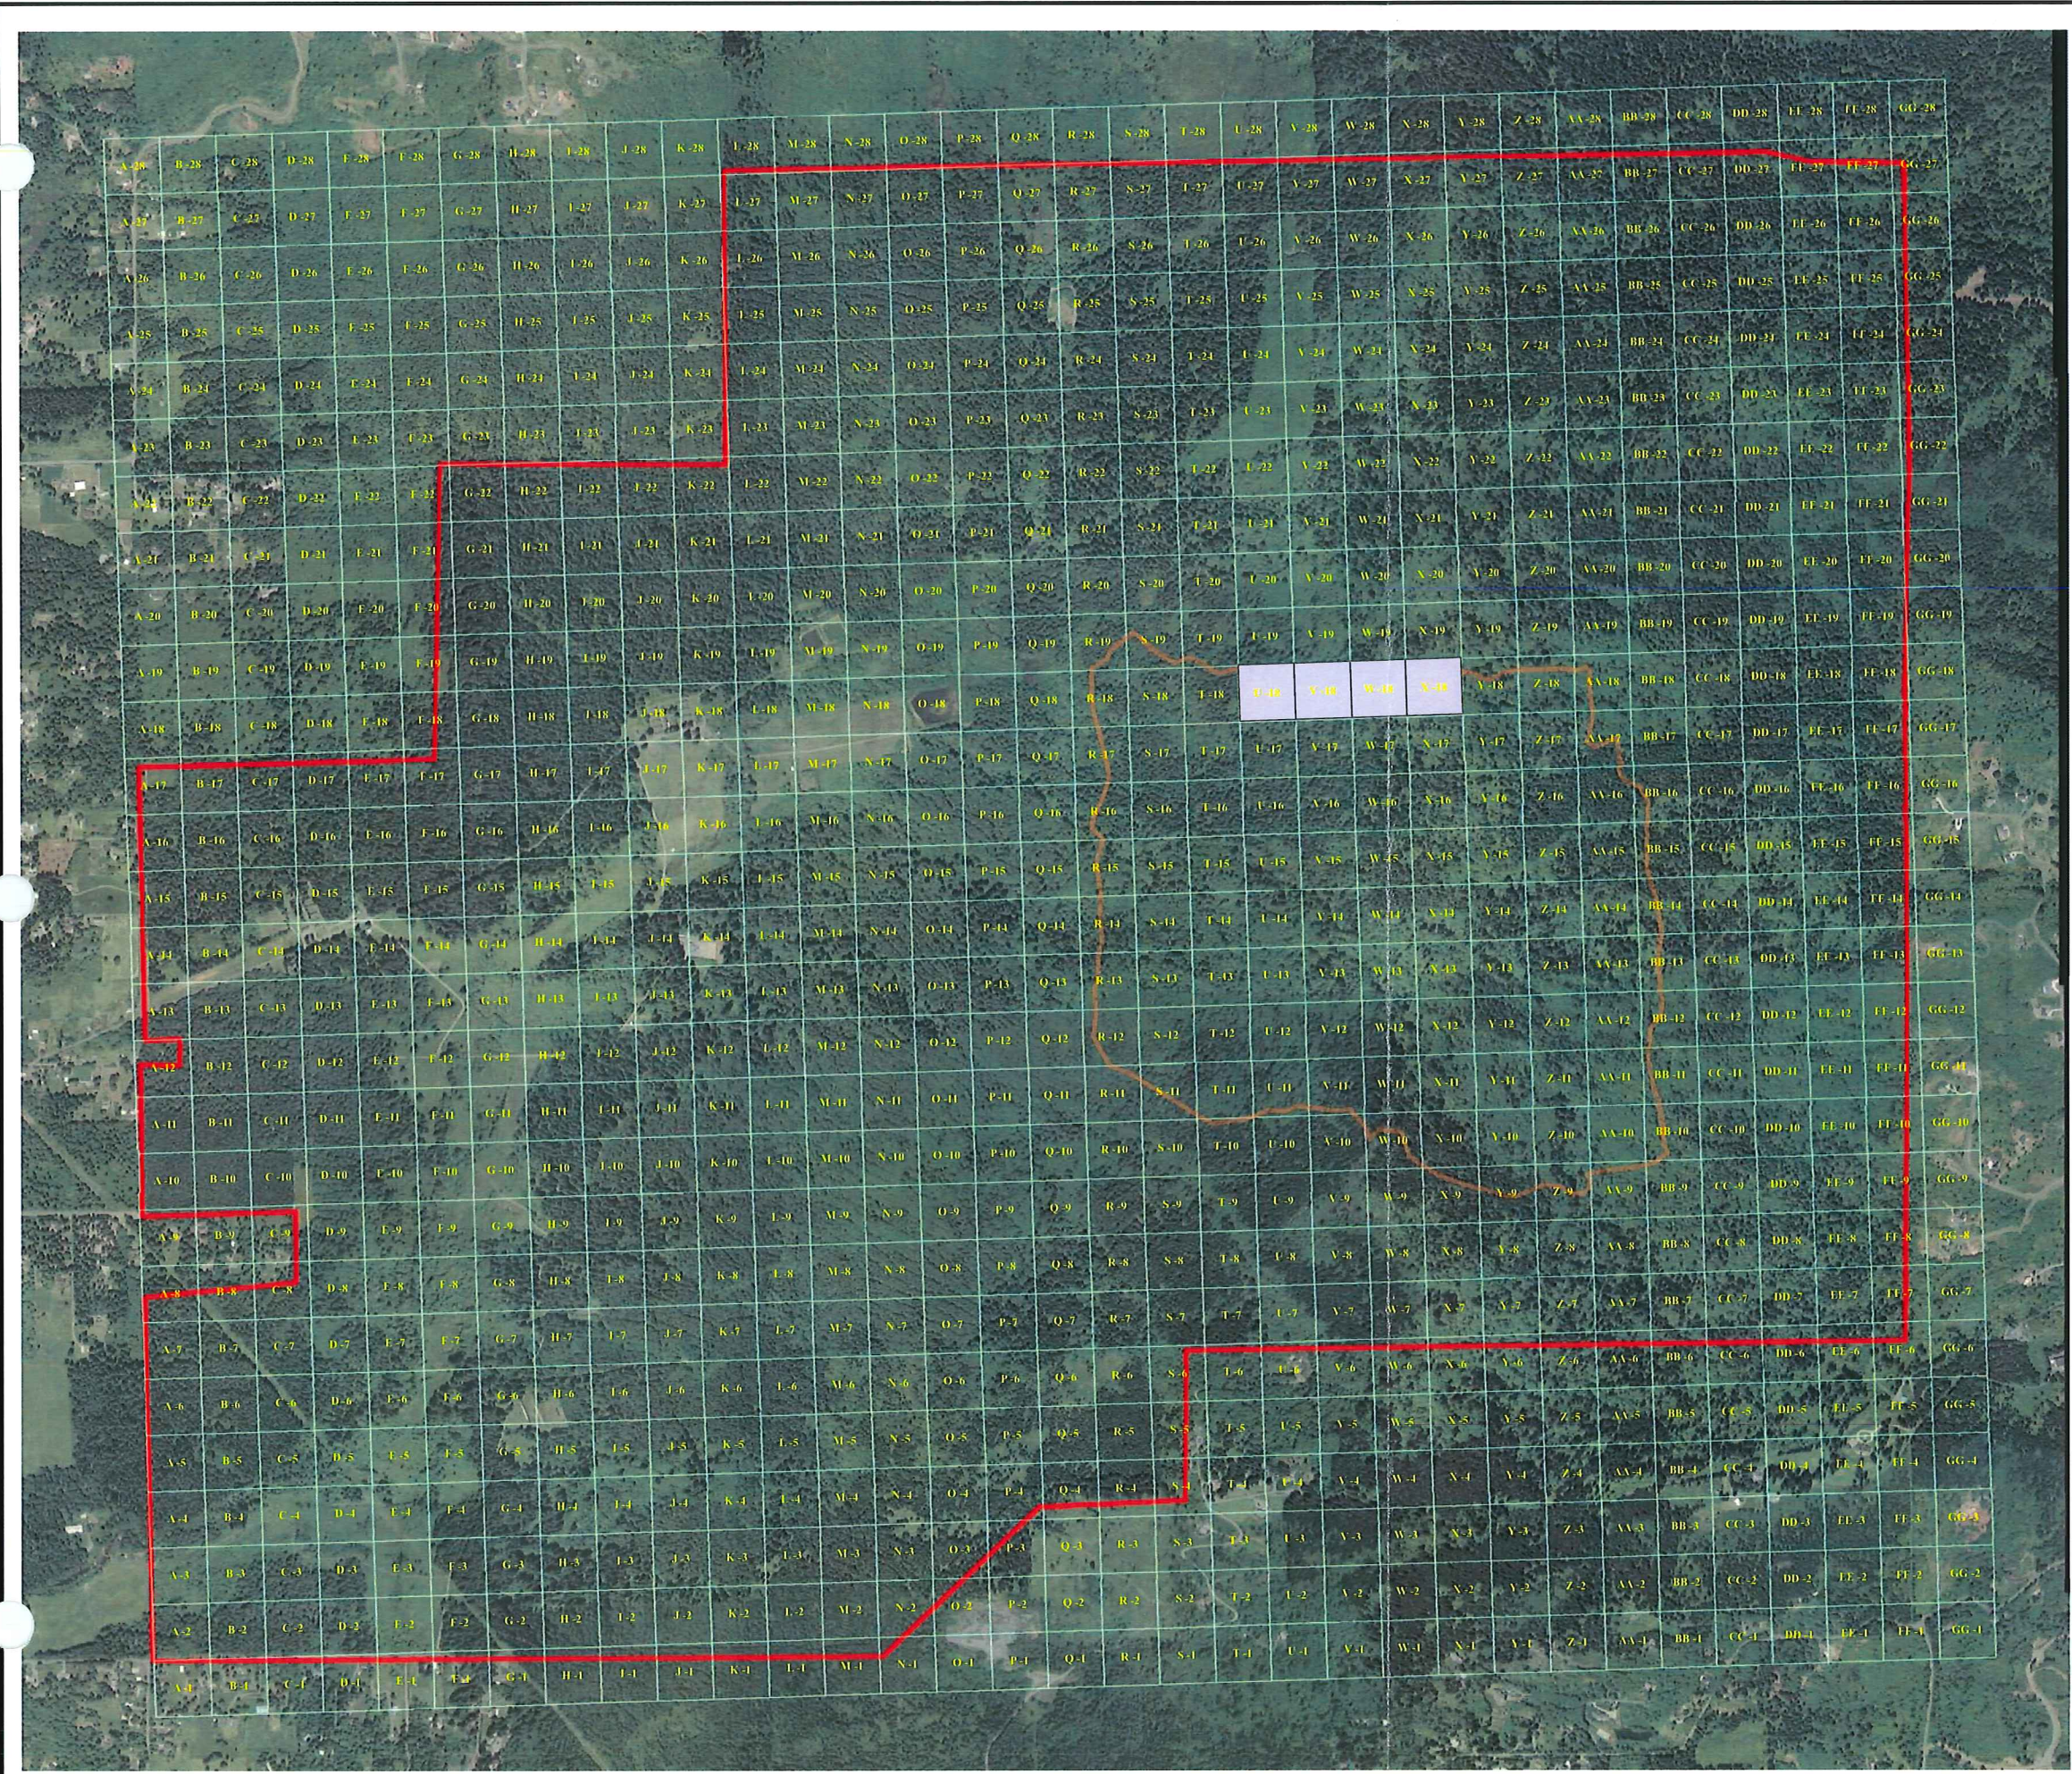
MD was found in four adjacent grids on the northern side of the CITA. A total of 9.5 pounds (lbs) of MD were identified and removed from these four grids: U18, V18, W18, and X18 (**Figure 4-1**). **Table 4-1** gives the relevant information for these MD findings. These four grids were inspected by WDOE and will not require additional investigations or step-out grids.

- Boundary
- CITA
- Grids (500x500)
- Munitions Debris Grids

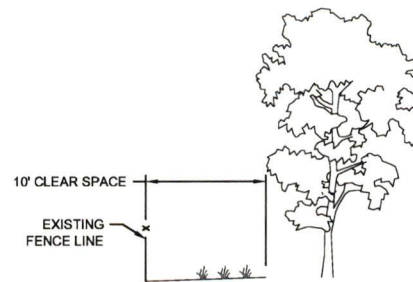
CROSS SECTION - FENCELINE

Damaged or missing fence will be repaired or replaced with new wire and posts as necessary to maintain site access controls. The majority of the fence is comprised of a 5-strand barb wire with metal posts. Portions of the western perimeter fence consist of 6-foot high chain link security fence. The repaired or restored fence will be ensured along the entire existing fence alignment.

- No mechanical equipment will enter wetlands or waterbodies.
- The fence will be repaired, restored, and maintained within its existing footprint.
