PHASE 1 ENVIRONMENTAL SITE ASSESSMENT AND HAZARDOUS MATERIALS SURVEY

Duwamish Waterway Park
7900 – 10th Avenue South
Seattle, Washington 98106

Prepared for: Seattle Parks and Recreation
800 Maynard Avenue South, 3rd Floor
Seattle, Washington 98134

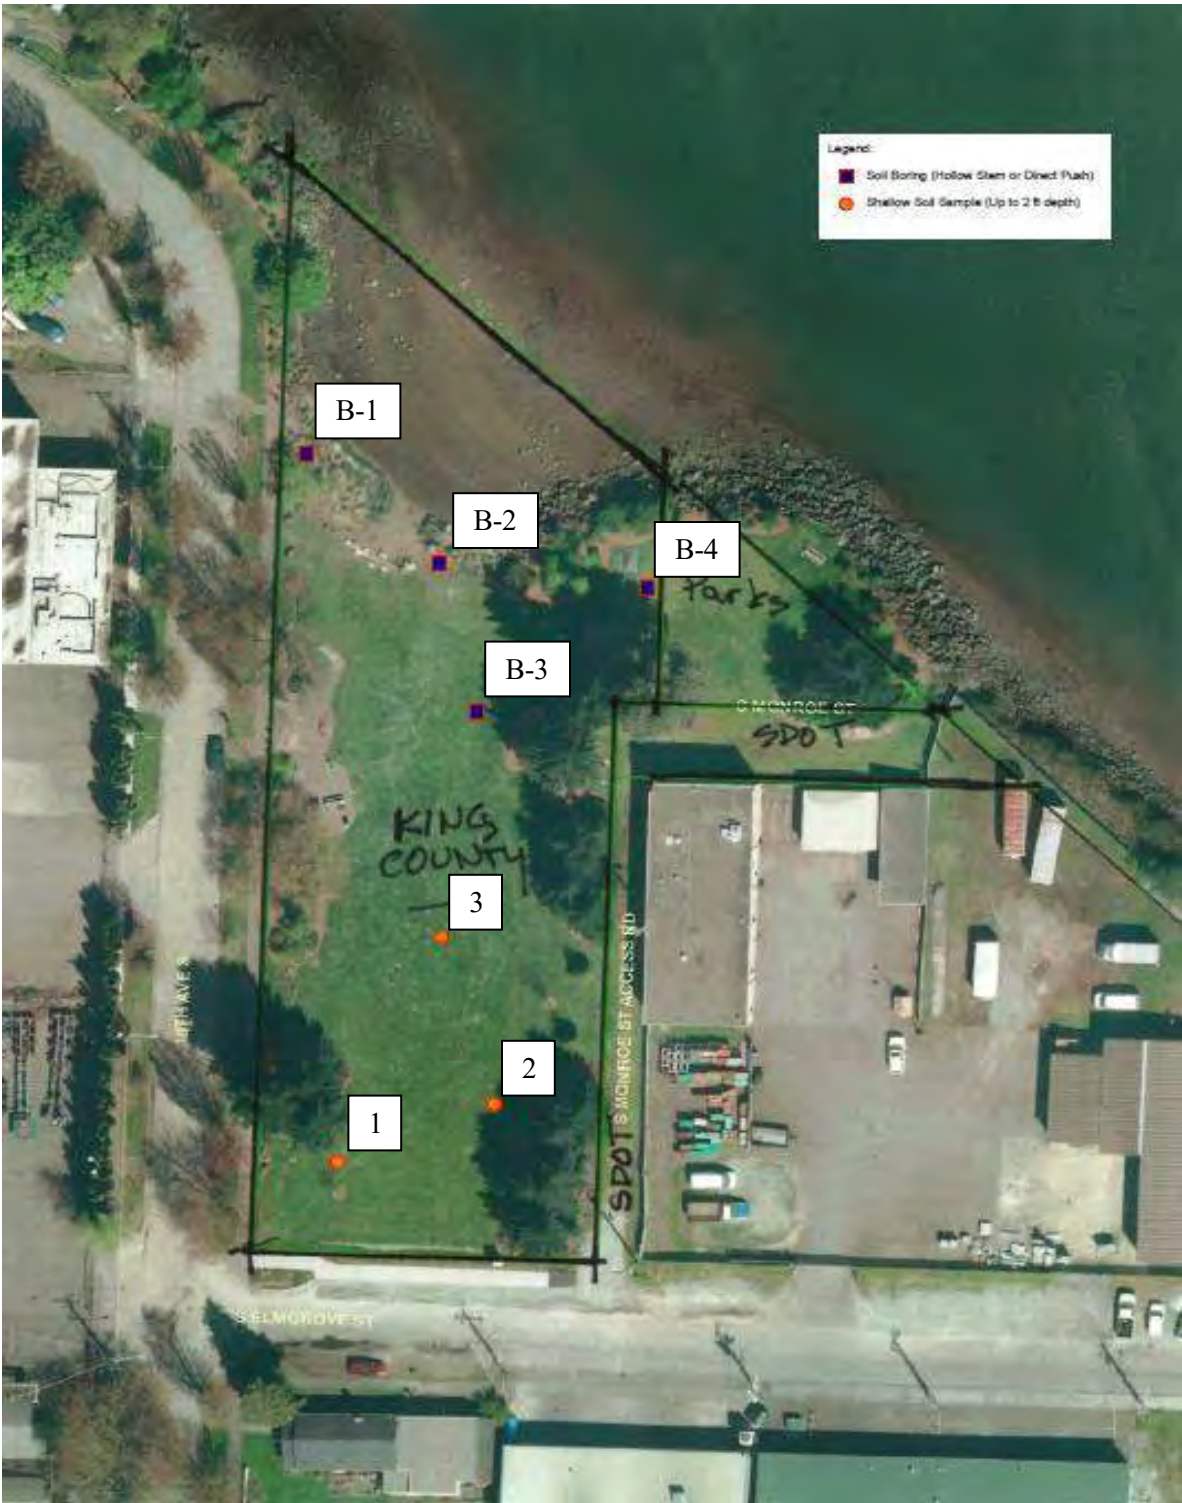
Figure 1. Approximate soil sampling locations. Duwamish Waterway Park. January 18, 2019.

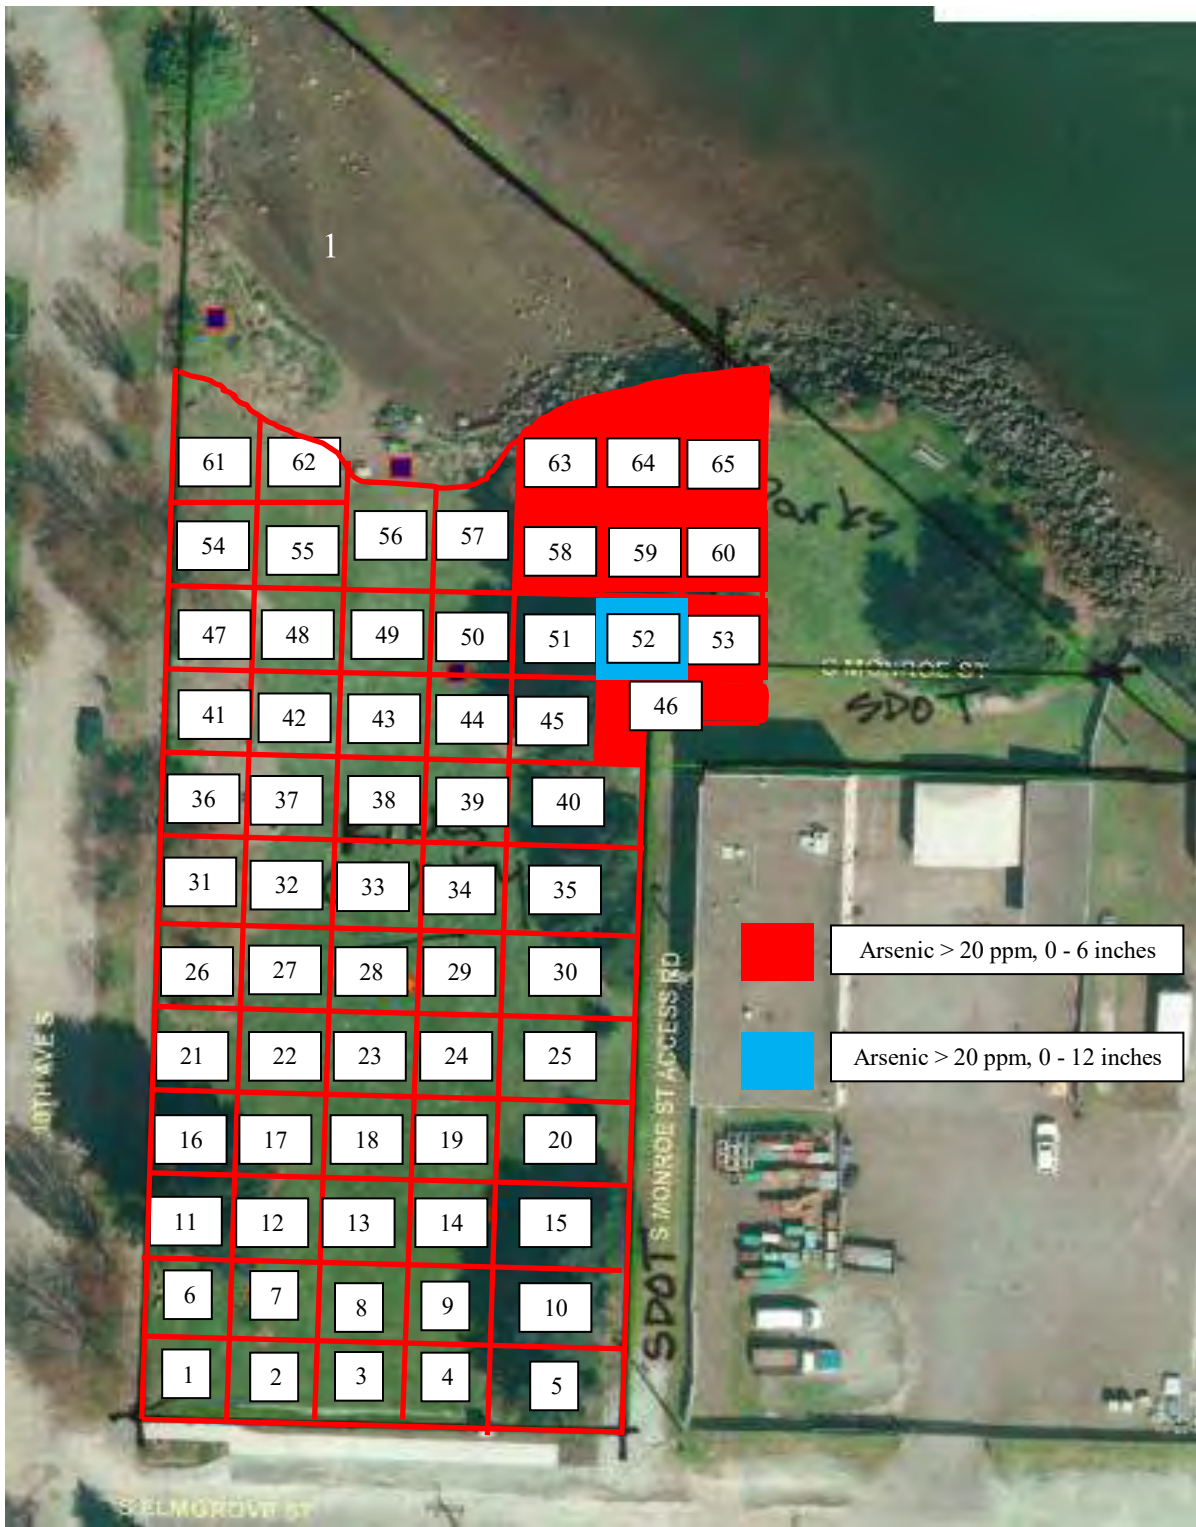
Figure 1. Soil sampling grids with arsenic above the Ecology cleanup standard of 20 ppm. Duwamish Waterway Park, Seattle. January, 2019.
