Supplemental Phase II
Environmental Site Assessment
Brightwater Conveyance System
Ballinger Way Portal
20031 Ballinger Way NE
Shoreline, Washington

May 19, 2005

**SUPPLEMENTAL PHASE II ENVIRONMENTAL SITE ASSESSMENT
BRIGHTWATER CONVEYANCE SYSTEM
20031 BALLINGER WAY NE
SHORELINE, WASHINGTON**

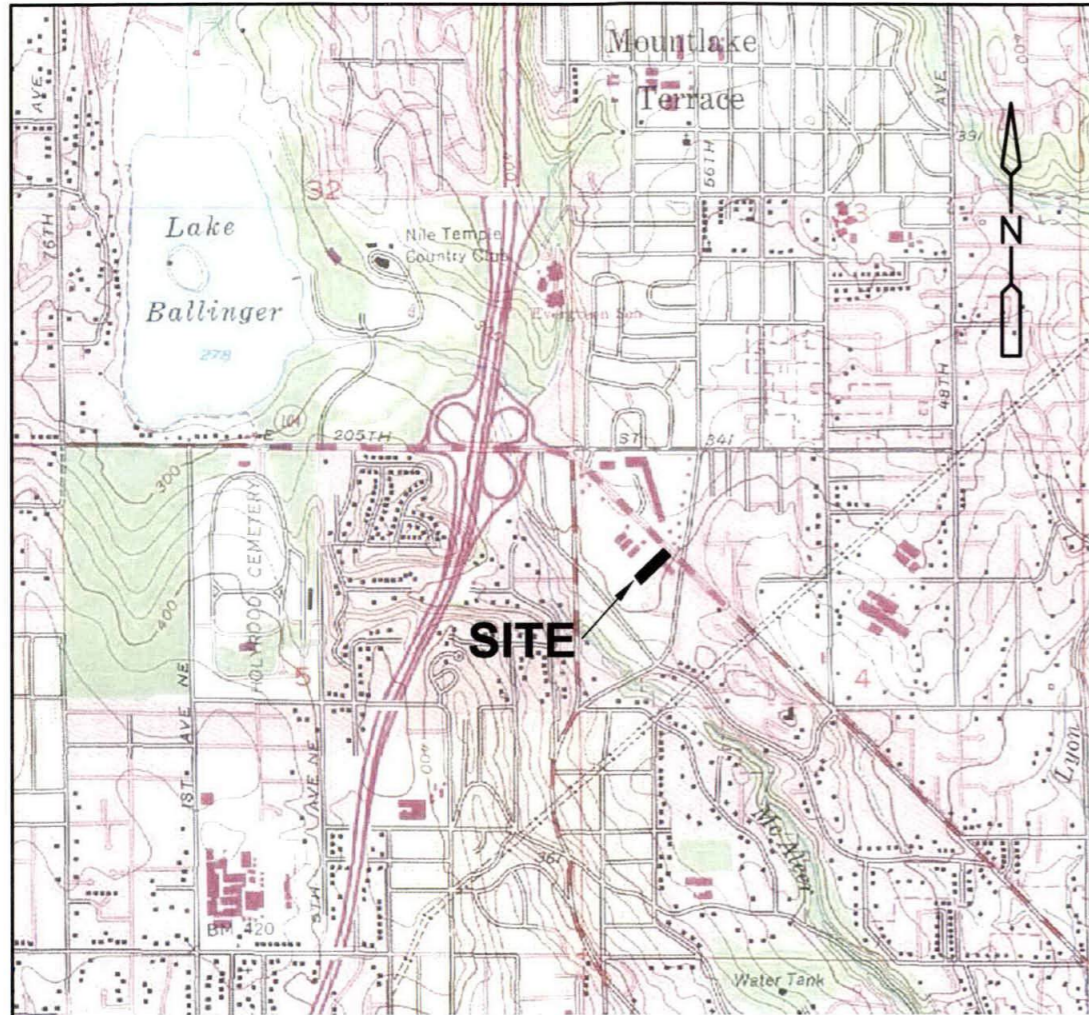
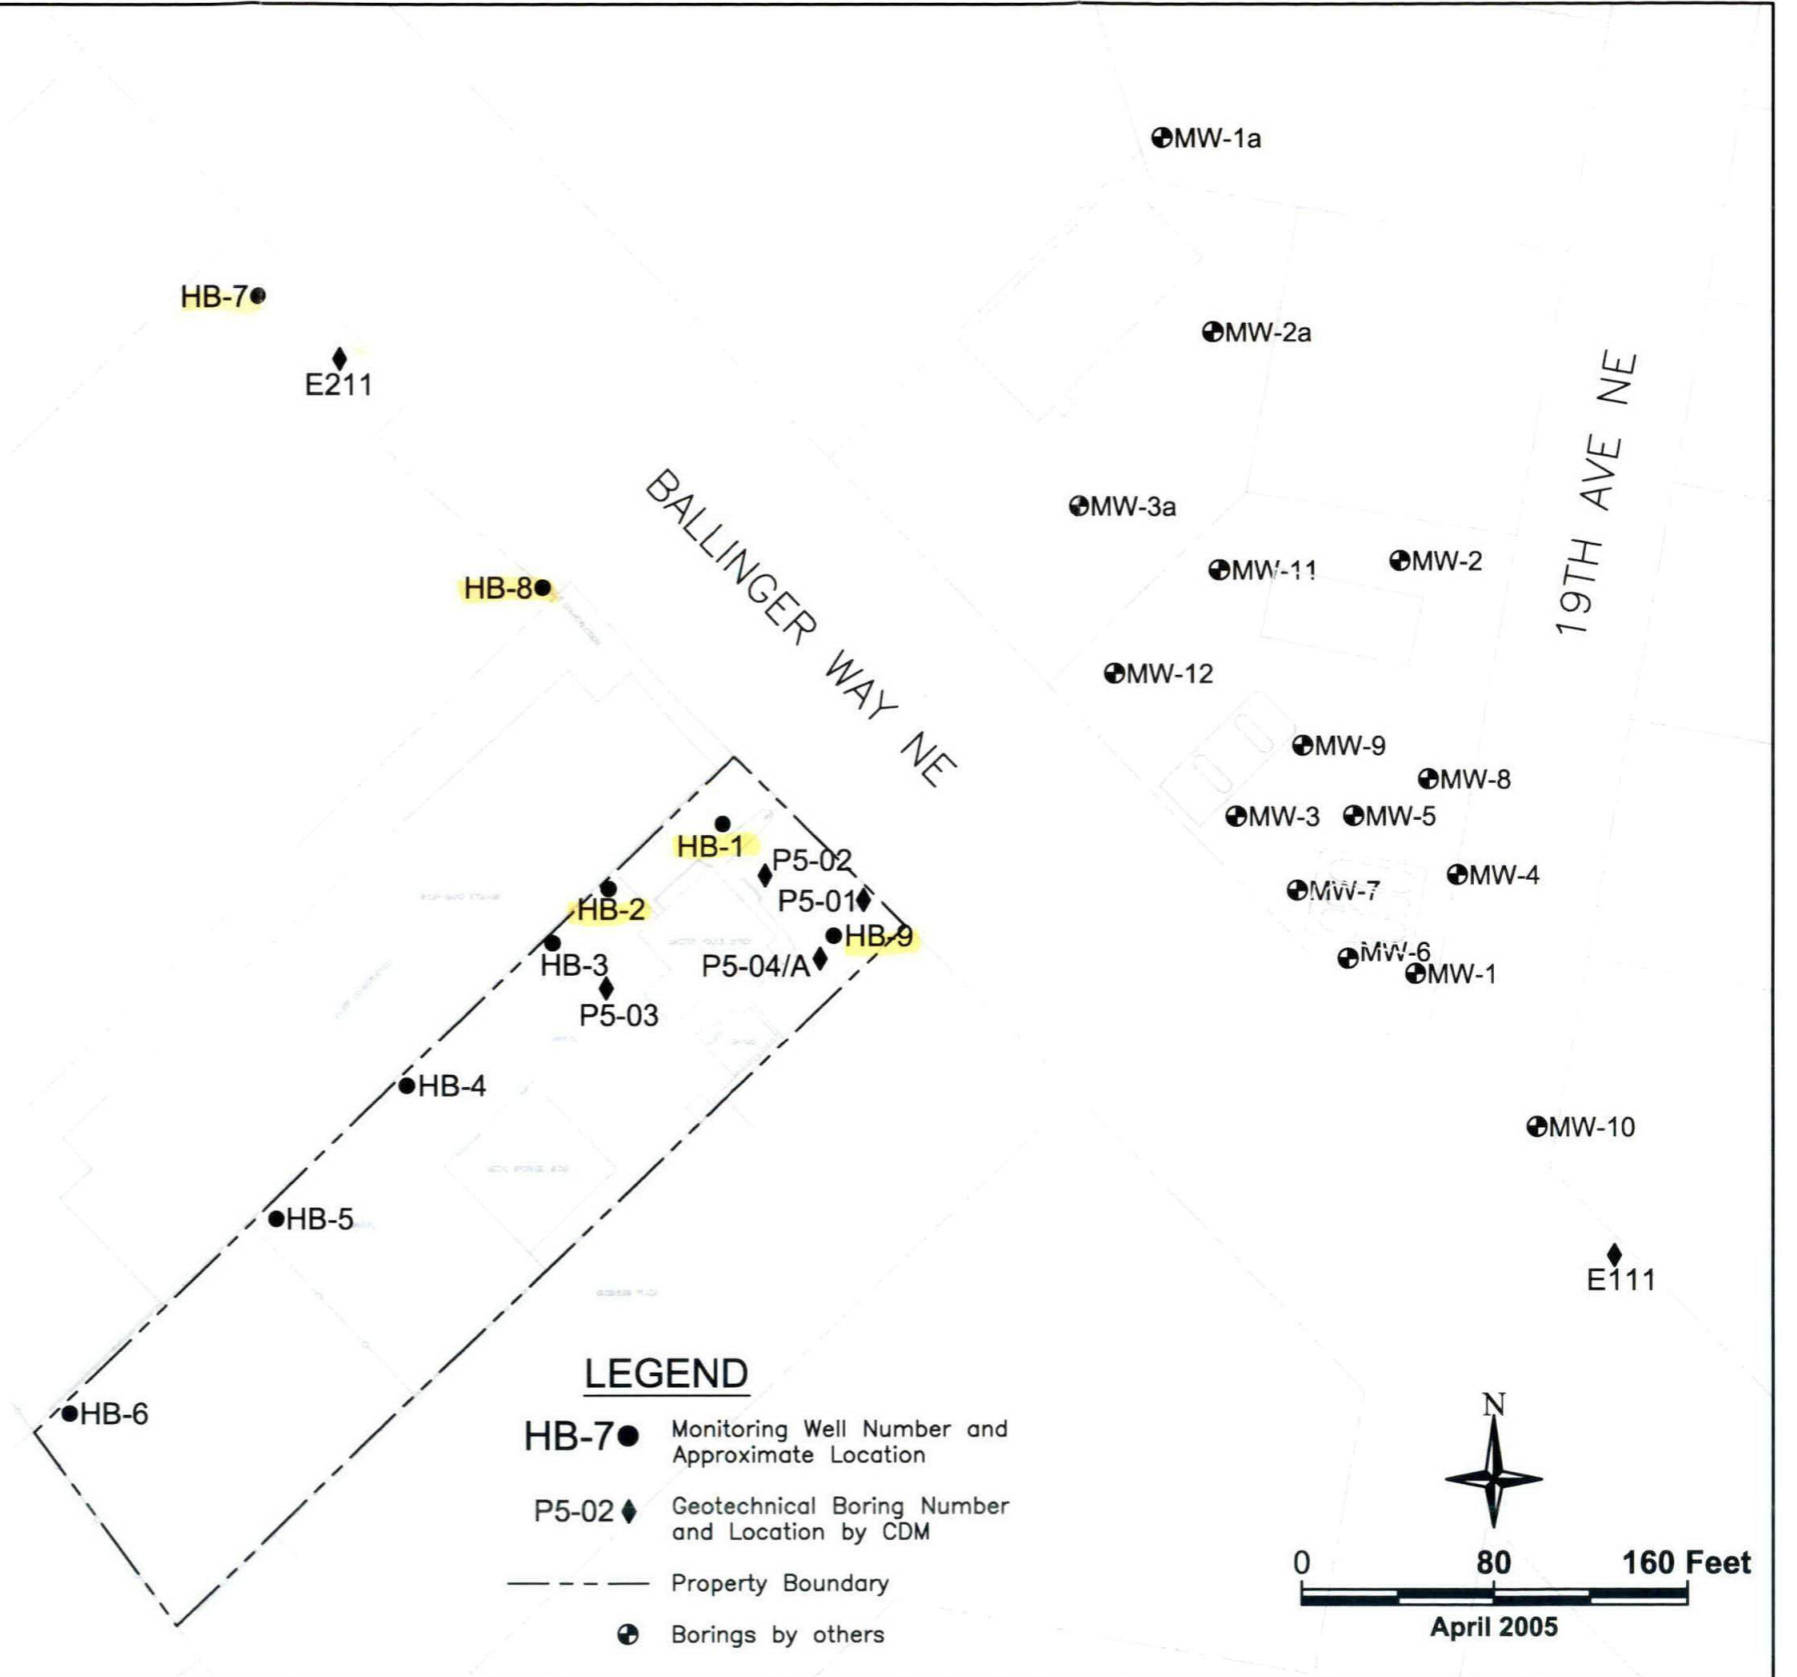
Figure 1
Ballinger Way Portal Vicinity Map & Site Plan
BRIGHTWATER REGIONAL
WASTEWATER TREATMENT SYSTEM

The site is rectangular shaped and covers an area of 0.94 acres, with the long axis trending northeast. The site contains two 1-story commercial buildings: one office/retail building, and one warehouse. Figure 1 shows a site plan and pertinent site features.

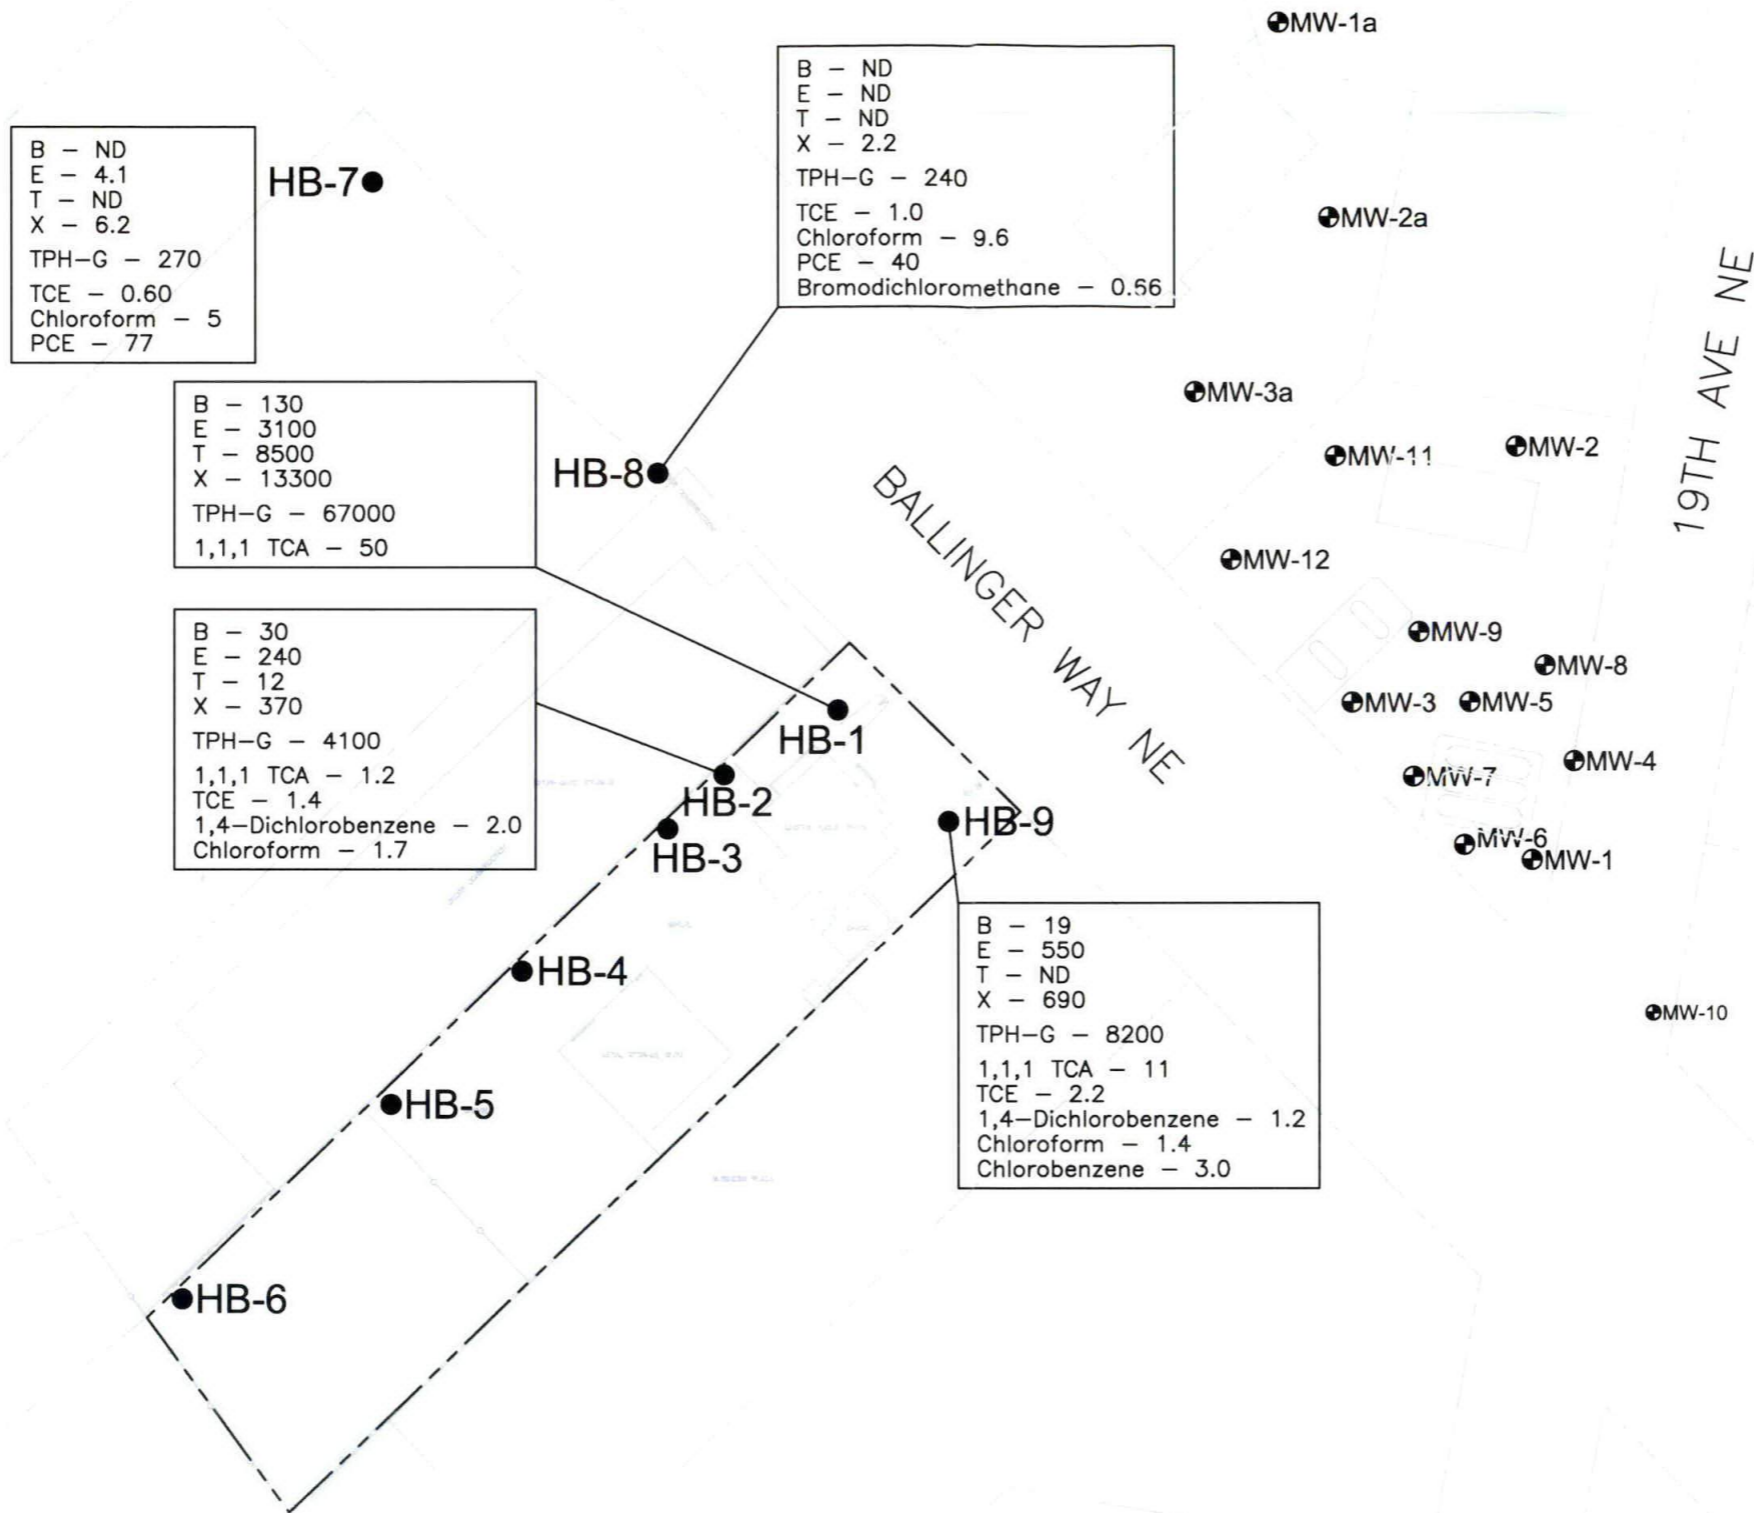
Figure 3 shows the distribution of the TPH-G, BETX, and various VOC compounds in groundwater.

- HB-7** ● Monitoring Well Number and Approximate Location
- B - Benzene
 - E - Ethylbenzene
 - T - Toluene
 - X - Xylene
 - TPH-G - Gasoline
 - 1,1,1 TCA - Trichloroethane
 - TCE - Trichloroethene
 - PCE - Tetrachloroethene

Note: Concentrations are reported in micrograms per liter ($\mu\text{g}/\text{l}$) equivalent to parts per billion.

The PCE found above Method A cleanup levels in HB-7 and HB-8 upgradient of the site and the adjacent Shurgard property are most likely associated with a release from a dry cleaner operation (Ballinger Cleaners formerly located in the Ballinger Village Shopping Center) across Ballinger Way N.E. PCE above Method A cleanup levels was detected in groundwater monitoring Wells MW-1a, MW-2a, MW-3a, and MW-11 installed as part of the Chevron site investigation. These wells are located across Ballinger Way N.E. to the north and northeast of the site (see Figure 3) and are down gradient of the former Ballinger Cleaners site.

The hydrocarbons found in the onsite wells HB-1, HB-2, and HB-9 appear to result from a nearby release of gasoline. No gasoline tanks have ever been identified on the site and no soil contamination associated with a source has been found in numerous closely spaced borings in the front of the property. If the source were onsite, soil contamination above the seasonal fluctuation in groundwater levels would have been encountered in one of the borings. However, the nature of the contamination and the drop in hydrocarbon levels in groundwater across the site suggest the source is nearby. Therefore, the most likely source of the contamination is north, northwest of HB-1 and south, southeast of HB-8.

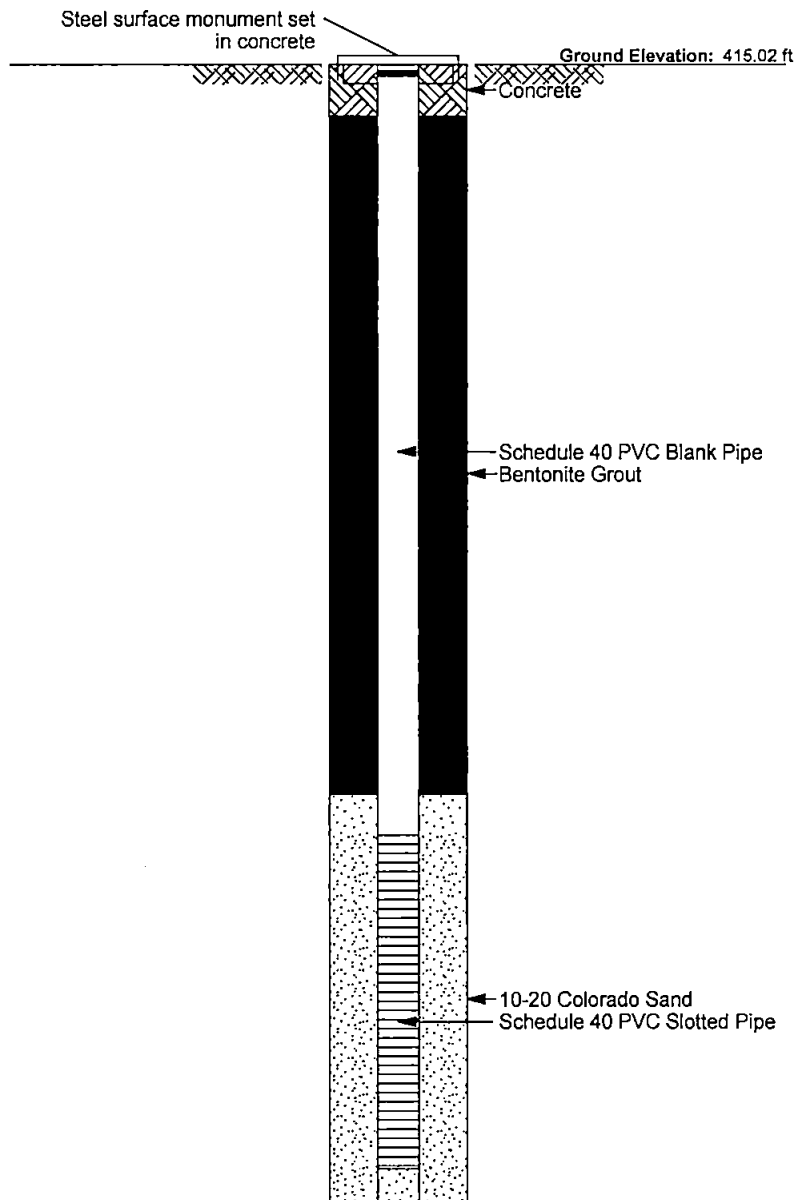
TYPICAL MONITORING WELL CONSTRUCTION

Groundwater was encountered during drilling in each of the three borings. All soil borings were completed as 2-inch-diameter PVC groundwater monitoring wells (designated, HB-7, HB-8, and HB-9 on **Figure 2**), in accordance with Washington Administrative Code (WAC) 173-160. A typical monitoring well construction is shown on **Figure B2** in **Appendix B**. Decontamination procedures for soil sampling and drilling equipment were conducted as described in **Appendix A**. Following installation, the wells were developed and surveyed. Jacobs Associates of Seattle, Washington surveyed reference elevations for each well.
