Supporting Quality Control Results

(C8-C40) Semi-Quantitative Molecular Characterization
by GC/MS - full scan mode
TIC, n-Alkanes, Iso-Alkanes, Isoprenoids, Alkylcyclohexanes,
C4-monoaromatics, Bicyclanes, Terpanes, Steranes

Shell Woodland

Re: Notice of Potential Liability under the Model Toxics Control Act for the Release of Hazardous Substances at the following Hazardous Waste Site:

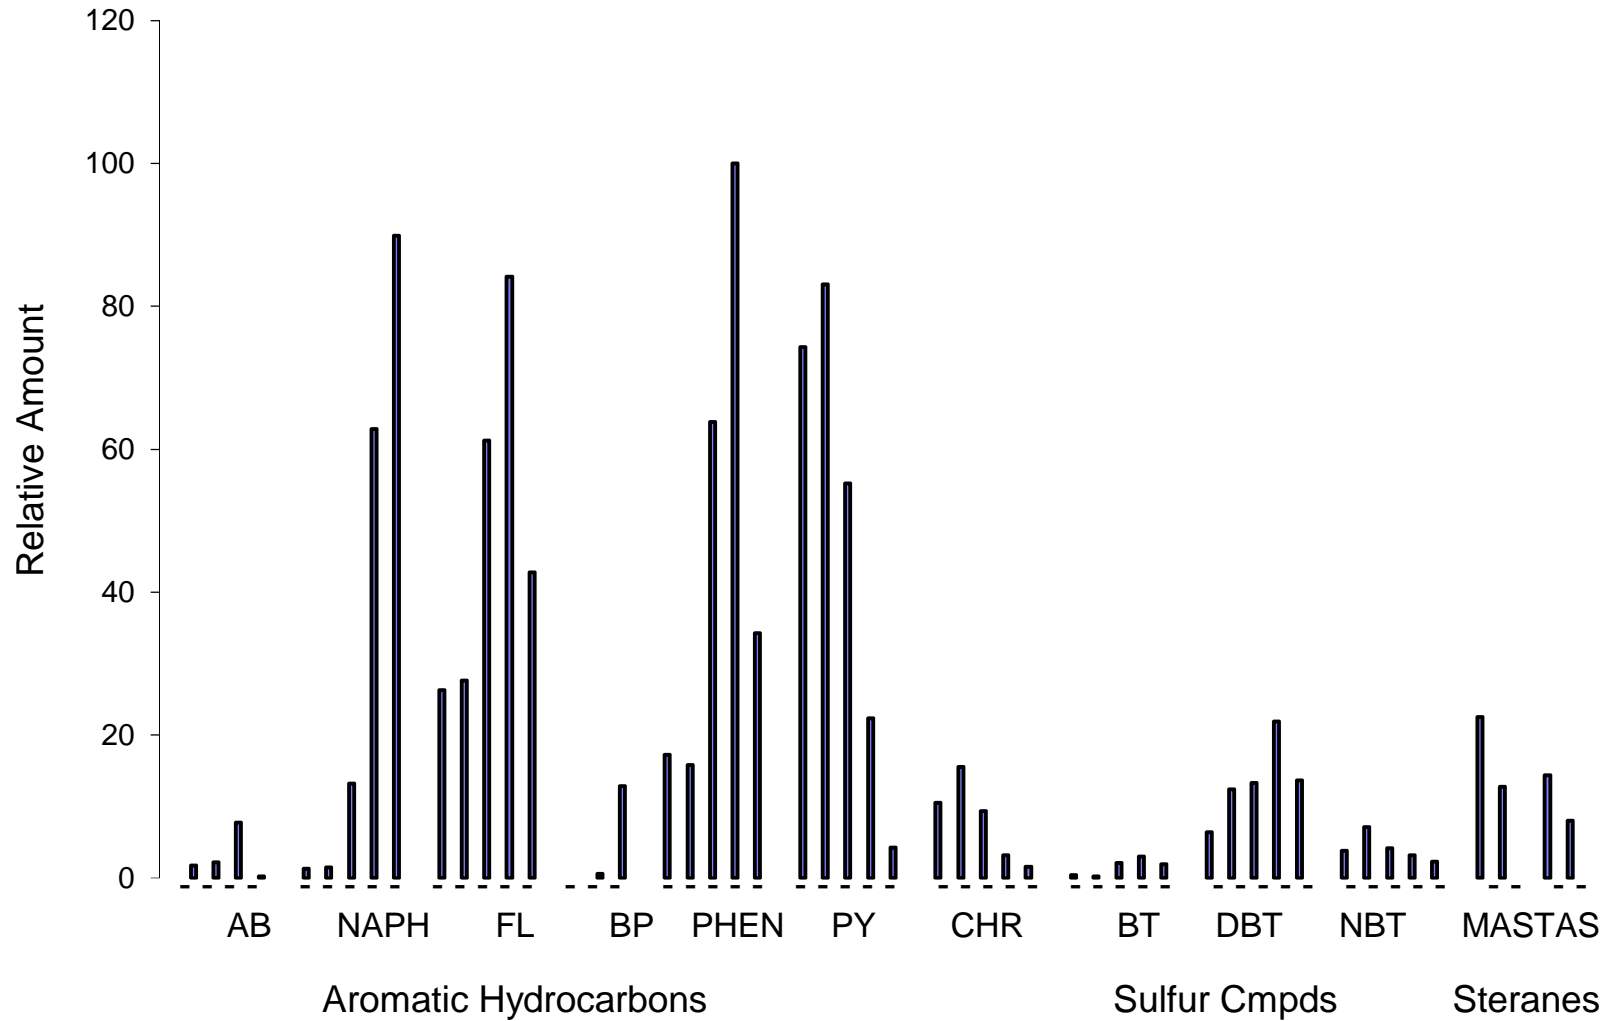
29604-1 [P.060866.022619.DT.SUMP]

Aromatic Hydrocarbon Distribution

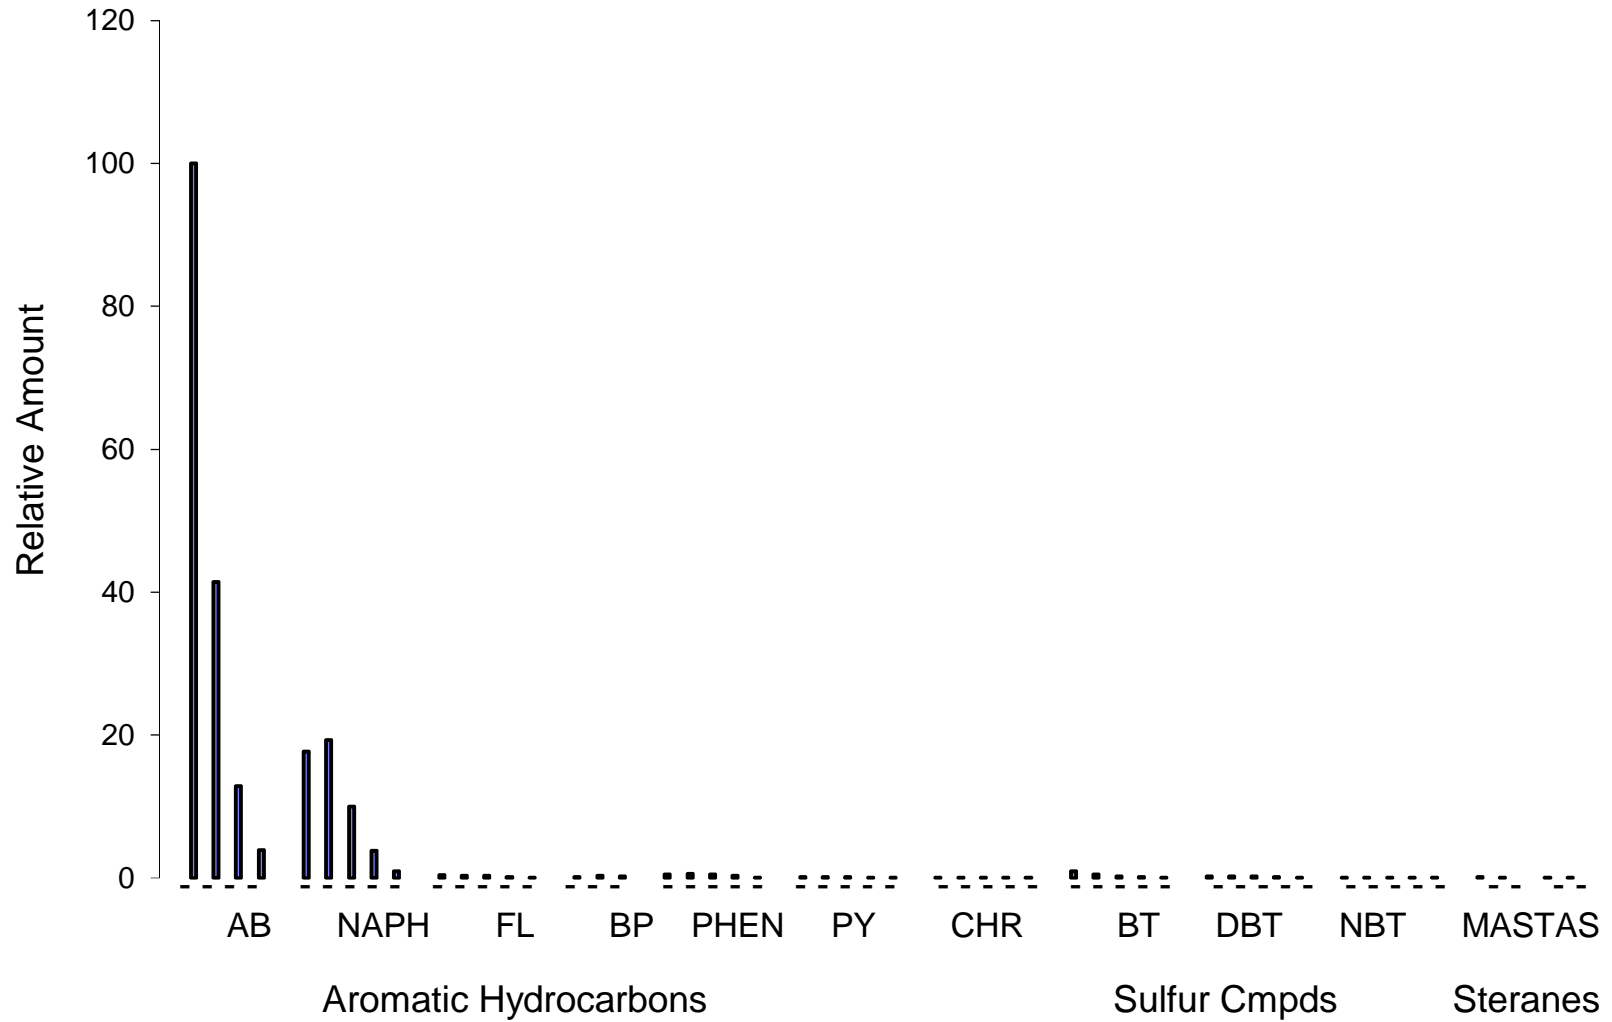
29604-3 [P.060866.022619.DT.MW10] 1/10

Aromatic Hydrocarbon Distribution

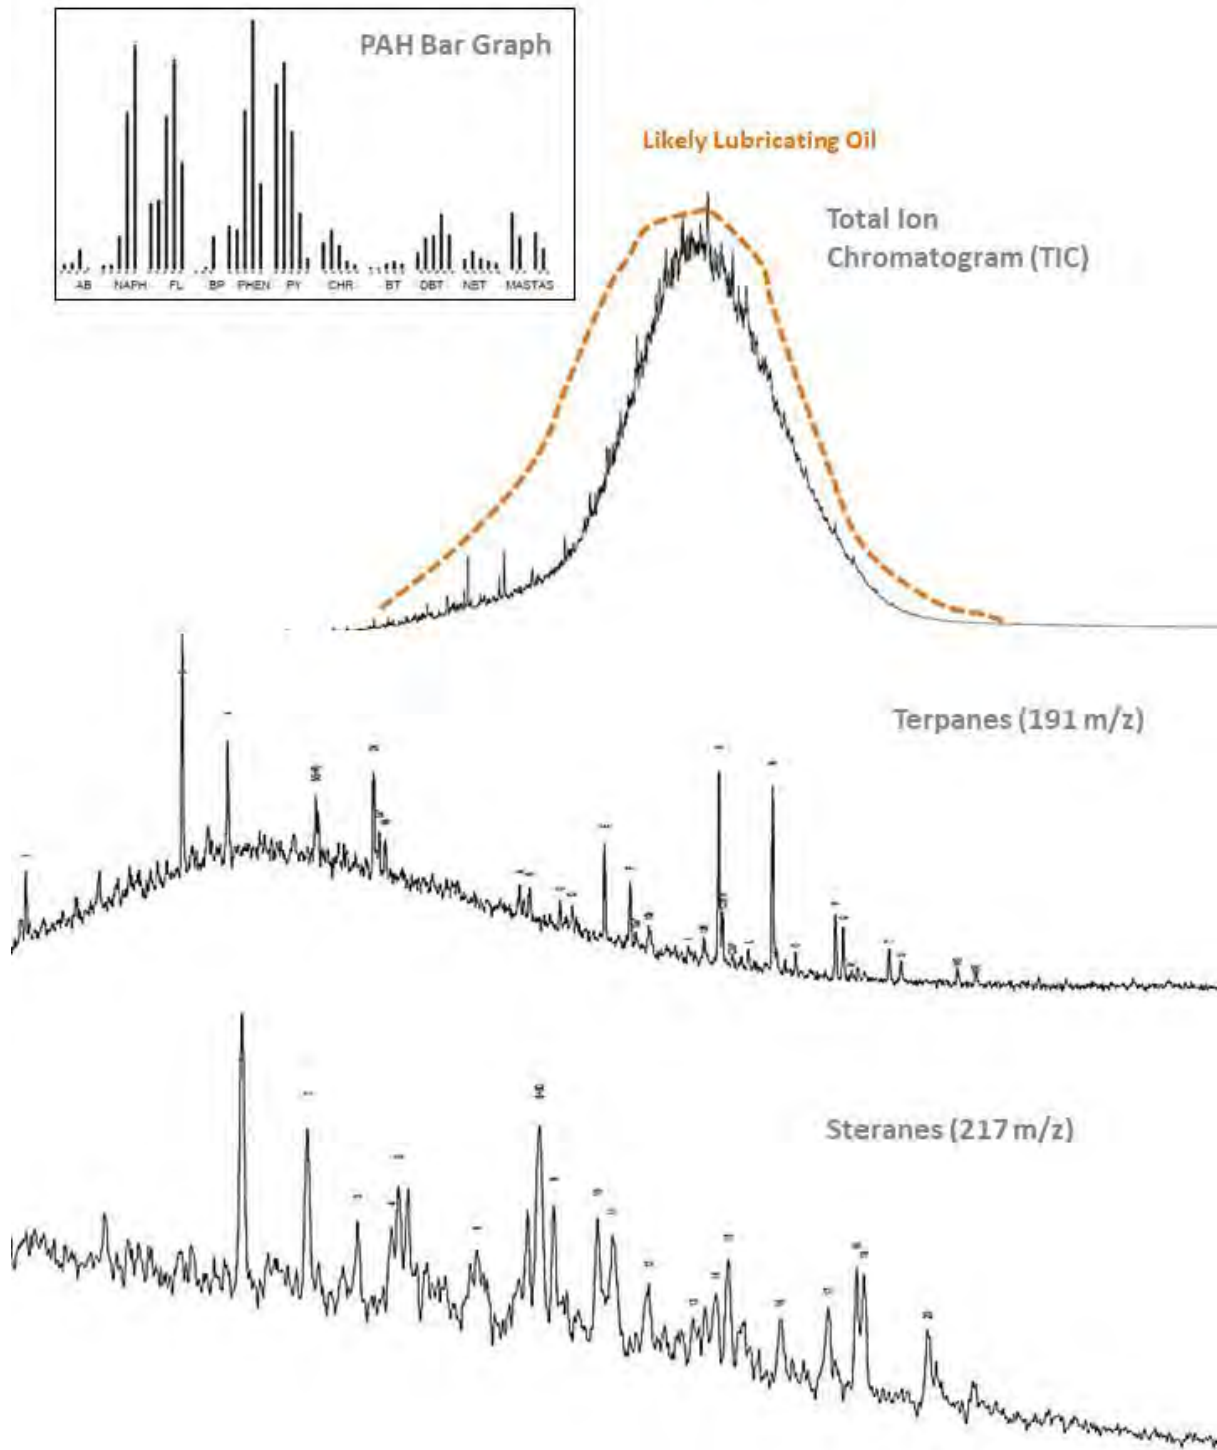
DT Sump (29604-1)

Figure 1. Diagnostic petroleum attributes of DT Sump.

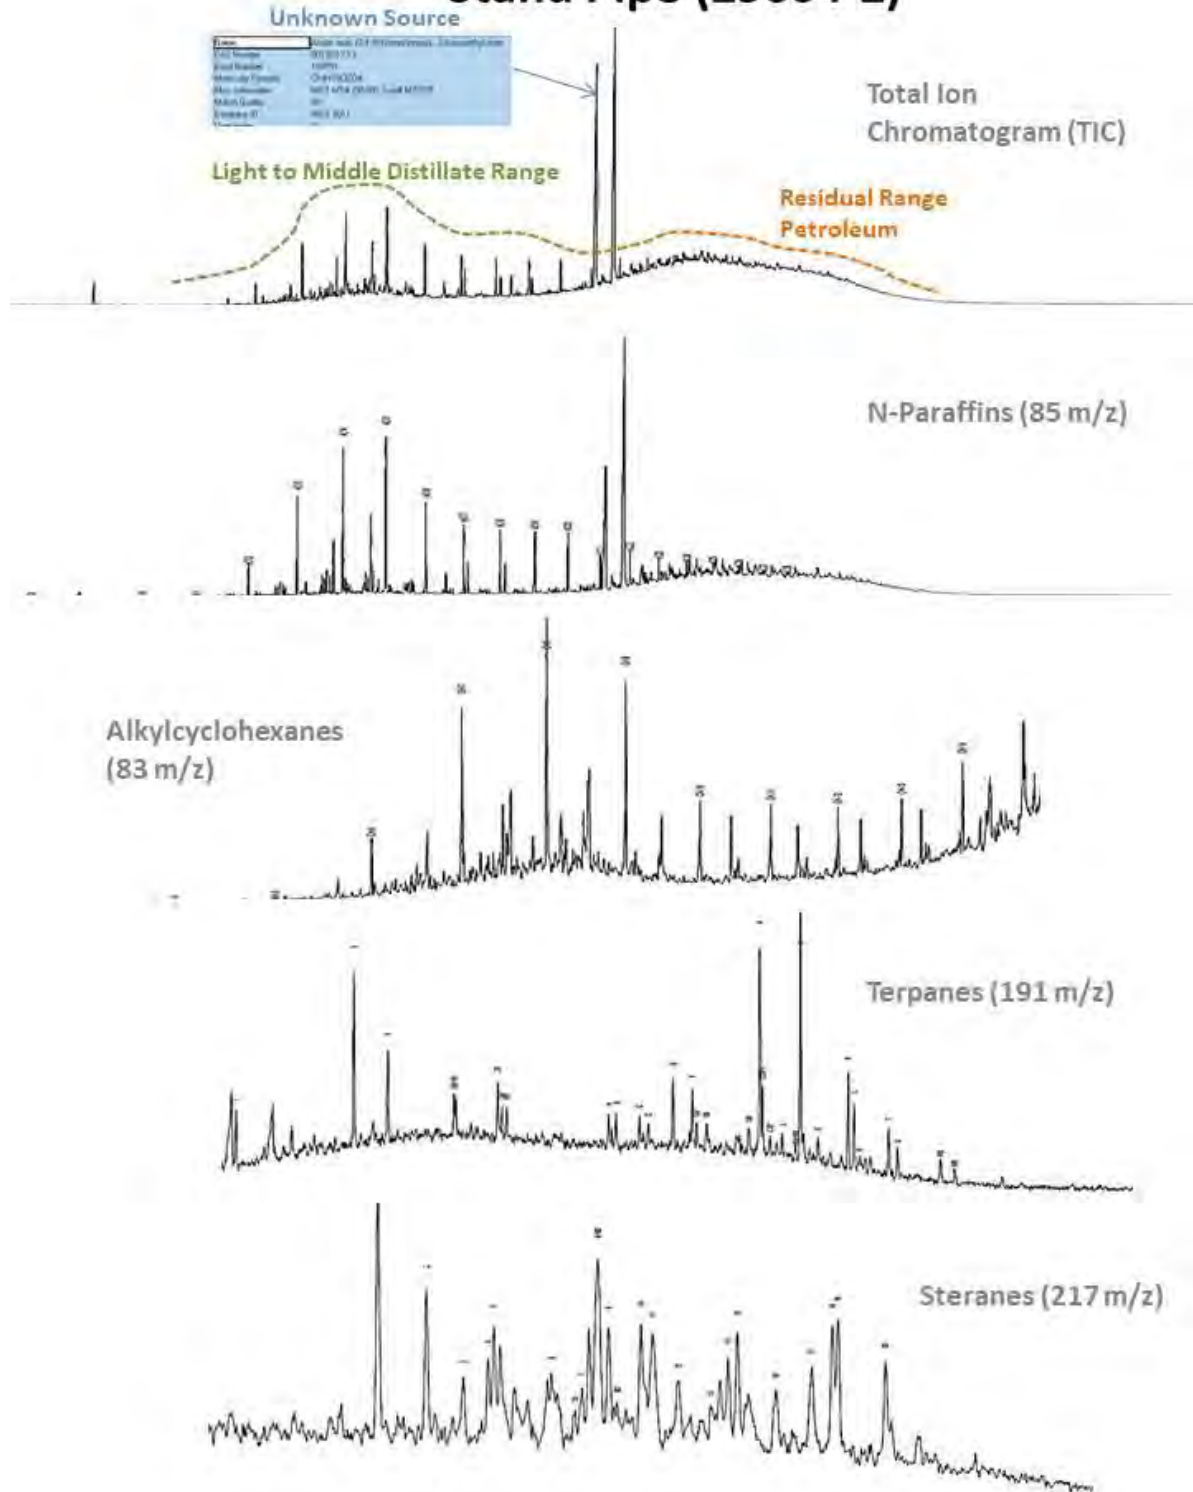
Stand Pipe (29604-2)

Figure 2 Diagnostic petroleum attributes of Stand Pipe.

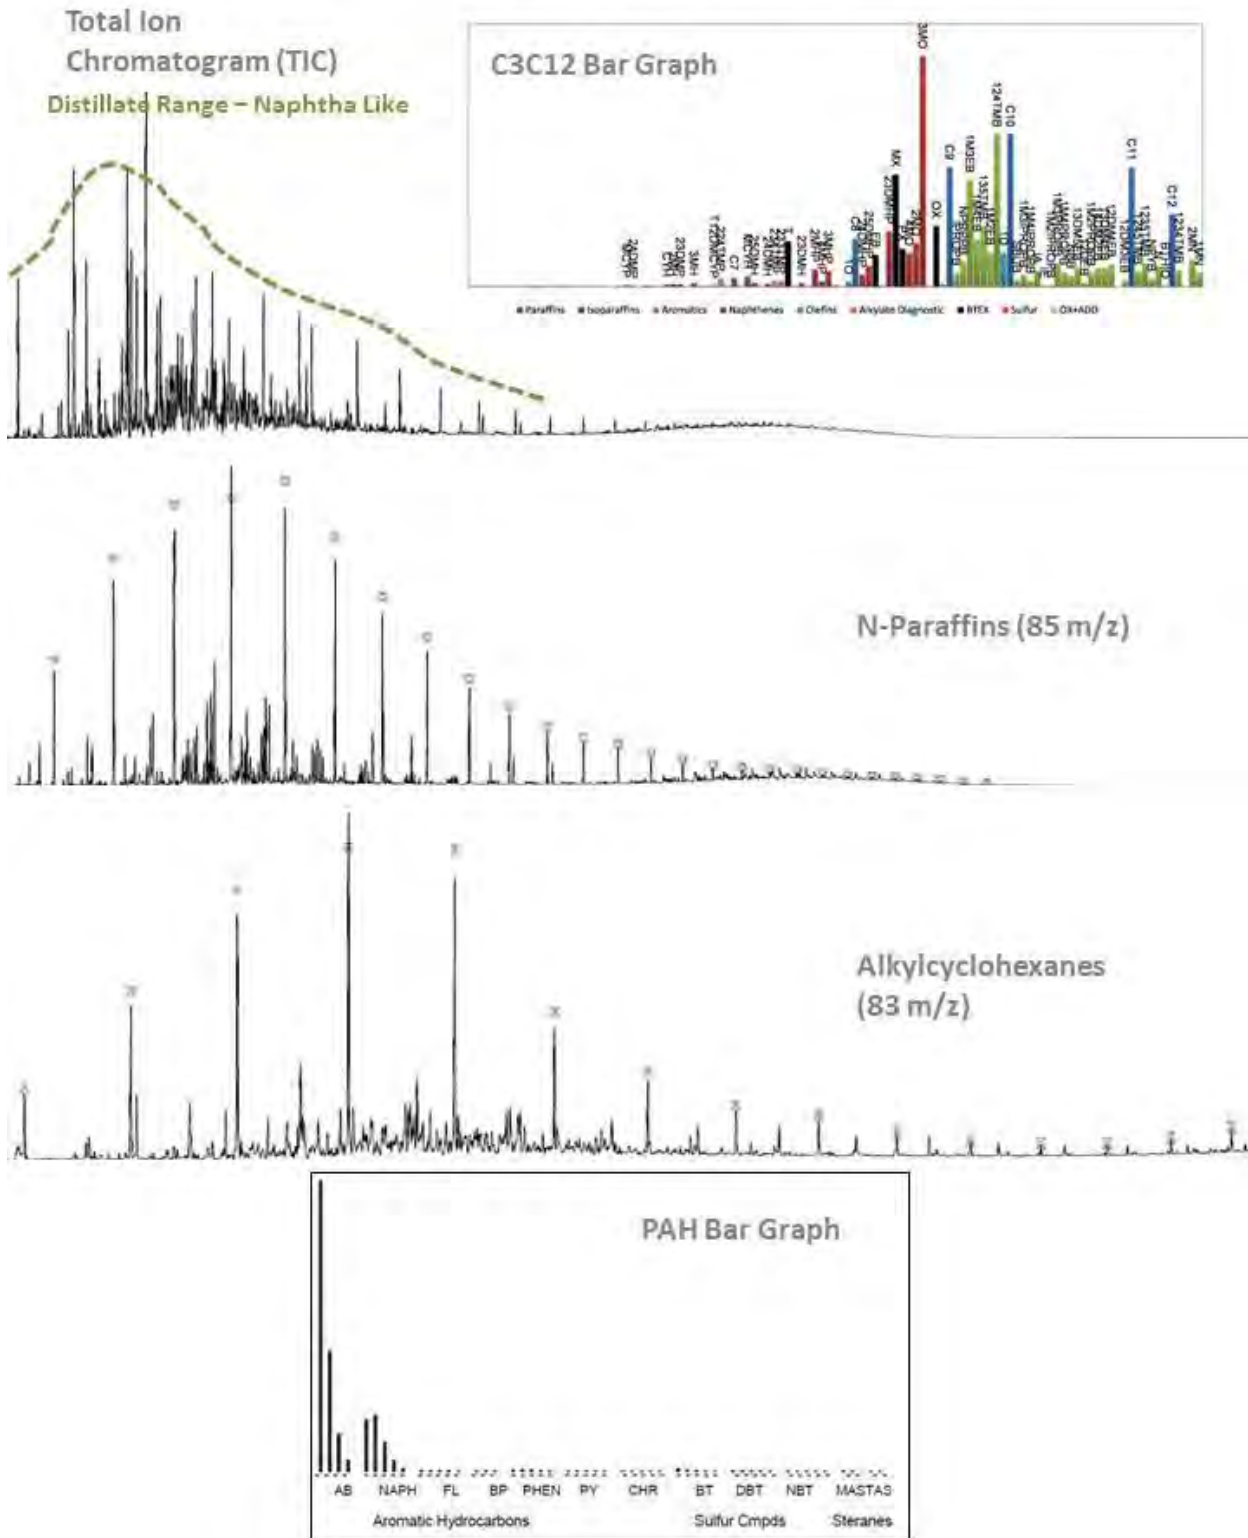
MW10 (29604-3)

Figure 3. Diagnostic petroleum attributes of MW10.
