CLEANUP ACTION SUMMARY REPORT

DECEMBER 2006 TO JUNE 2007

**EVERGREEN FUEL FACILITY
661 EAST PINE STREET
SHELTON, WASHINGTON**

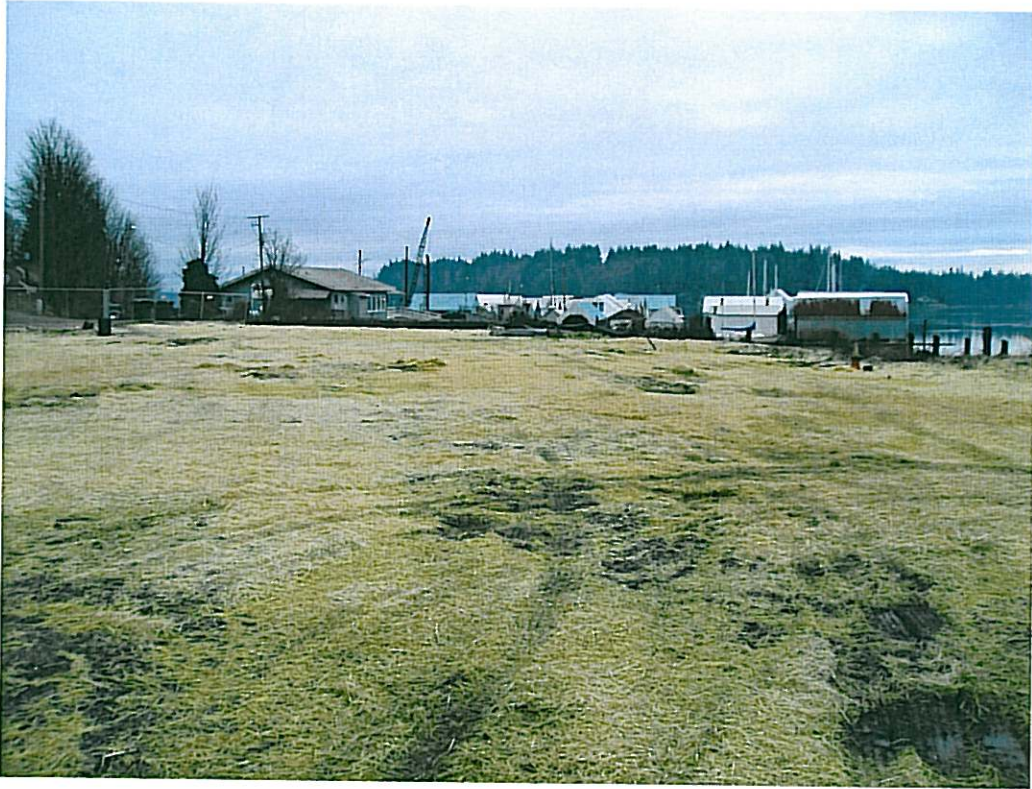
Photograph 1: Surface stabilization with straw.

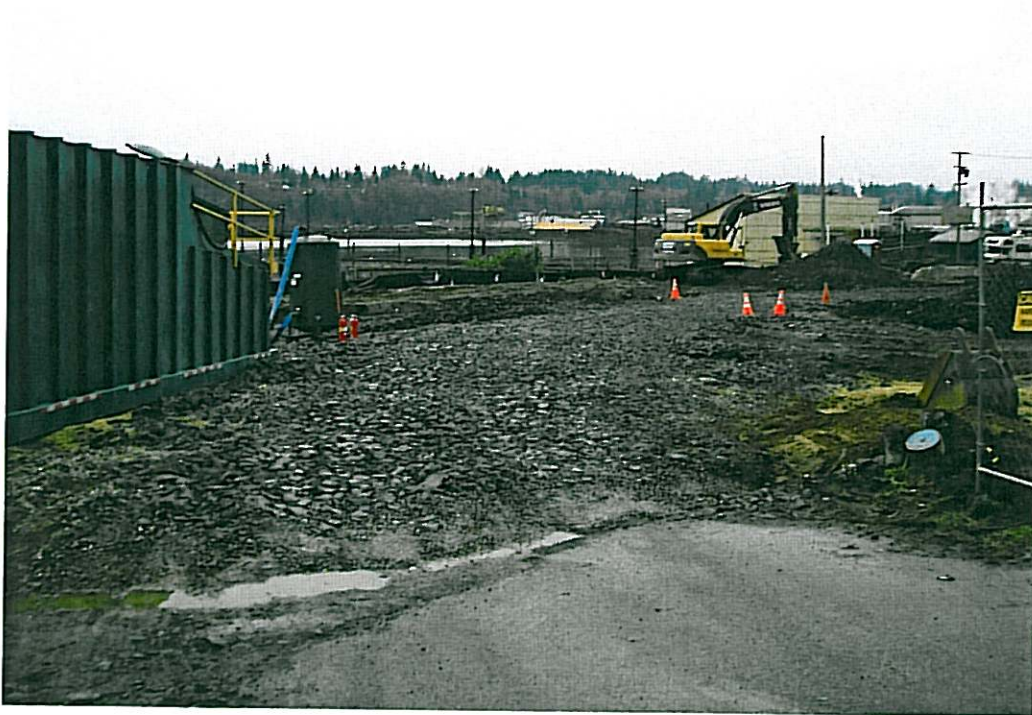
Photograph 2: Gravel construction entrance.

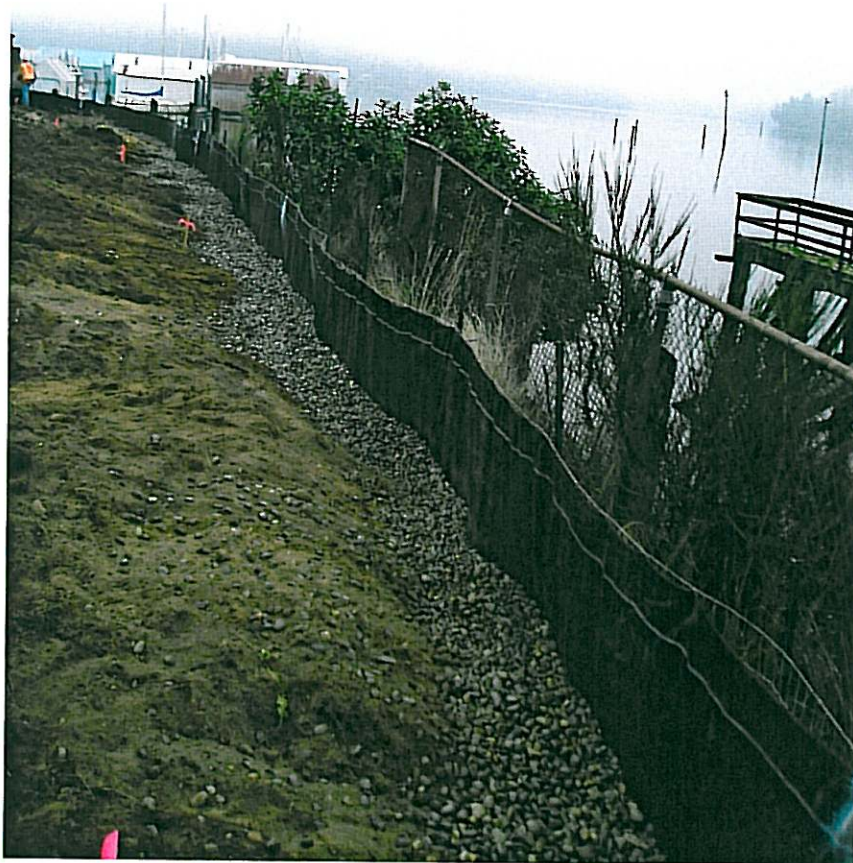
Photograph 3: Erosion control – Silt fence.

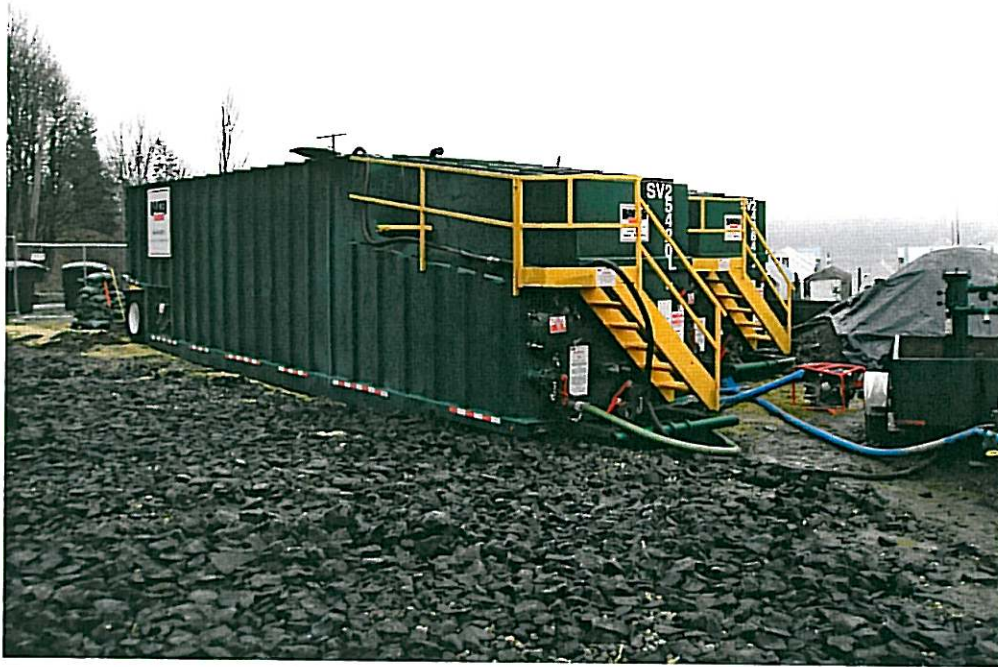
Photograph 4: Wastewater storage.

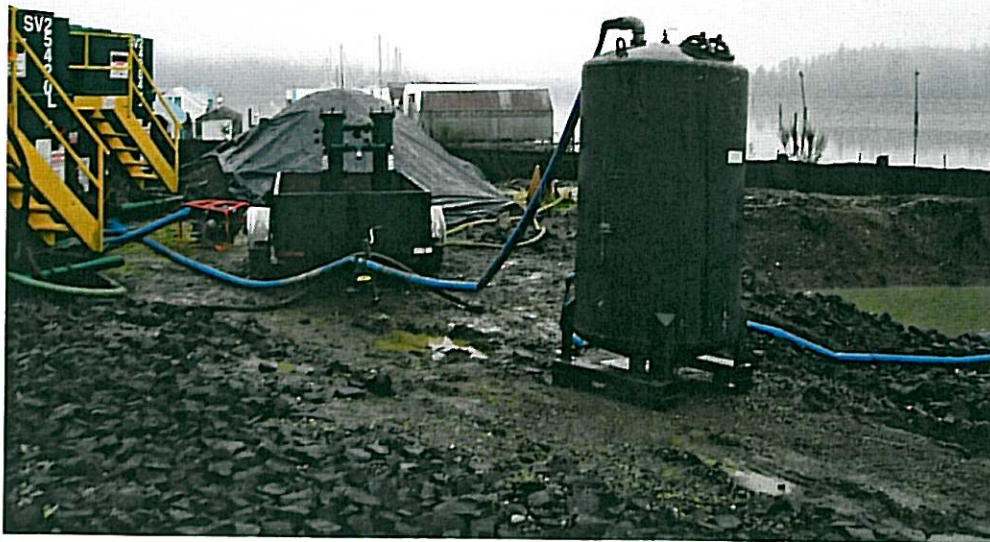
Photograph 5: Wastewater treatment and discharge.

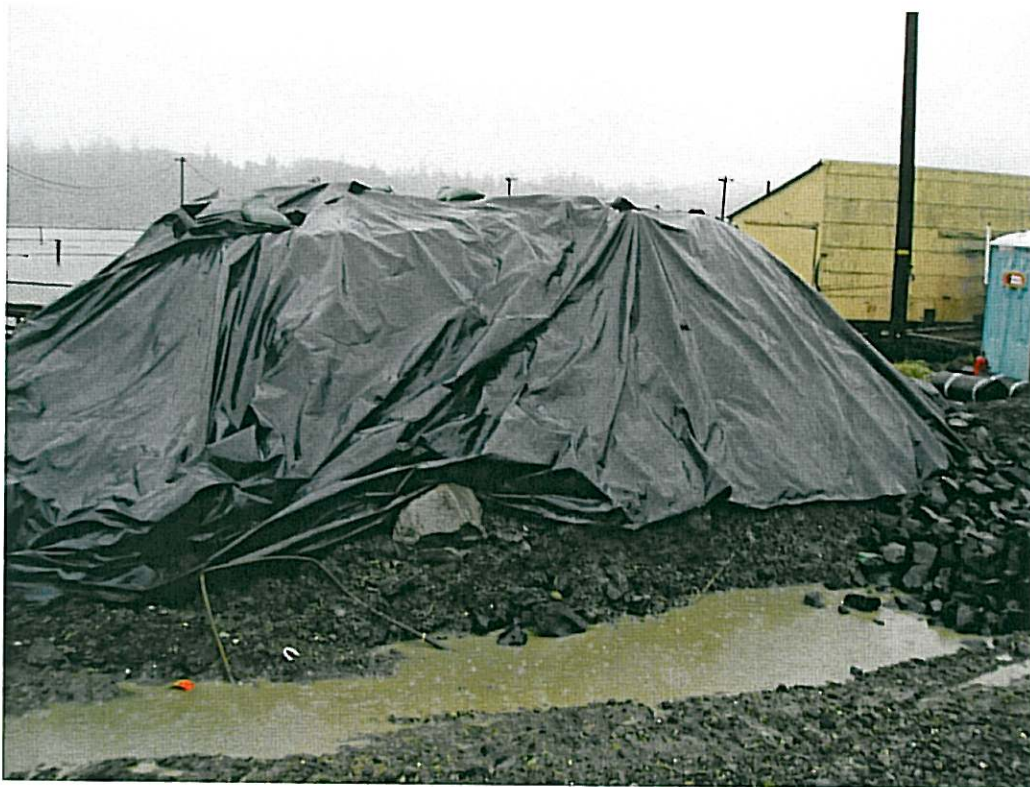
Photograph 6: Stockpile stabilization.

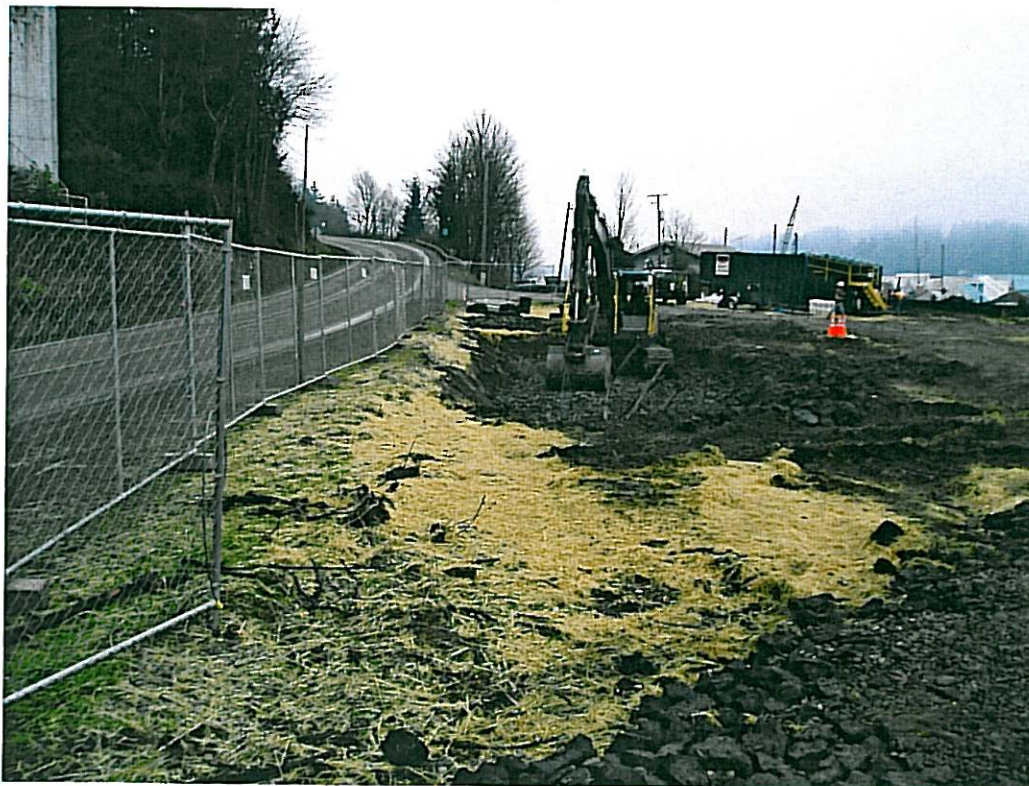
Photograph 7: Excavation and backfill along State Route 3.

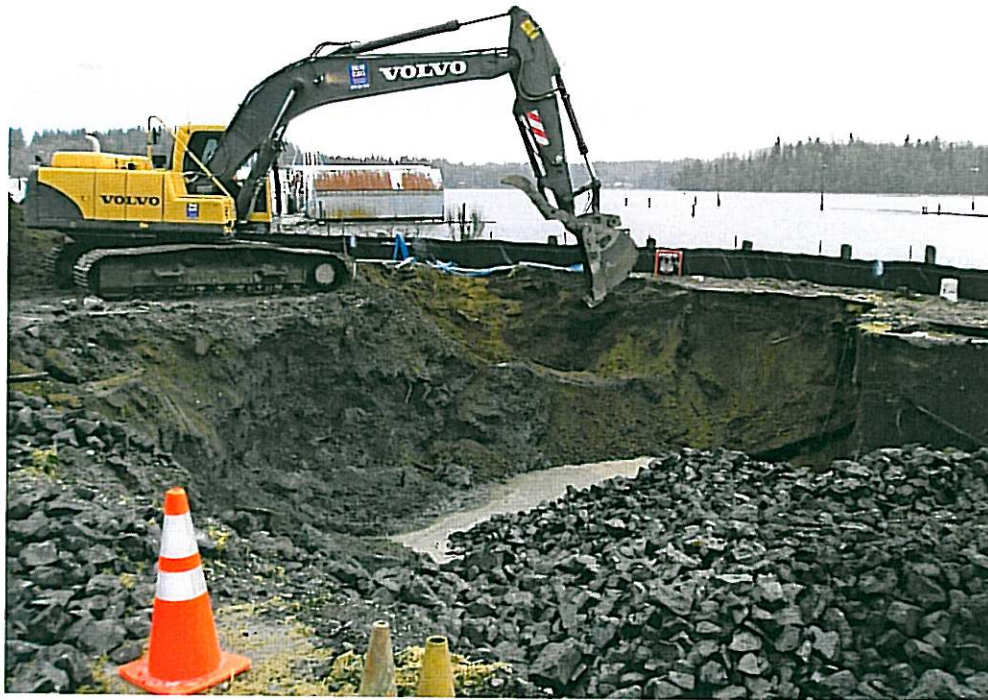
Photograph 8: Excavation on southeast portion of the Site.

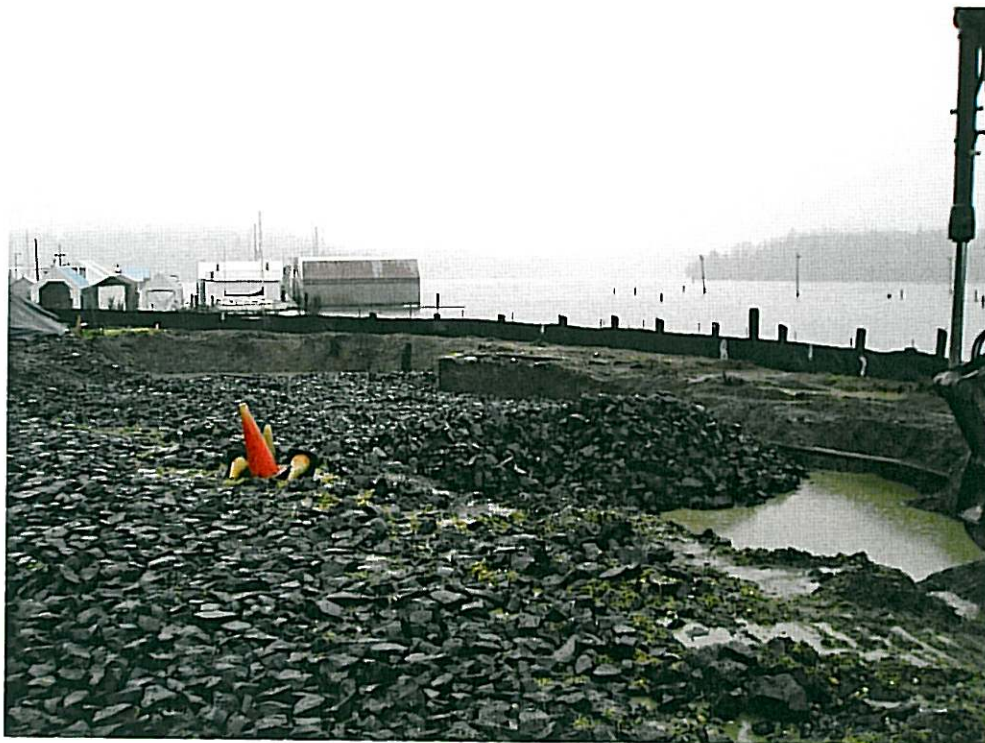
Photograph 9: Excavation on southern portion of the Site.
(Note: Oil-water separator in center of photo)

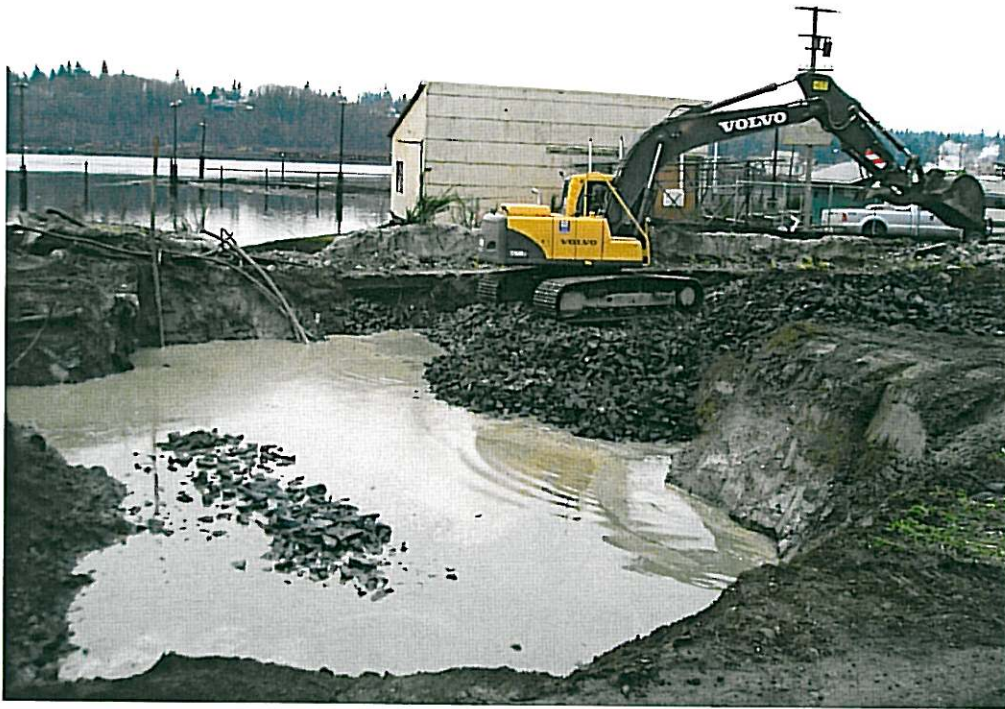
Photograph 10: Excavation on southwest side of the Site.

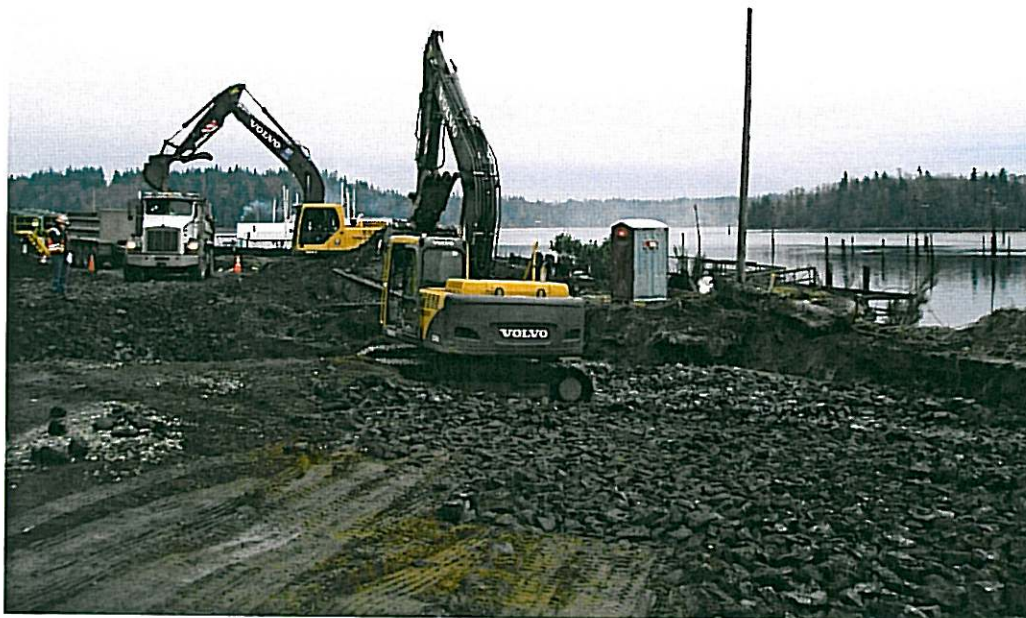
Photograph 11: Excavation on western side of the Site.

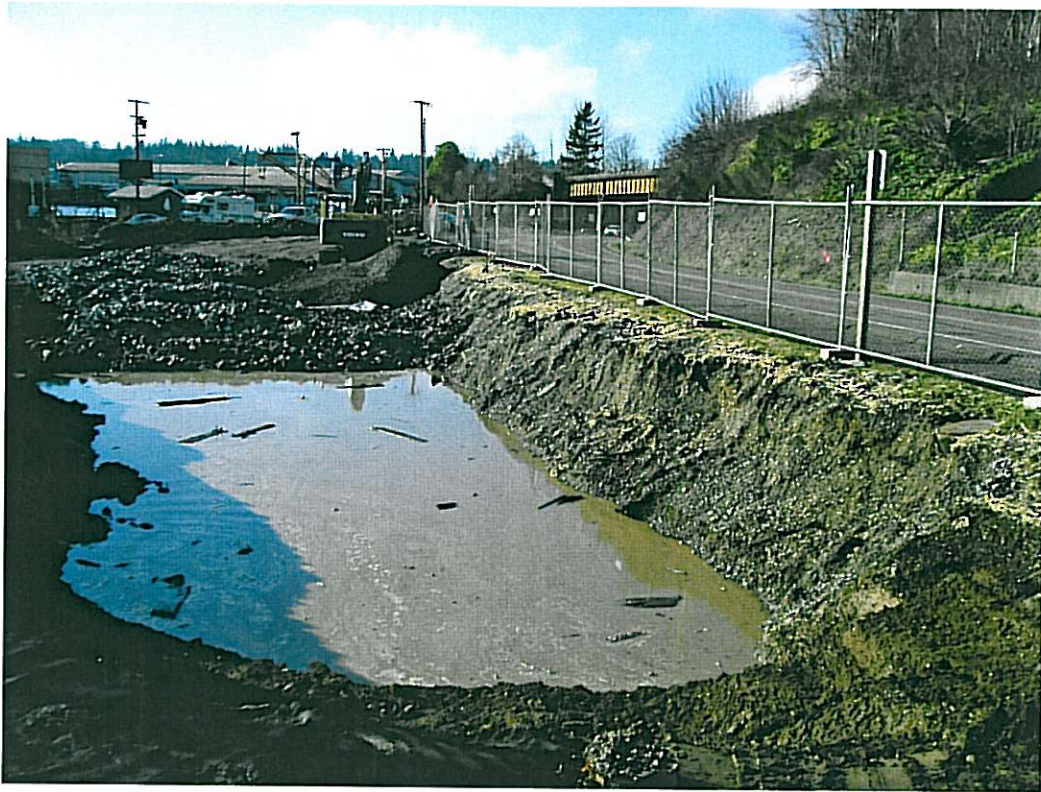
Photograph 12: Excavation along State Route 3.

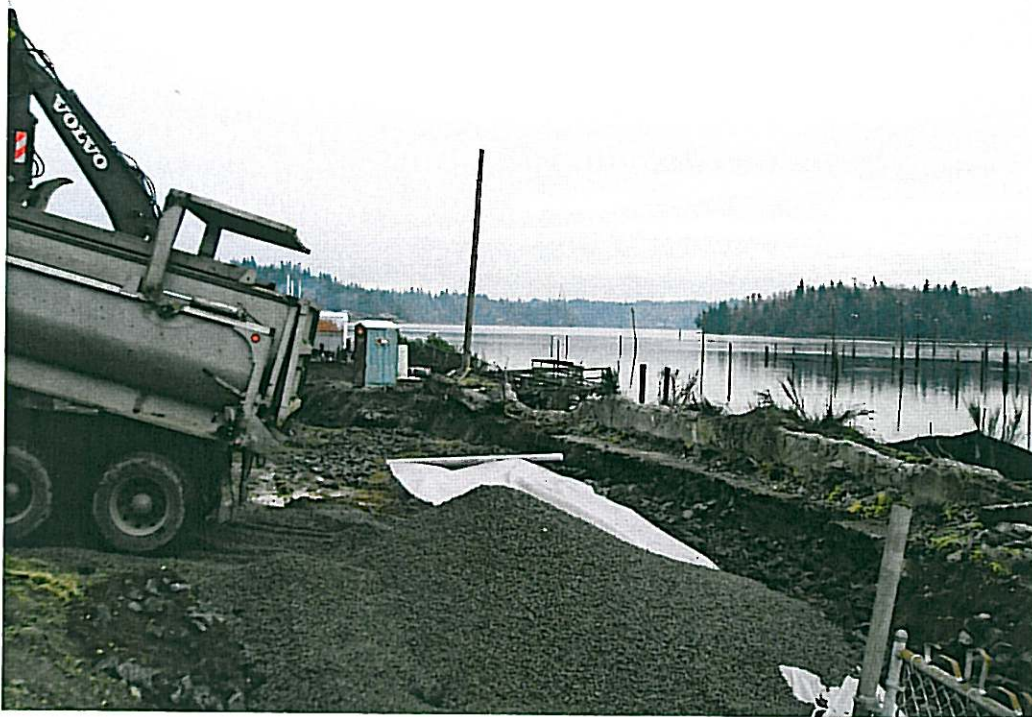
Photograph 13: Backfill.

The excavation areas were backfilled with 2- to 4-inch-diameter quarry spalls and compacted in 3-foot lifts to a minimum depth of 2 feet above the water table, or approximately 3 feet bgs. The quarry spalls were mixed with a total of 4,000 pounds of Advanced Oxygen Release Compound (ORC Advanced™) manufactured by Regensis. A geotextile filter fabric was installed on top of the quarry spalls and the top 3 feet were completed with 1.5-inch minus crushed rock that was compacted. Compaction testing was performed for CCS by Professional Service Industries of Tacoma, Washington. The results of the compaction testing indicate that the minimum standard of compaction to 95% maximum dry density modified proctor dry was met or exceeded.

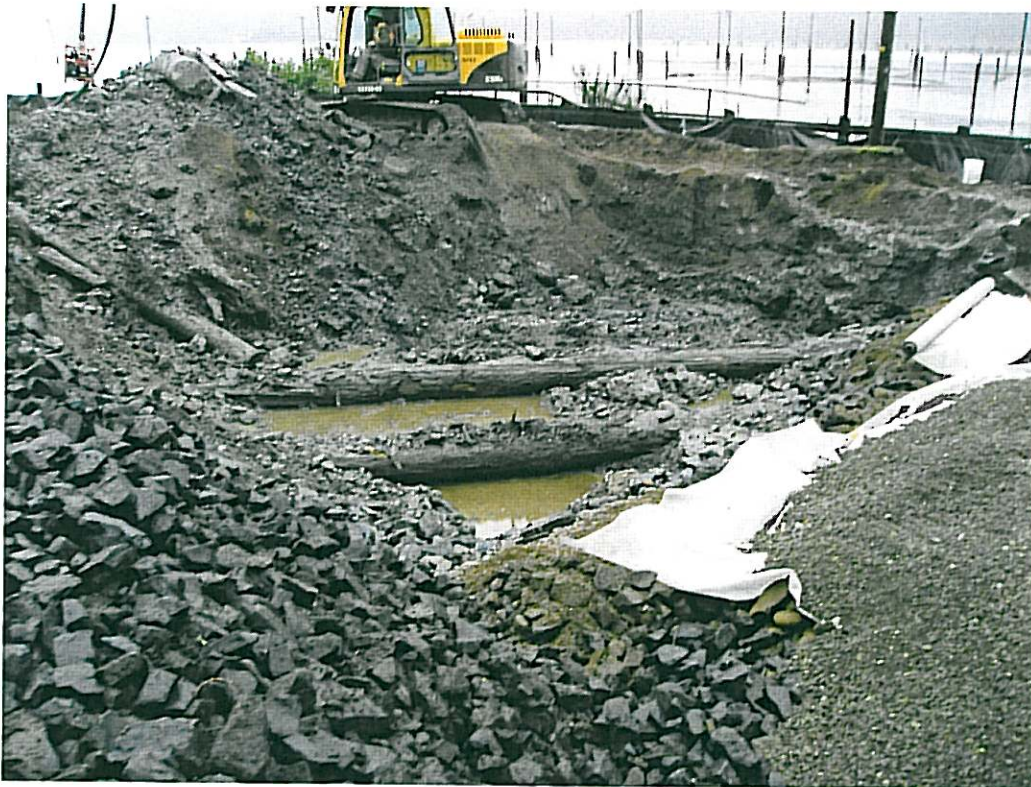
Photograph 14: Backfill showing quarry spalls, filter fabric, and crushed rock.

above water table but could be placed up to within 2' of final grade if the contractor determined that this was the most economical method of backfilling. Prior to placement of the select structural backfill above the quarry spalls, the contractor was to install a layer of geotextile filter/separation fabric to prevent migration of the smaller backfill materials into the quarry spalls.

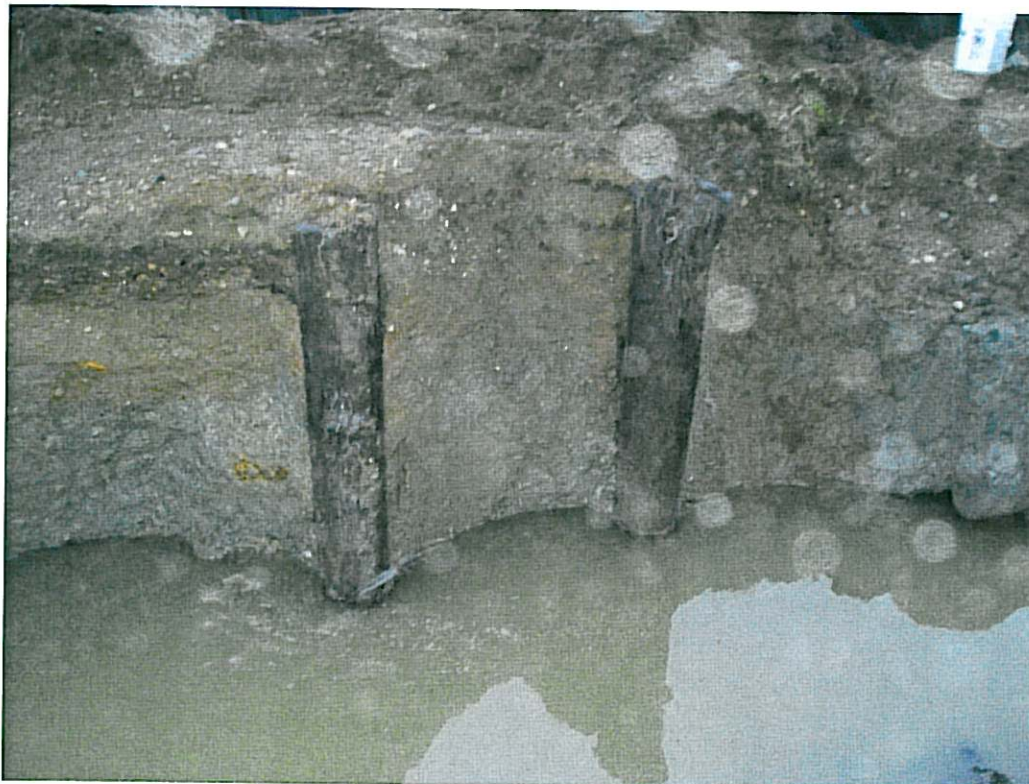
Photograph 15: Earth piles B.

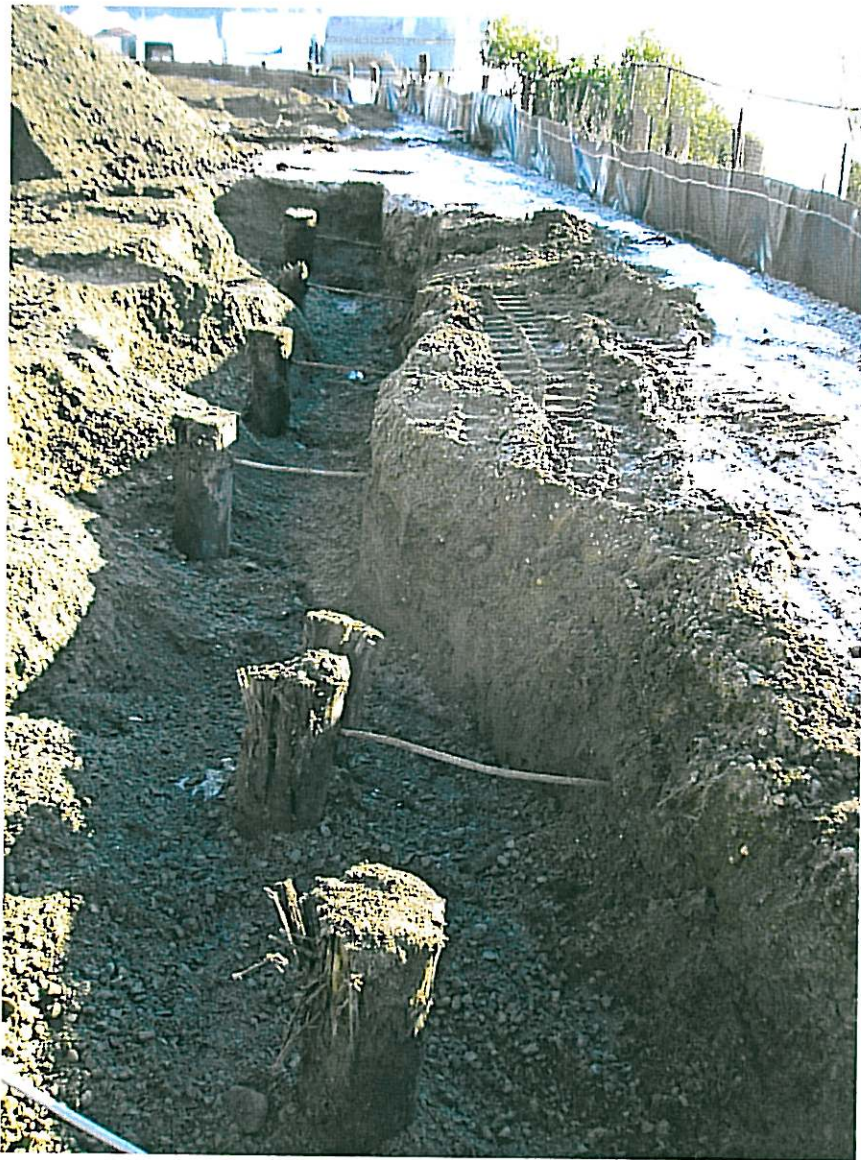
Photograph 16: Earth piles A.

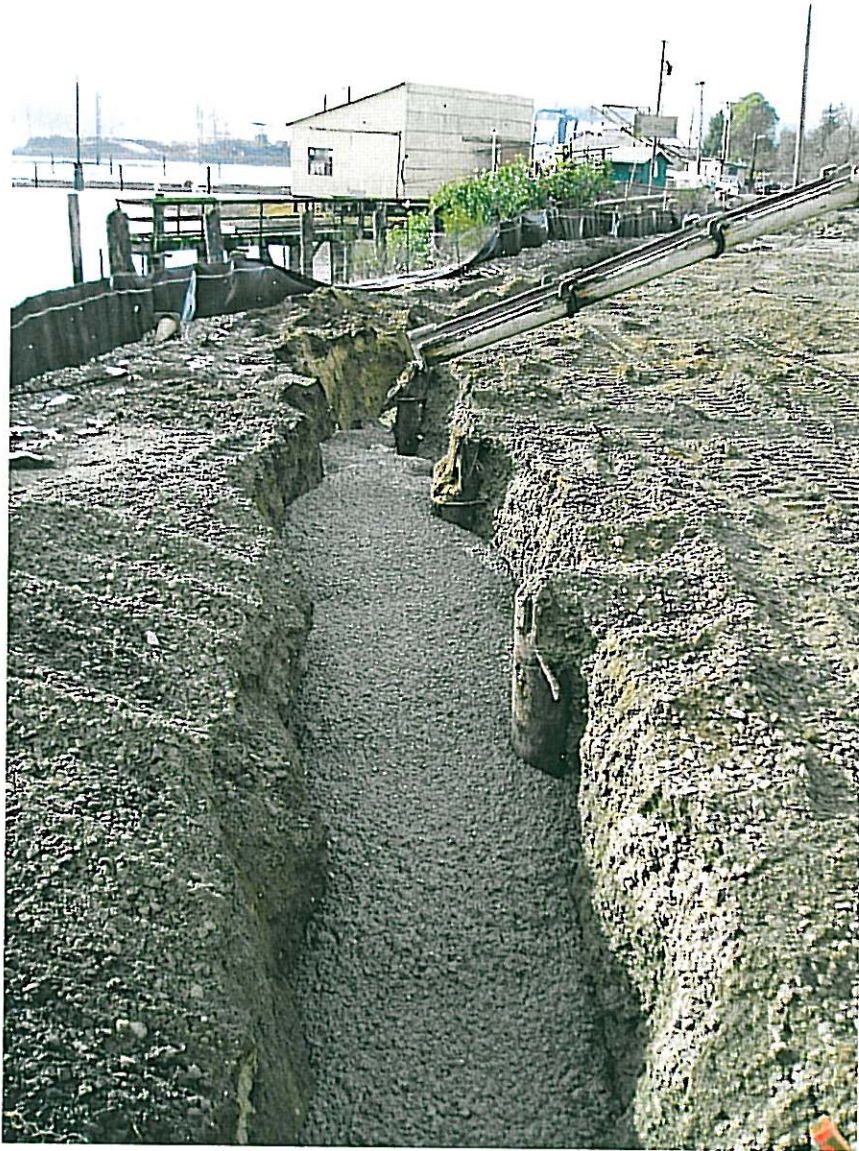
Photograph 17: Emplacement of concrete earth anchors.

Nelson prepared a letter Regarding Evergreen Fuel Retaining Wall Evaluation dated January 5, 2007, and Design Drawings dated January 9, 2007 to provide details and specifications to repair the support system for the main bulkhead in-kind (Attachment D). The repairs included installation of concrete earth anchors to increase the capacity of Earth Piles A that directly support the main bulkhead, allowing for the abandonment of Earth Piles B. The Contractor was responsible for conducting the work to repair the structural support system under the observation and documentation of Farallon and Nelson. Nelson observed the final construction of the concrete earth anchors and determined that the installation of the concrete earth anchors was sufficient to allow abandonment of Earth Piles B with no reduction in the original capacity of the main bulkhead. These results are documented in the letter Regarding Evergreen Fuel Retaining Wall Earth Anchor Repair dated January 18, 2007, prepared by Nelson (Attachment D).

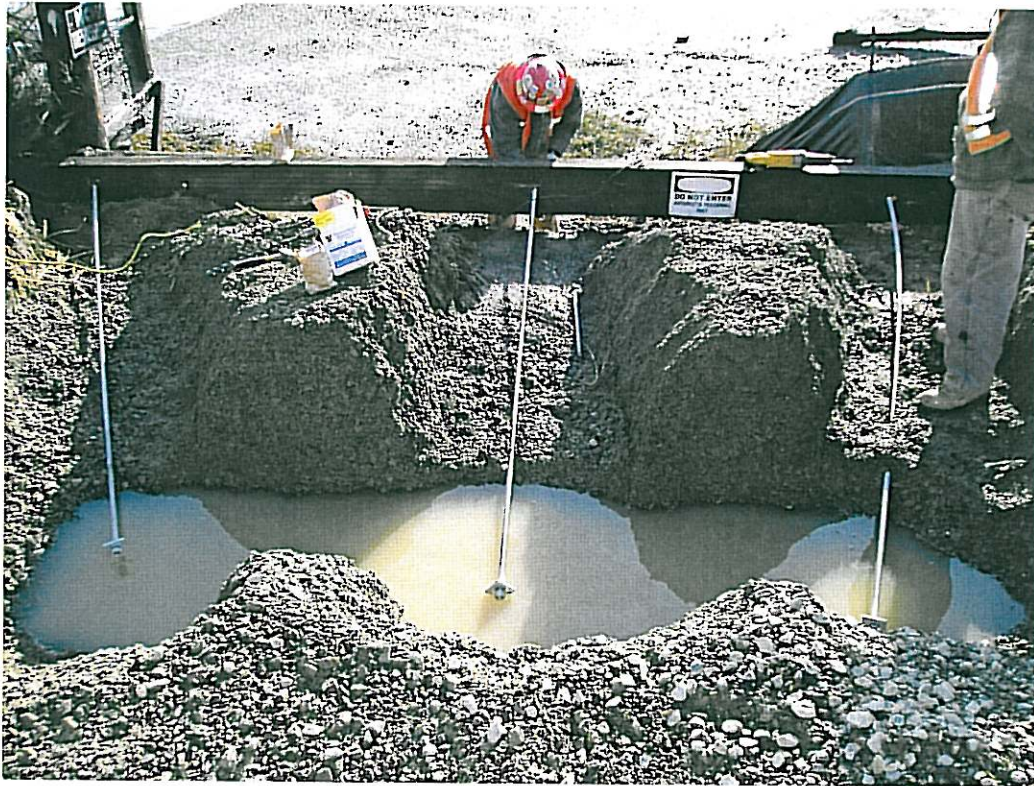
Photograph 18: Replacement of tension rods and preparation for emplacement of concrete earth anchors.

Tension rods which have been damaged must be replaced in kind, with hot dipped galvanized steel, with new 4" diameter washers on both ends and nuts. Where the piles have split by the rods pulling thru, apparently due to impact during excavation, it is recommended that bolted, galvanized steel collars be installed to prevent further splitting of the piles.

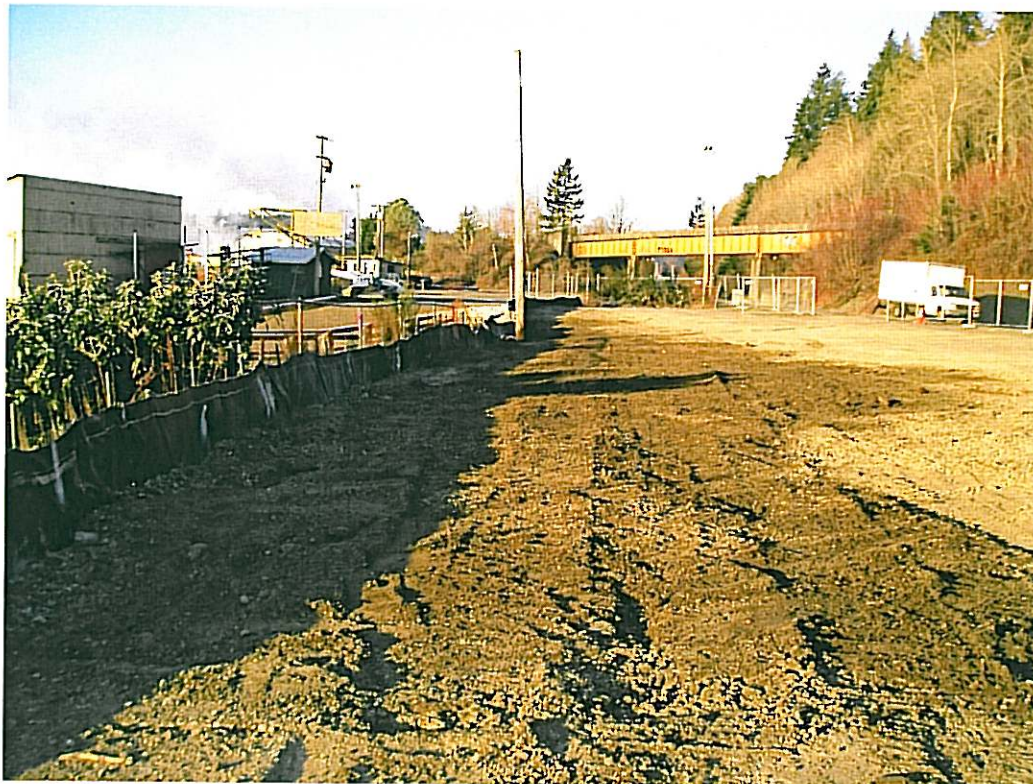
Photograph 19: Backfill and compaction.

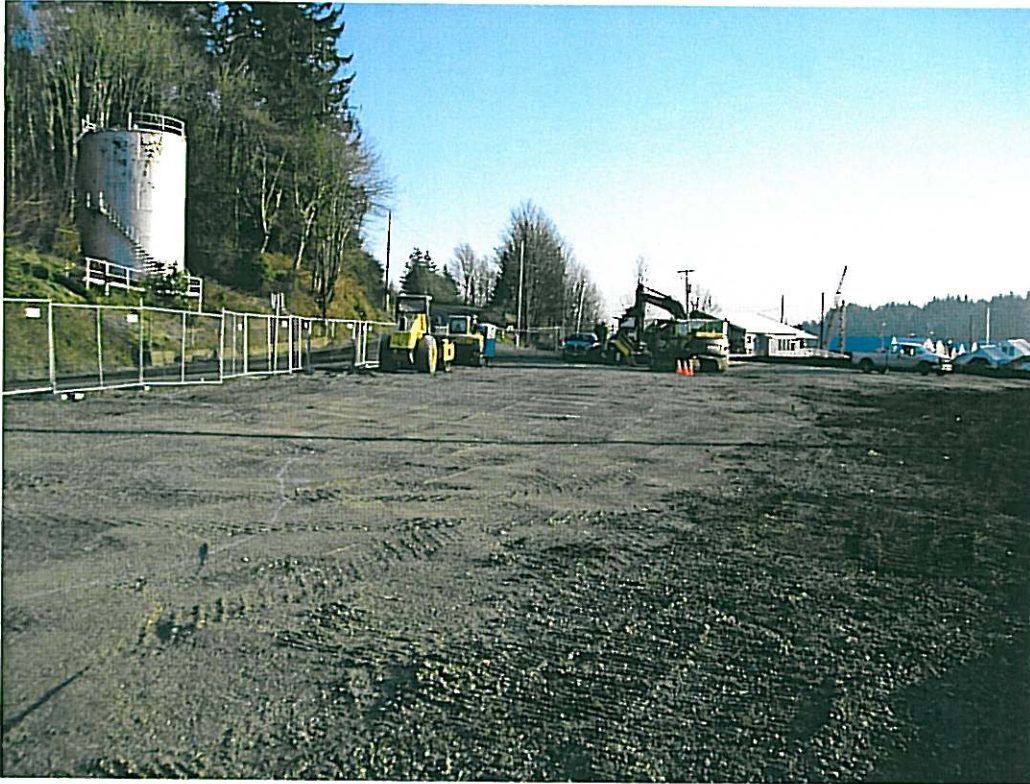
Photograph 20: Site restoration.

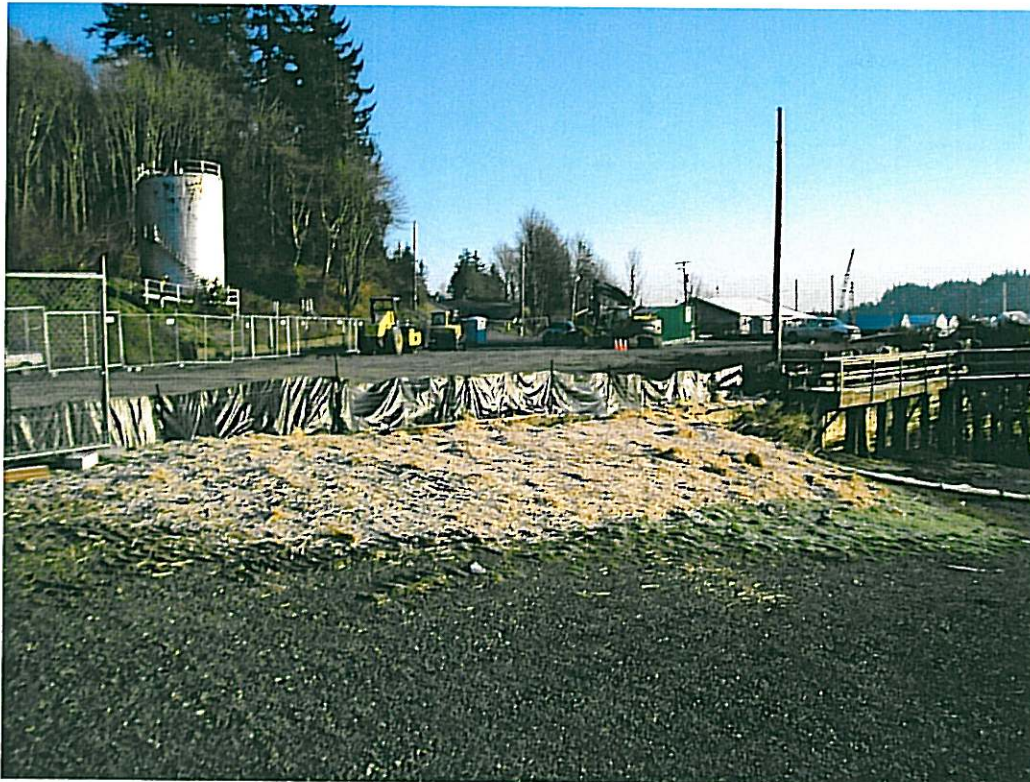
Photograph 21: Site restoration and surface stabilization.

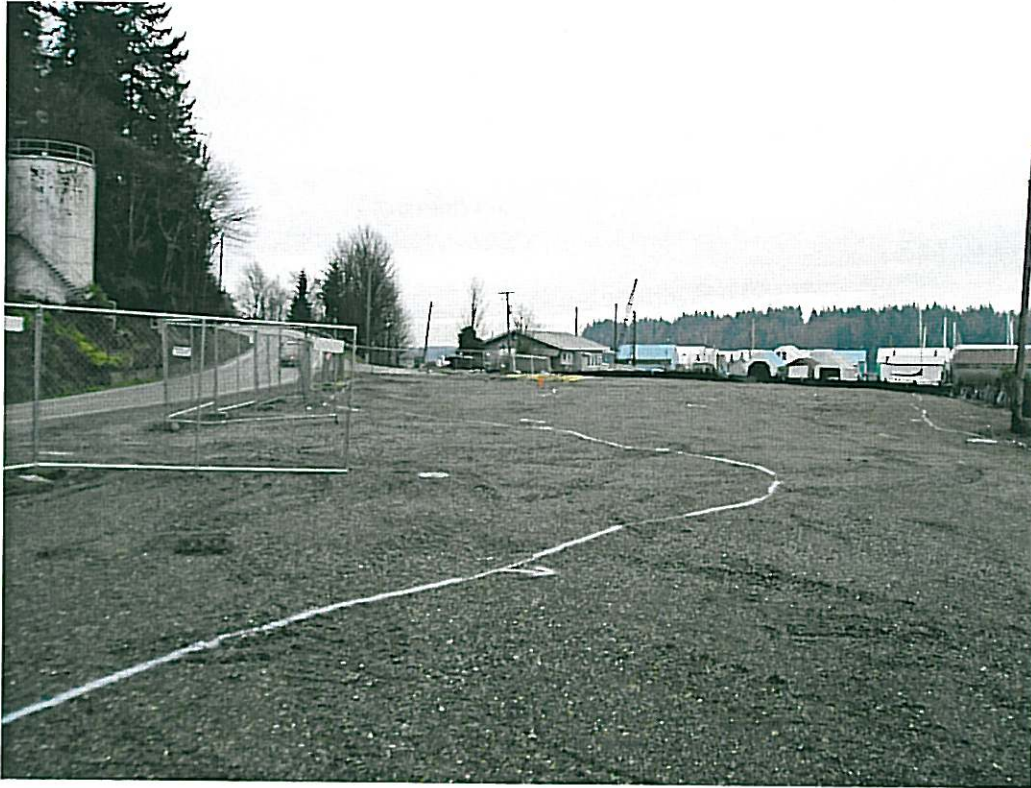
Photograph 22: Post-cleanup action Site conditions.
