**UNDERGROUND STORAGE TANK
REMOVAL & LIMITED CLEANUP ACTION**

Former Glitsa, Inc. Property
327 South Kenyon Street
Seattle, Washington

April 1, 2009

JN-28275-2

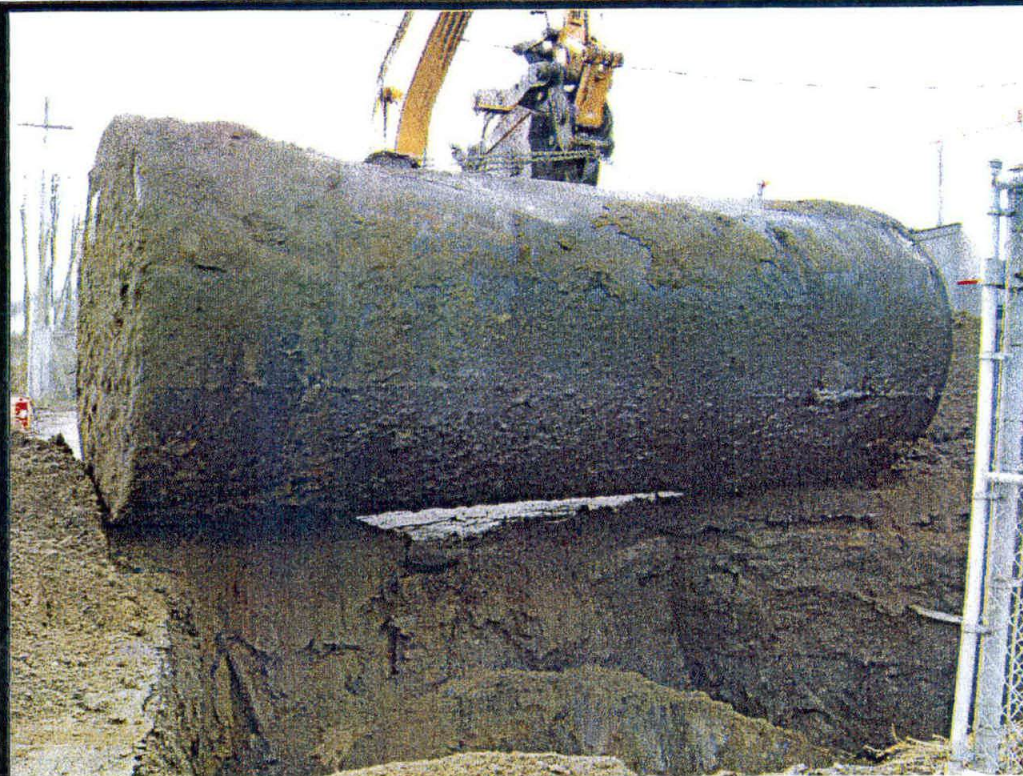
View of the 7,500-gallon stoddard solvent UST as it was being lifted from the excavation.

On March 3, 2009, EAI visited the subject site to observe the removal of the solvent tank following sign off on the removal permit by the Seattle Fire Marshall's field inspector. To remove the UST, Global excavated and removed the overburden soil and proceeded to excavate along the south side and west end of the tank. After sufficient earth pressure was removed, the tank was chained up through its lifting tabs and hoisted from the excavation (Plate 4, Site Photographs).

Upon removal the tank was measured and inspected. The tank was constructed of single-wall steel and had an approximate diameter and length of 8 feet by 20 feet, which would correspond to a tank with a capacity of 7,500 gallons. The tank was moderately rusted, however, with the exception of the sampling holes made in the 1990's, no other readily visible holes due to corrosion were observed on the tank.

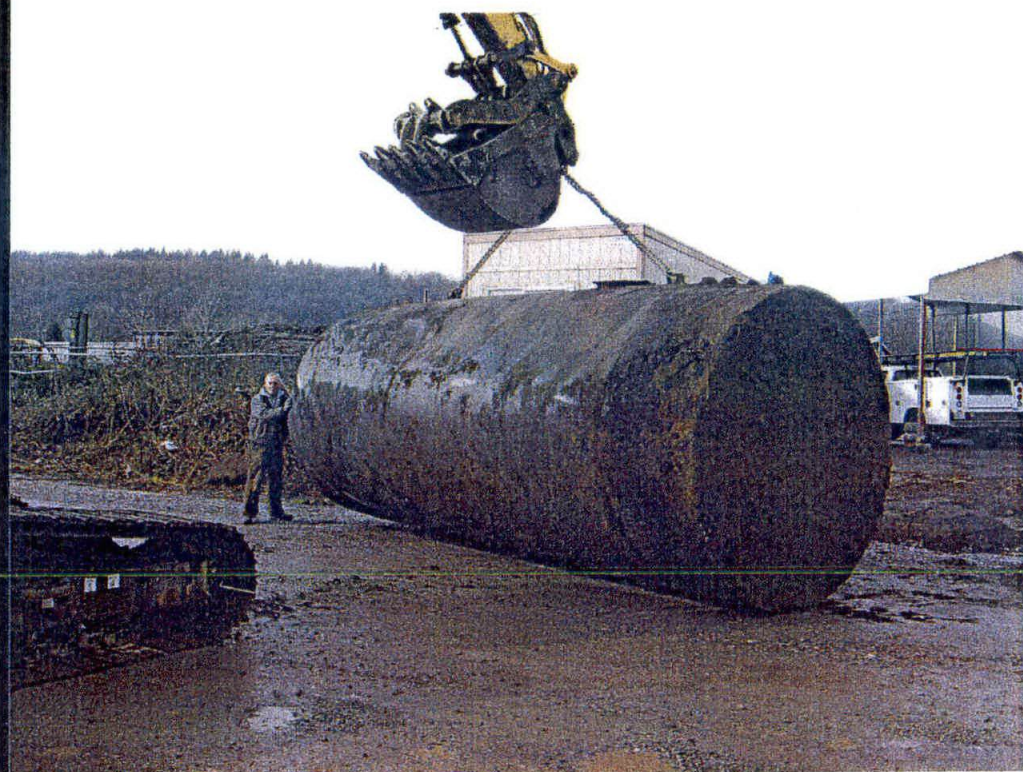
View of the UST being positioned for loading onto a flat bed truck for transportation off site.

The tank was loaded onto a flat bed truck and removed from the site for final disposal as scrap metal.

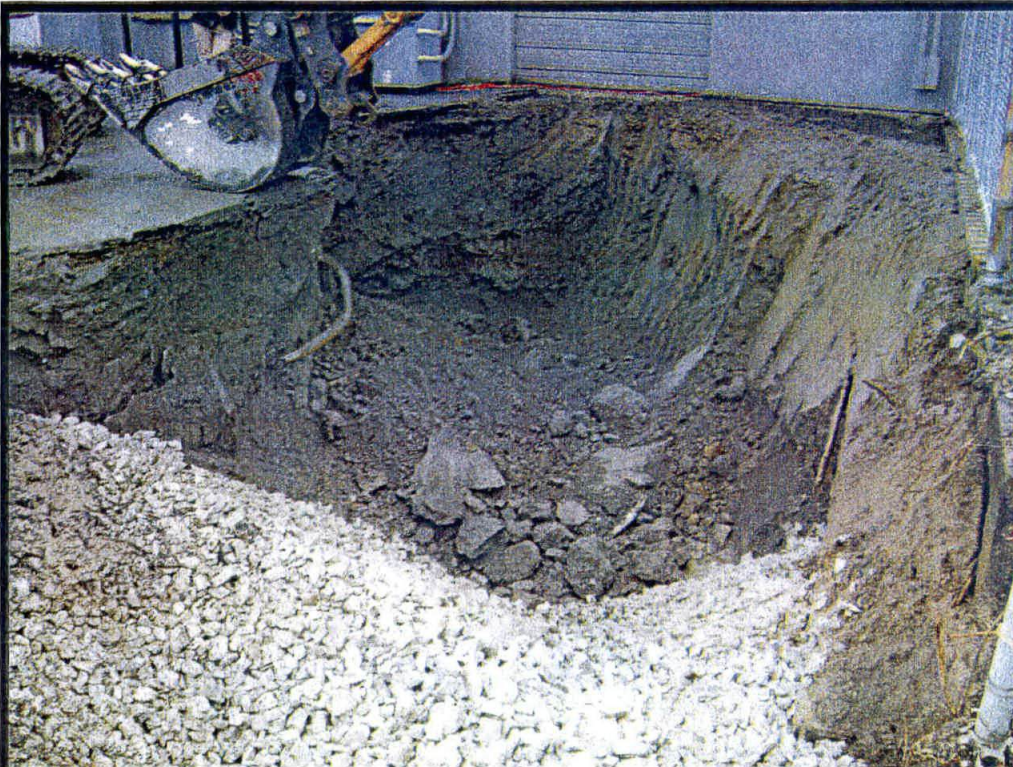
View of the final limits of excavation. Importation of back-fill is visible in the foreground.

On March 5, 2009, EAI and Global returned to the site to remove additional soil from the west end of the excavation. The extension of the excavation to the west was restricted by the proximity of the building foundation and a ground-mounted electrical transformer. An additional approximate 58 tons of contaminated soil was excavated and transported to Waste Management for disposal.

Following excavation of the remaining accessible soil, three (3) additional soil samples were collected to document soil conditions at the final limits of excavation. These samples were collected in the northwest corner of the excavation (RE-NW-6), the center of the west sidewall (RE-W-6) and southwest corner of the excavation (RE-SW-6).

The excavation was backfilled with "clean" imported 2" by 4" quarry spalls and type 17 gravel "pit run." During backfilling, perforated PVC pipe was laid out in three (3) pipe runs through the excavation as depicted on Plate 3, Exploration Plan and Plate 5, Site Photographs. These pipe runs were installed in the event that property ownership may desire to apply remediation enhancing compounds to the former tank excavation to help stimulate remediation of the groundwater. Alternatively, these pipe runs could also be used in the future as part of a vacuum extraction system.
