Dickman Mill Sediment Transport Study

Task 1 Technical Summary Memorandum

Subject: Task 1 - Technical Summary

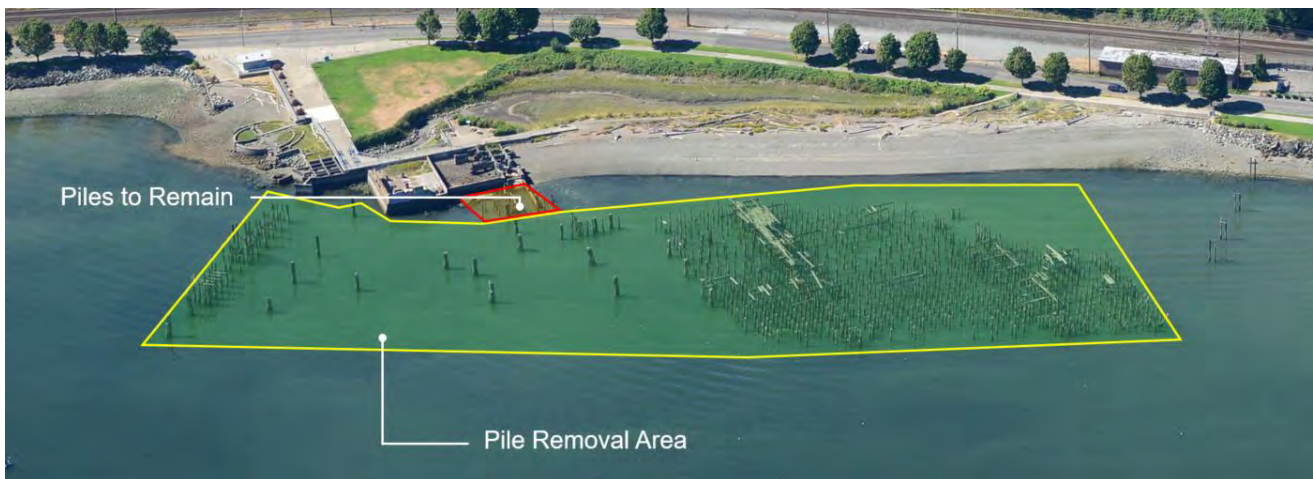
Figure 1. Pile Removal Areas Assessed

- Removal Area: The pile removal area is shown in Figure 1 and does not include the piles directly adjacent to the mill site.
- Pile Removal: All piles within the designated area are to be removed. Removal of pile stubs requires a different extraction process than full pile removal. Whether the stubs will be included in the removal depends in part on actions out of this analysis (Task 1 and Task 2).

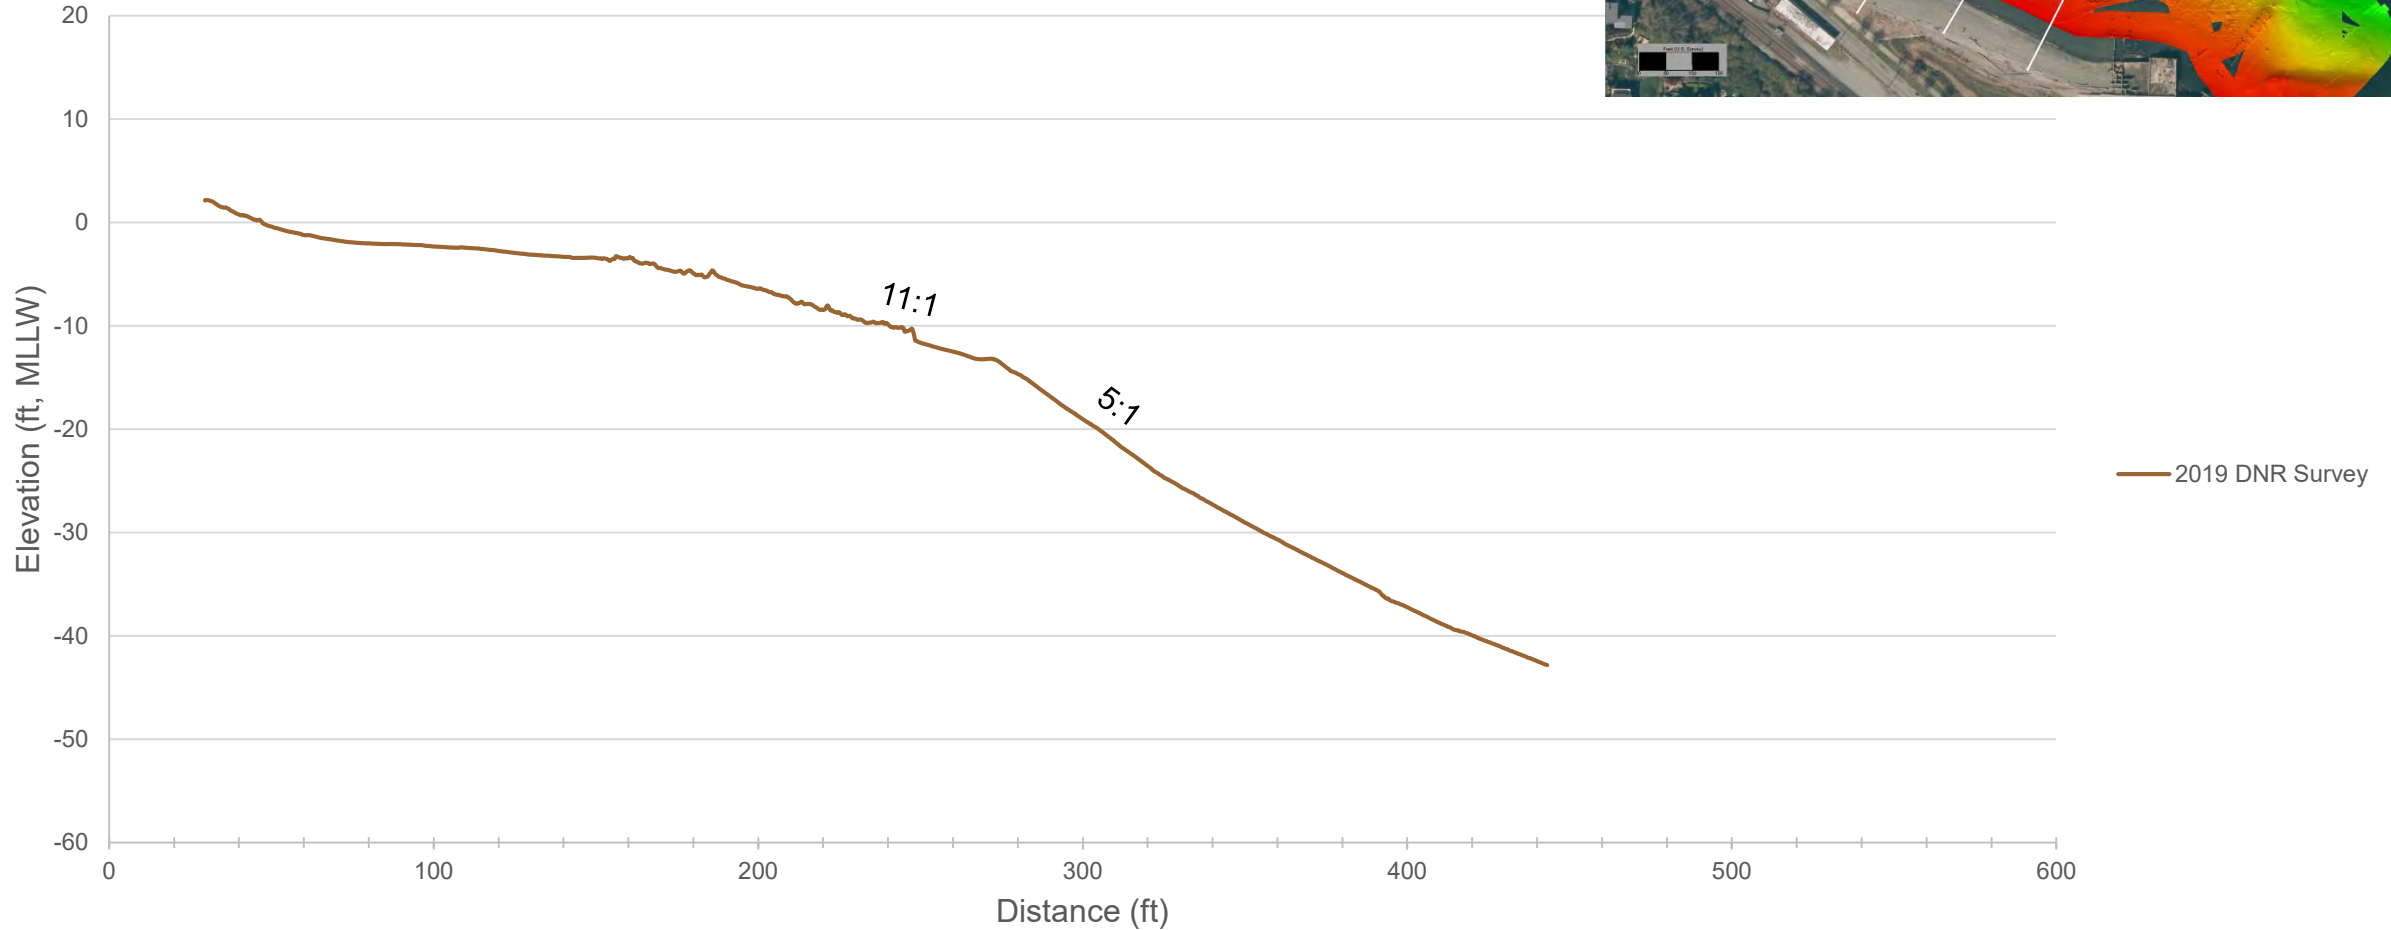
Survey: Section 1

Section	-10ft	-20ft	-30ft	-40ft
1	11:1	5:1	5.5:1	7:1
2	9:1	3.5:1	2.5:1	9:1
3	9:1	2.5:1	4:1	7:1
4	11:1	3.5:1	4:1	7:1

North of Pile Field

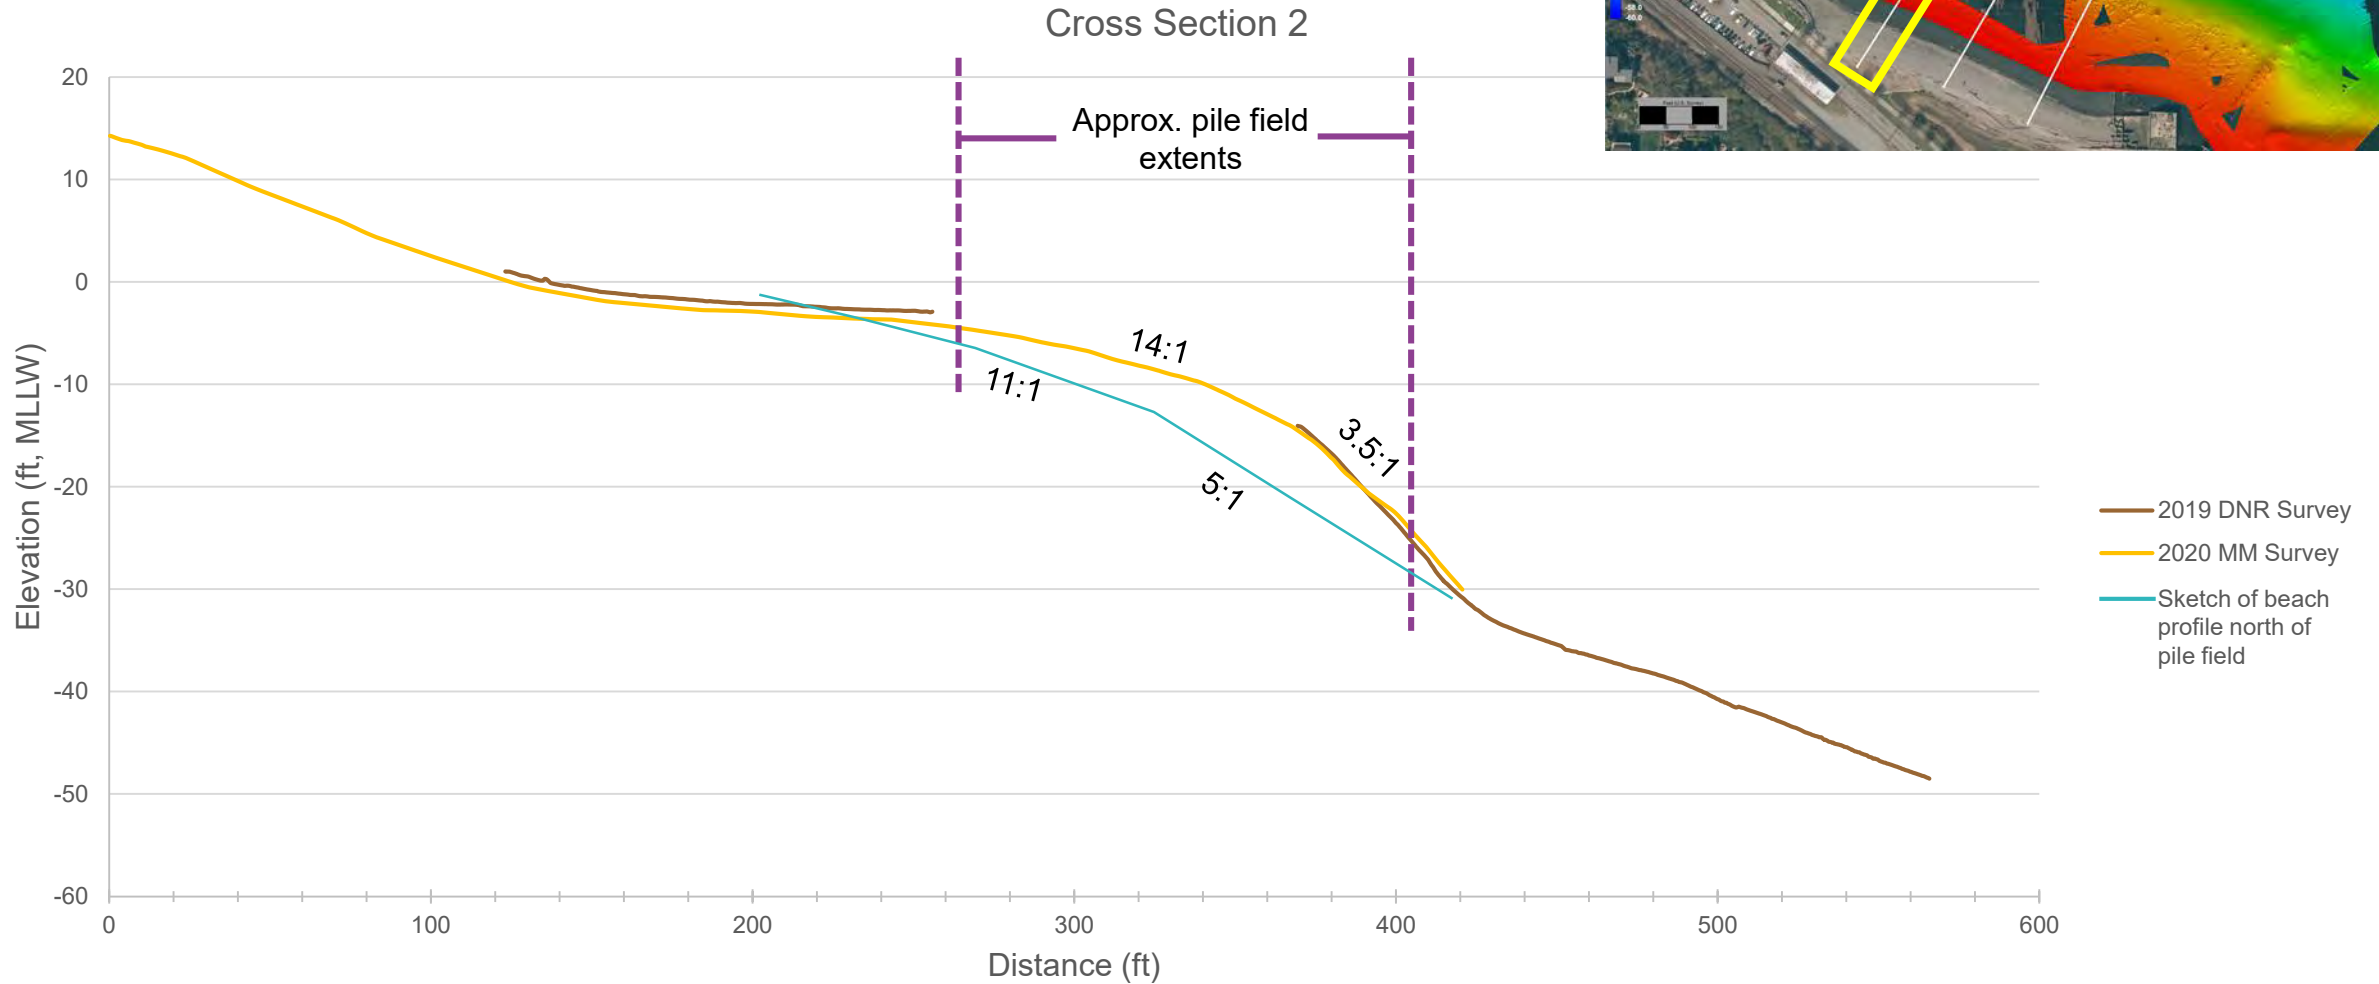
Survey: Section 2

Within Pile Field

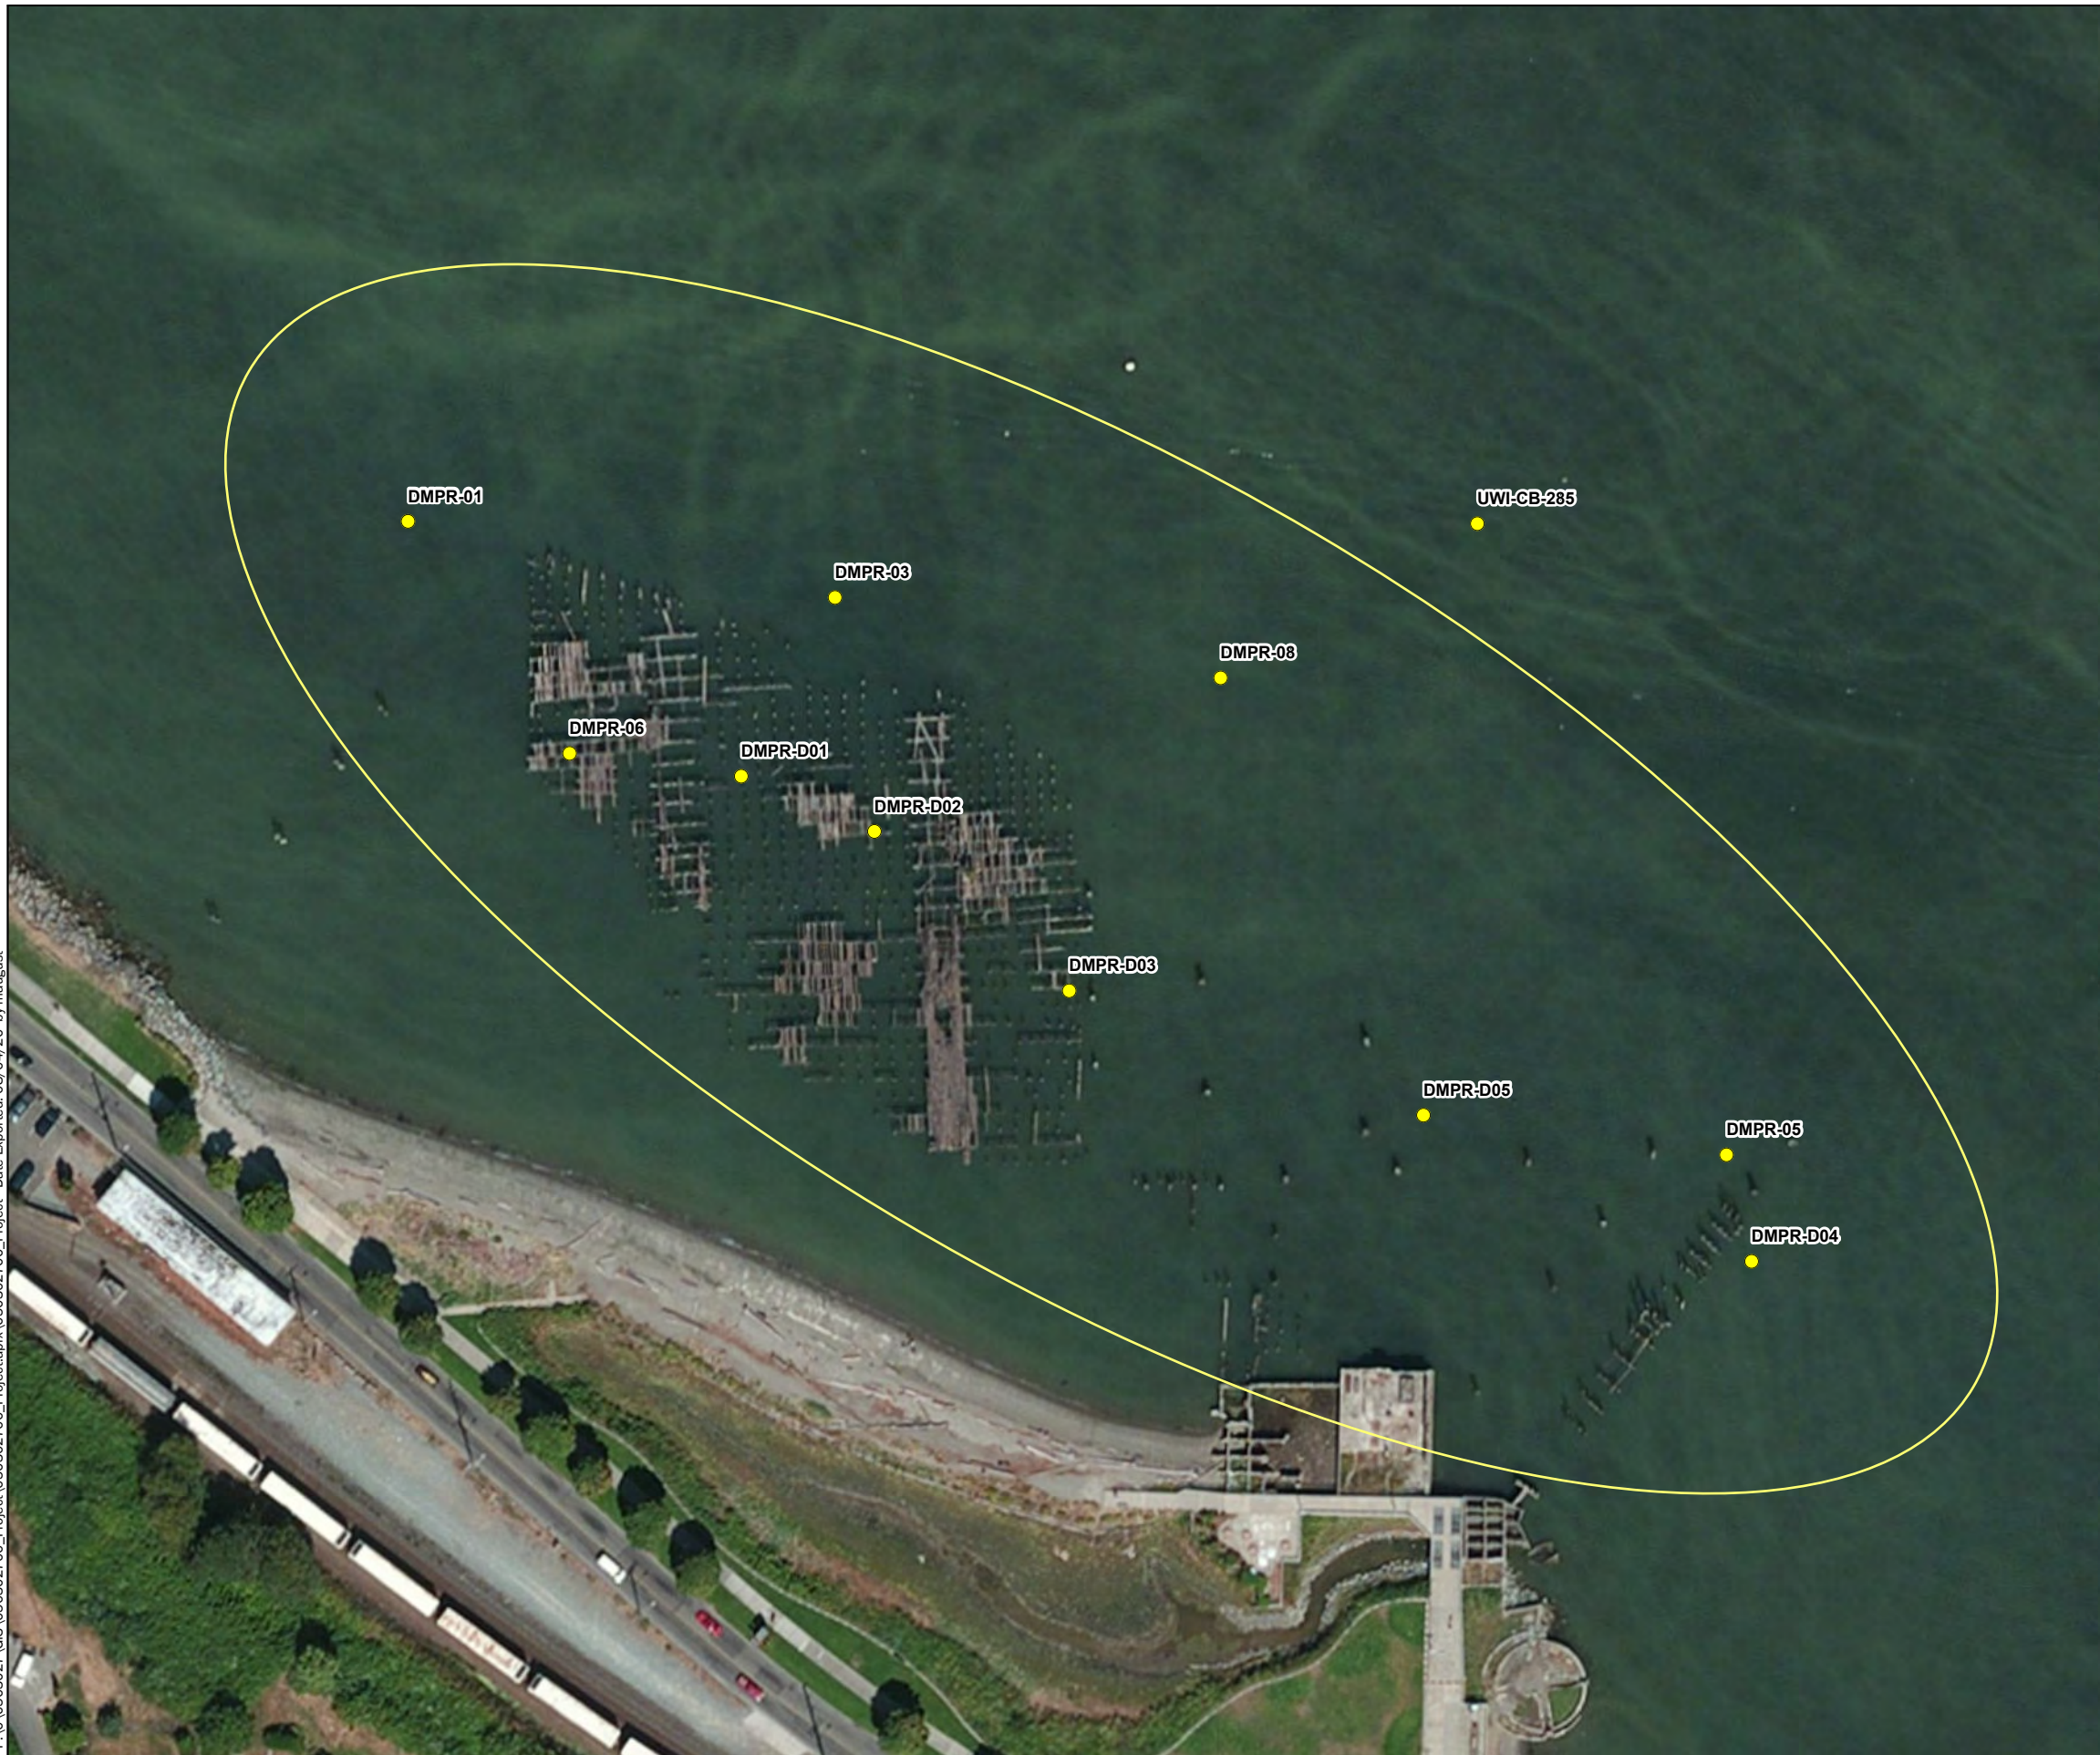
Site Plan	
Dickman Mill Tacoma, Washington	
	Figure 2

The site is located in the nearshore environment of Commencement Bay, adjacent to a former sawmill that operated between 1889 and 1977. Historically, the site contained a large wharf built over the water that has since deteriorated but many of the piles remain. Historical mill activities contributed to contamination in the upland and nearshore areas. The remaining creosote treated piles are suspected to be an ongoing source of contamination. Using aerial imagery, a polygon was drawn around the piles to establish the boundaries for our evaluation (shown on Figure 2) and what we refer hereafter as the “Study Area”.

Available data were limited to surface sediment samples collected in the nearshore area adjacent to Ruston Way. For this review, only those samples falling within the piling field were used and were represented by two investigations conducted by WDNR in 2015. One additional sampling location (UWI-CB-285) used in a long-term monitoring program was included in our analysis as a far-field sample and is considered offsite. The surface sediment sampling locations data used in our analysis is summarized in Table 1 and shown on Figure 2.

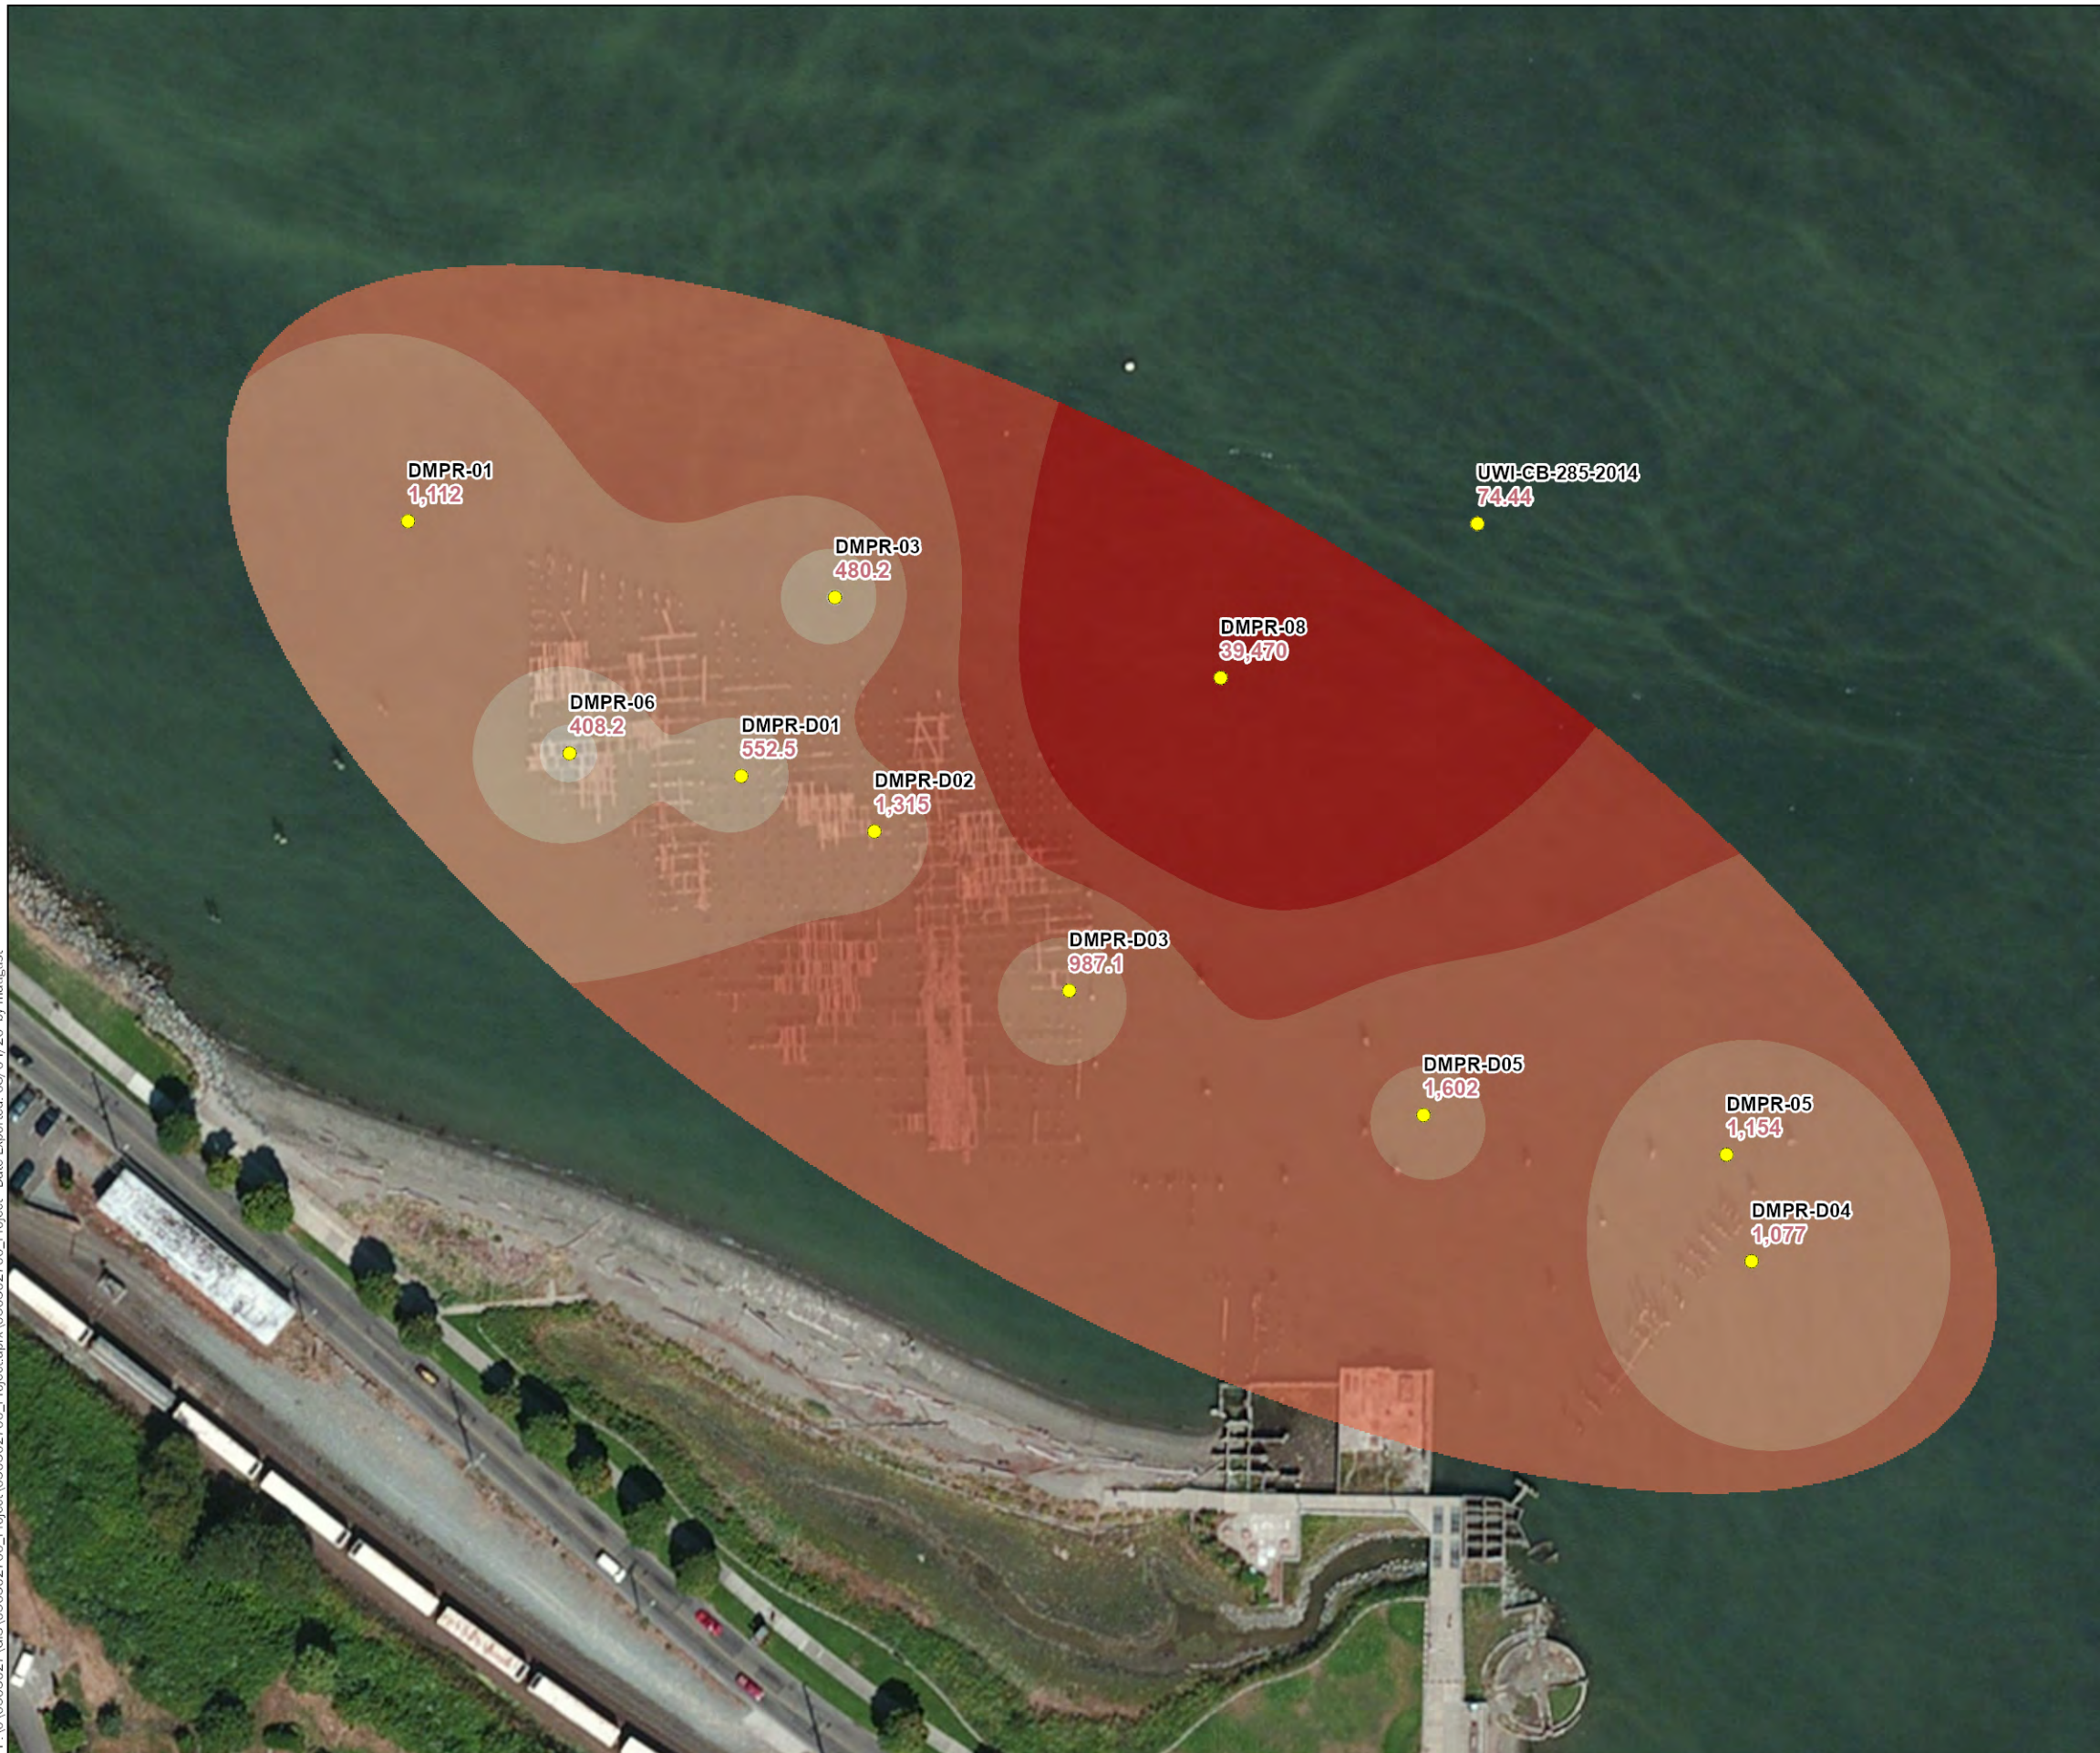
Figure 3a

cPAH TEQ

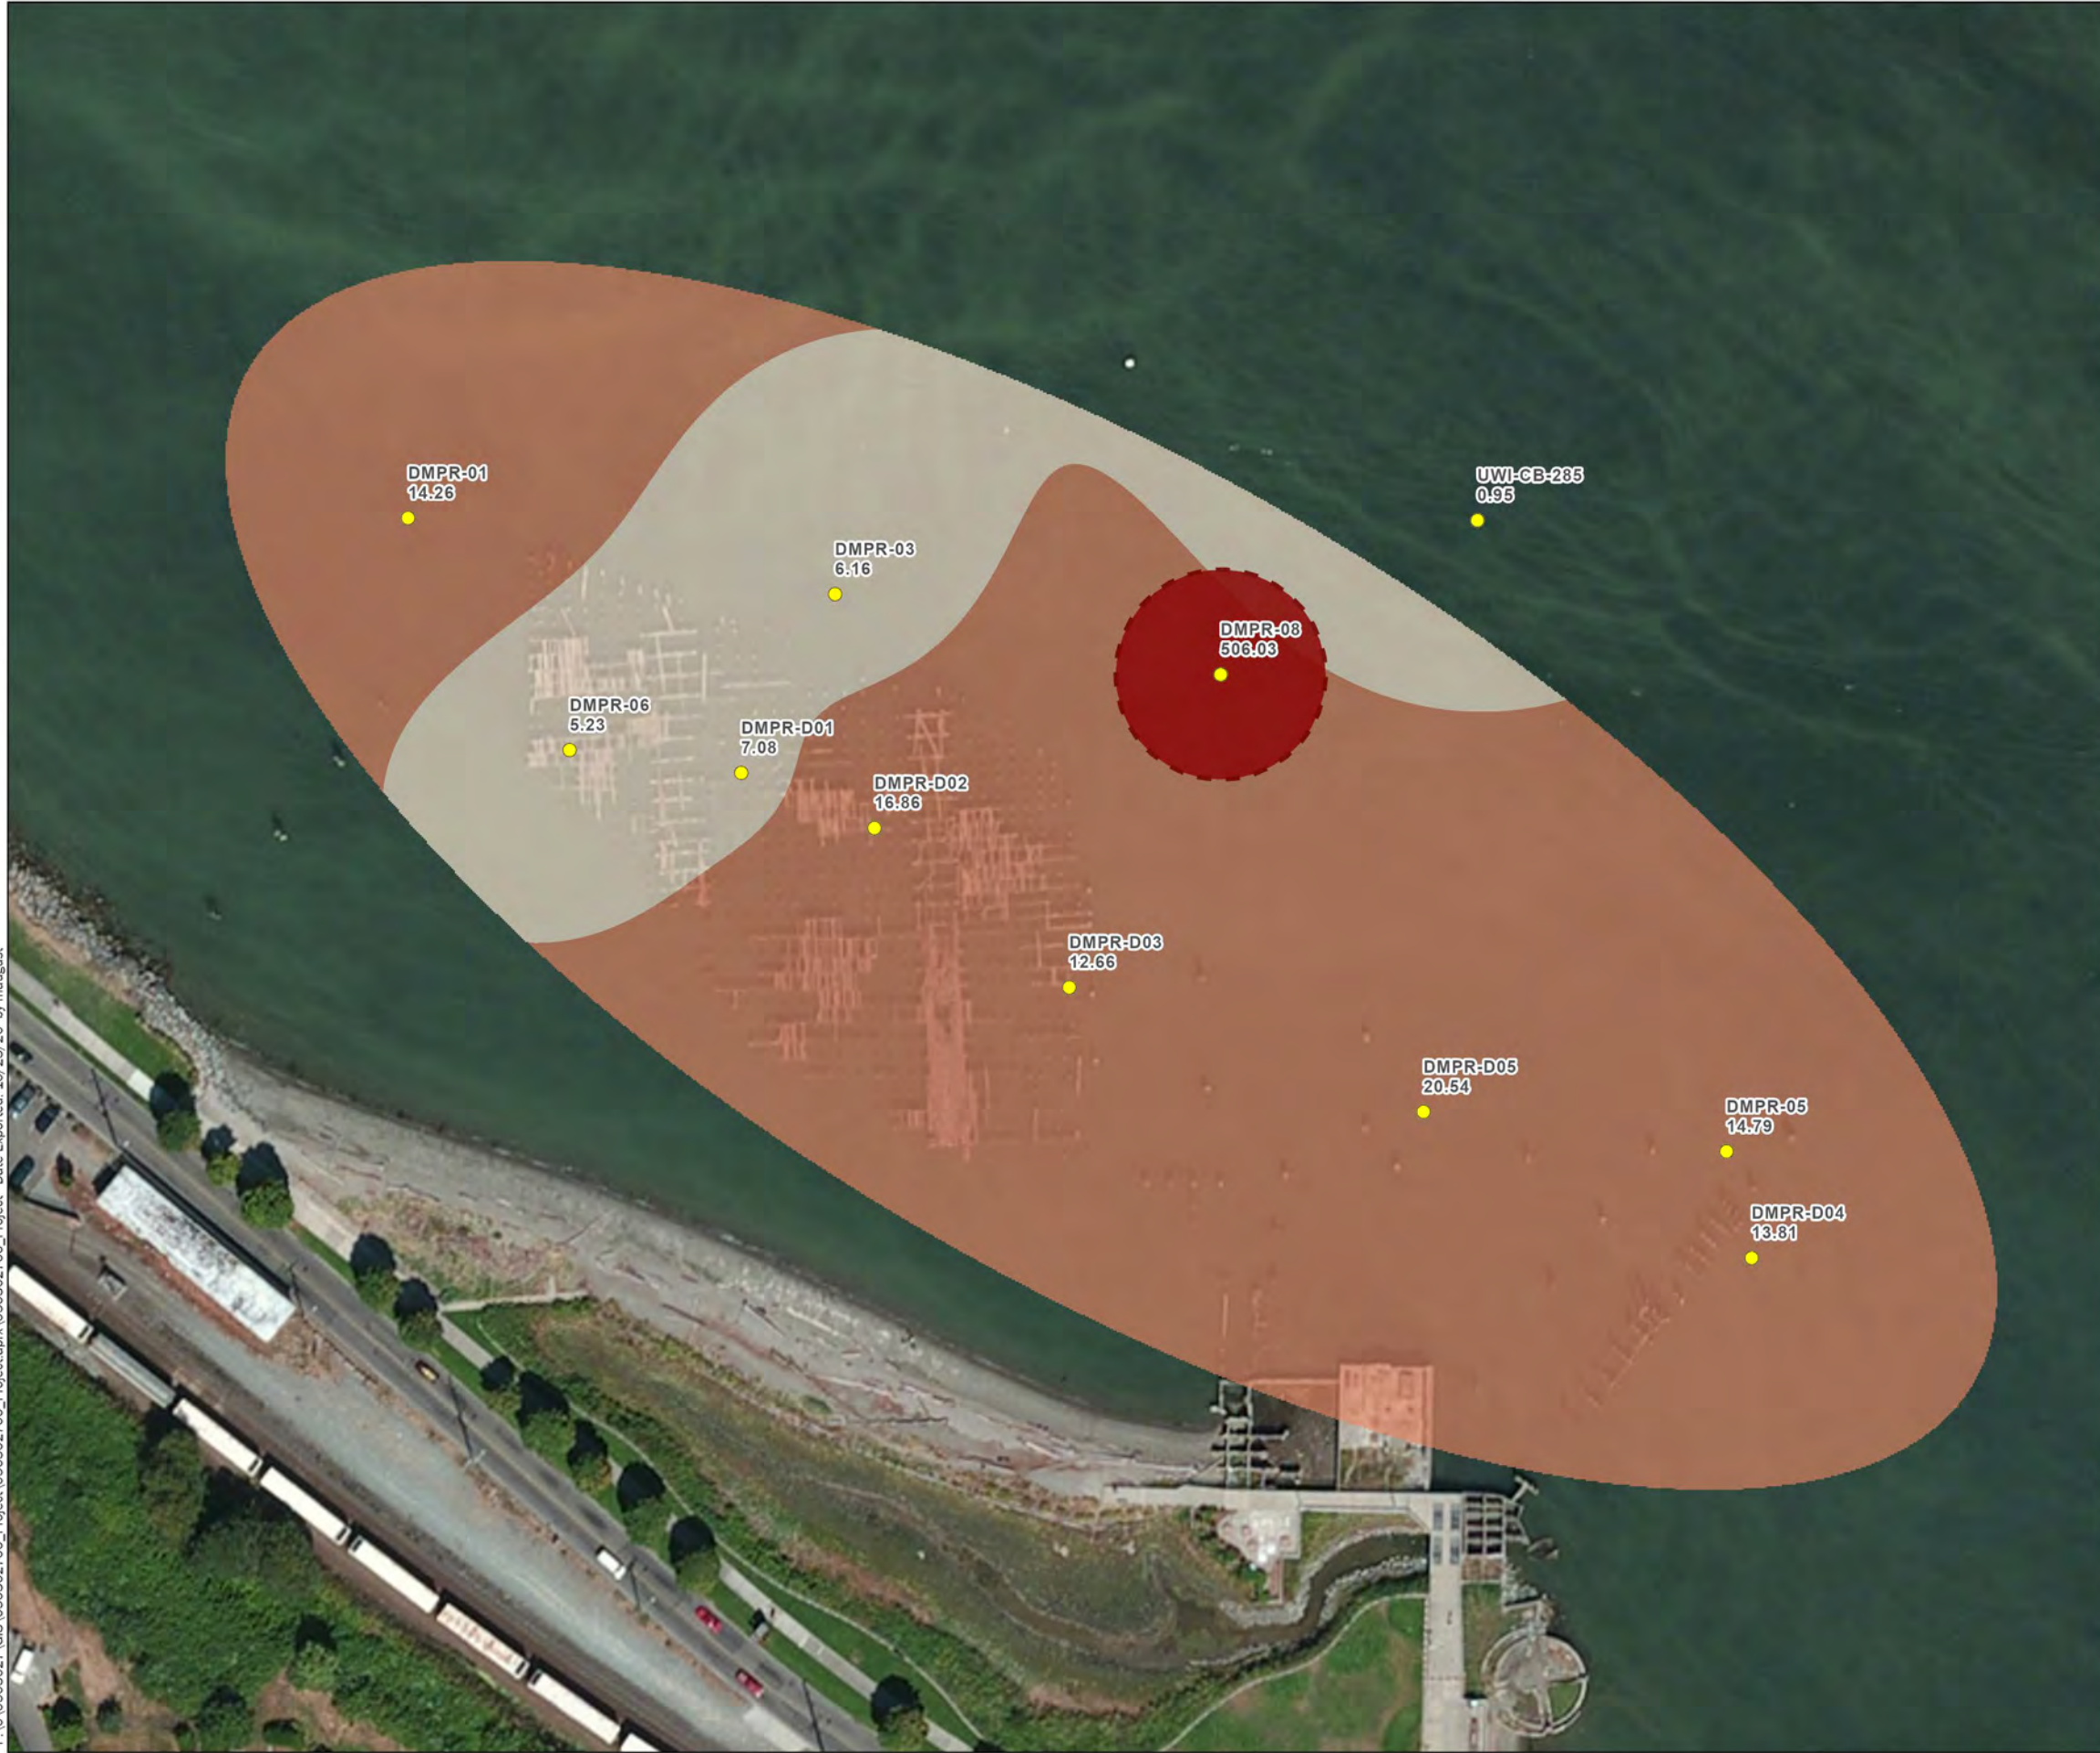
cPAH TEQ Exceedance Factor	
Dickman Mill Tacoma, Washington	
	Figure 3b

- Sample Location cPAH TEQ Result
- cPAH TEQ Concentration (Exceedance Factor)
 - ≤ 10
 - 10 - 21
 - > 21
- - - Estimated Extent of Sample DMPR-08

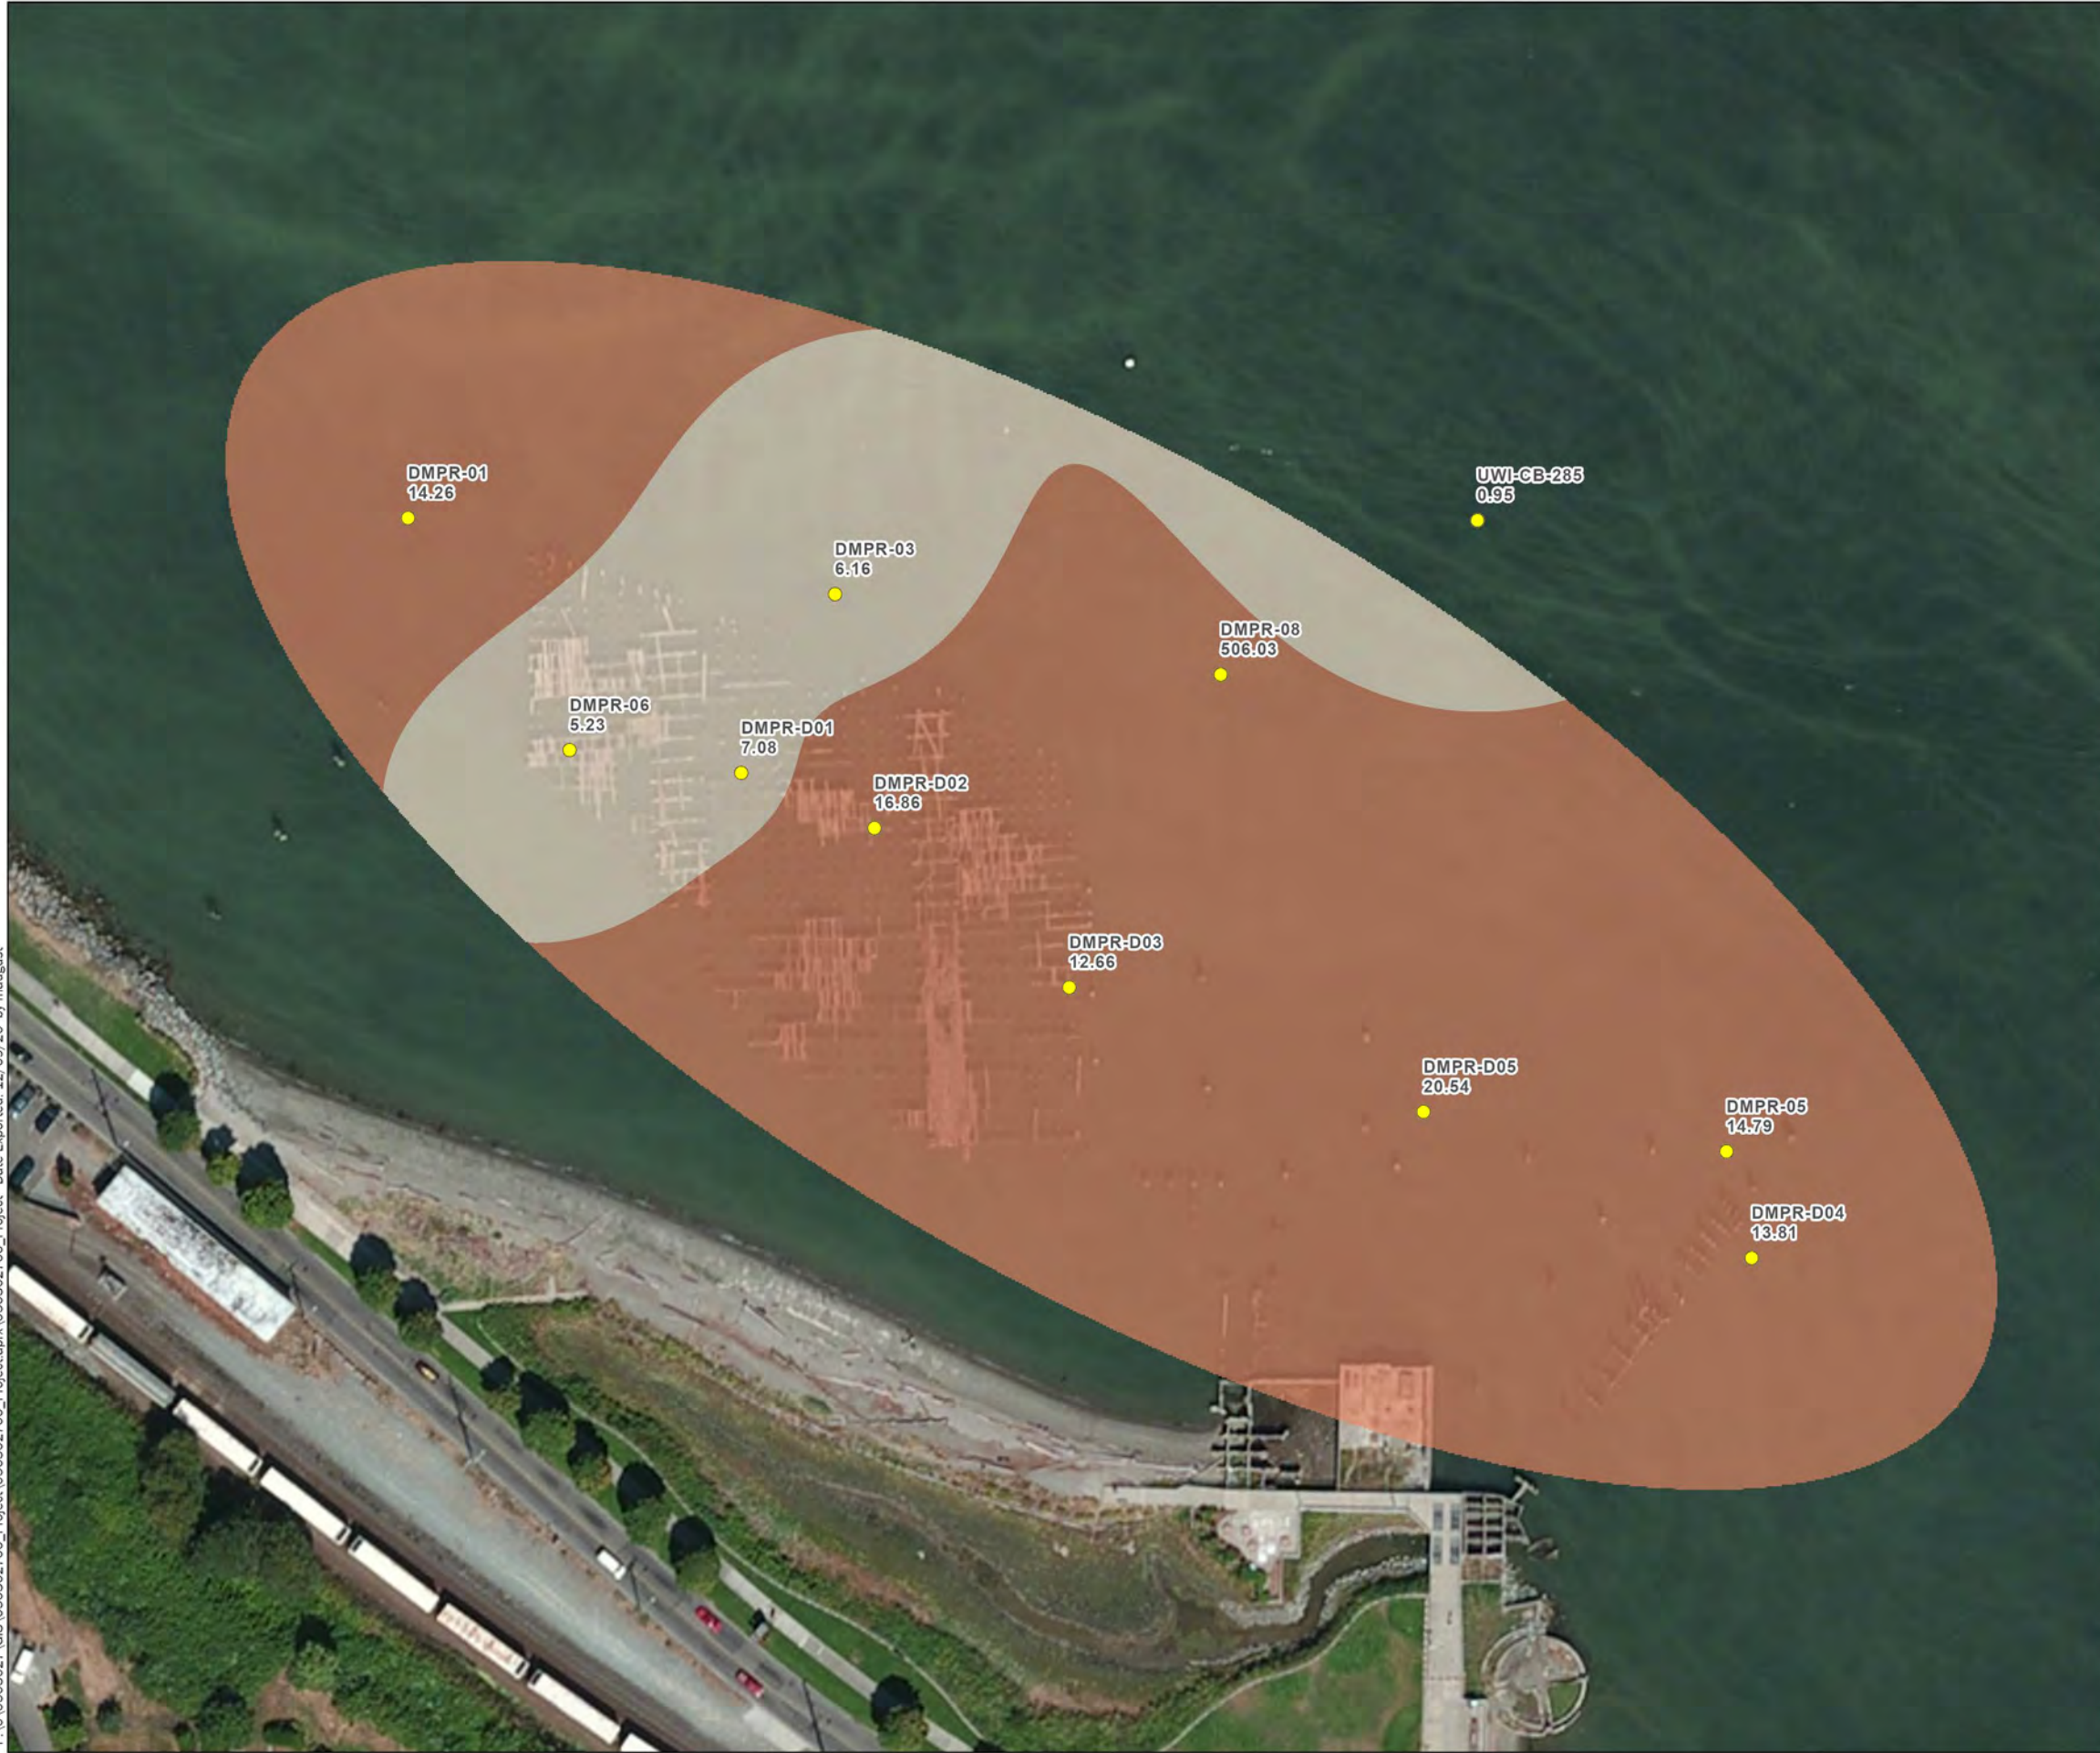
cPAH TEQ Exceedance Factor without DMPR-08	
Dickman Mill Tacoma, Washington	
	Figure 3c

- Sample Location cPAH TEQ Result
- cPAH TEQ Concentration (Exceedance Factor)
- ≤ 10
- 10 - 21
- > 21
