Dickman Mill Sediment Transport Study

Task 1 Technical Summary Memorandum

Subject: Task 1 - Technical Summary

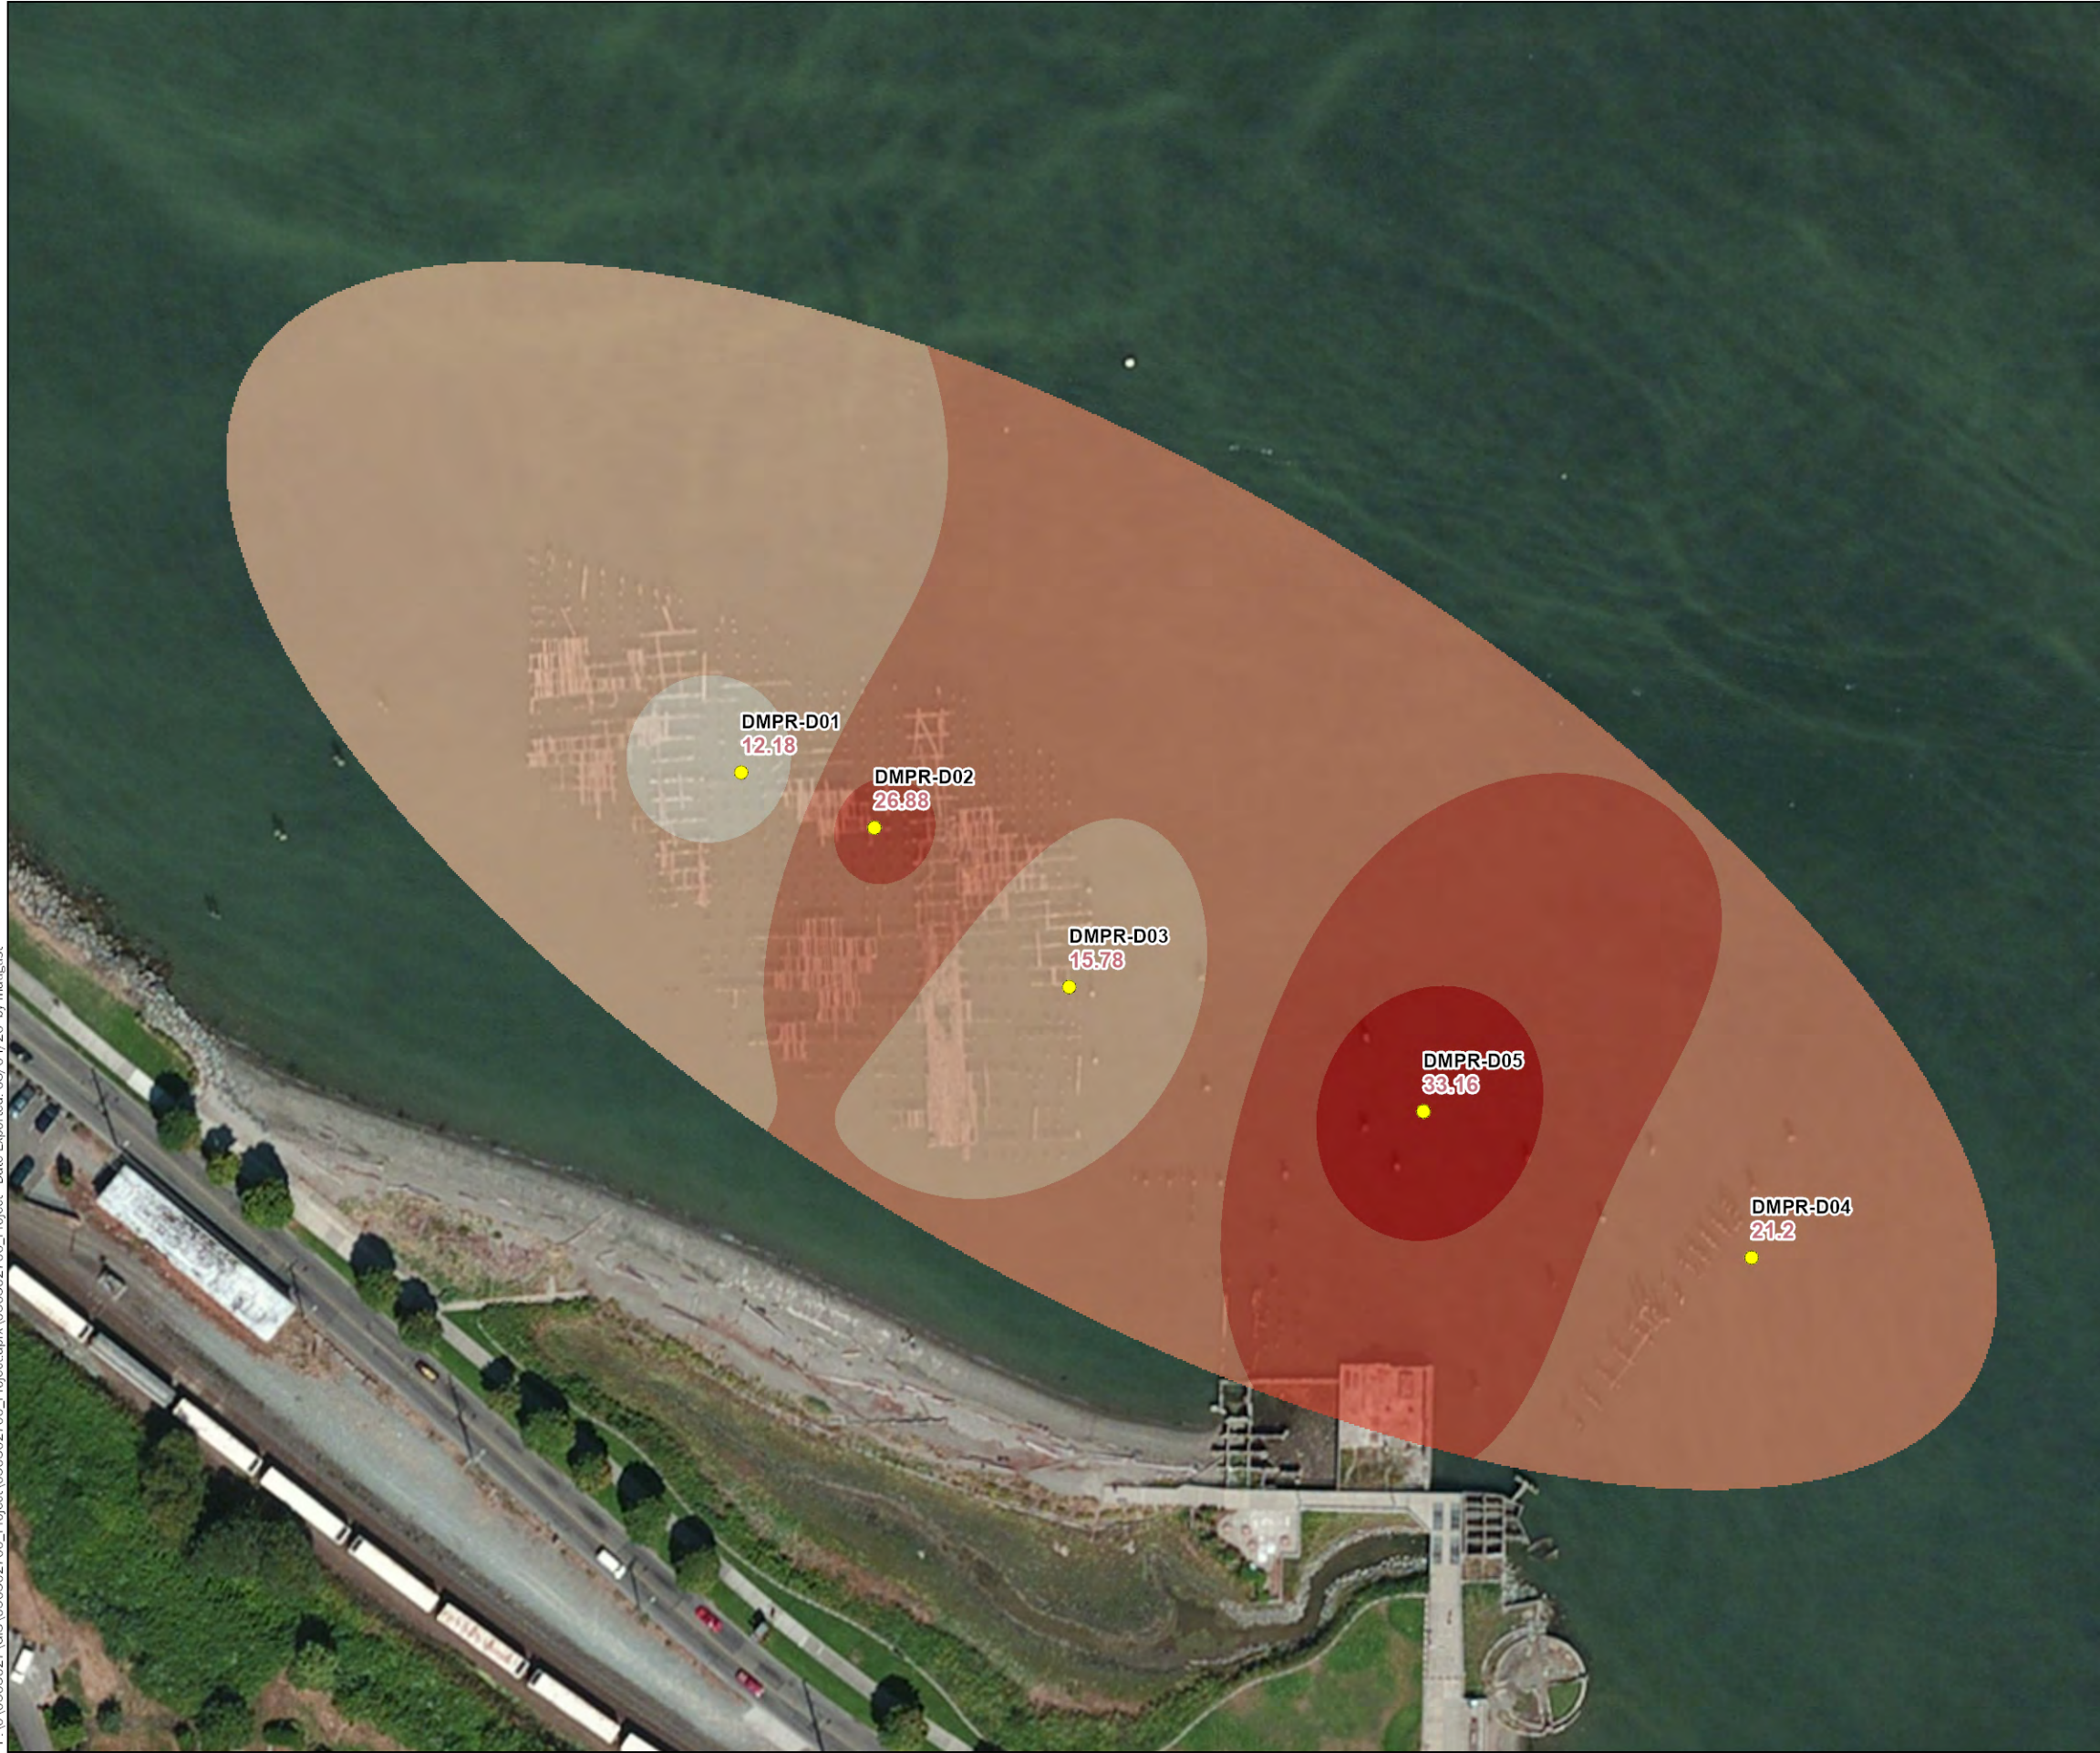
Dioxin TEQ	
Dickman Mill Tacoma, Washington	
	Figure 4a

- Sample Location Dioxin TEQ Result
- Dioxin TEQ (pg/g)
- ≤ 15
 - ≤ 20
 - ≤ 25
 - ≤ 30
 - ≤ 35

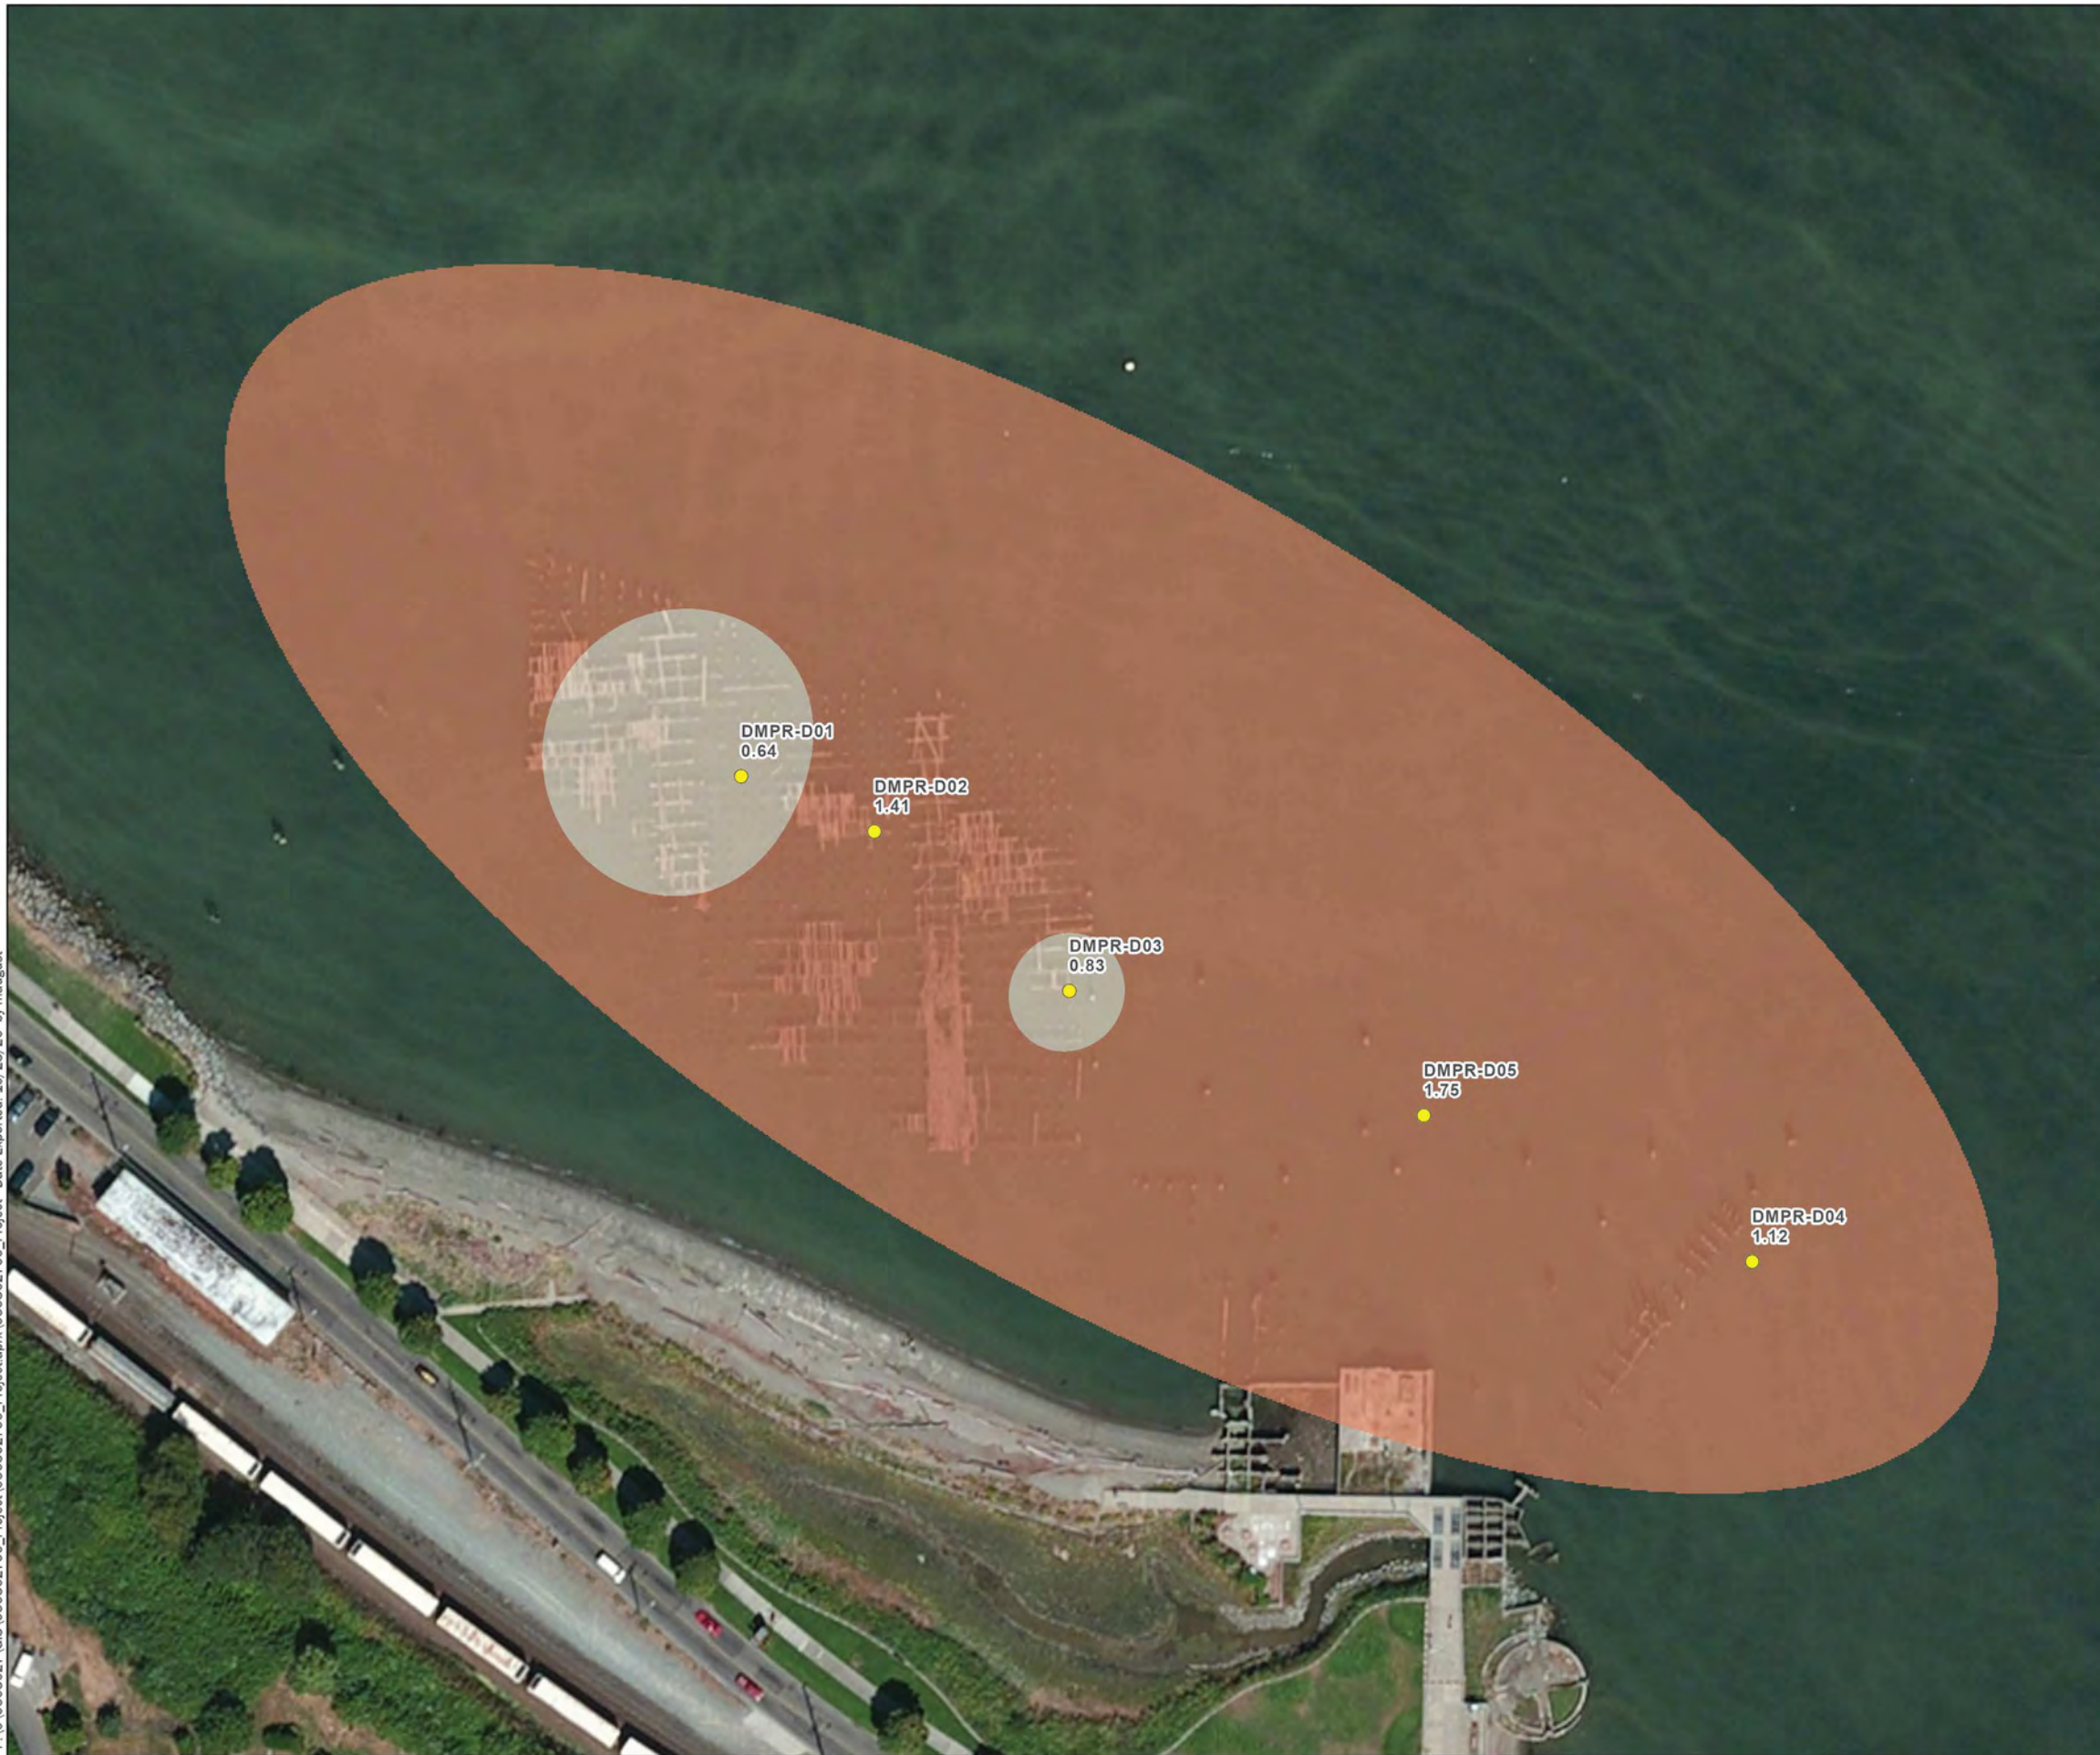
Dioxin TEQ Exceedance Factor	
Dickman Mill Tacoma, Washington	
	Figure 4b

- Sample Location Dioxin TEQ Result
- Dioxin TEQ (Exceedance Factor)
- <1
 - 1-2
 - >2

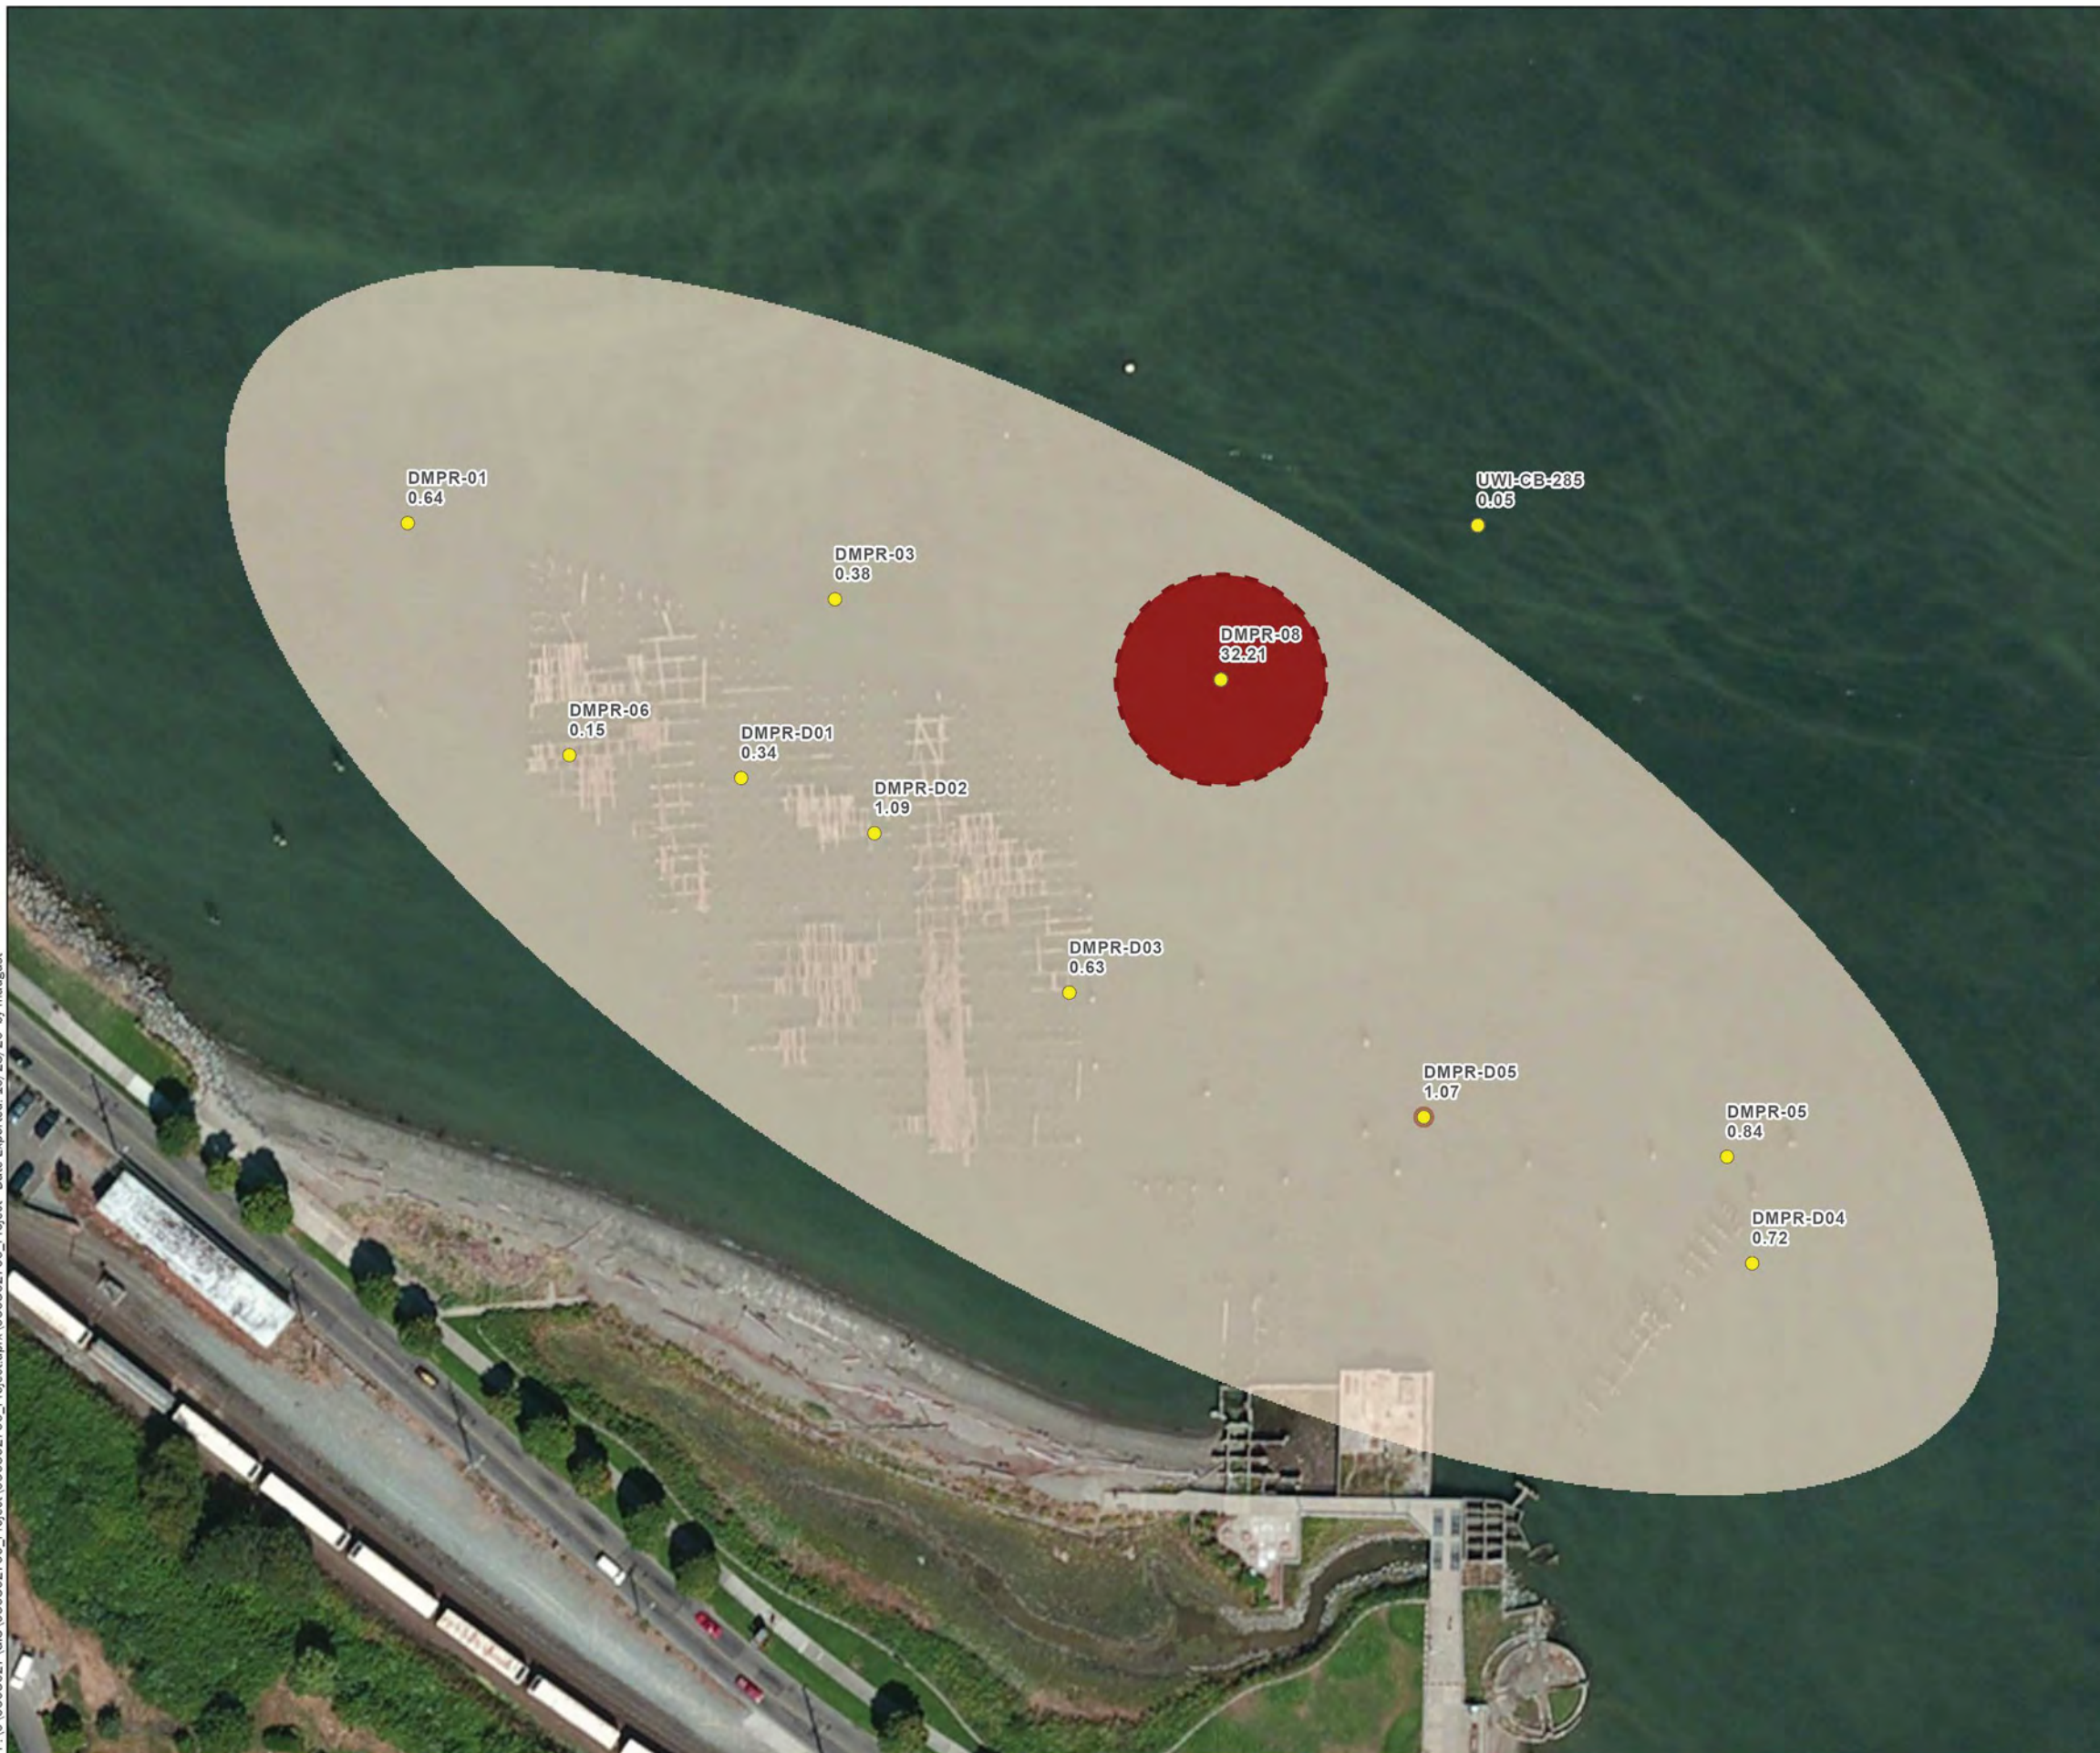
LPAH Exceedance Factor	
Dickman Mill Tacoma, Washington	
	Figure 5b

- Sample Location LPAH Result
- LPAH (Exceedance Factor)**
- <1
- 1-2
- >2
- Estimated Extent of Sample DMPR-08

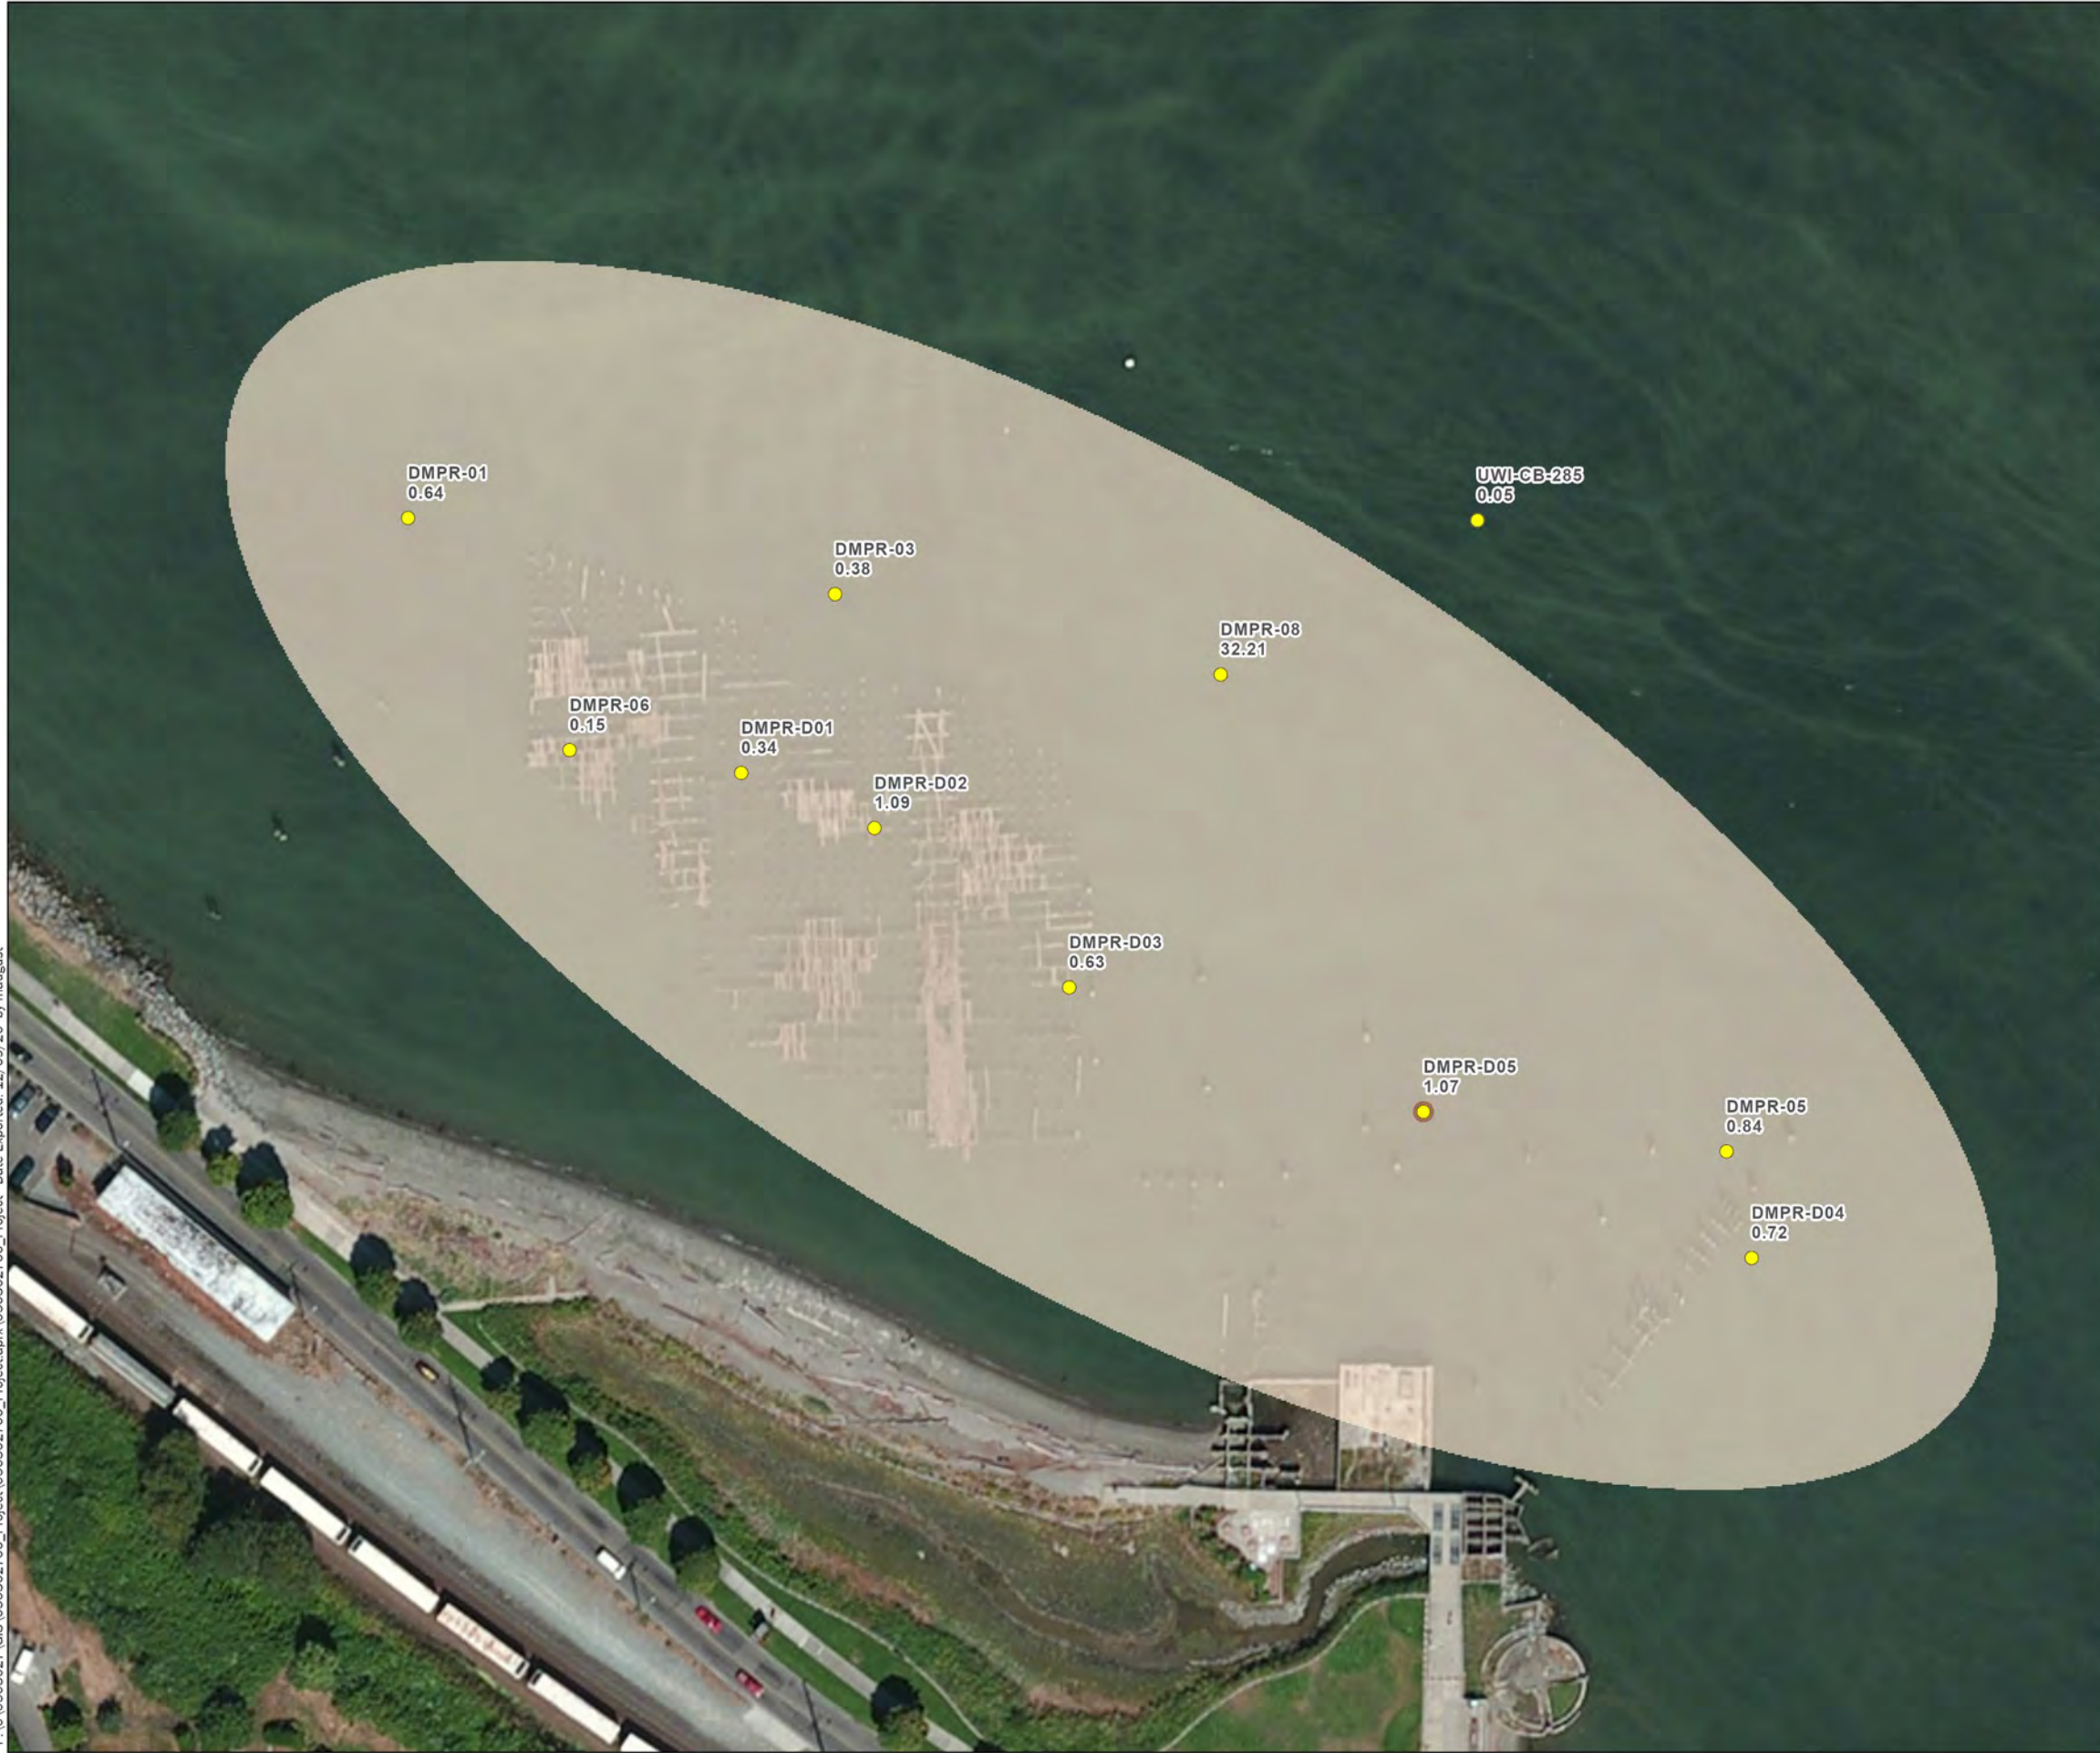
LPAH Exceedance Factor without DMPR-08	
Dickman Mill Tacoma, Washington	
	Figure 5c

- Sample Location LPAH Result
- LPAH (Exceedance Factor)
- <1
 - 1-2
 - >2

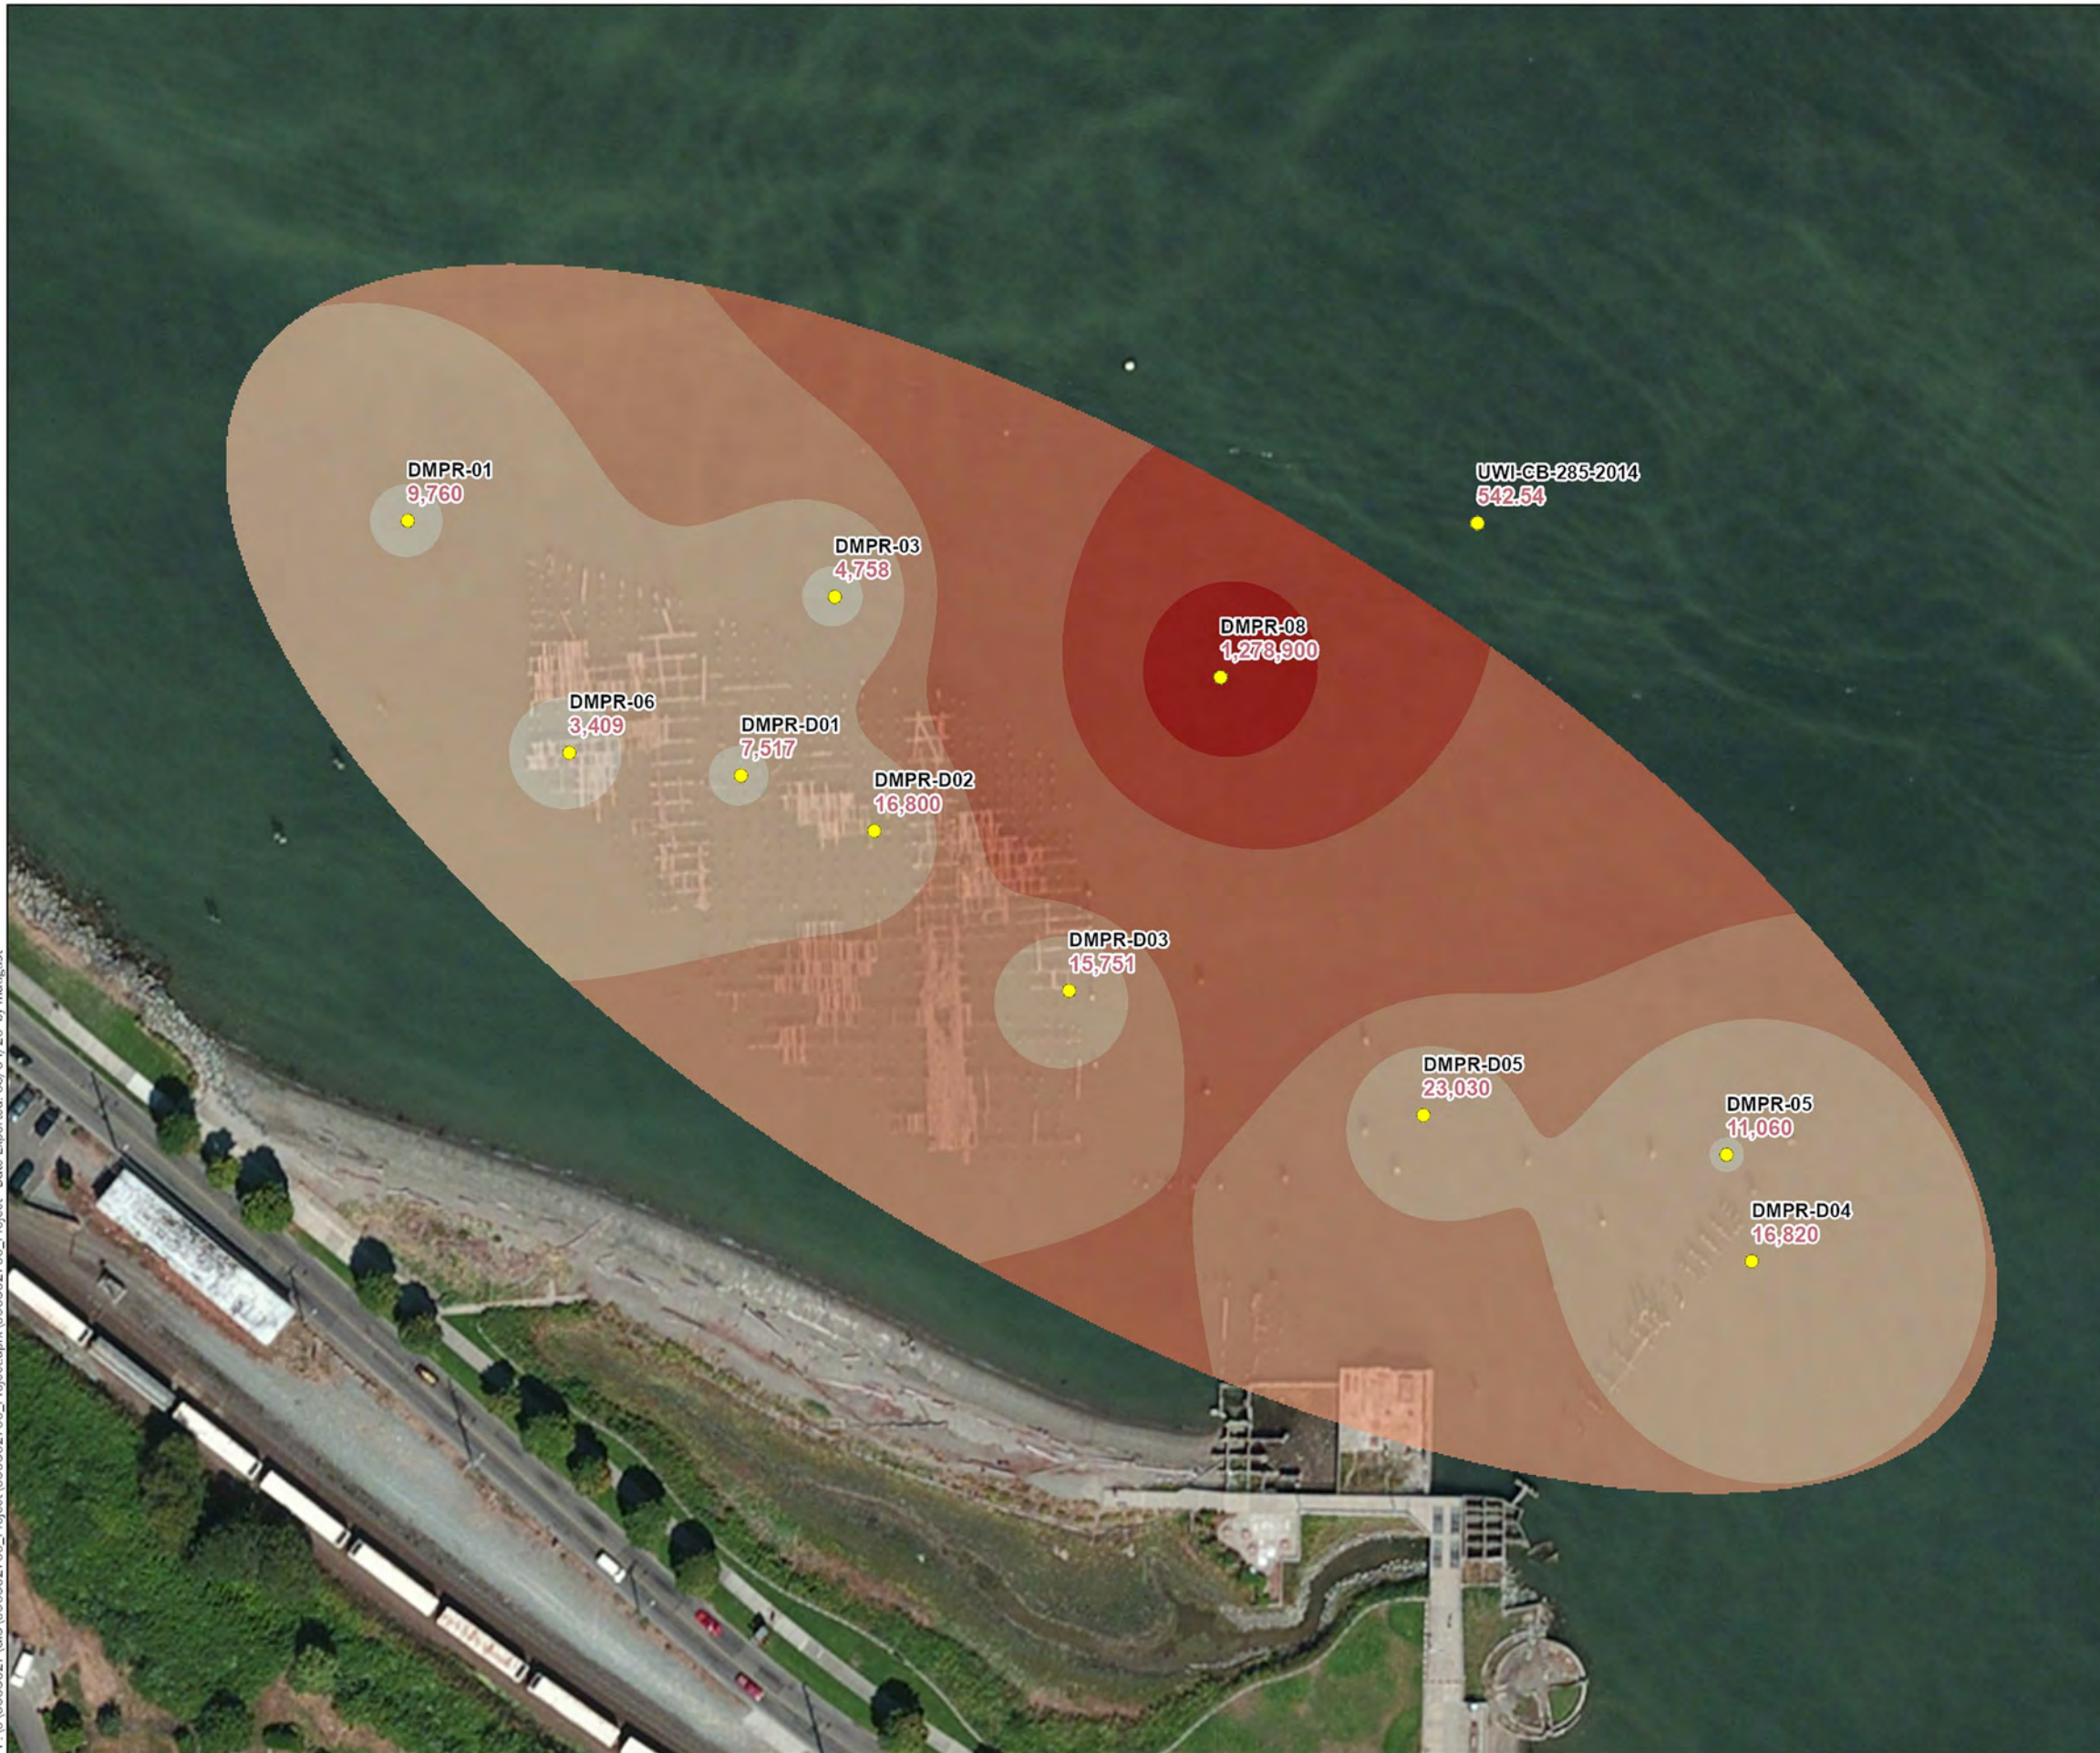
HPAH	
Dickman Mill Tacoma, Washington	
GEOENGINEERS	Figure 6a

- Sample Location HPAH Result
- HPAH (µg/kg)
- ≤ 12000
- ≤ 50000
- ≤ 100000
- ≤ 500000
- ≤ 1000000
- ≤ 1500000

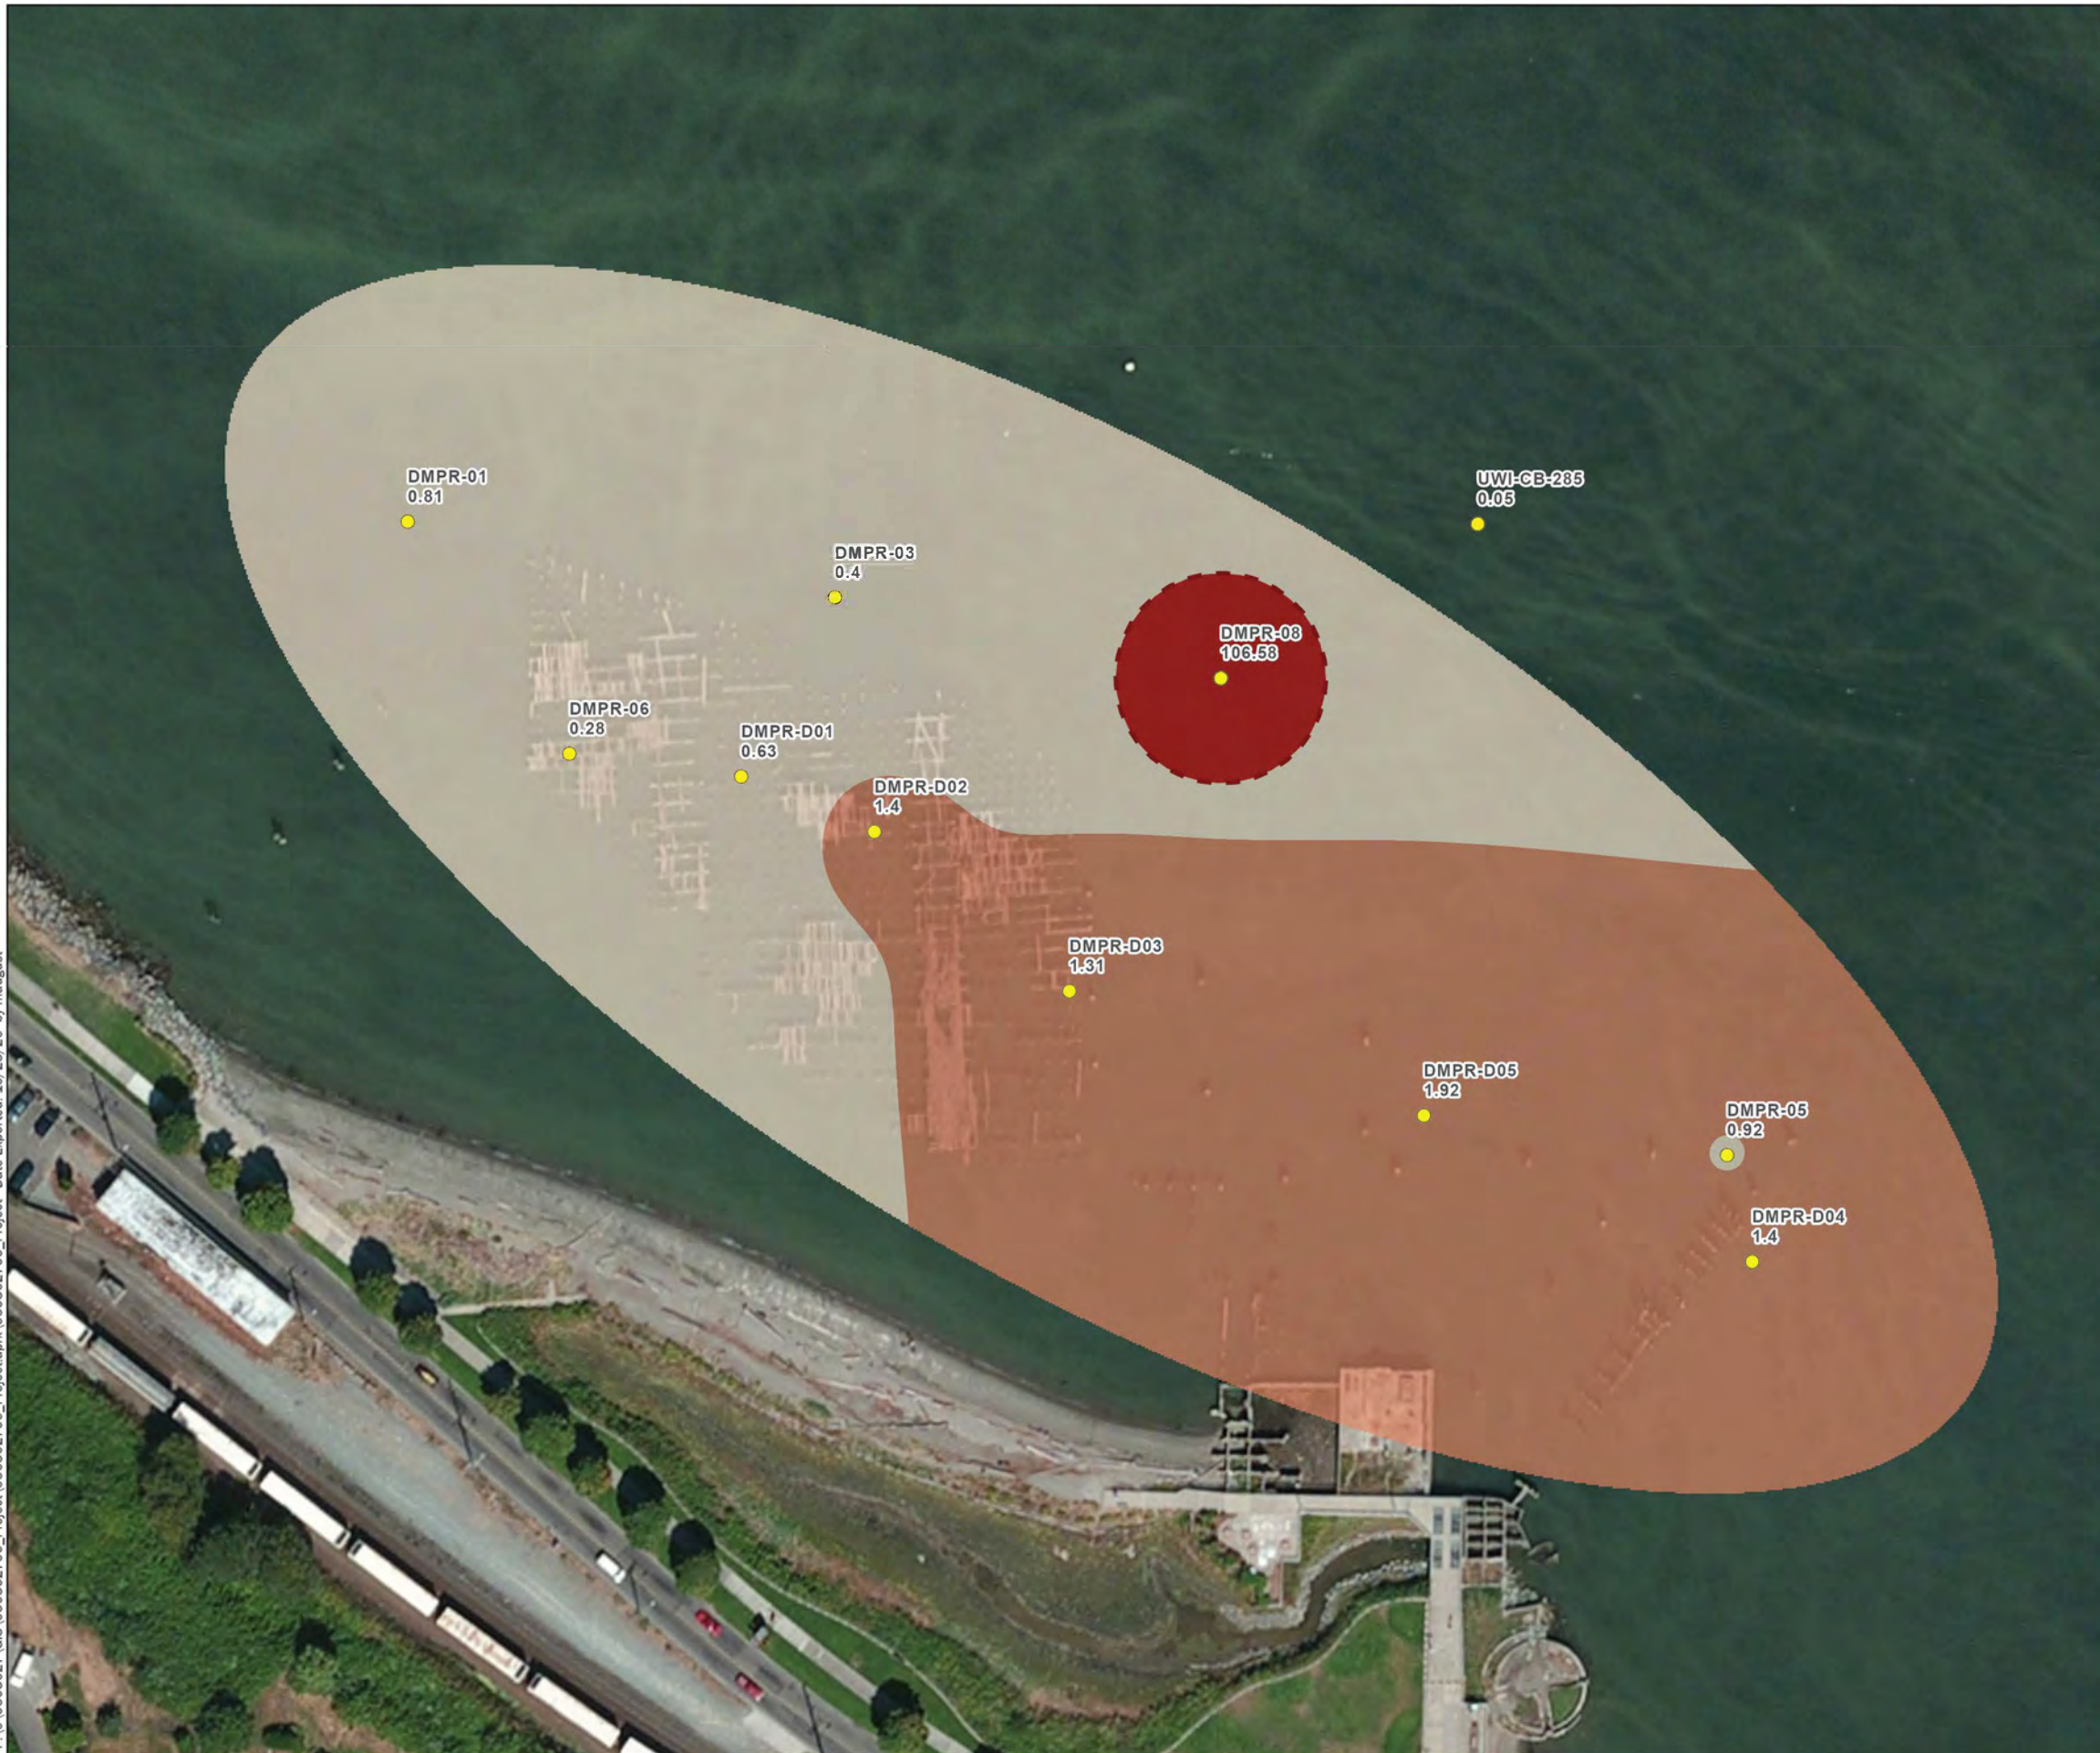
HPAH Exceedance Factor	
Dickman Mill Tacoma, Washington	
	Figure 6b

- Sample Location HPAH Result
- HPAH (Exceedance Factor)**
- <1
- 1-2
- >2
- Estimated Extent of Sample DMPR-08
