Dickman Mill Sediment Transport Study

Task 1 Technical Summary Memorandum

Subject: Task 1 - Technical Summary

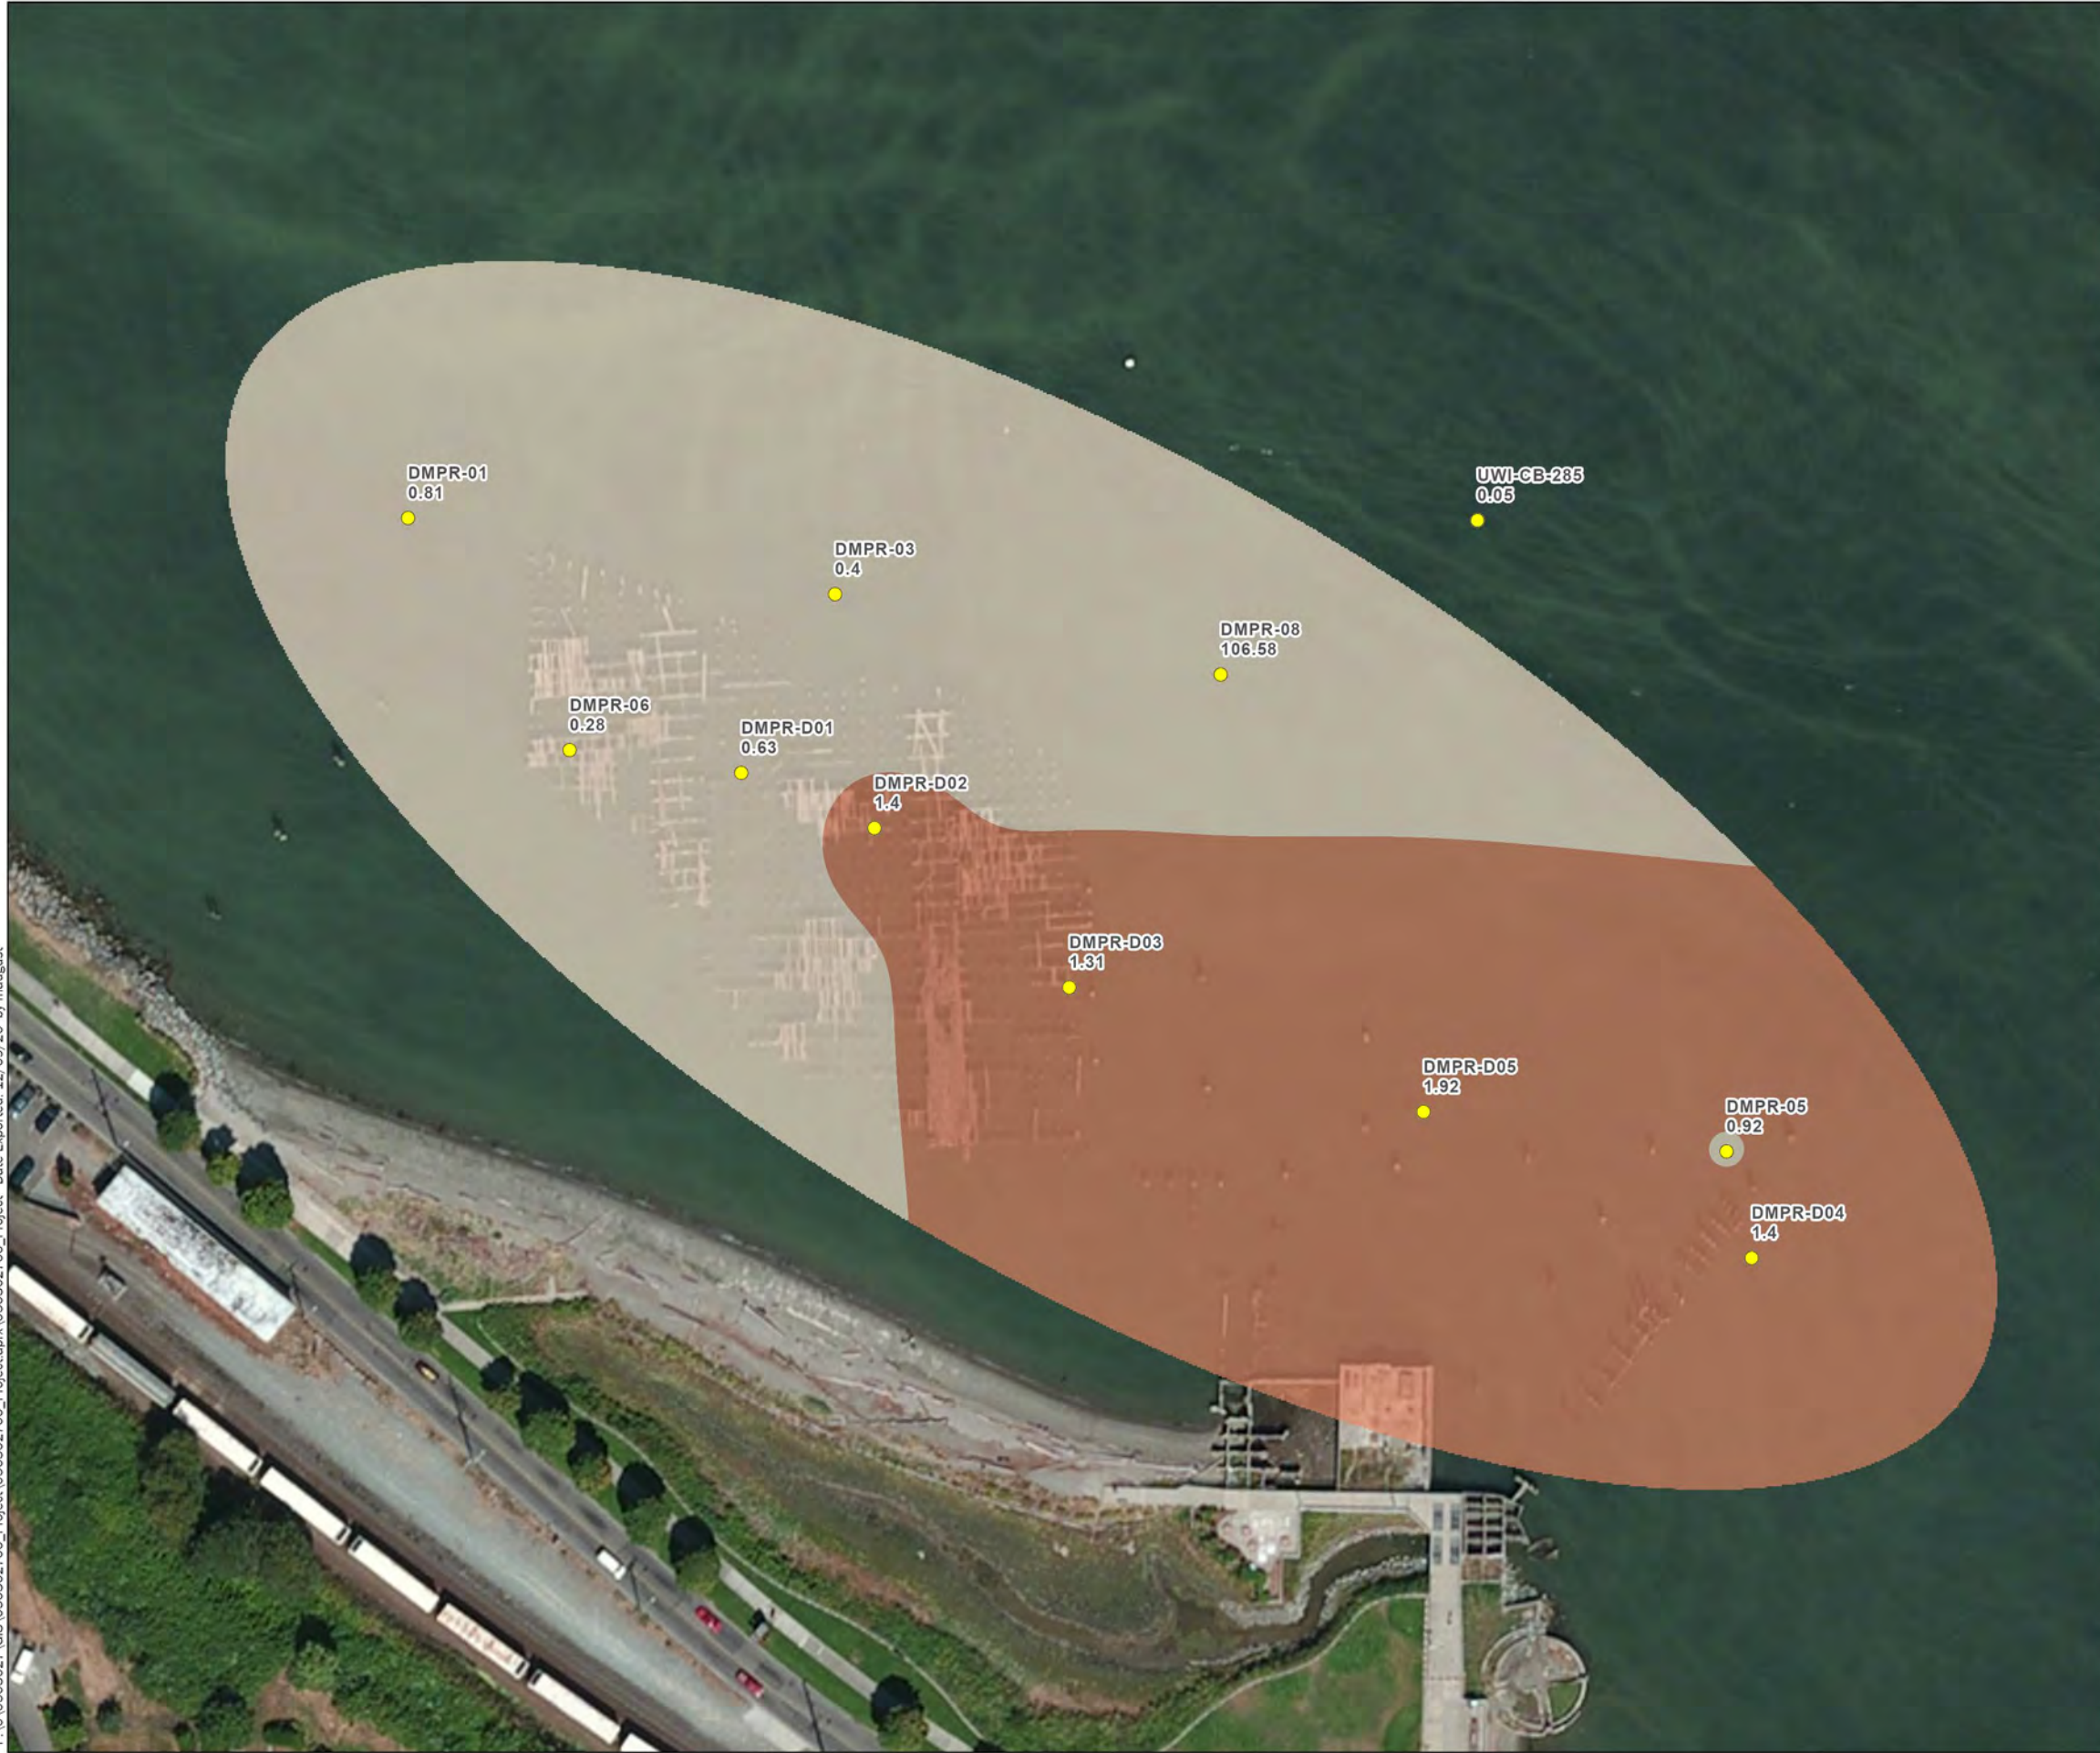
HPAH Exceedance Factor without DMPR-08	
Dickman Mill Tacoma, Washington	
	Figure 6c

- Sample Location HPAH Result
- HPAH (Exceedance Factor)
 - <1
 - 1-2
 - >2

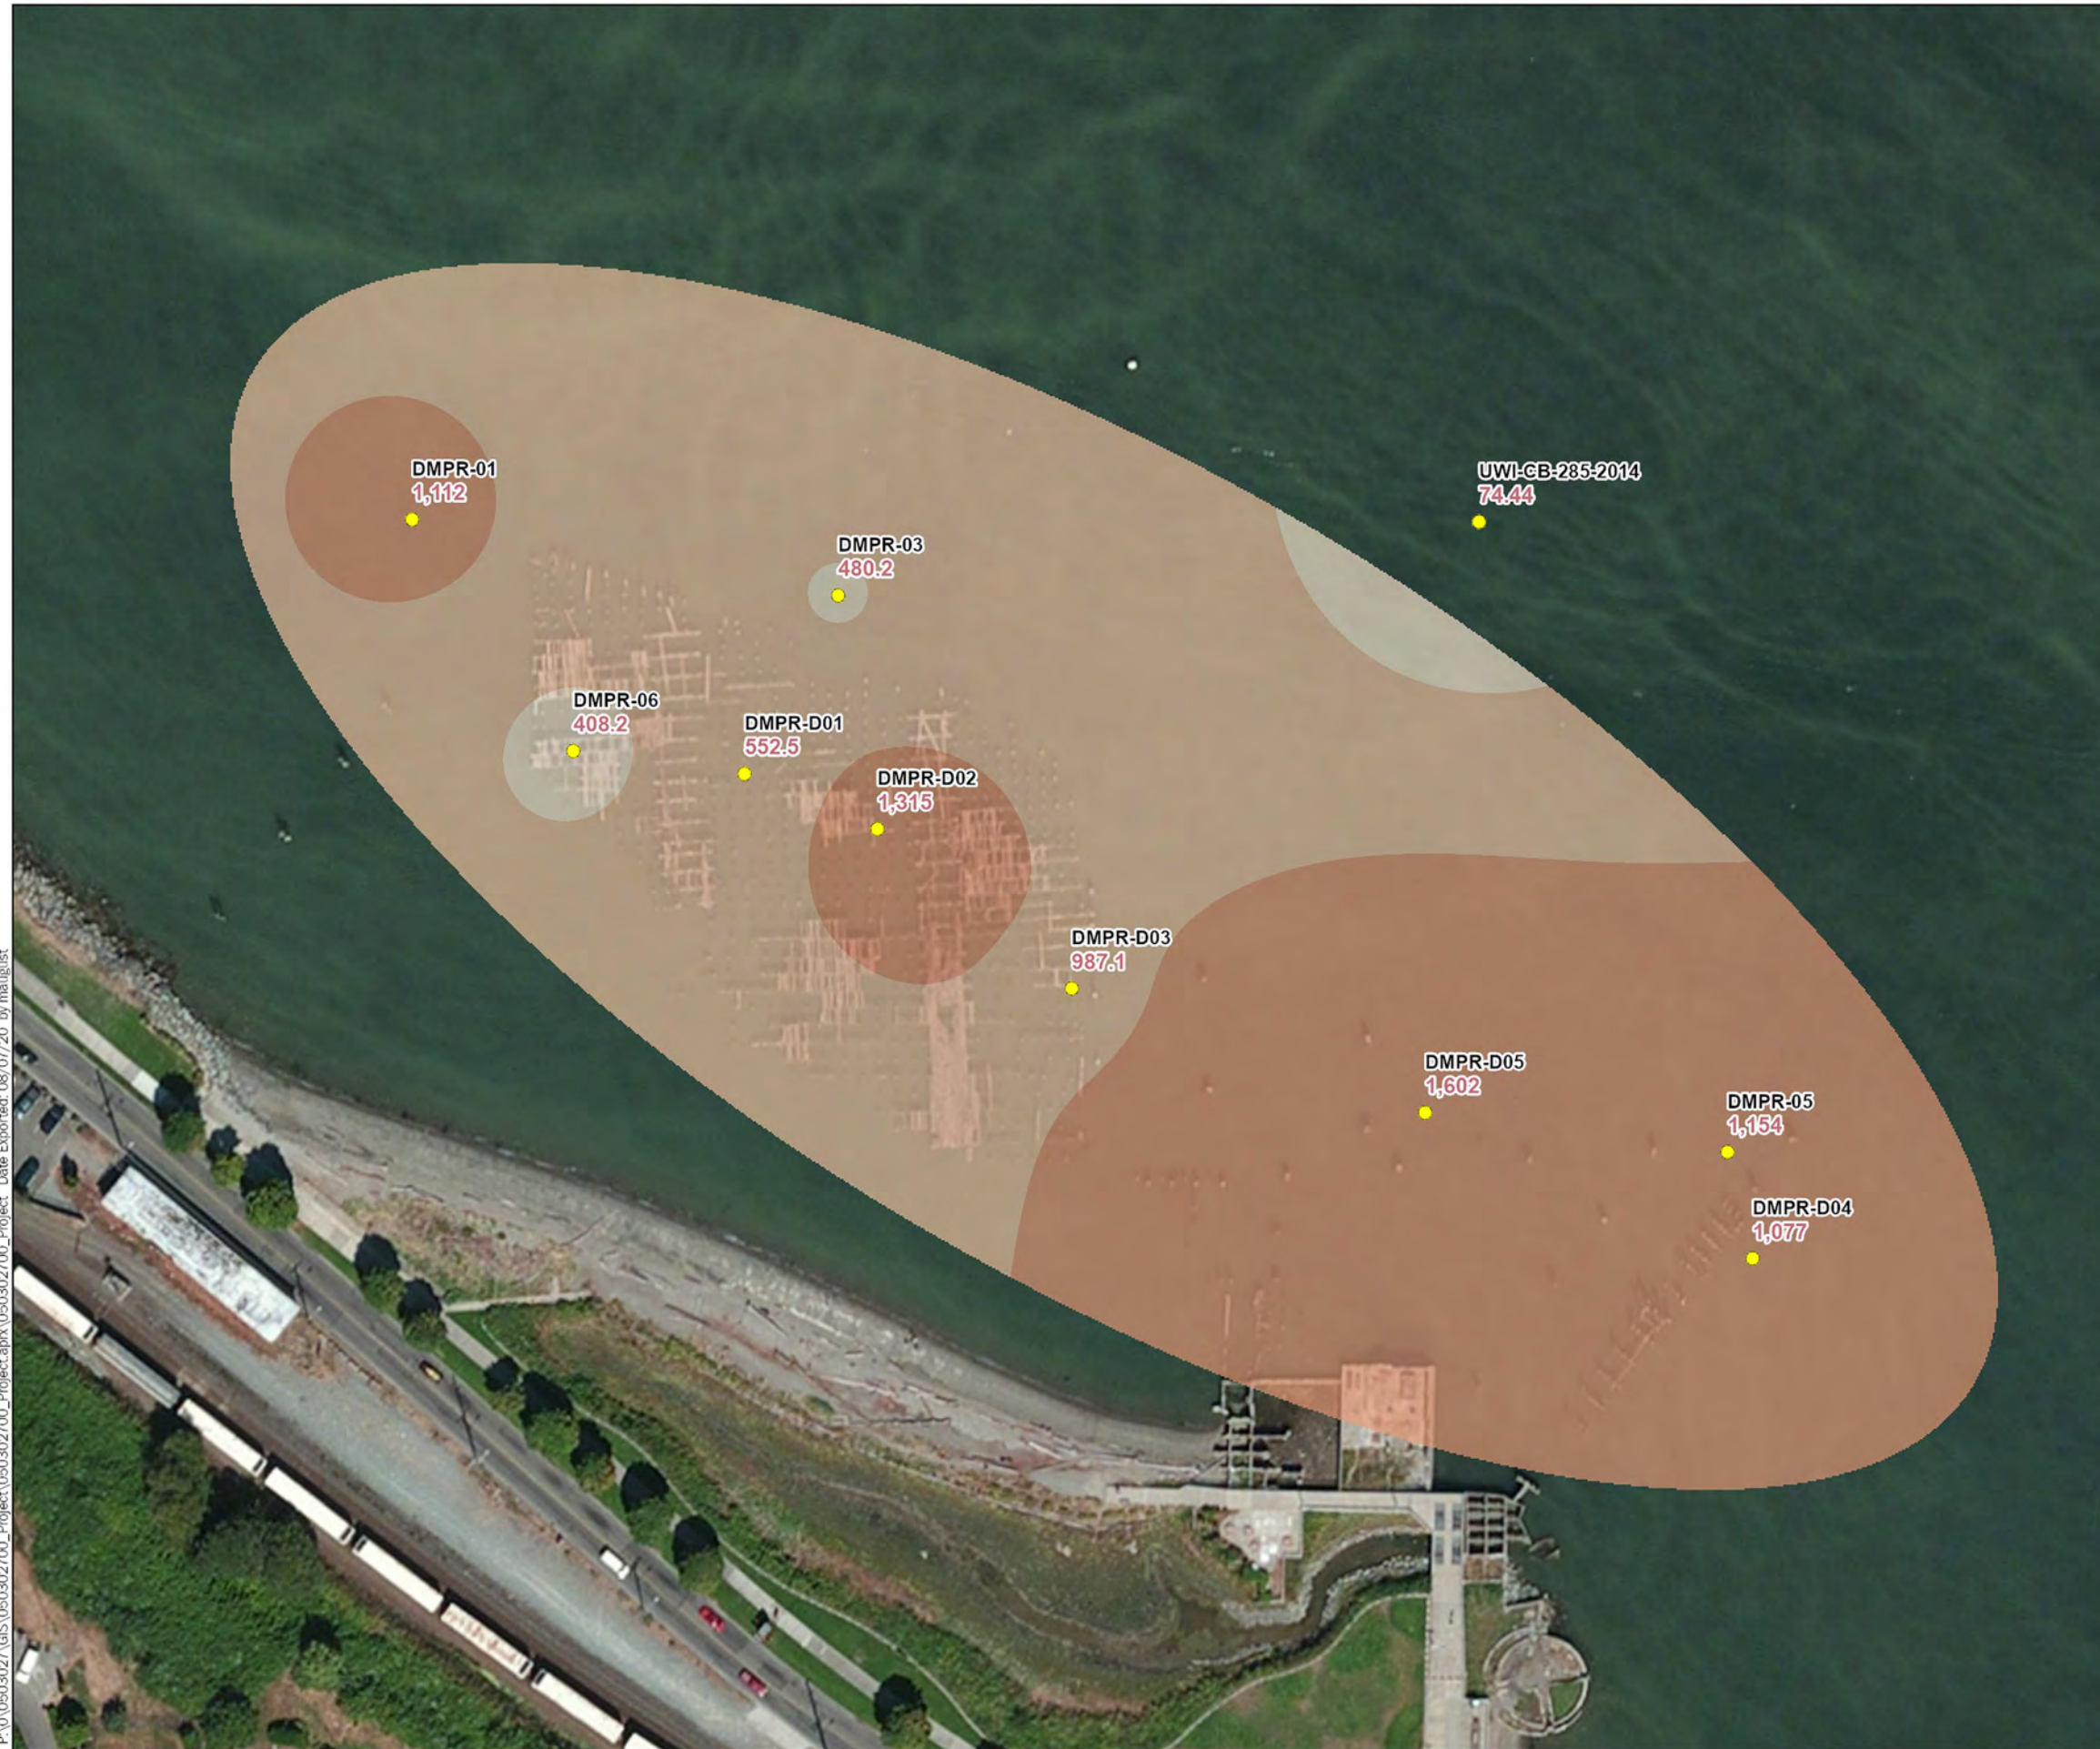
Figure 7

- Sample Location cPAH TEQ Result
- cPAH TEQ Concentration (µg/kg)
 - ≤ 500
 - ≤ 1000
 - ≤ 2000
 - ≤ 5000
 - ≤ 10000
 - ≤ 25000

cPAH TEQ Interpolation Without DMPR-08

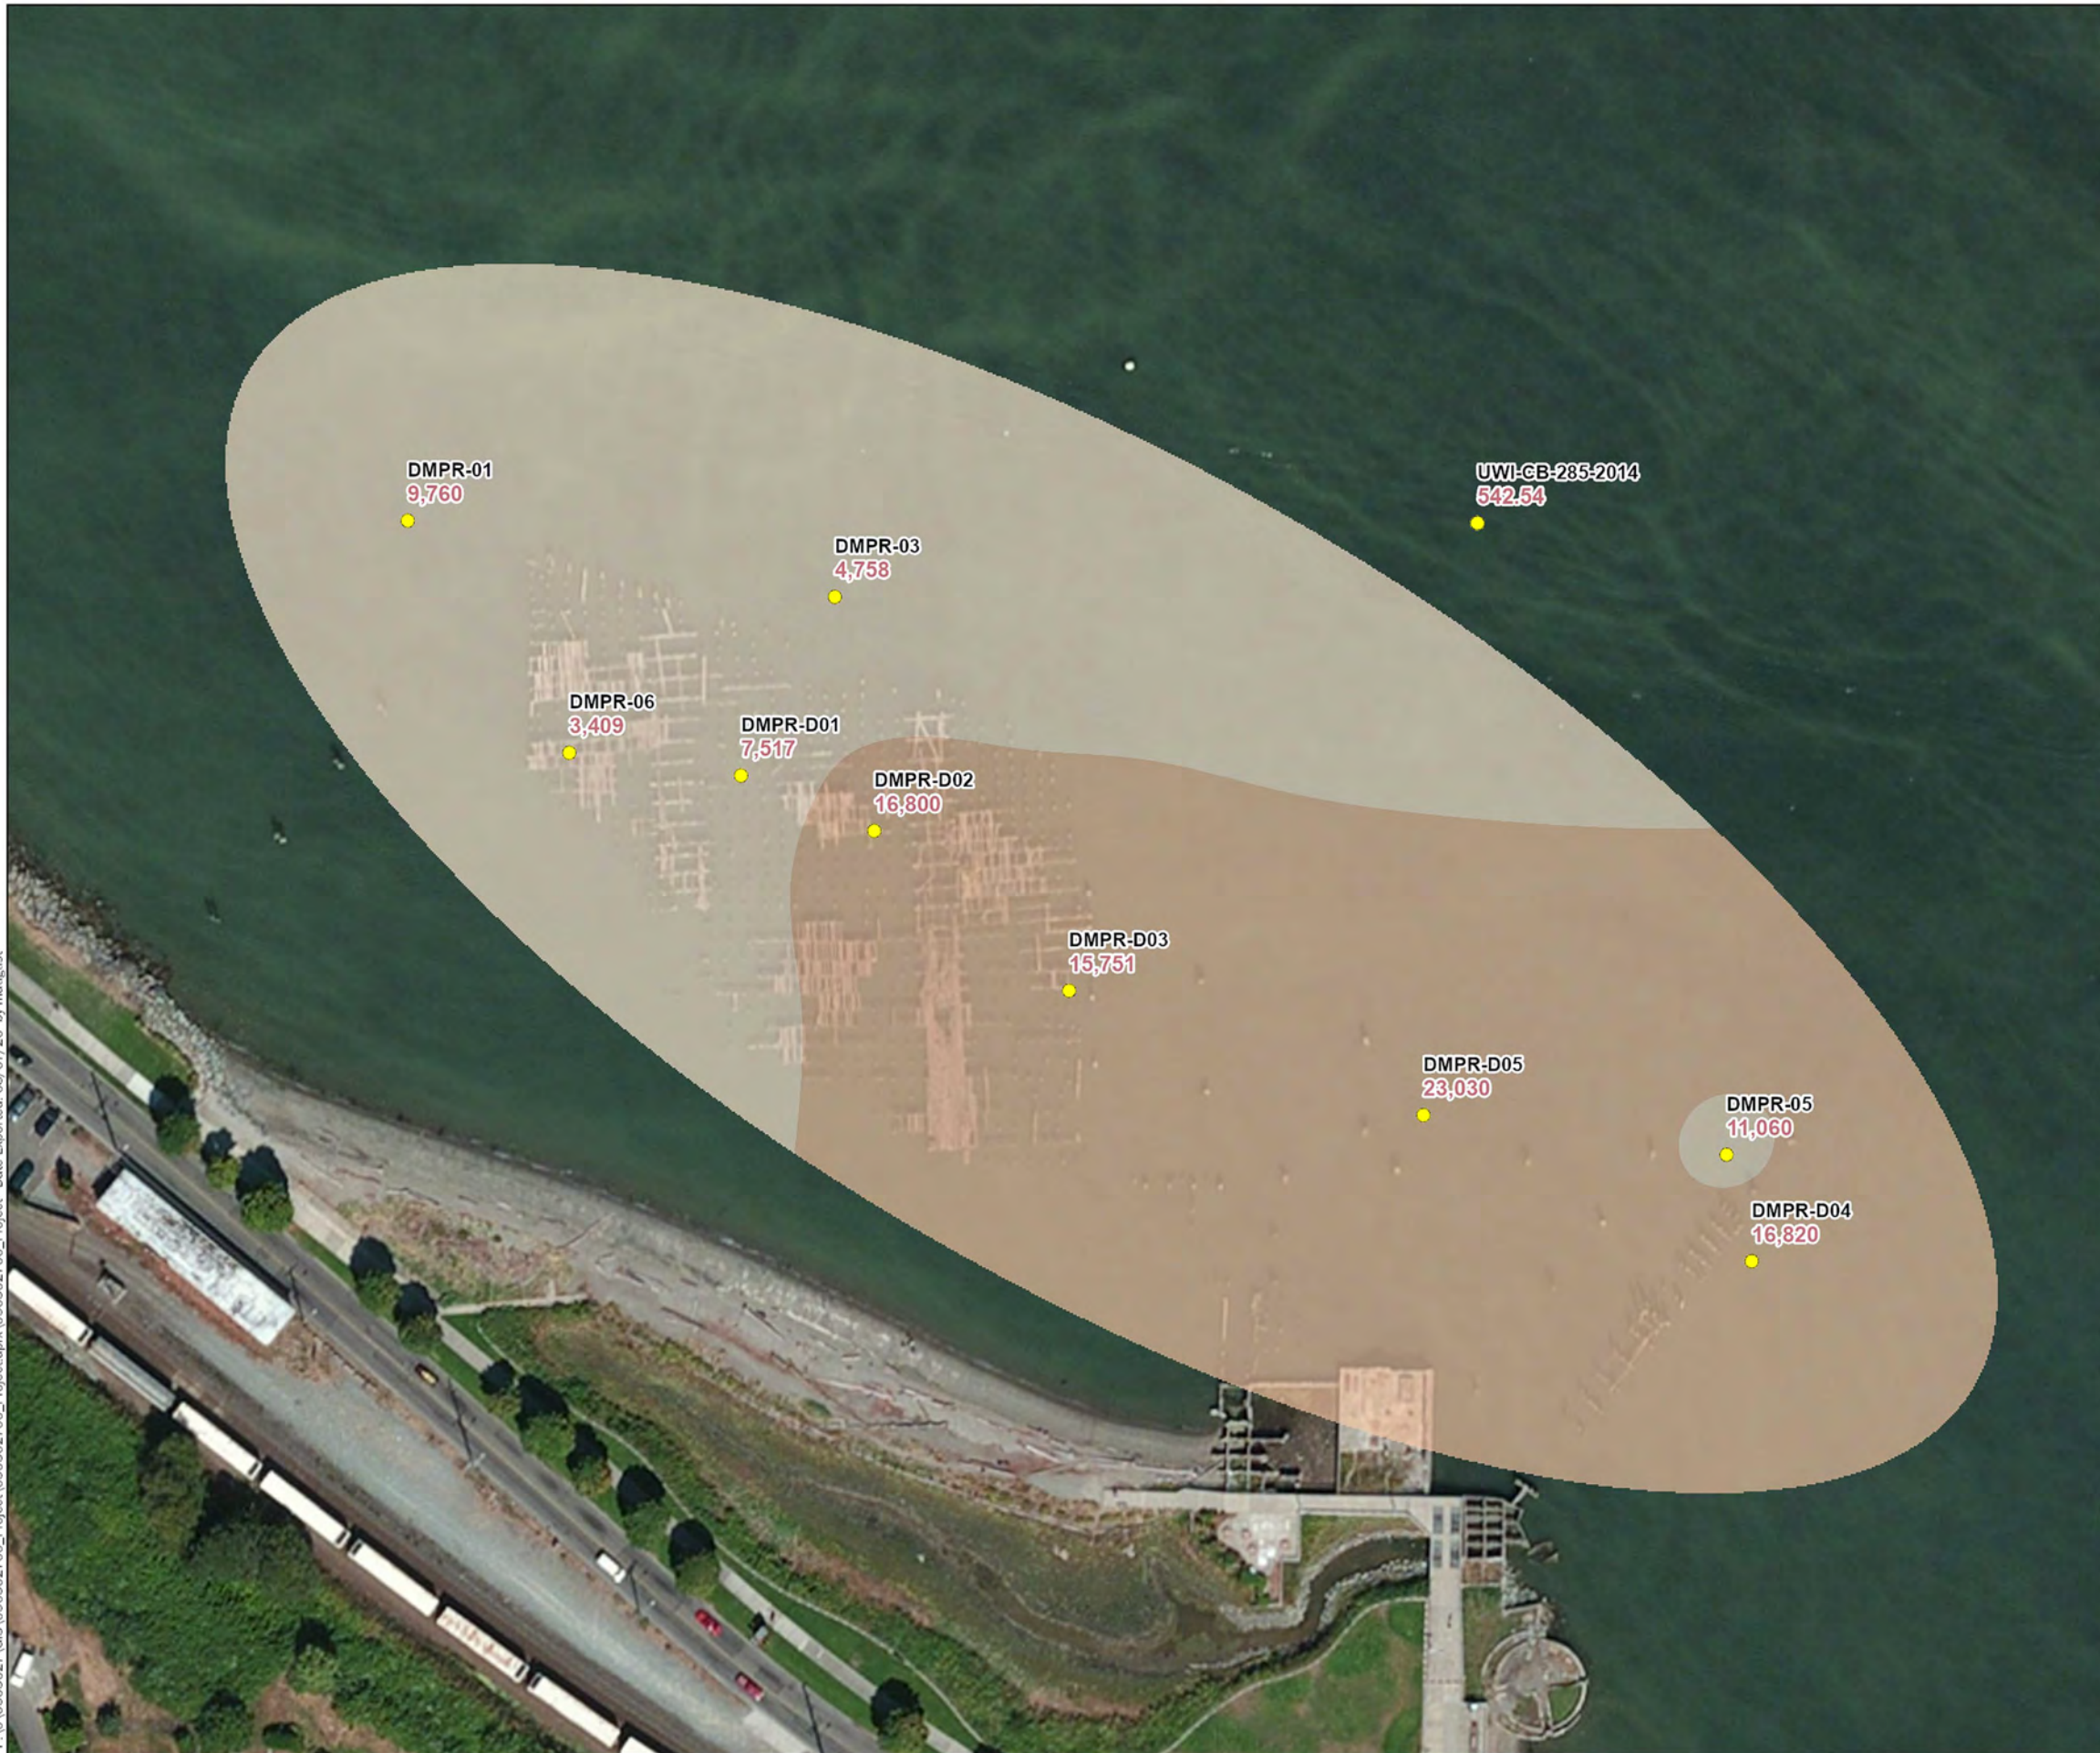
Figure 9

- Sample Location HPAH Result
- HPAH (µg/kg)
- ≤ 12000
 - ≤ 50000
 - ≤ 100000
 - ≤ 500000
 - ≤ 1000000
 - ≤ 1500000

Total HPAHs Interpolation Without DMPR-08

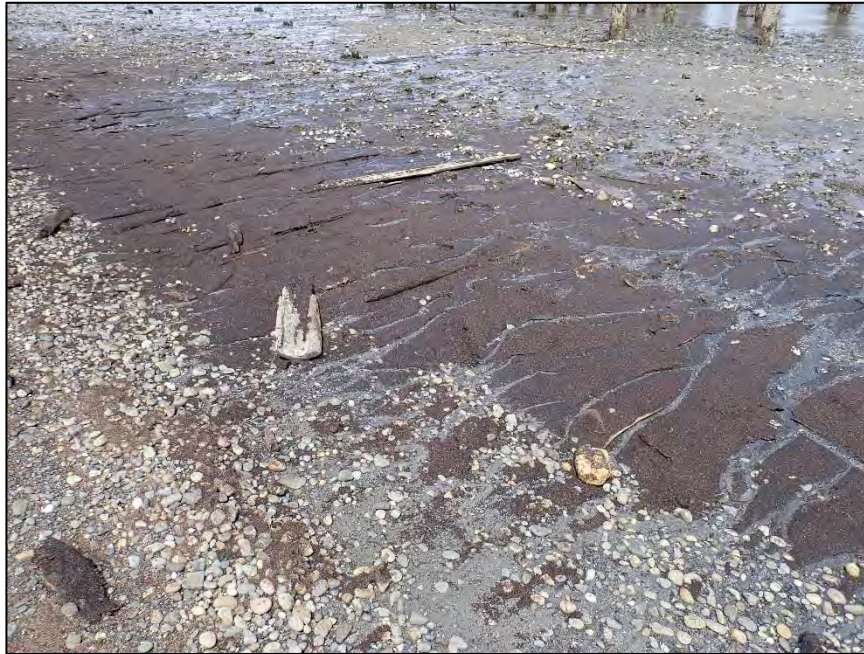
Photograph 1. Patches of anoxia and wood waste (sawdust) observed in the intertidal.

Patches of bacterial mats and associated anoxia were noted on the sediment surface throughout the Study Area. Signs of large infauna (burrows, siphon holes, etc.) were largely absent in areas surveyed, further supporting widespread anoxic conditions within the sediment. A large continuous eelgrass bed was observed west of the pile field that abutted the pile perimeter. Isolated patches of eelgrass were also observed east of the pile field.

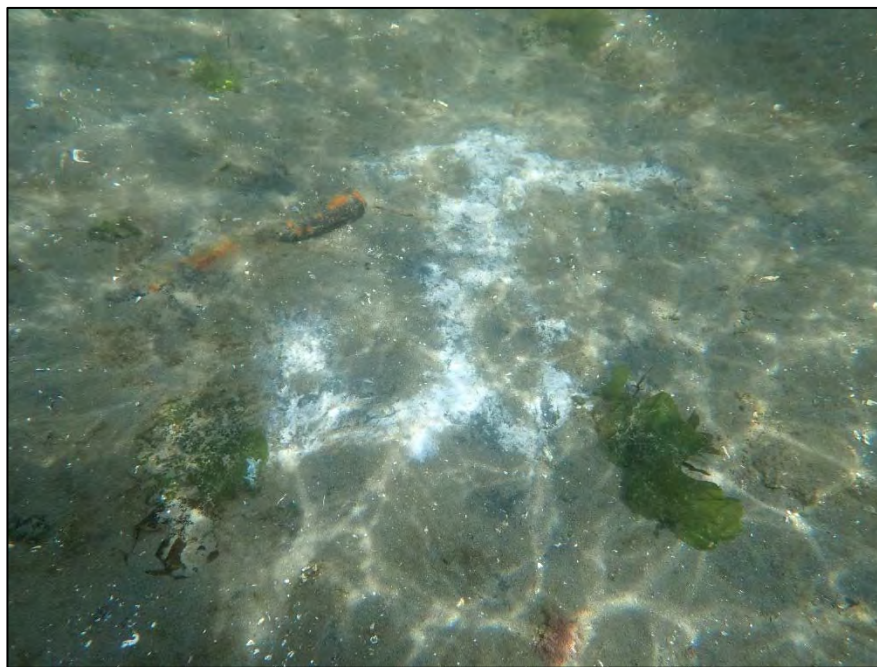
Photograph 2. Bacterial mats noted on sediment surface.

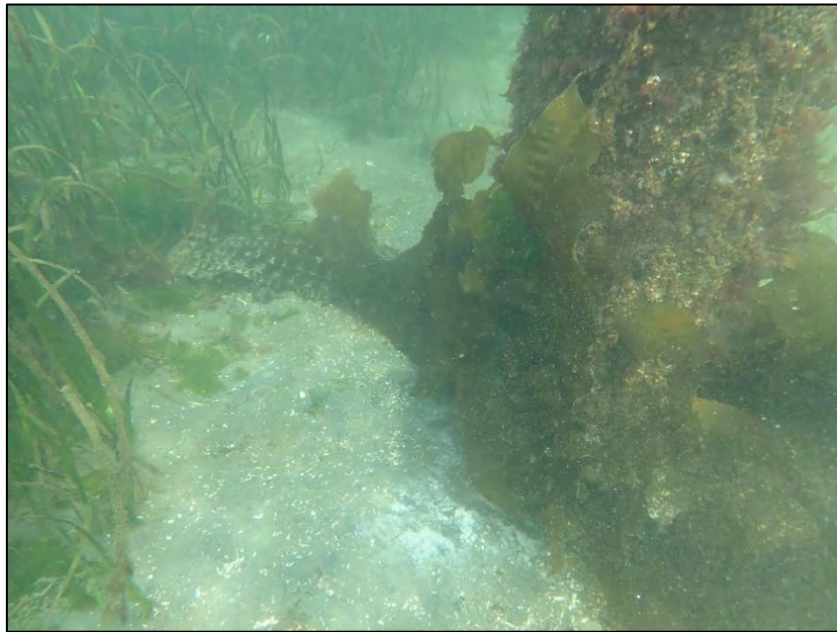
Photograph 4. Edge of eelgrass near pile field and example of laminarian kelp growing at the base of the pile.

A general field survey was performed June 8, 2020 to document current physical and biological characteristics of the Study Area. The shallow sediment observed during the survey was coarse-grained with a fine silt layer on top. There was shell hash from sessile invertebrate communities within the pile fields that has modified the sediment characteristics locally. Patches of bacterial mats and associated anoxia were noted at the sediment surface throughout the Study Area (Appendix A, Figure A-1). Signs of large infauna (burrows, siphon holes, etc.) were largely absent in areas surveyed, further supporting widespread anoxic conditions within the sediment. A large continuous eelgrass bed was noted west of the pile field (Appendix A, Figure A-2, Photograph 3) that abutted the pile perimeter (Appendix A, Figure A-2, Photograph 4). This suggests that eelgrass would likely occur in the pile field if not for the anoxia present. Isolated patches of eelgrass were also noted to the east of the pile field. Laminarian kelp was present at the base of most piles.

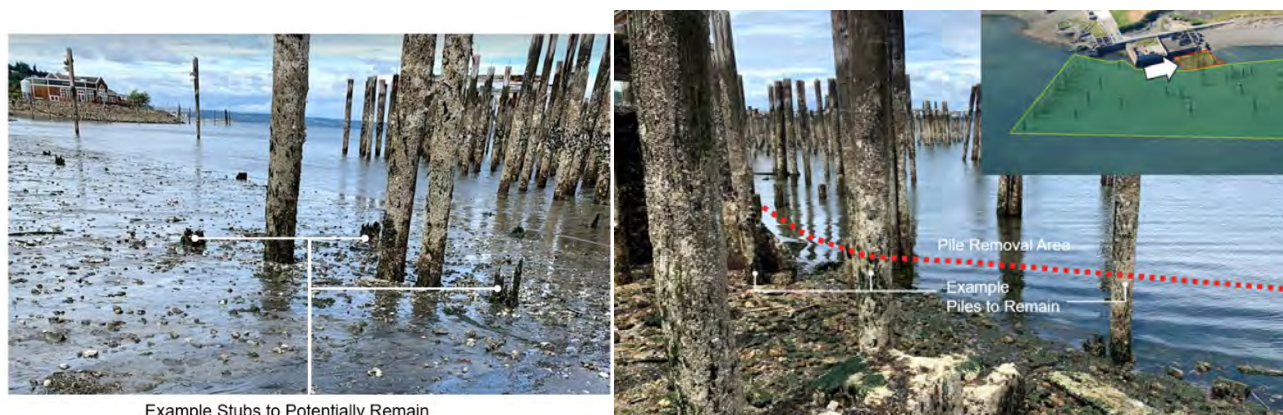
Figure 4 - Pile Stubs to potentially remain (left) and Nearshore Piles to Remain (right)
