Remedial Investigation Report

JSP Silverdale Lots 25 and 26
Brian Lane, NW
Silverdale, Washington

Facility /Site No.: 6865393
VCP No: NW3213

October 19, 2021

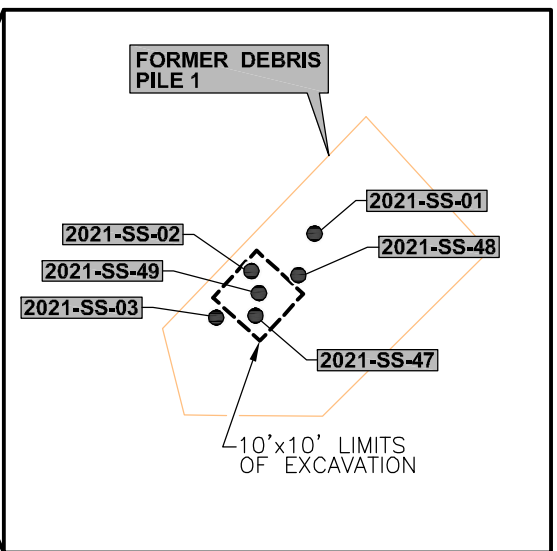
INSET A - FORMER DEBRIS PILE 1 SAMPLING LOCATIONS
NOT TO SCALE

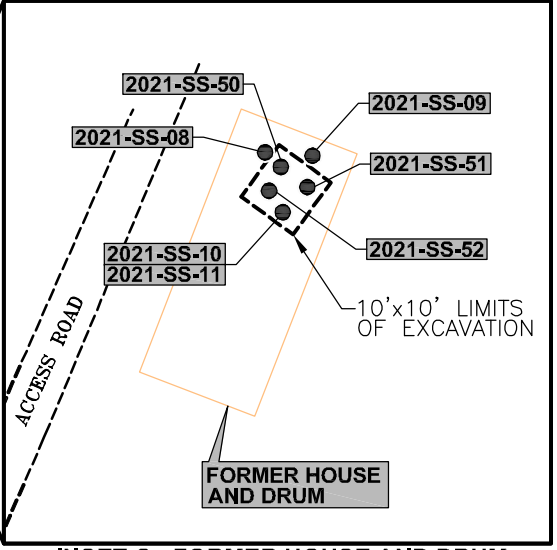
INSET C - FORMER HOUSE AND DRUM SAMPLING LOCATIONS
NOT TO SCALE

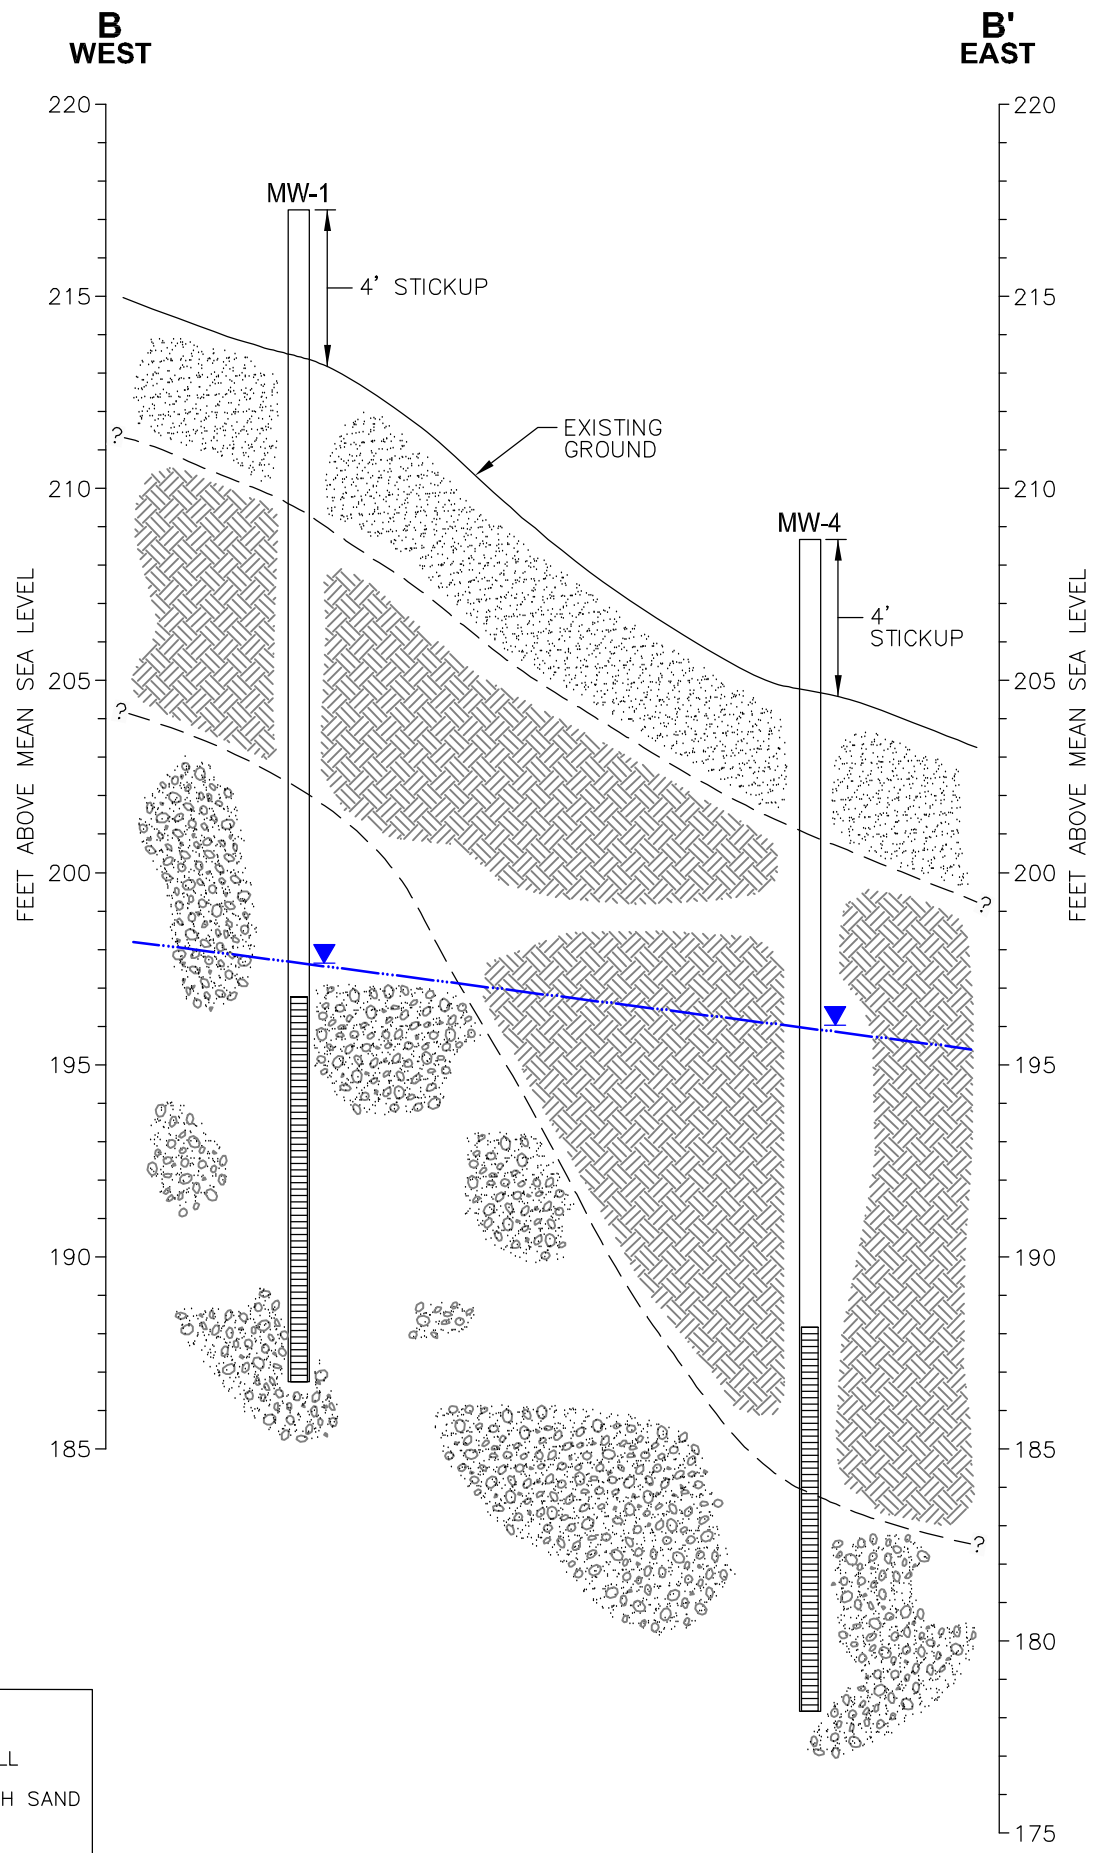
FIGURE 6
REV.: -		
CHKD: K.L.W.		
DRAWN: C.E.H.		
PROJ. No.: 104-21020		
CROSS SECTION B-B' JSP SILVERDALE LOTS 24 AND 25 Silverdale, Washington

HORIZONTAL SCALE: 1"=30'
VERTICAL SCALE: 1"=5'
EXAGGERATION 6X

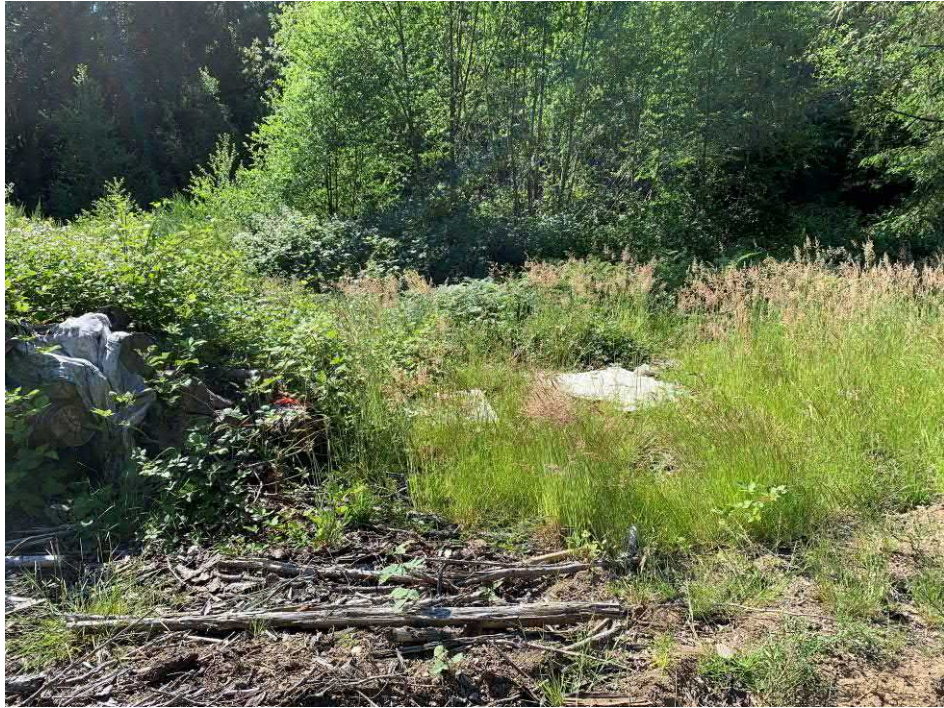
Photo 1: 6-18-21 Surface Sampling – Surface Soil Sampling location, former house and drum area.

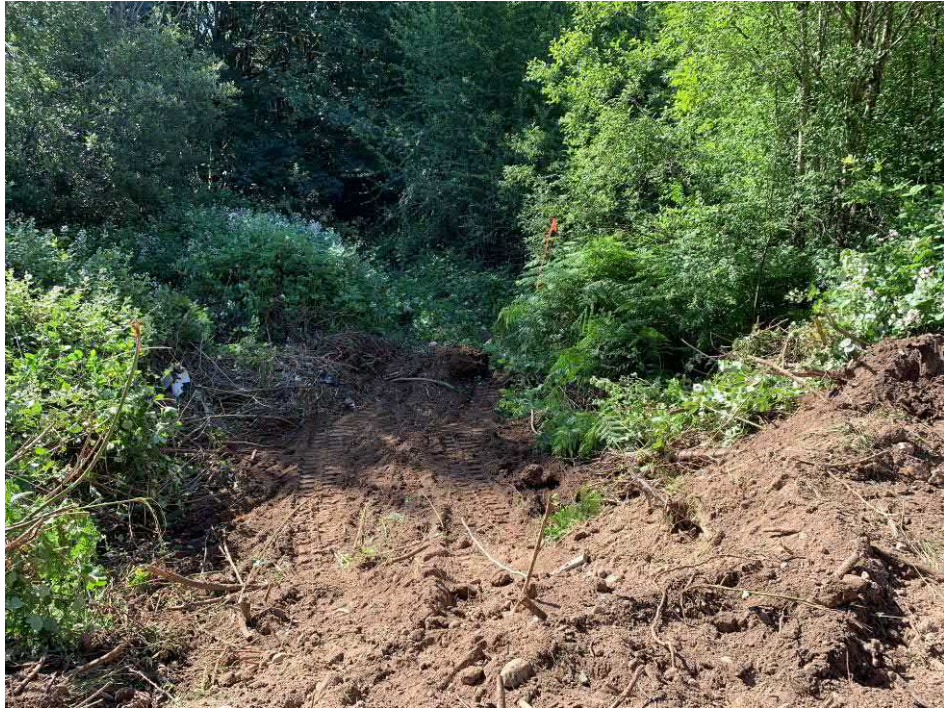
Photo 2: 6-18-21 Surface Sampling – Surface Soil Sampling location, former Debris Pile Two.

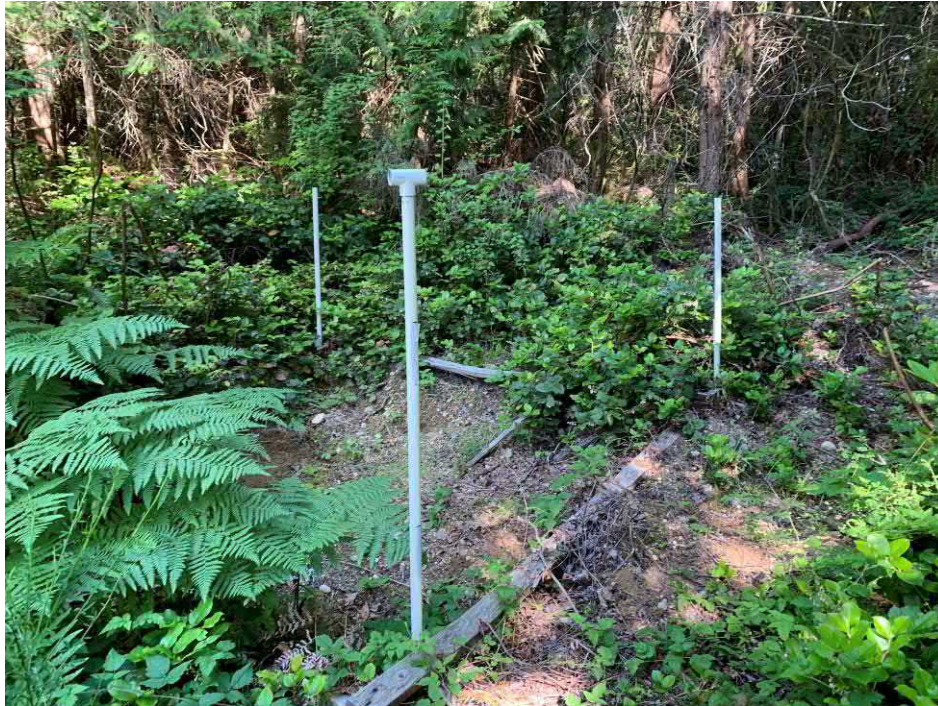
Photo 3: 6-18-21 Surface Sampling – Surface Soil Sampling location, former Drum Storage Area.

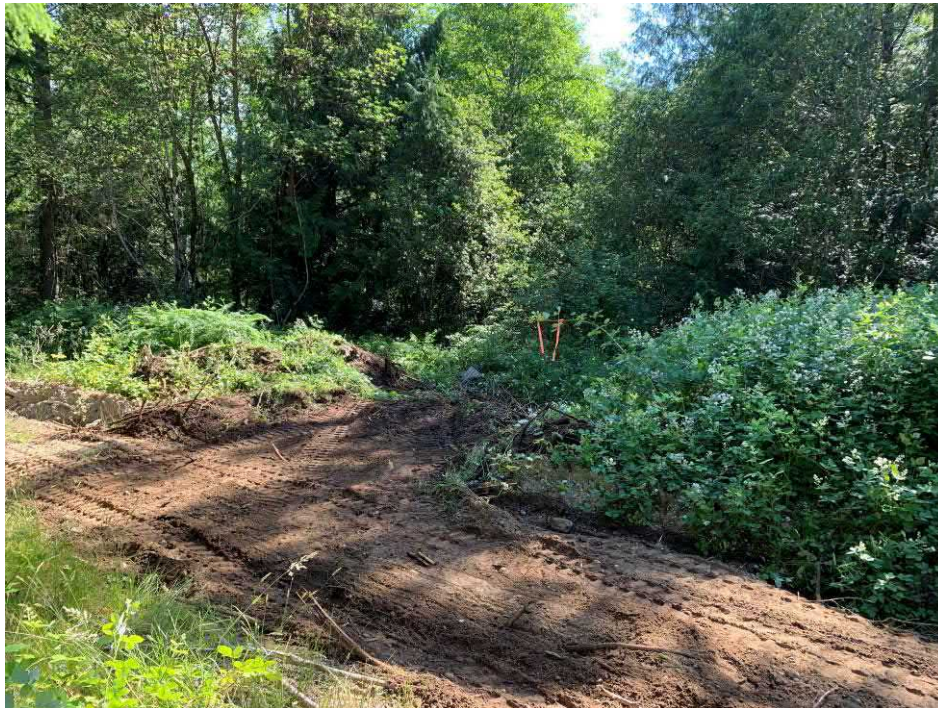
Lead was detected above the MTCA Method A Cleanup Level for surface soil in Sample 2021-SS-2 in the vicinity of the former debris pile No. 1. Diesel and motor oil were detected in surface soil above MTCA Method A Cleanup Levels for surface soil in Samples 2021-SS-10 and 2021-SS-11 in the vicinity of the former drum found near the former house.

Photo 4: 6-18-21 Surface Sampling – Surface Soil Sampling location, former Debris Pile 1.

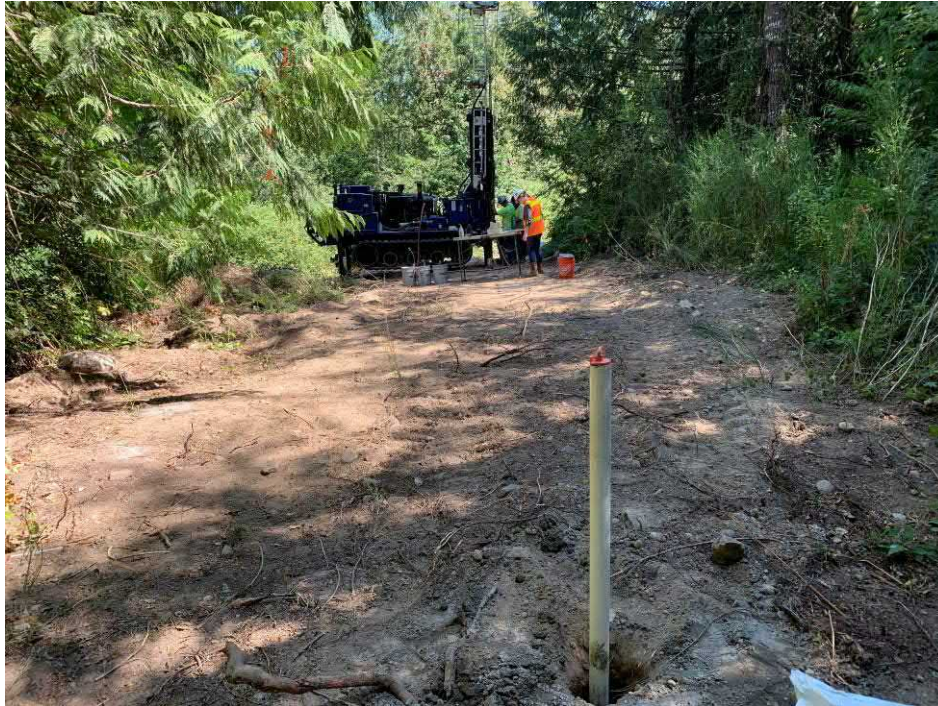
Photo 5: 7-12-21 Monitoring Well Installation – Showing installation of Monitoring Well MW-3 in the former drum storage area with completed MW-1 in foreground.

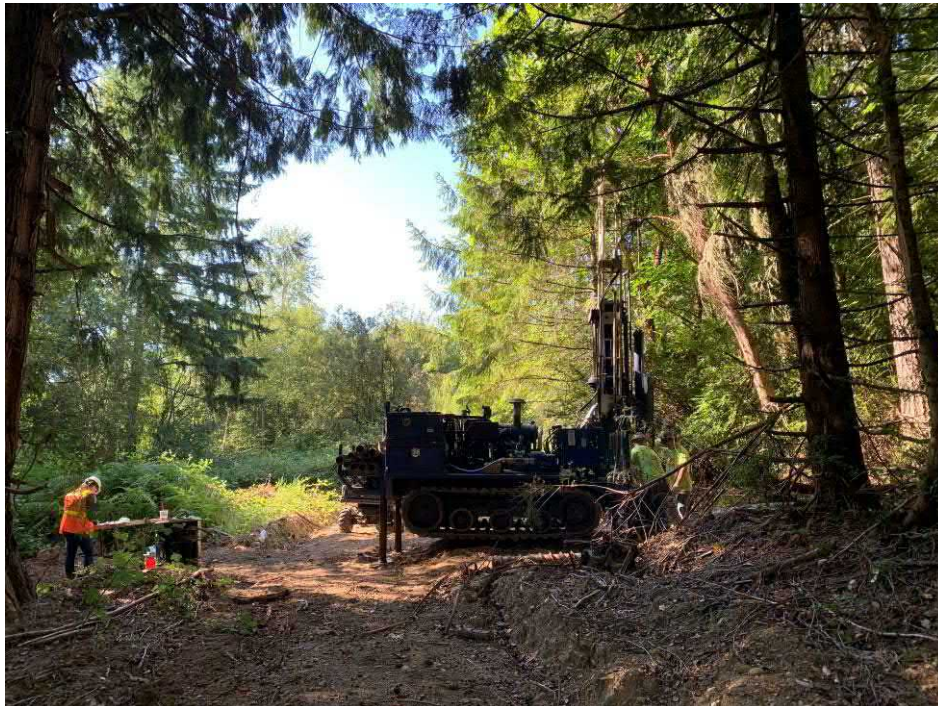
Photo 6: 7-12-21 Monitoring Well Installation – Showing installation of Monitoring Well MW-2 adjacent to the former drum storage area.

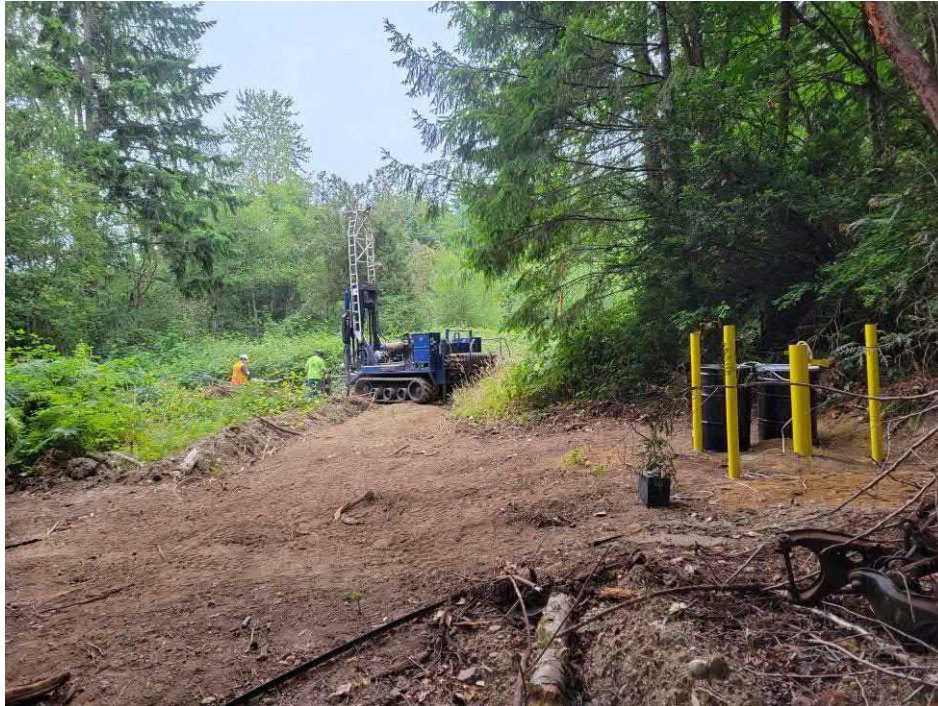
Photo 7: 7-13-21 Monitoring Well Installation – Showing installation of Monitoring Well MW-4 in the area of former debris pile 1.

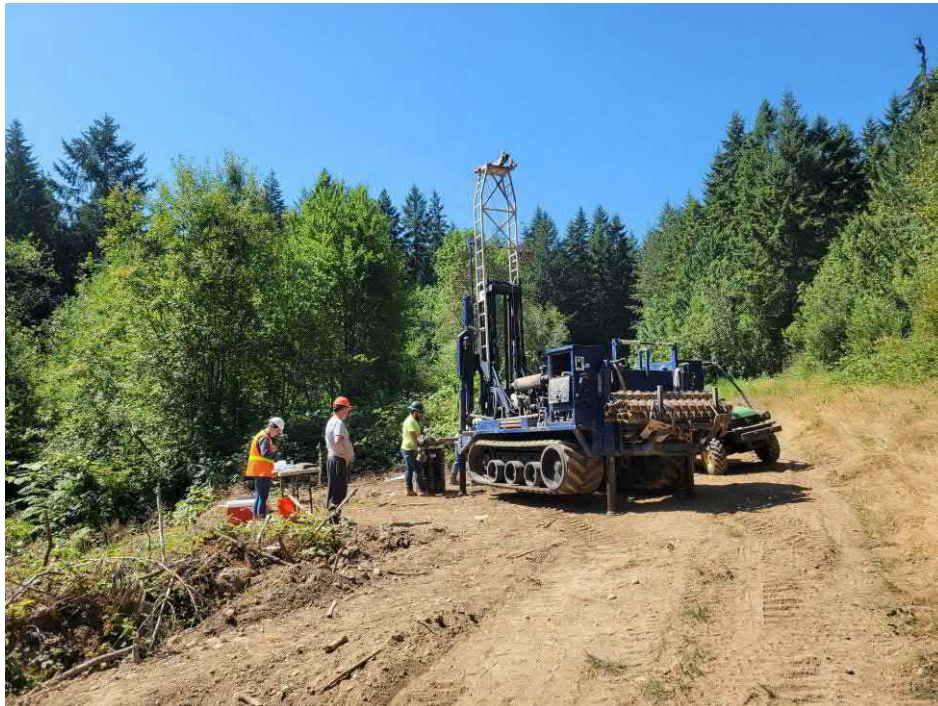
Photo 8: 7-13-21 Monitoring Well Installation – Showing installation of Monitoring Well MW-5 in the area of former debris pile 2.

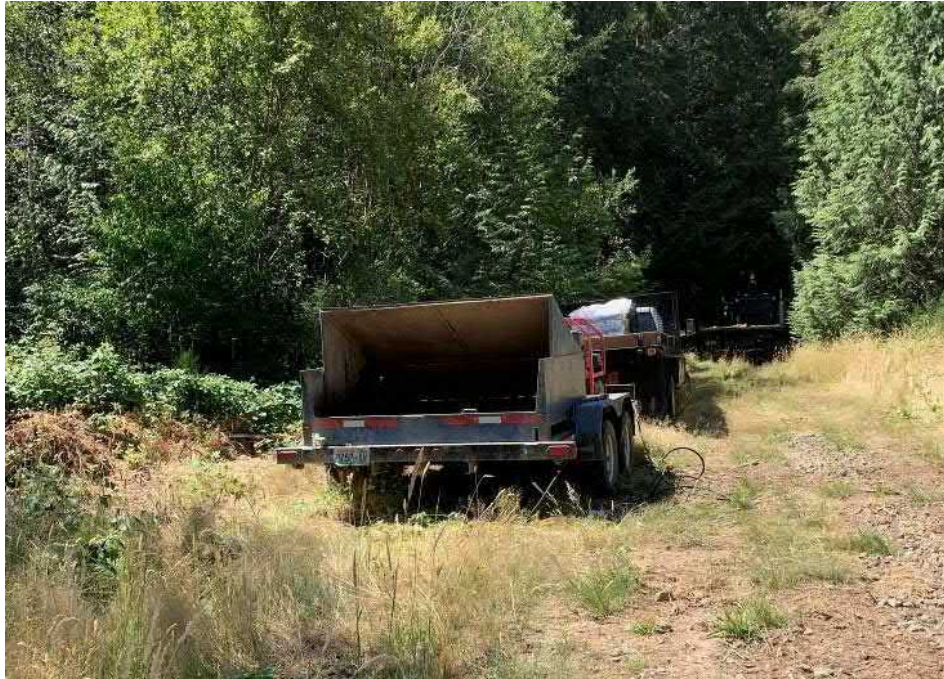
Photo 9: 7-13-21 Monitoring Well Installation – Showing the decontamination equipment set up.

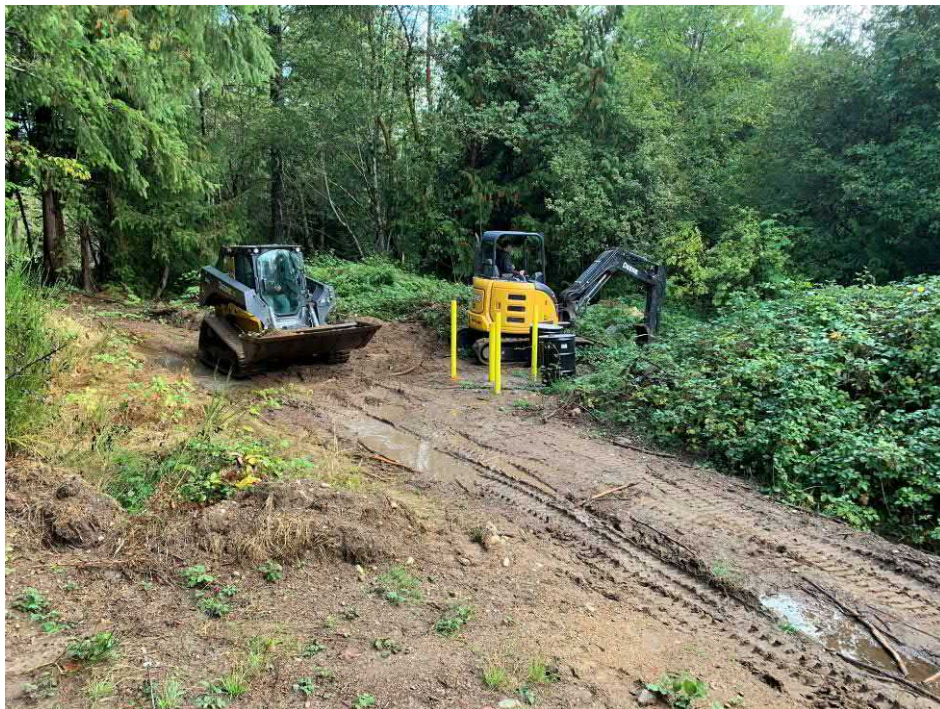
Photo 10: 9-27-21 Remedial Action Soil Removal – Showing soil removal in the area of former debris pile 1.

All contaminants originally identified as present at the site have been removed, and no samples indicate that any residual levels associated with the source areas remain above cleanup levels in soil. Soil sample results and subsequent excavation indicated that the shallow soil contamination resulted from spills or leaks from the former drum and slight impact from the metal debris in Debris Pile 1. The sources of this contamination were removed.

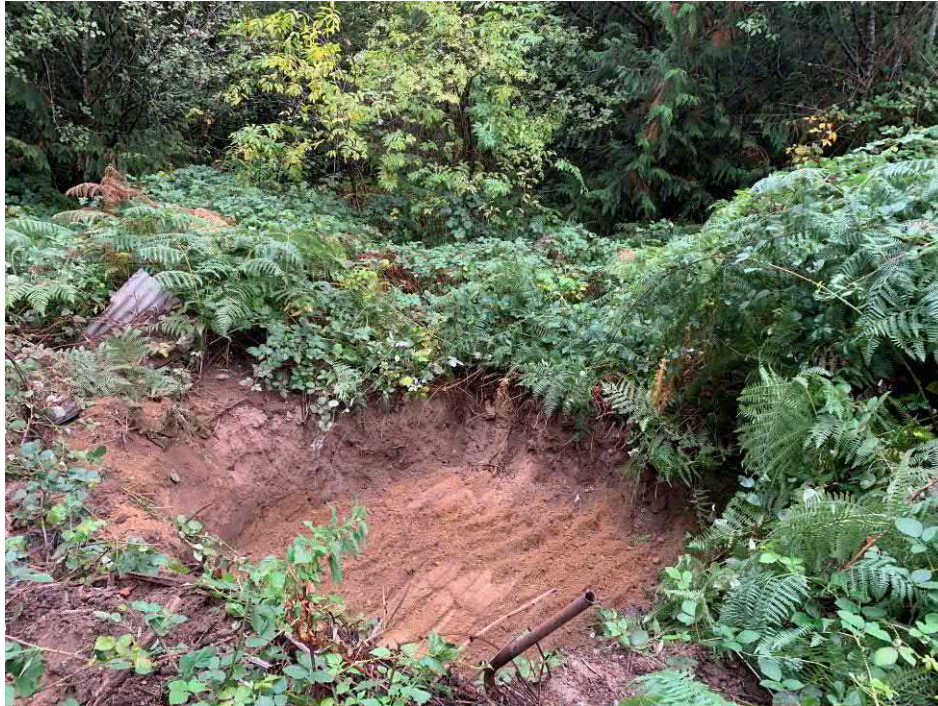
Photo 11: 9-27-21 Remedial Action Soil Removal – Showing the limits of the soil removal excavation in the area of former debris pile 1.

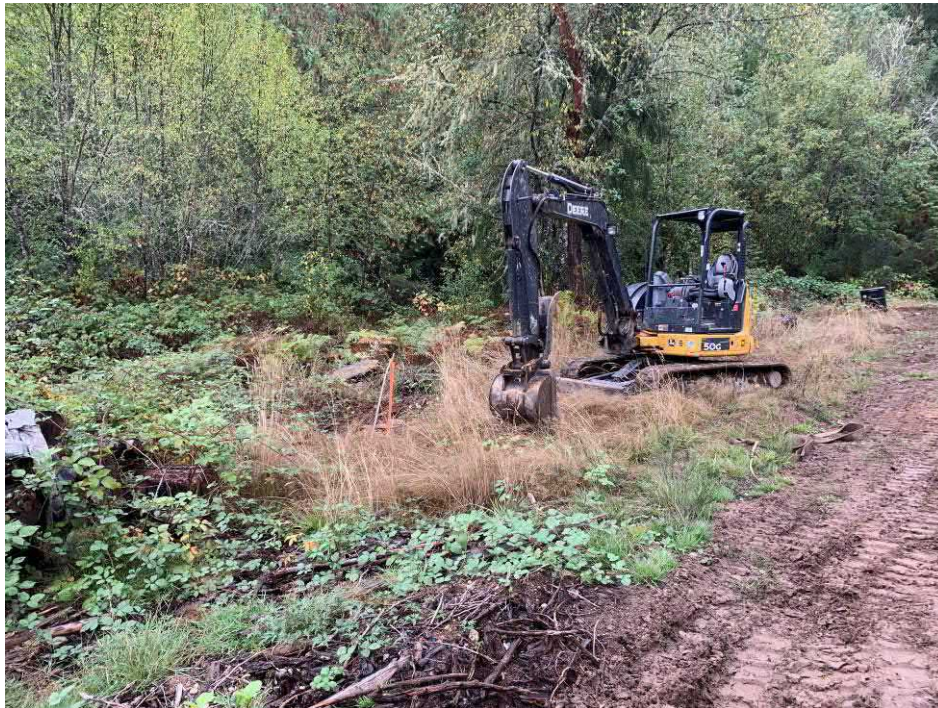
Photo 12: 9-27-21 Remedial Action Soil Removal – Showing soil removal in the former house and drum area.

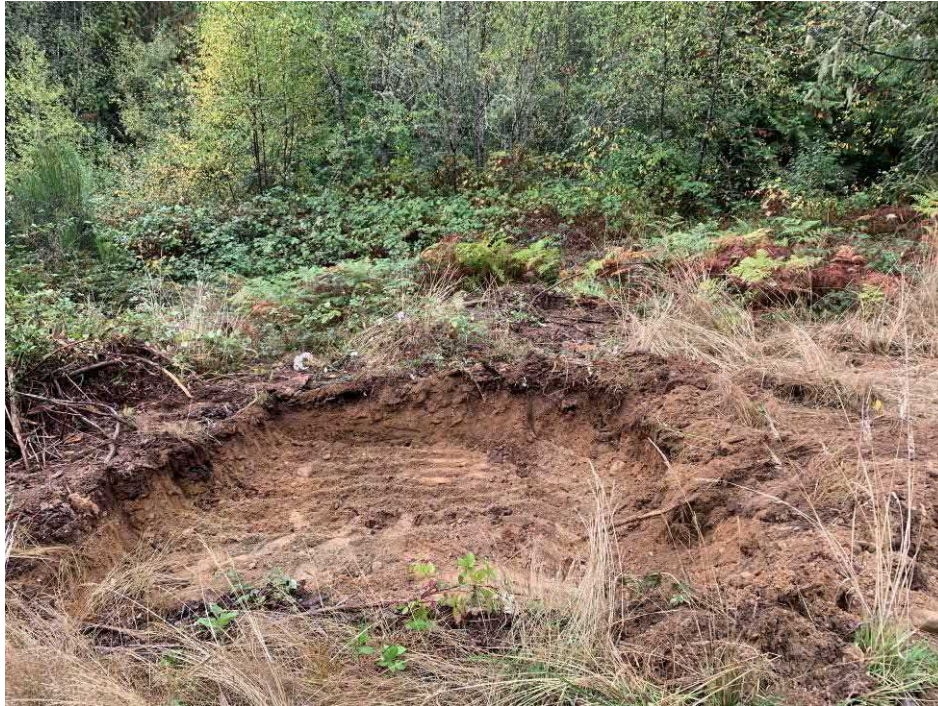
Photo 13: 9-27-21 Remedial Action Soil Removal – Showing limits of the soil removal excavation in the former house and drum area.

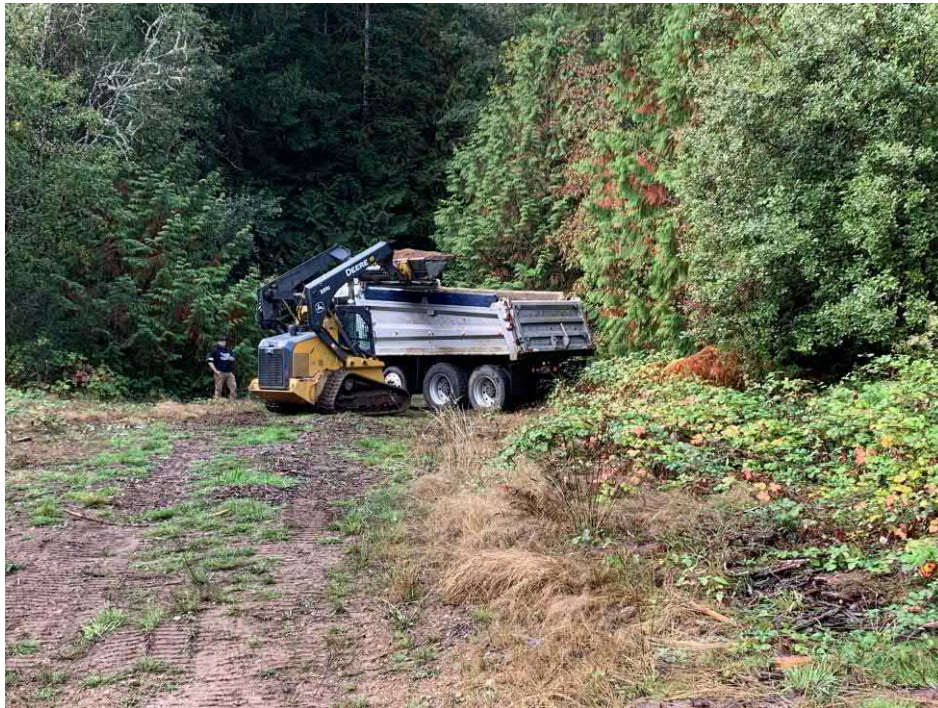
Photo 14: 9-27-21 Remedial Action Soil Removal – Showing some of the removed soil being placed in the truck for transport to offsite disposal site.
