September 13, 2021

Re: Vapor Assessment Report
Aegis Senior Living - Kirkland
6700 Lake Washington Boulevard
Kirkland, Washington 98033
Ecology VCP No. NW2850

TRC Project Number: 416736.0000

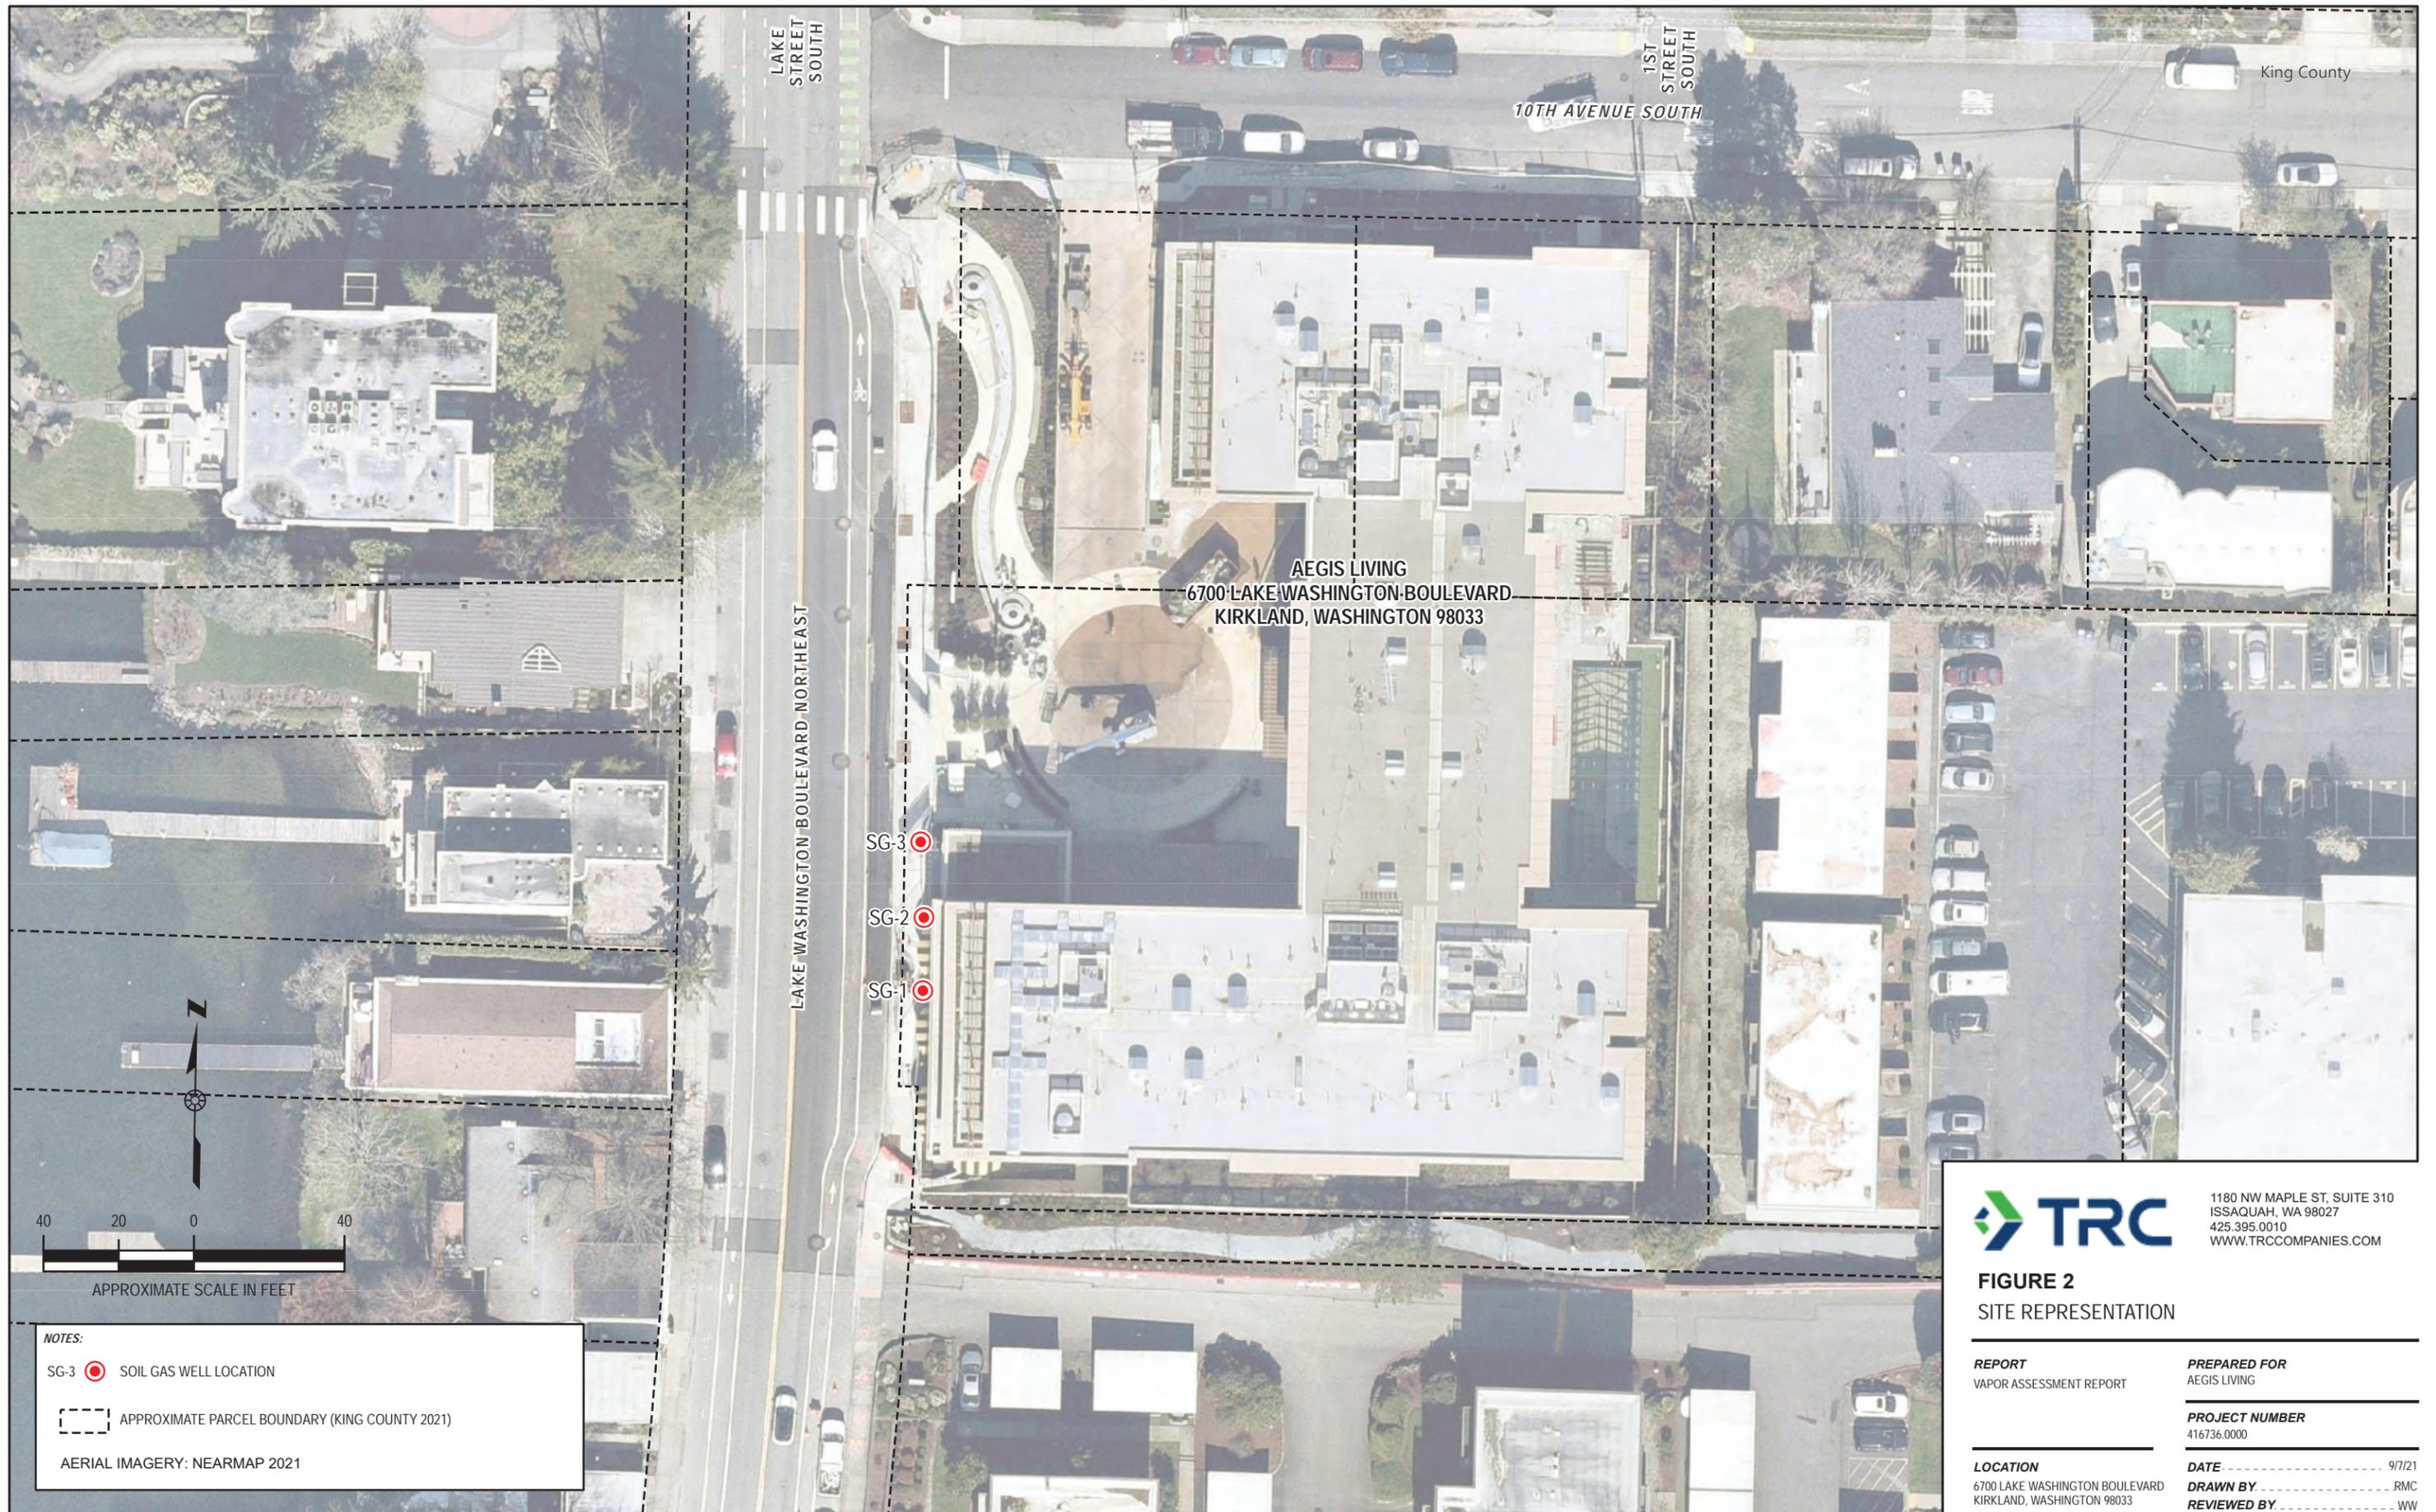
FIGURE 2
 SITE REPRESENTATION

TRC installed three shallow soil vapor wells in the sidewalk along the southwestern property boundary, east of the remaining residual impacts located in the City of Kirkland ROW as shown on Figure 3. The shallow soil vapor wells were installed to assess the effectiveness of a Volclay-bentonite panel installed during redevelopment activities, meant to suppress the remaining inaccessible contamination that is beneath Lake Washington Boulevard from migrating through vapor intrusion pathways onto the Site. The locations of the three shallow soil vapor wells are indicated on Figure 2.

SG-3
SG-2
SG-1

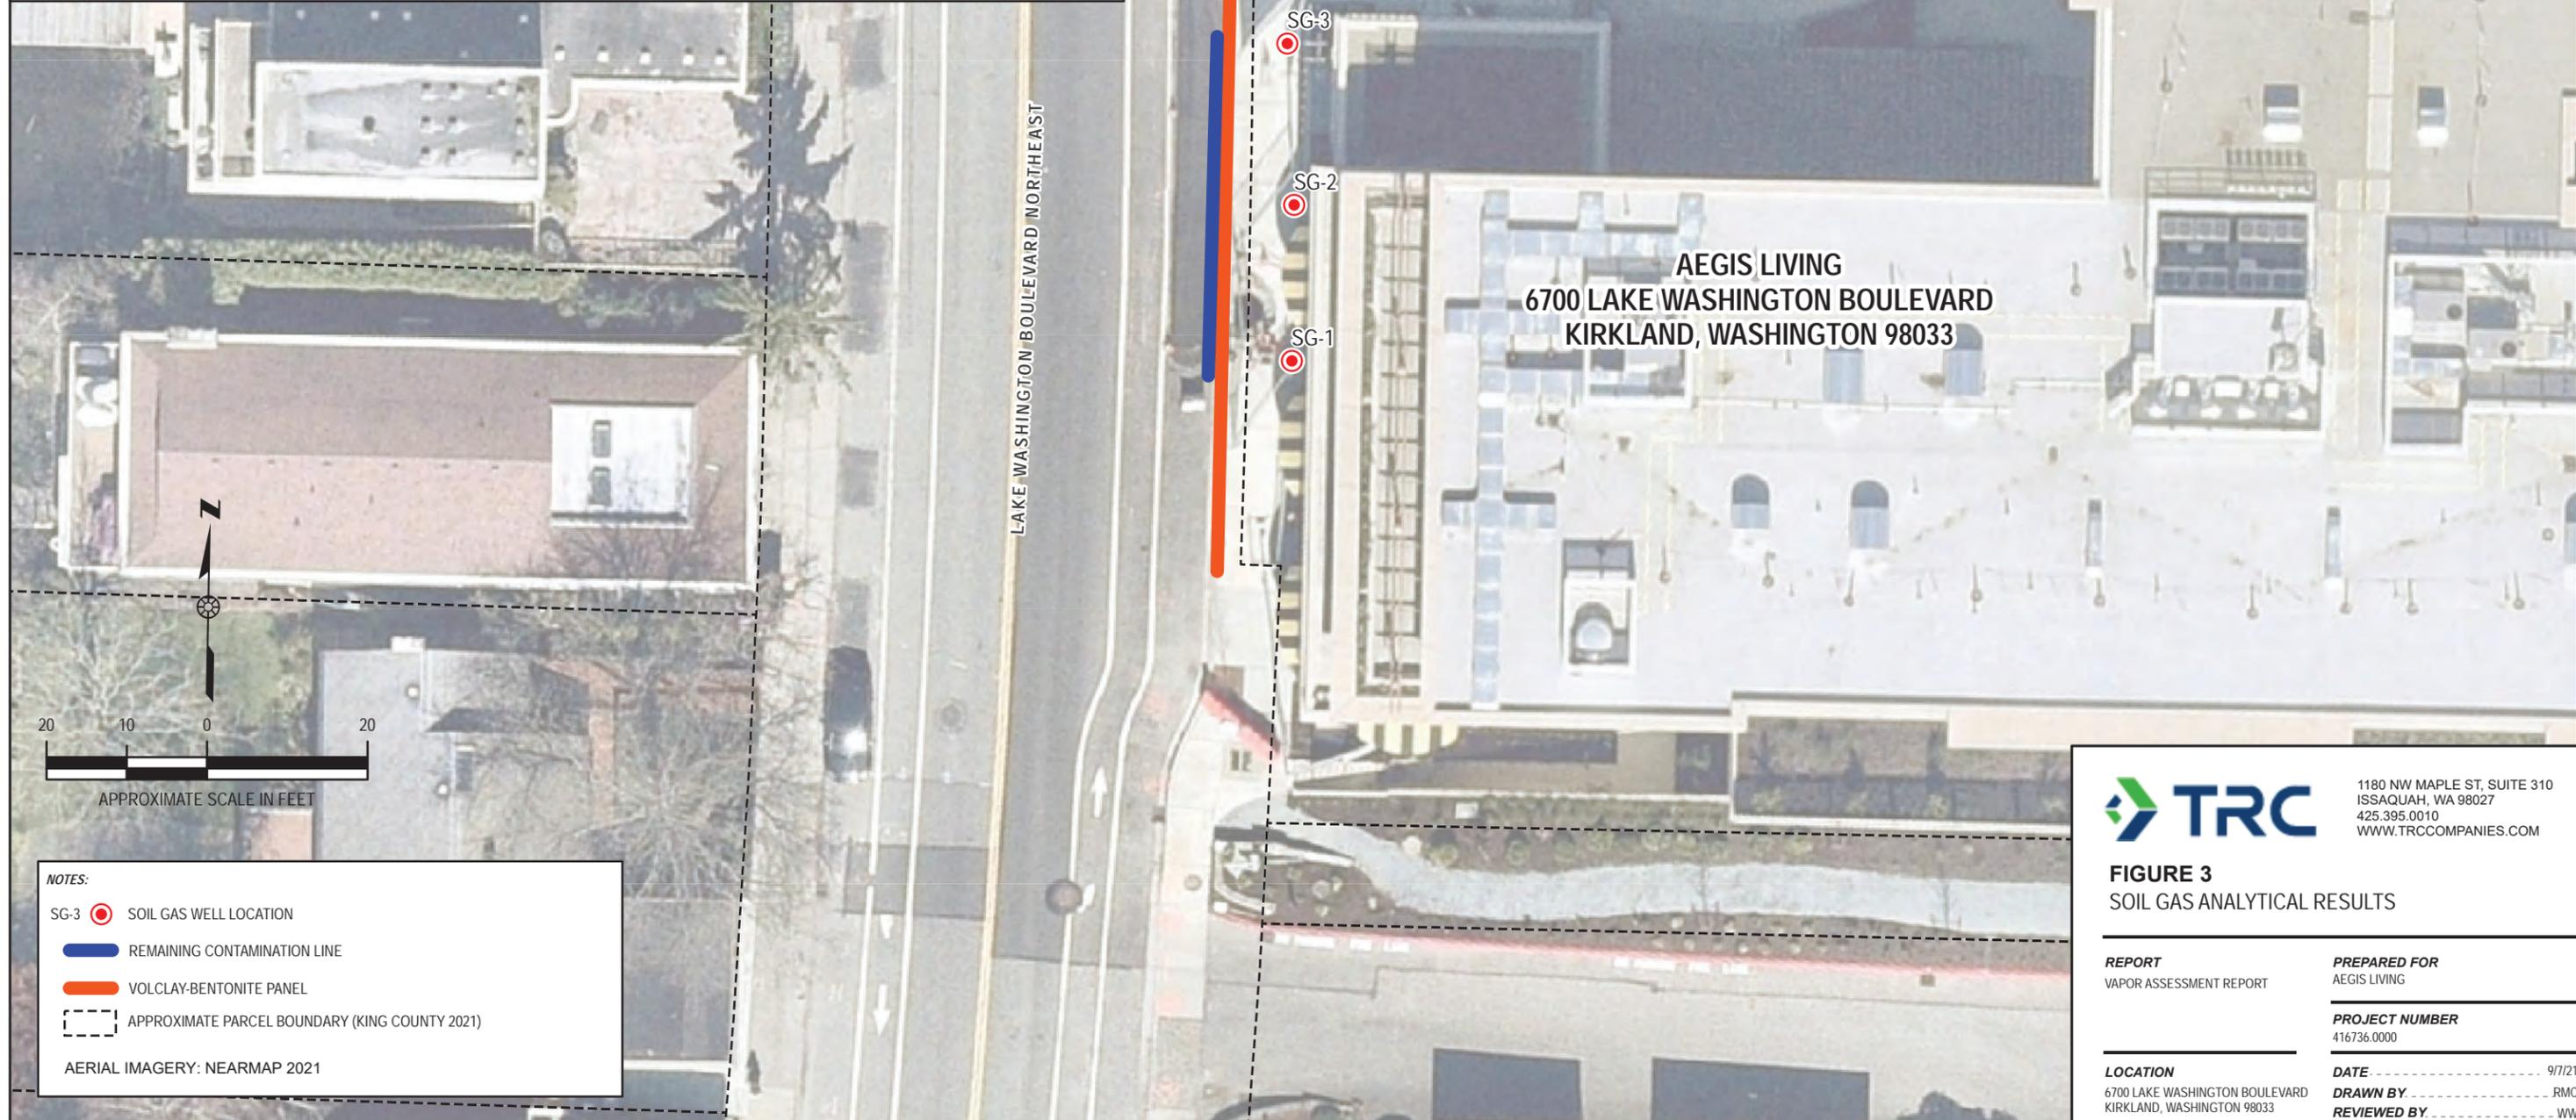
FIGURE 3
SOIL GAS ANALYTICAL RESULTS

(Attachment A). Residual impacts are at an approximate depth of 4 to 6 feet below ground surface, and a horizontal distance of approximately 40 feet along the Site boundary. The approximate location of the residual soil impacts and the Volclay-bentonite panel is shown on Figure 3.

Sample ID	Sample Date	Volatile Organic Compounds ^a					Air Phase Hydrocarbons ^b		
		Benzene	Toluene	Ethylbenzene	m,p-Xylene	o-Xylene	APH EC5-8 aliphatics	APH EC9-12 aliphatics	APH EC9-10 aromatics
SG-1	8/17/2021	2.2	<130	<3	<6	<3	710	290	<170
SG-2	8/17/2021	<2.2	<130	3.7	15	5.6	1,100	260	<170
SG-3	8/17/2021	2.5	<130	<2.9	<5.8	<2.9	780	250	<170
Sub-Slab Soil Gas Screening Level		11^c	76,000^c	15,000^c	1,500^c	1,500^c	90,000^d	4,700^d	6,000^d

NOTES:
SG-3 SOIL GAS WELL LOCATION
 REMAINING CONTAMINATION LINE
 VOLCLAY-BENTONITE PANEL
 APPROXIMATE PARCEL BOUNDARY (KING COUNTY 2021)
AERIAL IMAGERY: NEARMAP 2021

- No concentrations of contaminants of concern greater than MTCA Method B Sub-Slab Screening Levels were detected in any of the soil gas vapor samples collected during the sampling event.
- Based on this information, it appears that the remaining soils with concentrations greater than the MTCA Method A Cleanup Levels that were left in place under Lake Washington Boulevard do not appear to be creating vapor intrusion issues at the newly constructed

building. Additionally, the low concentrations detected reveal that the installed Volclay-bentonite panel is effective at preventing *in situ* adjacent petroleum-contaminated soil from migrating onto the Site.

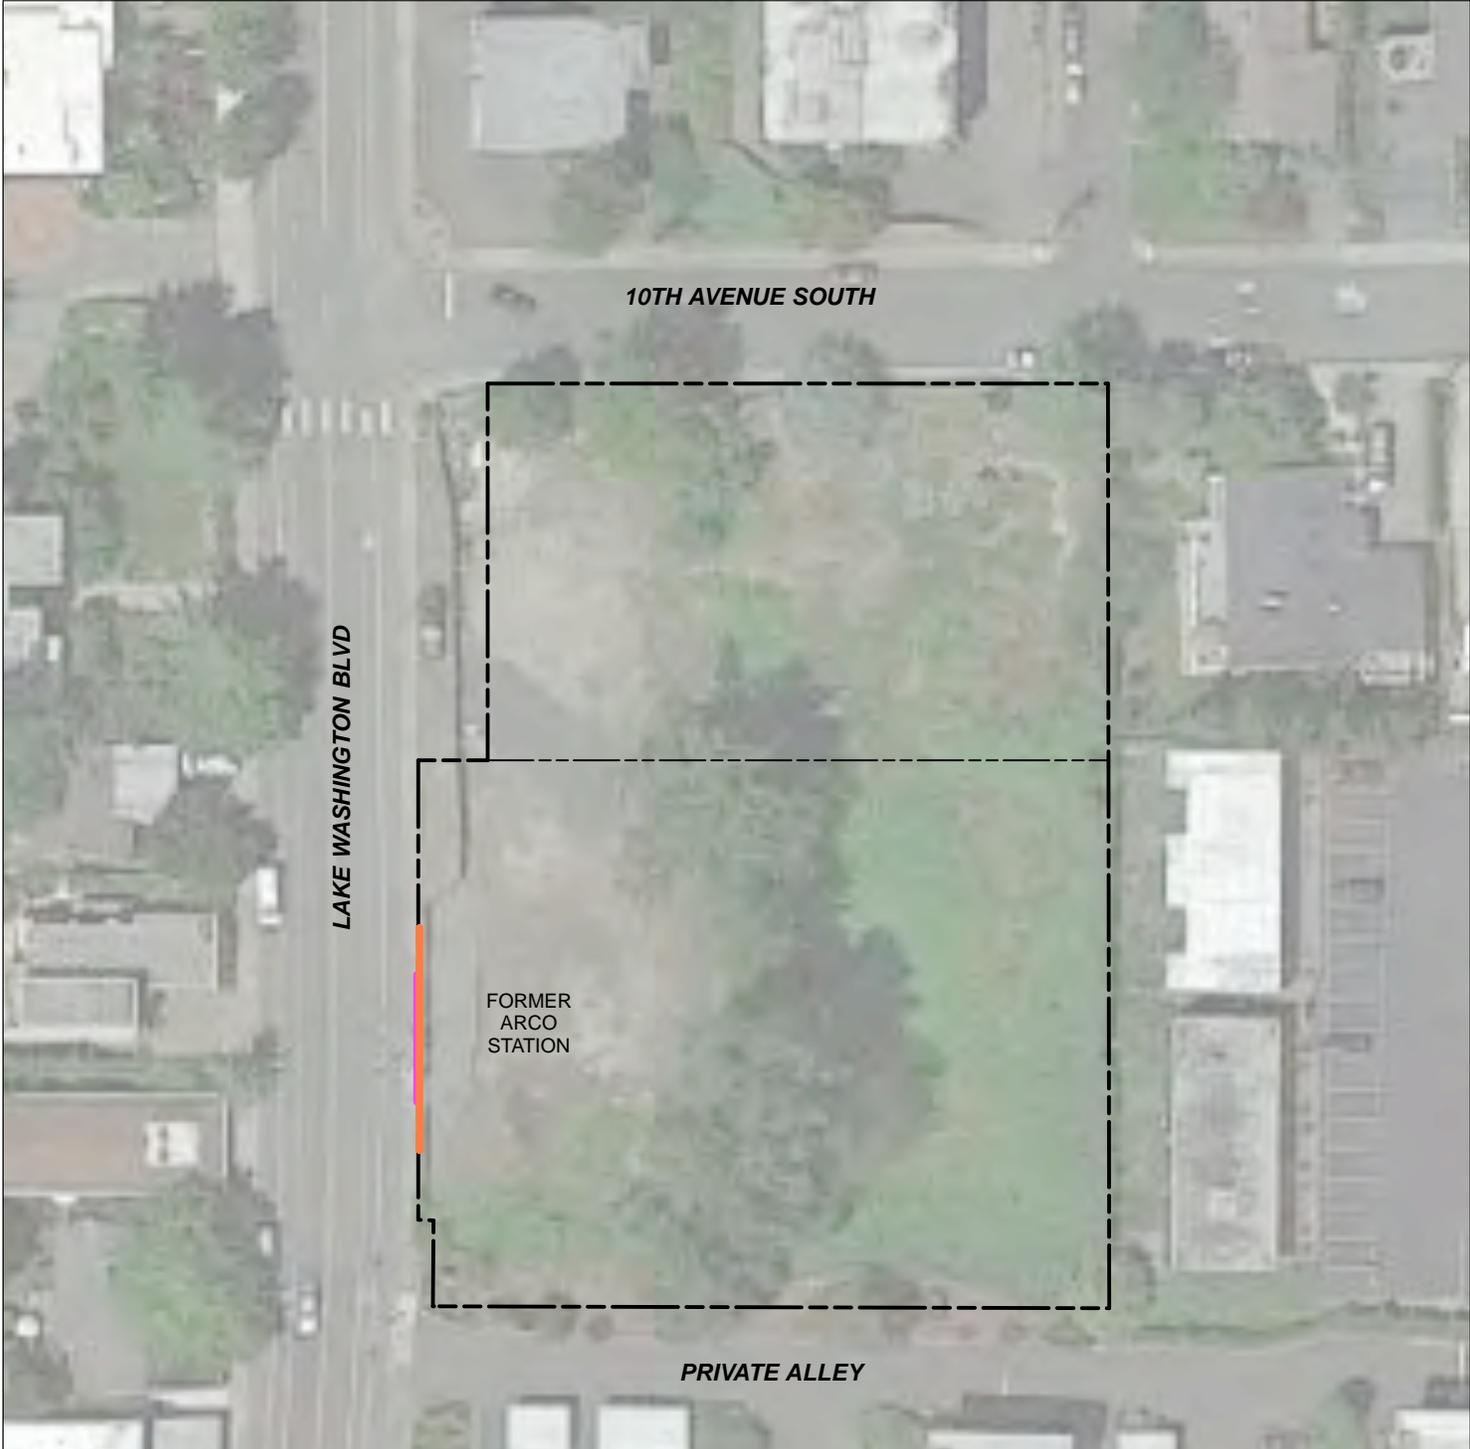
FIGURE 2
SITE REPRESENTATION

This CMP has been requested by Aegis Living in support of complying with the requirements of the Model Toxics Control Act (RCW 70.105D) and its implementing regulations (WAC 173-340; collectively "MTCA"). The Washington State Department of Ecology (Ecology) has requested this CMP as part of an Environmental Covenant to accompany a No Further Action Determination (NFA) through Ecology's Volunteer Cleanup Program (VCP) for residual petroleum impacts remaining in the soil under the City of Kirkland Right-Of-Way located beyond the southwestern Property boundary. All buildings have been demolished and the Property is currently vacant land with gravel cover. The general area of remaining soil impacts is shown on the Site Representation in Figure 2.

AREA OF RESIDUAL PETROLEUM SOIL IMPACTS
 -

VOLCLAY-BENTONITE PANAL
