## **Phase I Environmental Site Assessment**

**Everett Commercial Building  
3011 Grand Avenue  
Everett, Washington**

Subject: Phase I Environmental Site Assessment  
Vacant Commercial Building  
3011 Grand Avenue  
Everett, Washington

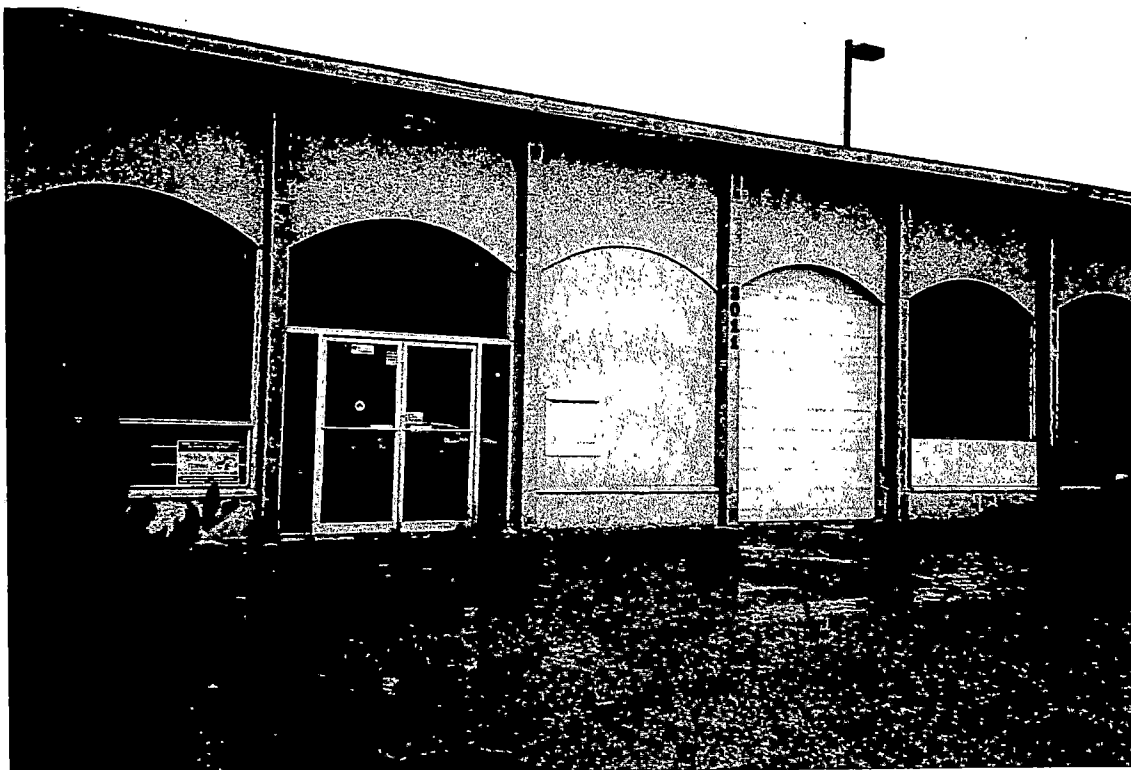
1 - View of the subject property building, as seen from the west.

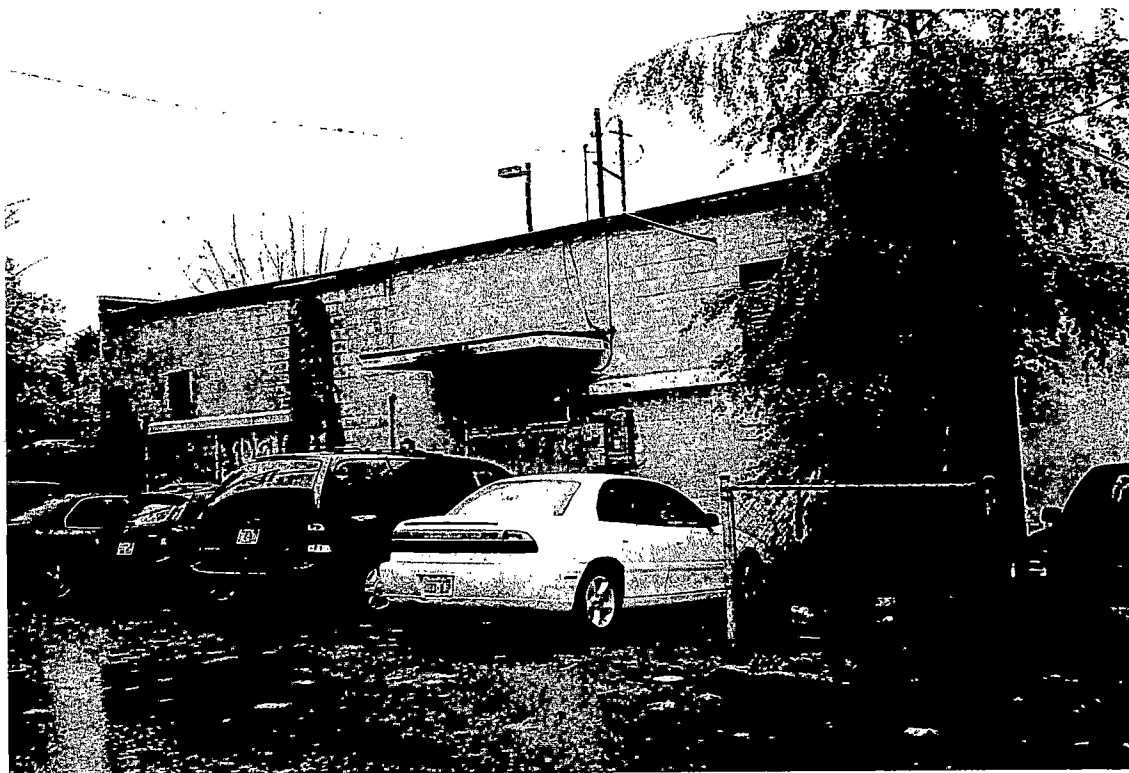
2 - View of the back of the building on the subject property, as seen from the northeast.

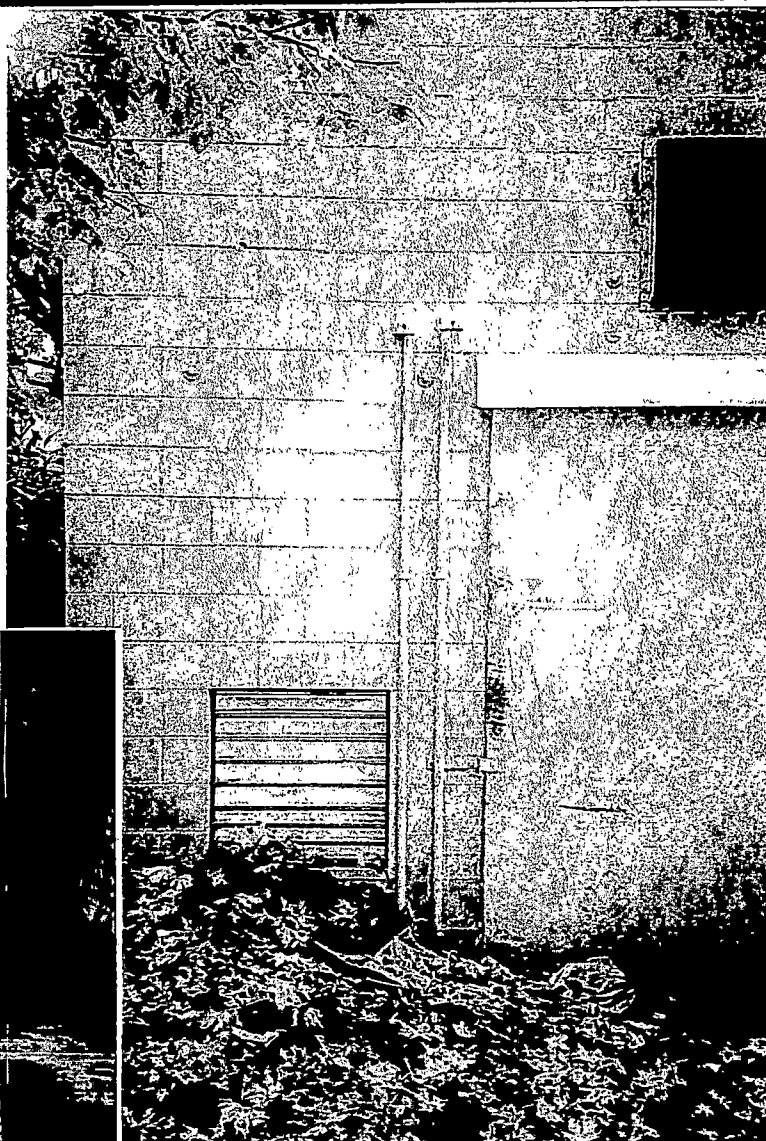
1. We observed two air vent pipes, indicative of possible underground or aboveground tanks, at the east side of the building.

3 – View of the air vent pipes near  
the southeast corner of the building. ✓

- **Recommendations:** A magnetometer survey in the vicinity of the air vent pipes may be prudent to locate potential underground storage tanks. Soil and groundwater sampling and analysis in the vicinity of the air vent pipes and in the building is also recommended to evaluate potential petroleum impacts at the property.
