REMEDIAL INVESTIGATION, FEASIBILITY STUDY, AND CLEANUP ACTION PLAN

Former Phinney Substation Site

Prepared for: Homestead Community Land Trust

Project No. 210143 • October 4, 2021

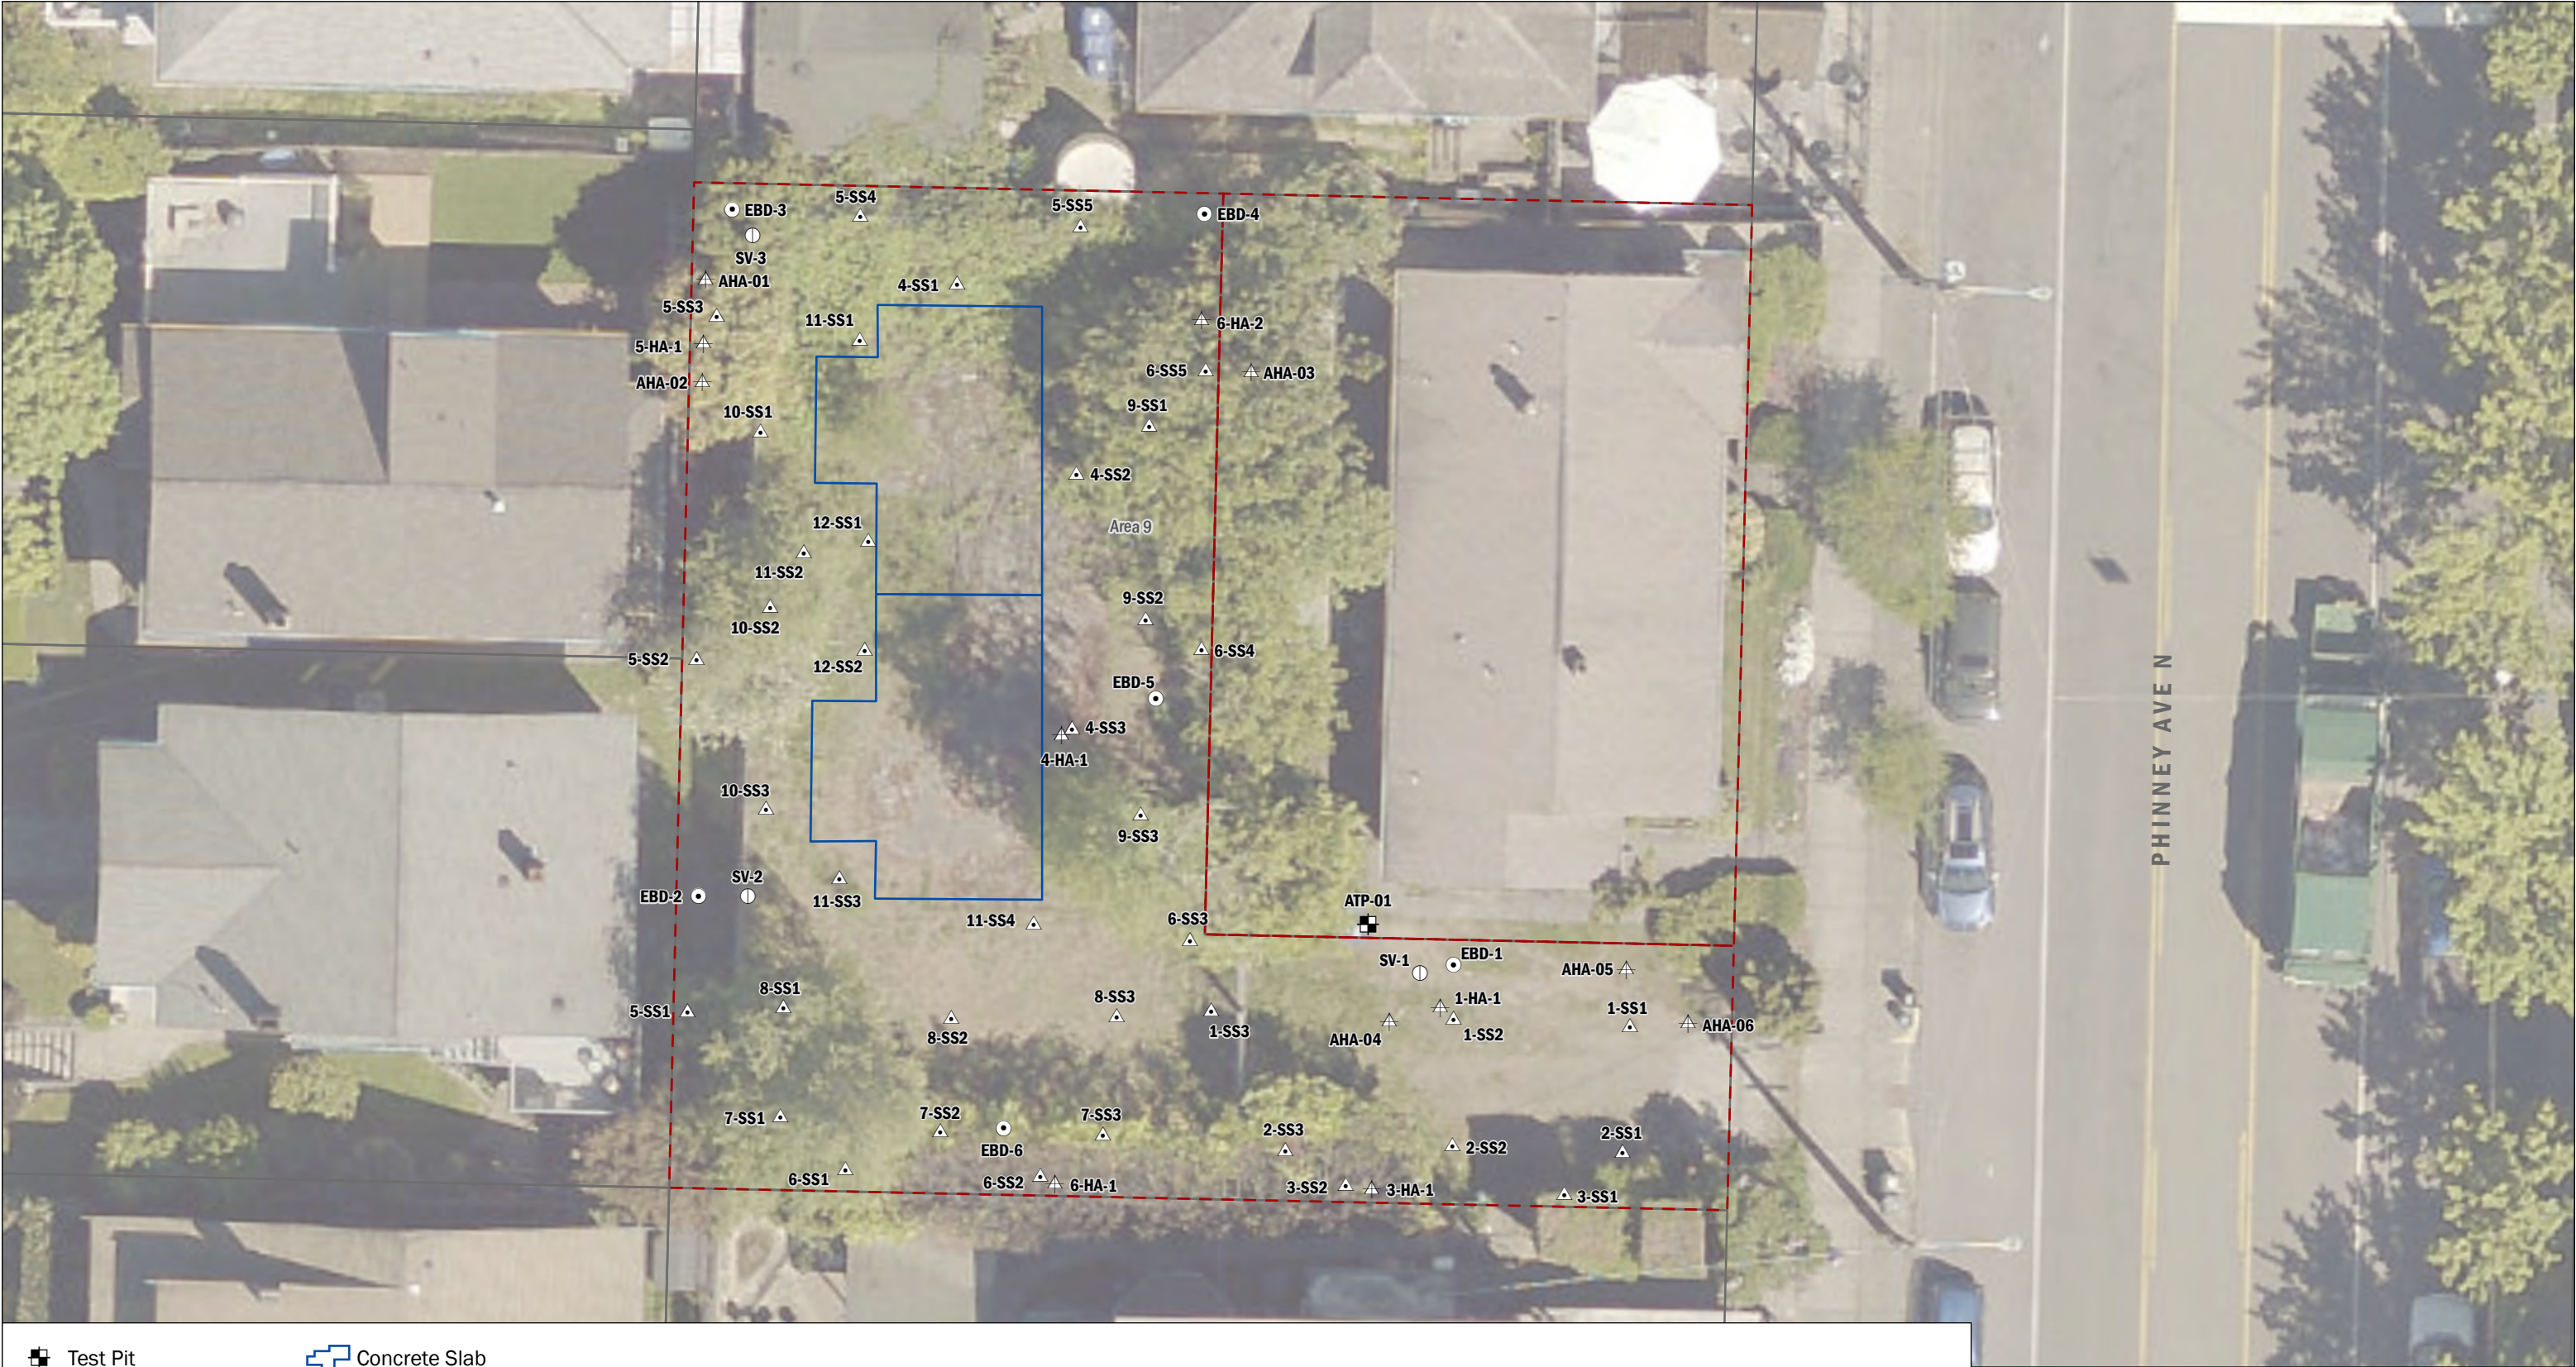
SEP-2021	BY: KB / WEG	FIGURE NO. 2
	PROJECT NO. 210143-02	REVISED BY: --- / ---

- Test Pit
- Discrete Soil Sample
- Soil Vapor Sample
- Direct Push Boring
- Hand Auger
- Concrete Slab
- Site Parcel
- King County Tax Parcel

Site Plan
Remedial Investigation and Feasibility Study
Former Phinney Substation
Seattle, Washington

The following provides a summary of the environmental investigations completed at the Site that informed this RI. Exploration locations from all investigations to date are shown on Figure 2. Supporting figures and tables from the investigations are included in Appendices A and B.

Shallow Soil and Lateral Extent. Composite and discrete samples were collected from surface soil (0 to 0.5 feet bgs) at locations across the Substation Property (Figure 2) and submitted for the above-listed contaminants of concern (TPH, pesticides/herbicides, VOCs, PCBs and metals). Initial screening of composite sampling results was used to determine which discrete samples would be submitted for follow-up testing, and for which analytes. Discrete samples for surface soil are shown on Figure 3 and contain the “SS” indicator in their sample names. The actual soil sampling figures and chemical analytical results tables from the 2018 study are also included in Appendix A.

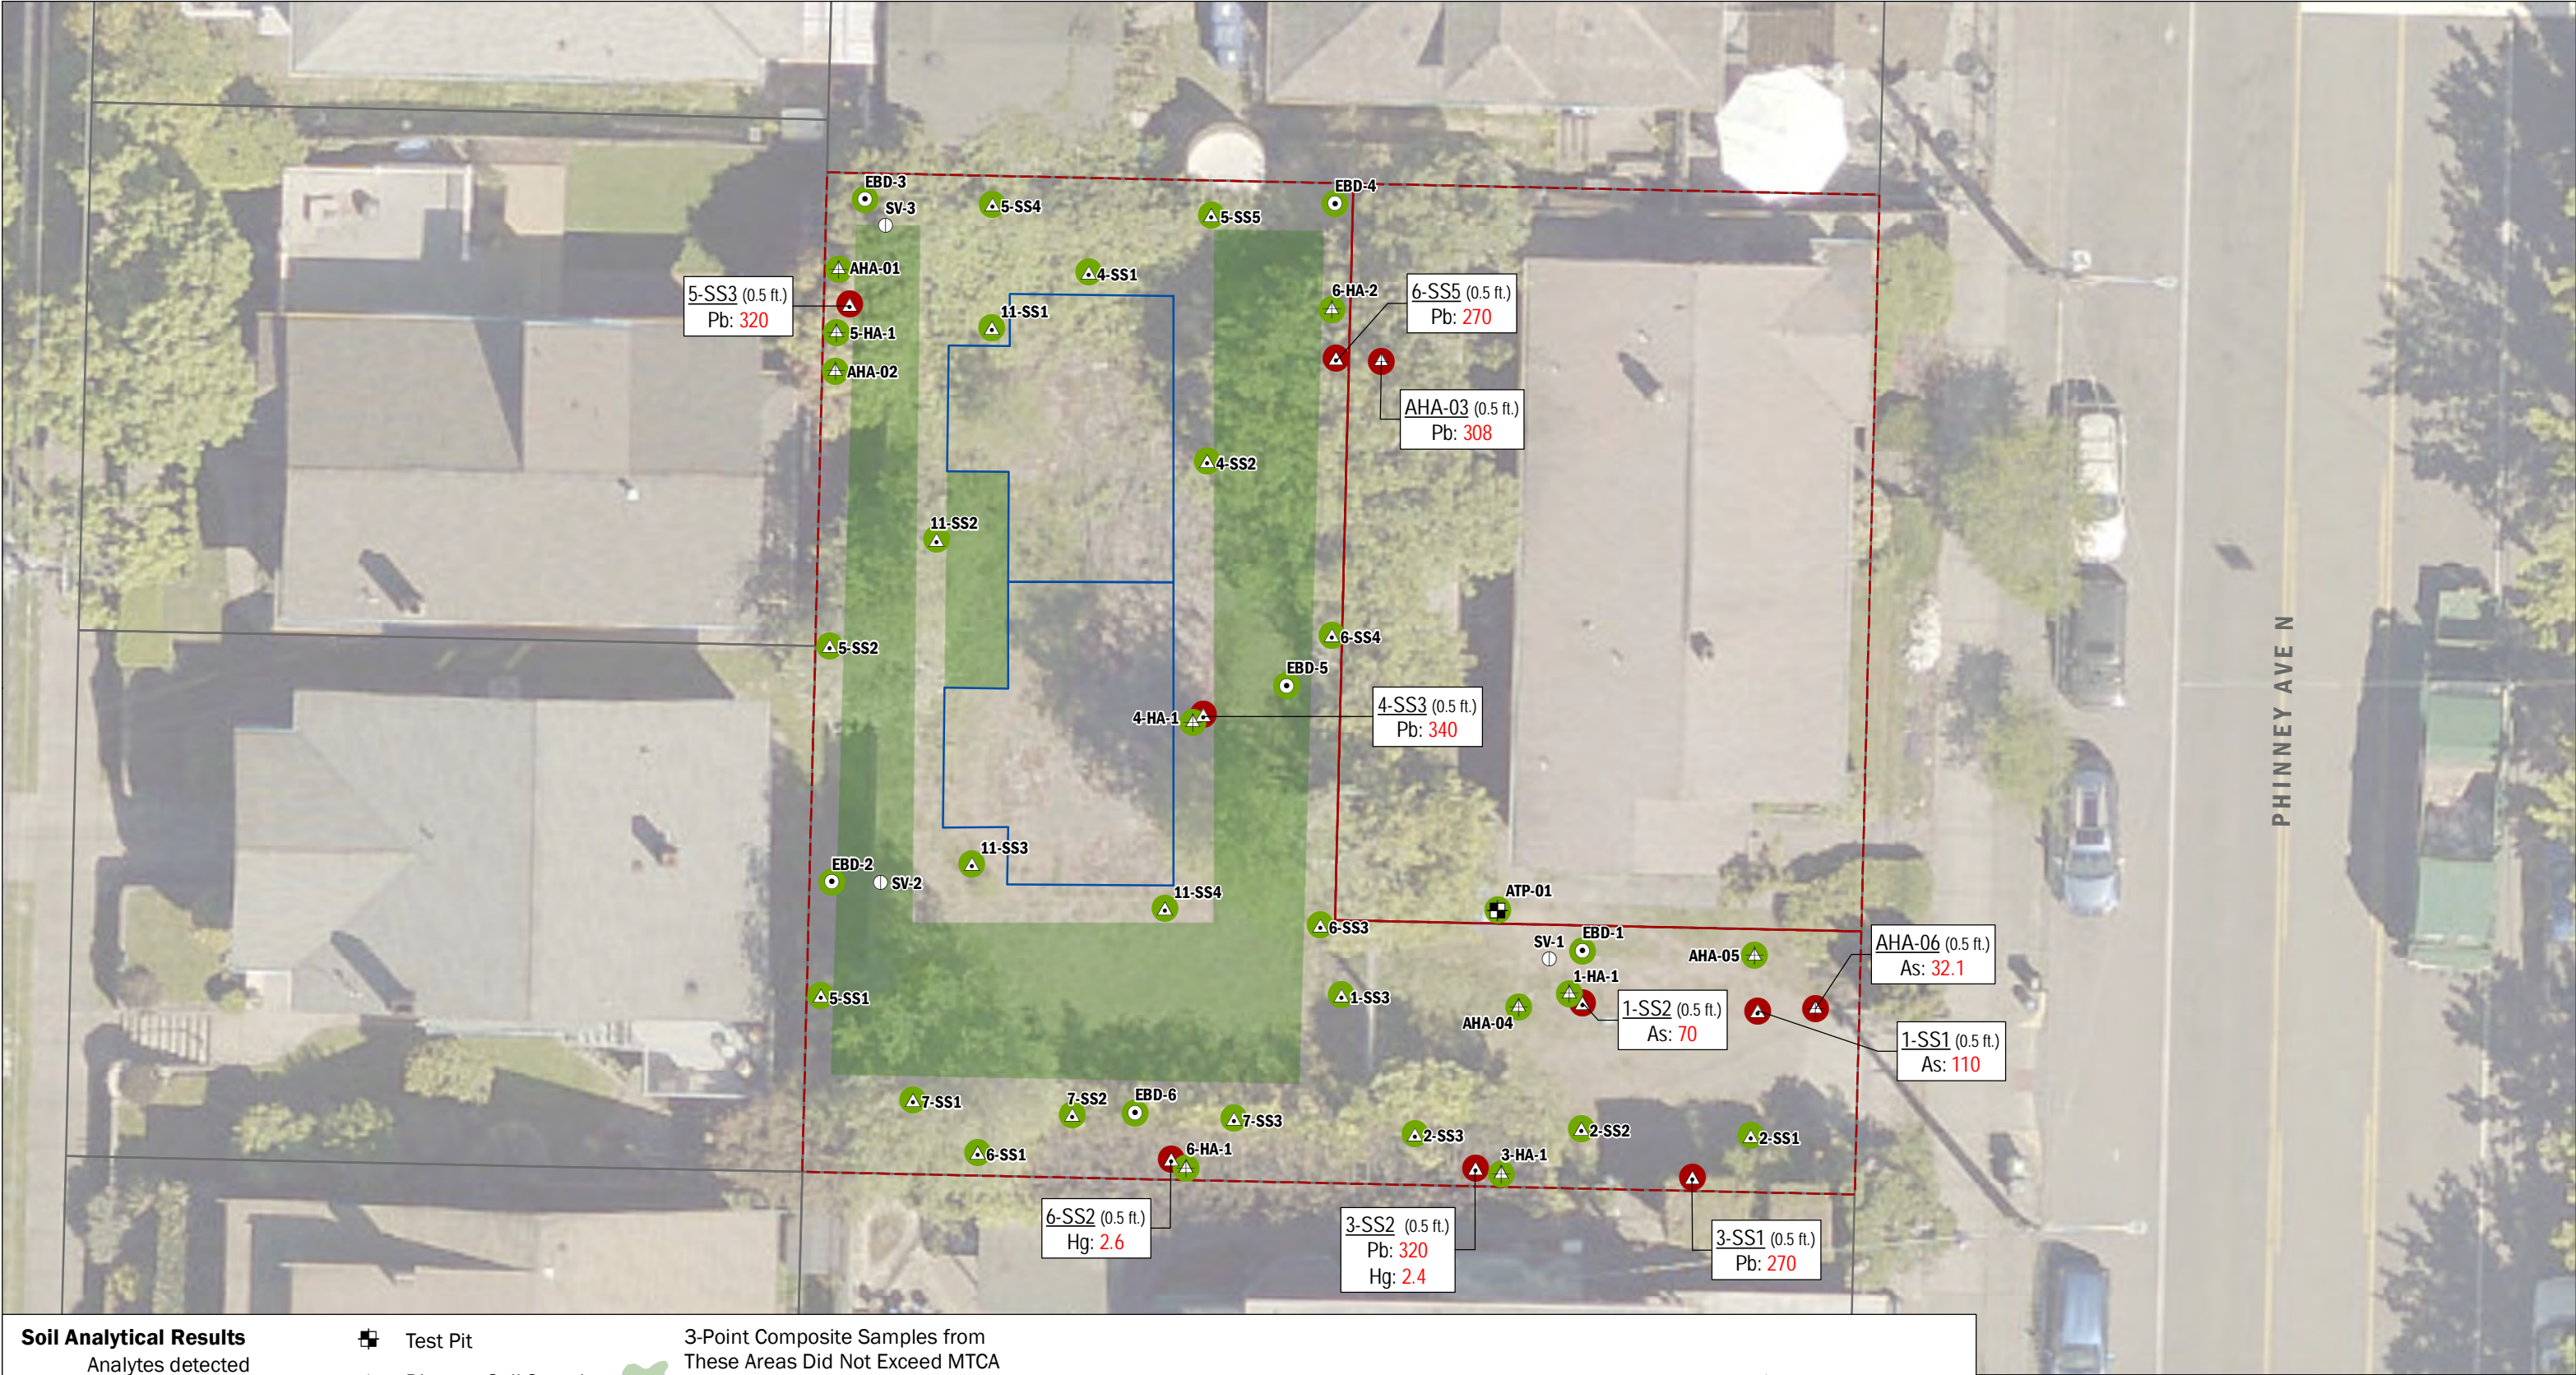
SEP-2021	BY: KB / WEG	FIGURE NO. 3
	PROJECT NO. 210143-02	REVISED BY: ---

Soil Analytical Results

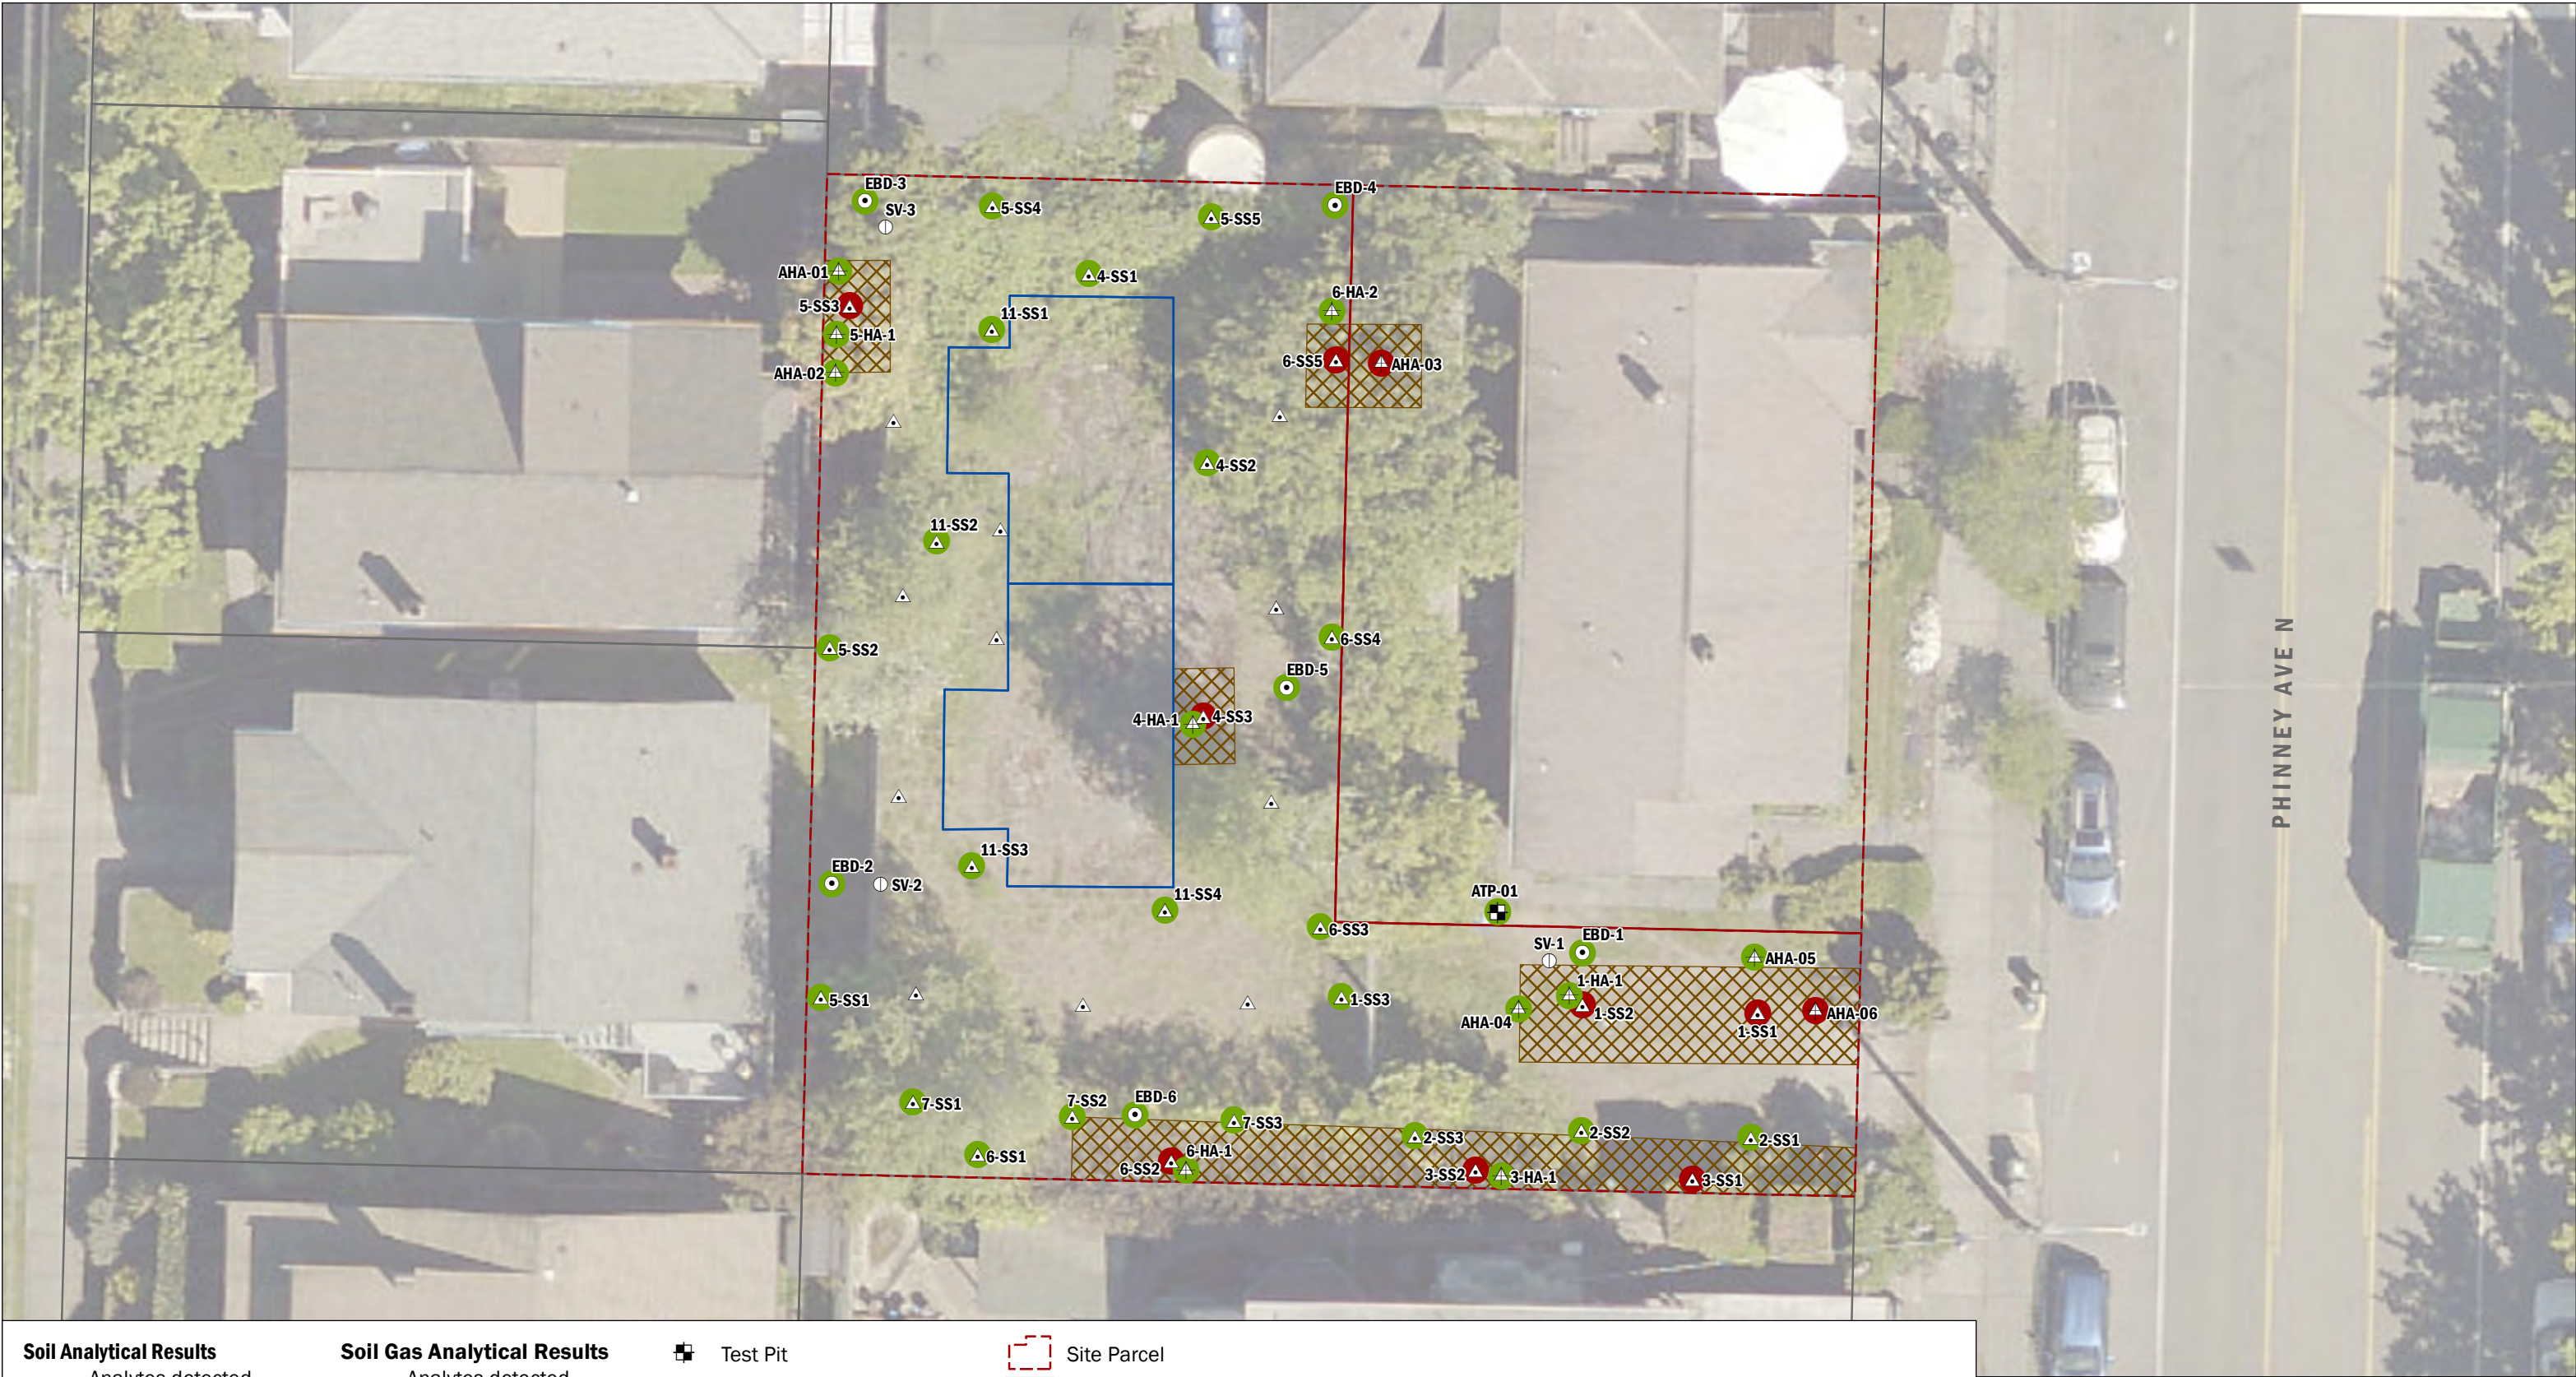
FIGURE NO.
5

Soil Analytical Results

- Analytes detected exceeded MTCA Method A cleanup levels.
- Analytes detected did not exceed MTCA Method A cleanup levels.
