**REPORT  
UST REMOVAL**

**BLACK MOUNTAIN RANCH  
6417 MOUNT BAKER HIGHWAY  
DEMING, WASHINGTON**

**BEK PURNELL ENGINEERING, INC.**  
*Consulting Engineers & Geologists*  
2138 Humboldt Street  
Bellingham, WA 98225  
(360) 676-9589

January 8, 1999

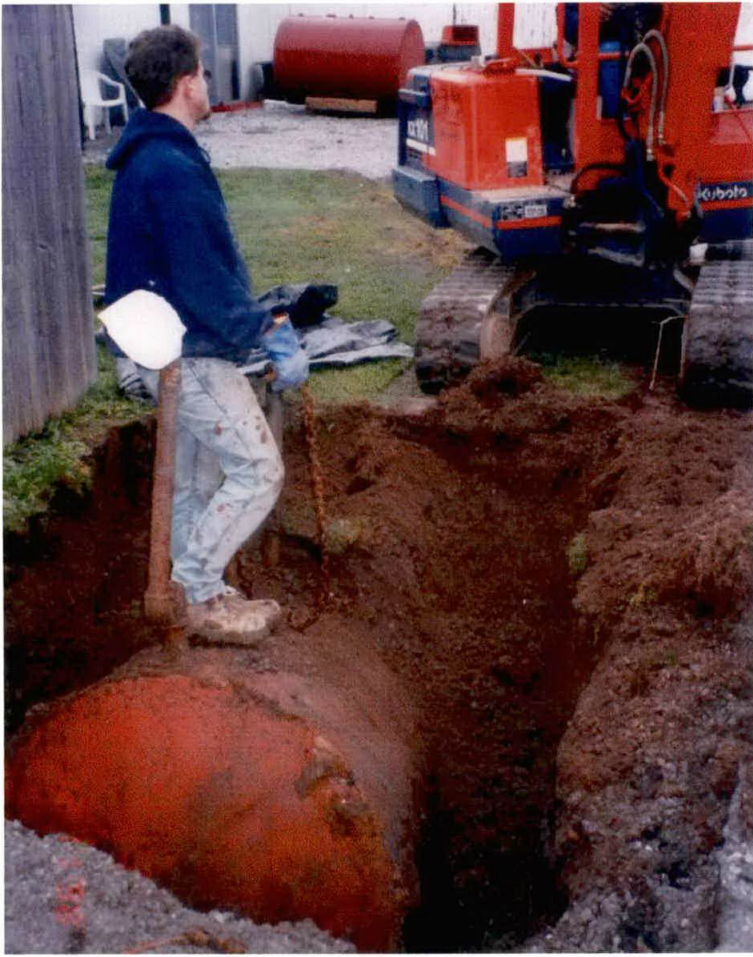
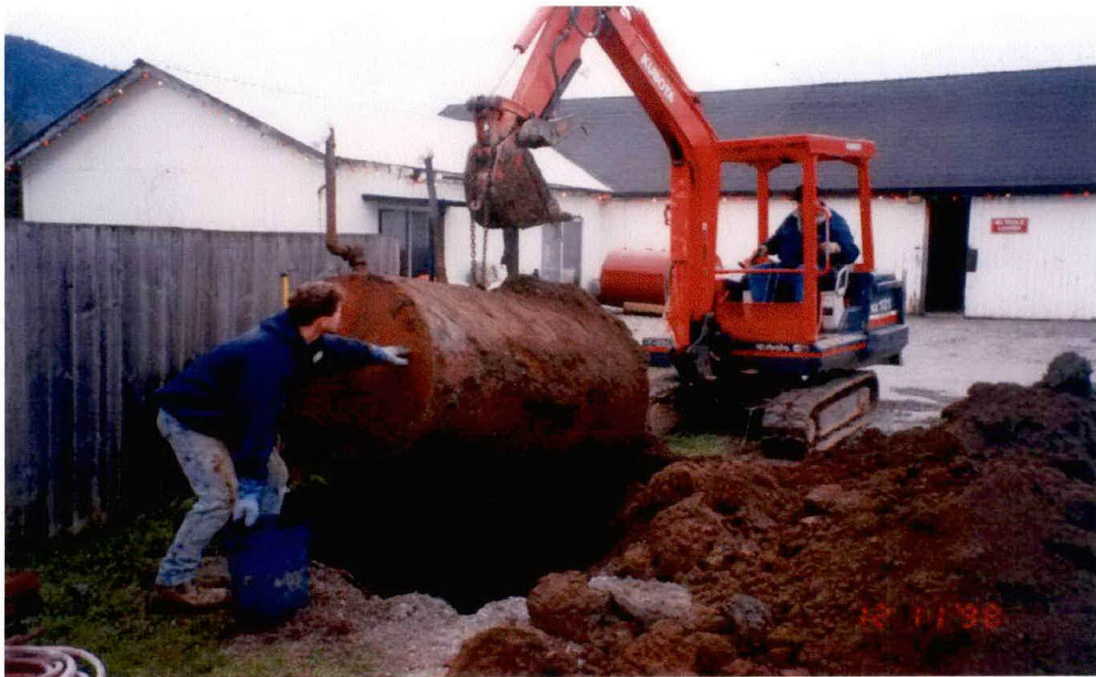
Figure 3. Tank photographs

BEK Purnell Engineering personnel completed the site assessment on December 11, 1998. Upon removal the tank was observed to be 500 gallons in size. The tank was in good condition, and no visual evidence for corrosion, pitting, or holes were observed. It is our understanding that the tank was disposed by Ultra Tank Services. Soil in the UST pit consisted of fine grained sand with some silt.

A hydrocarbon odor was noted in the UST pit following removal of the tank. Additional investigation revealed that gasoline contaminated soil emanated from beneath the former location of the fuel pump. The source of contamination is therefore likely to have been a leaking pipe fitting in the distribution line near the fuel pump, possibly combined with overfilling of vehicles. The excavation was extended through contaminated soil to a depth of approximately eight feet, where shallow ground water was encountered. Gasoline contaminated soil was in contact with shallow ground water.

The UST pit was backfilled with clean fill soils pending additional cleanup efforts.
