Cleanup Action Report

Former Olympia Manufactured Gas Plant Property
320 Columbia Street NW
Olympia, Washington

for
Puget Sound Energy

January 4, 2013

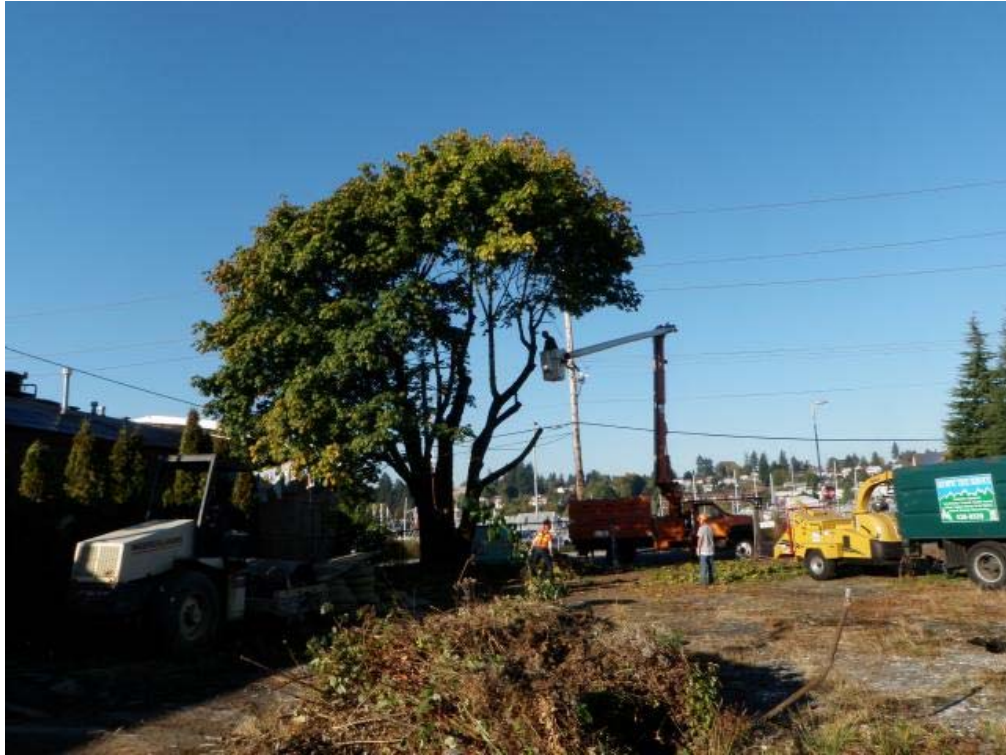
A maple tree located on the southwest corner of the Property was removed in accordance with a City of Olympia tree removal permit prior to initiating excavation activities (Photograph 1, Appendix A). No other trees were located within the Property boundaries.

Photograph 1: Tree being removed (southwest corner of property)

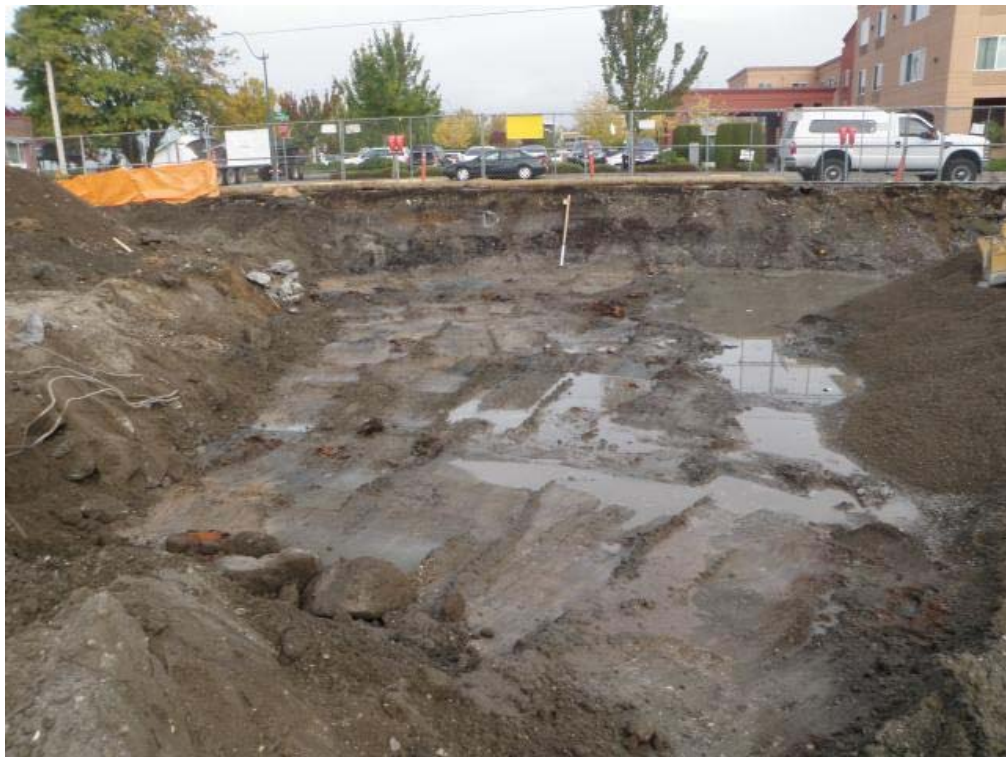
The remedial excavation limits are depicted in Figure 2. Typical subsurface conditions encountered during excavation activities are shown on Photographs 2 and 3 (Appendix A). The limits of the completed excavation measured approximately 120 feet by 120 feet and extended to a total depth of 6 feet below ground surface (bgs) in accordance with the revised CAP and Work Plan, with two exceptions. The excavation extended to a depth of 6½ feet bgs in a portion of Cell A-4 and 7 feet bgs in a portion of Cell E-1 to remove visually stained soil. Groundwater was encountered at approximately 6 feet bgs within the remedial excavation limits.

Photograph 2: Typical subsurface excavation conditions

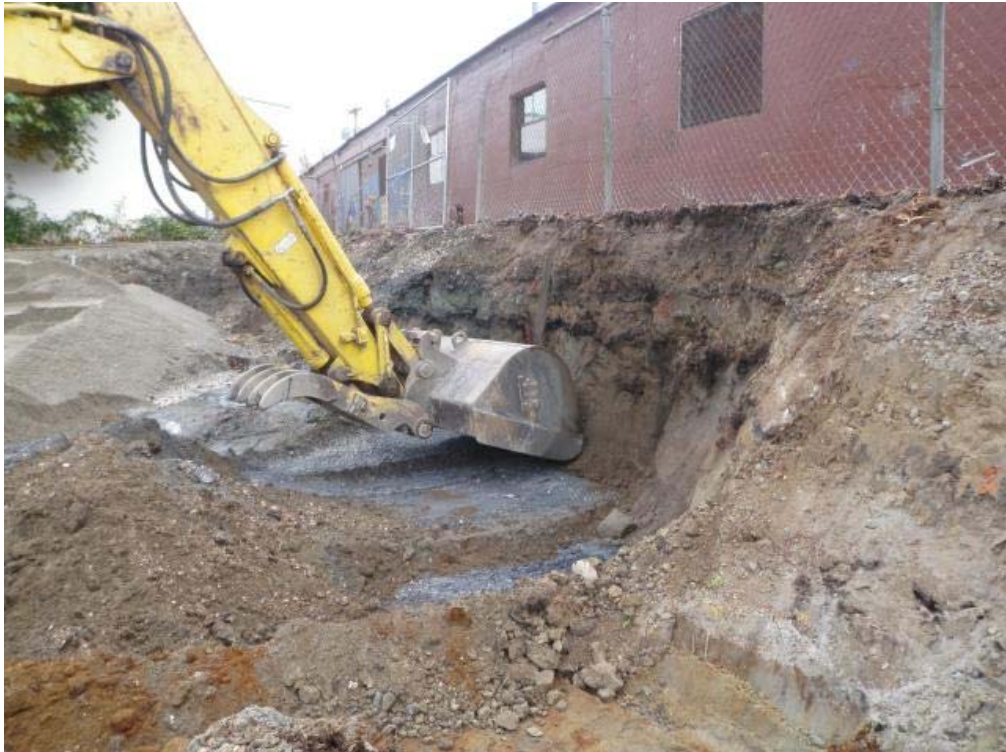
eastern excavation sidewalls. The eastern excavation sidewall was originally intended to be cut at an inclination of approximately 2H:1V (horizontal:vertical). During construction, GeoEngineers observed exposed soil along the east excavation sidewall and determined that the temporary cut slope could be safely steepened from 2H:1V to 1H:1V, as shown in Figure 5. This resulted in the removal of approximately 80 cubic yards of additional soil along the eastern Property line.

Photograph 3: Excavation sidewall vertical cut activities

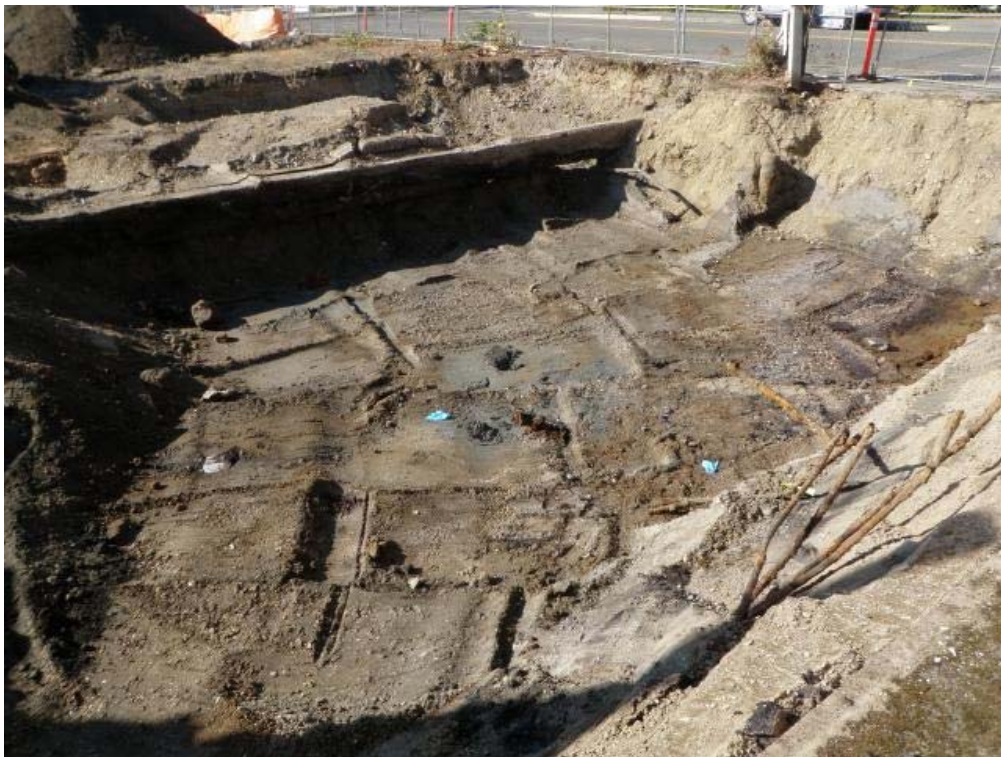
Subsurface concrete foundations and piping, apparently associated with former MGP facilities, were encountered during remedial excavation activities (Figure 3 and Photographs 4 and 5). These features were demolished to a manageable size for transport and disposal at a permitted off-site disposal facility (Photograph 6).

Photograph 4: Remnant underground piping (northeast corner of property)

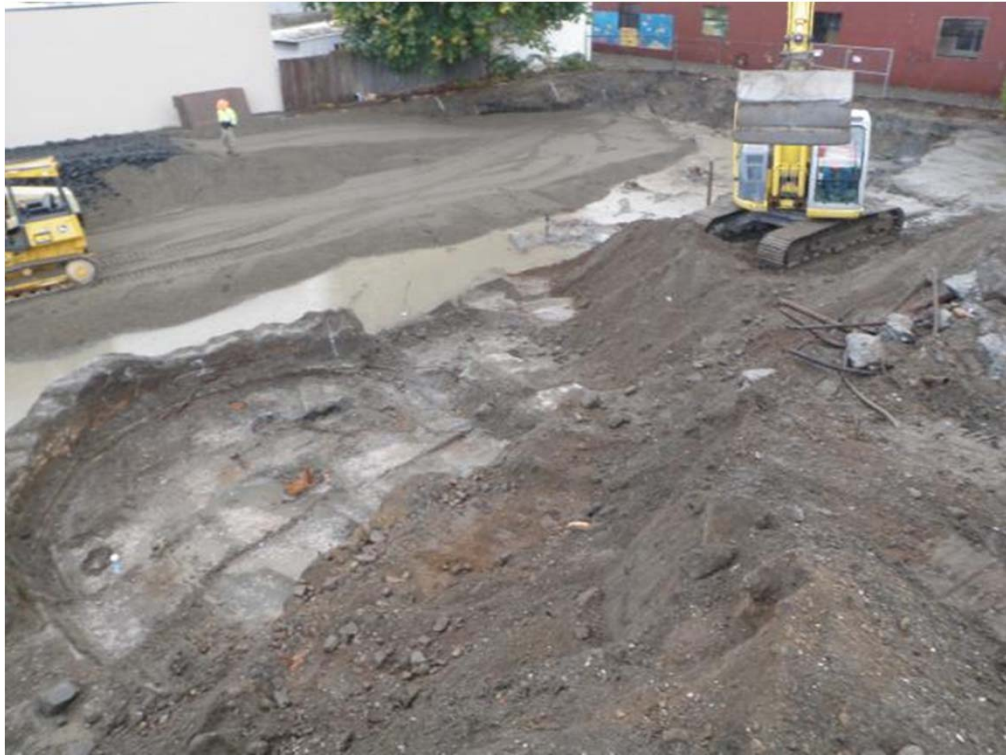
Photograph 5: Apparent concrete footing for the former gas holder (left side of photo) located towards the north-northwest portion of the site

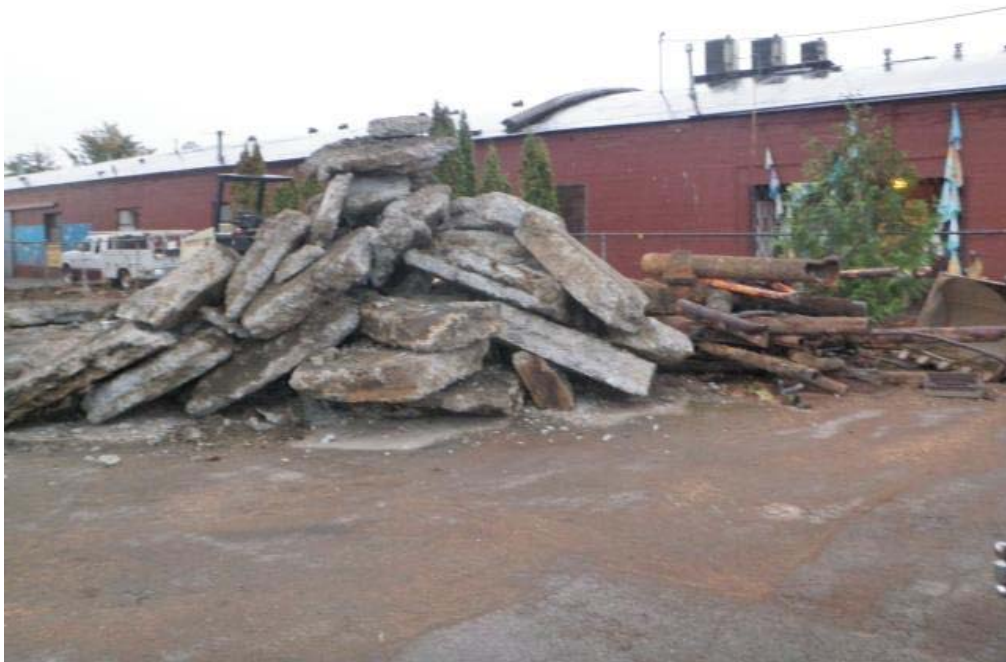
Photograph 6: Concrete footing/foundation and piping debris removed from excavation

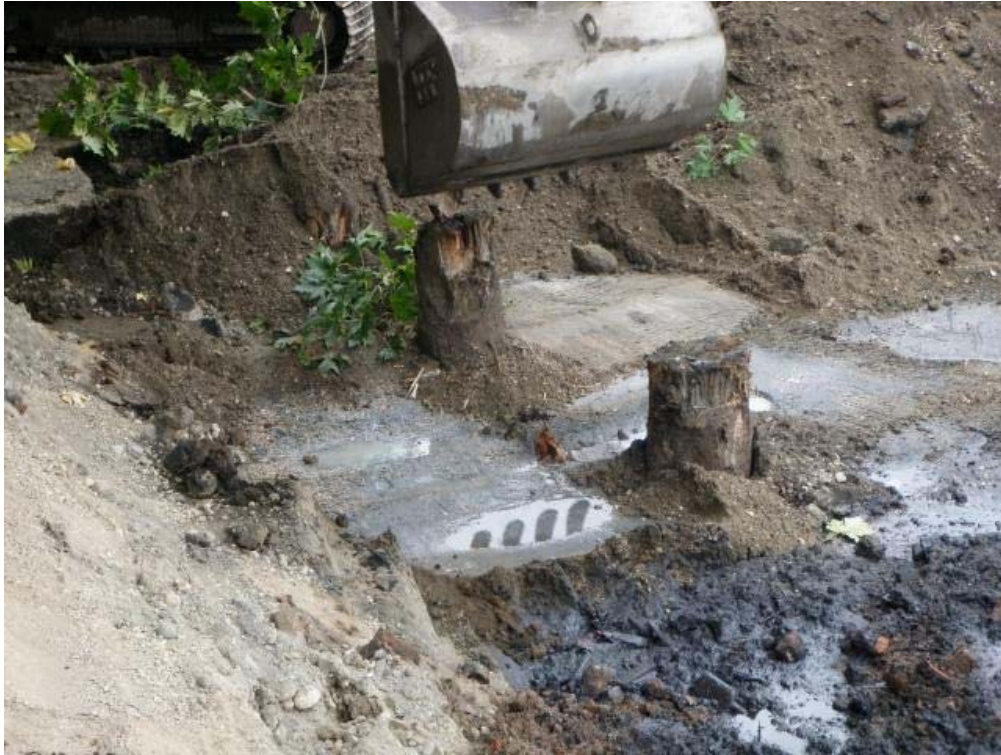
Wood piling also was encountered during remedial excavation in the central and southern portions of the Property (Photographs 7 and 8). The wood piles did not appear to be treated based on visual observations and were removed in their entirety or cut at the base of the excavation.

Photograph 7: Unpreserved wood piles (southeast corner of property)

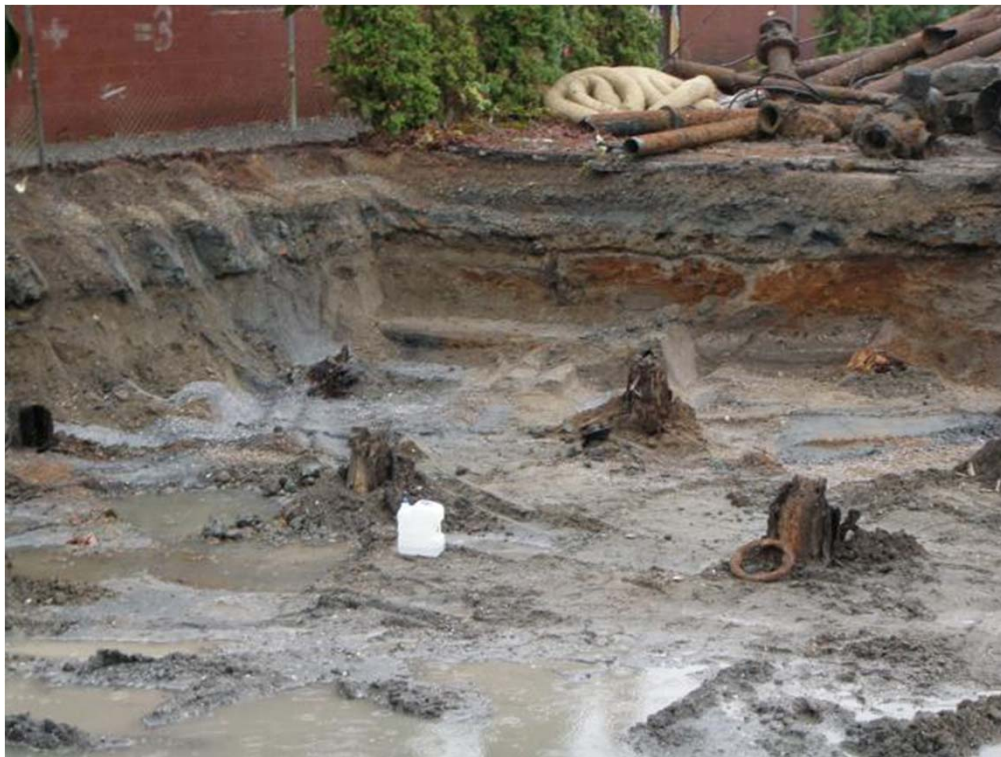
Photograph 8: Unpreserved wood piles (south-central area of property))

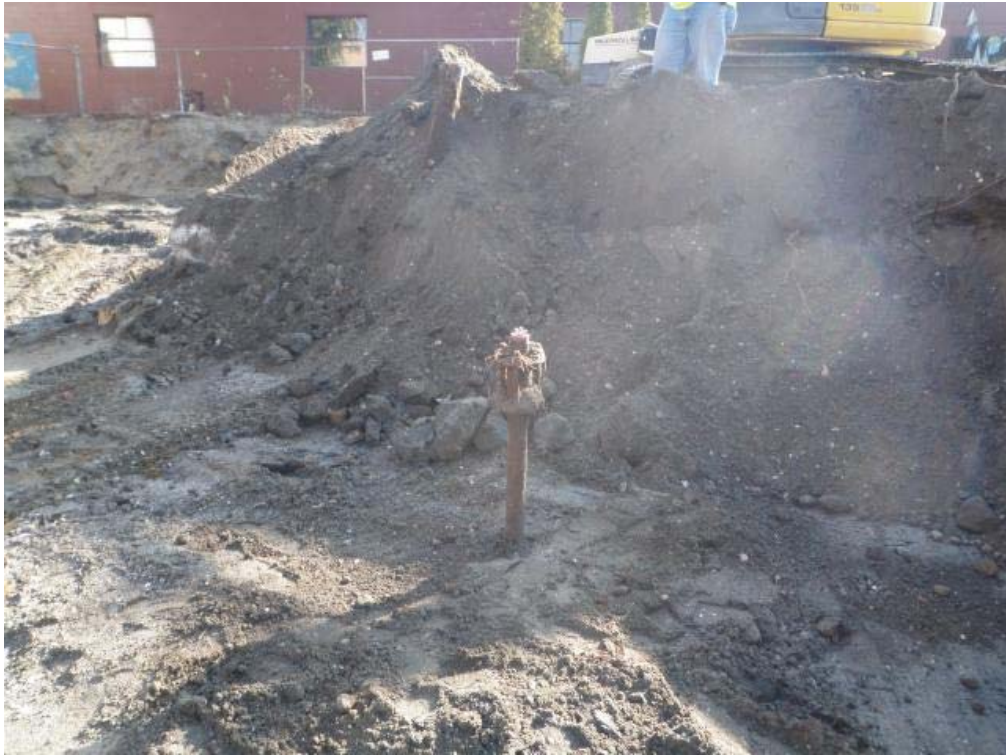
An apparent water supply well was encountered at the base of the remedial excavation as shown in Figure 3 and Photograph 9. The well exhibited artesian flow at the elevation it was encountered (approximately 4 to 5 feet below ground surface). The well casing was extended to the restored ground surface to facilitate subsurface efforts to abandon the well. The well will be decommissioned by a Washington State licensed well driller during future compliance groundwater monitoring well installation activities.

Photograph 9: Apparent water supply well encountered during excavation activities (east-central property area)

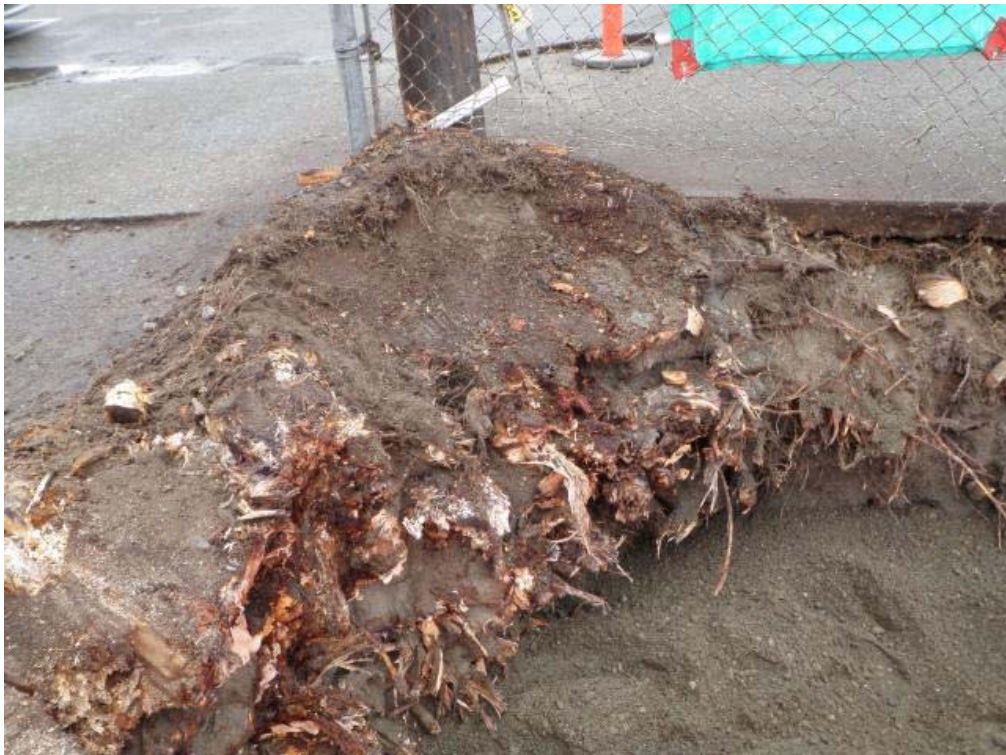
A portion of the maple tree stump (southwest corner of the Property) was unable to be removed without damaging nearby City right-of-ways (ROWS) and utilities (Photograph 10). Soil beneath the stump was removed to the maximum extent practicable. Stump remnants measure approximately 8 feet long by 2 feet wide by 3 feet deep as shown on Figure 3.

Photograph 10: Maple tree stump remnants (southwest corner of property)
