## REMEDIAL INVESTIGATION AND CLEANUP ACTION PLAN

Buca di Beppo/Ducati Property

Buca di Beppo/Ducati Property  
701 9<sup>th</sup> Avenue North  
Seattle, Washington

November 19, 2015

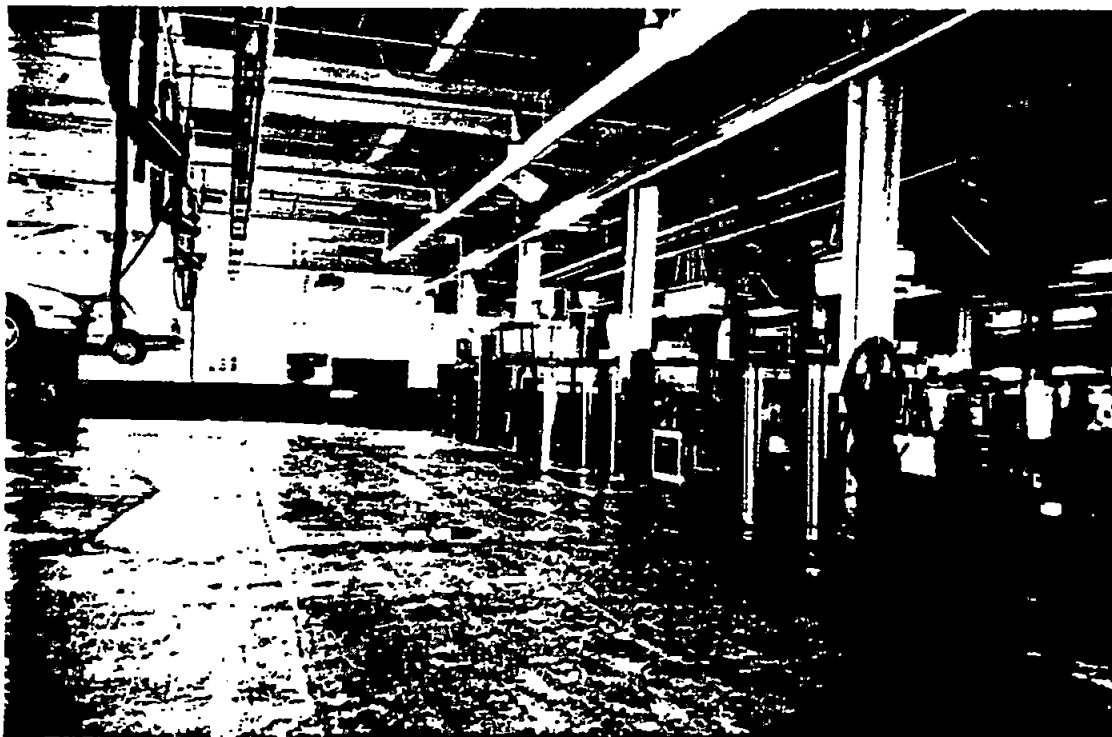
Photo 2 Hydraulic lifts in middle of building, look southwest.

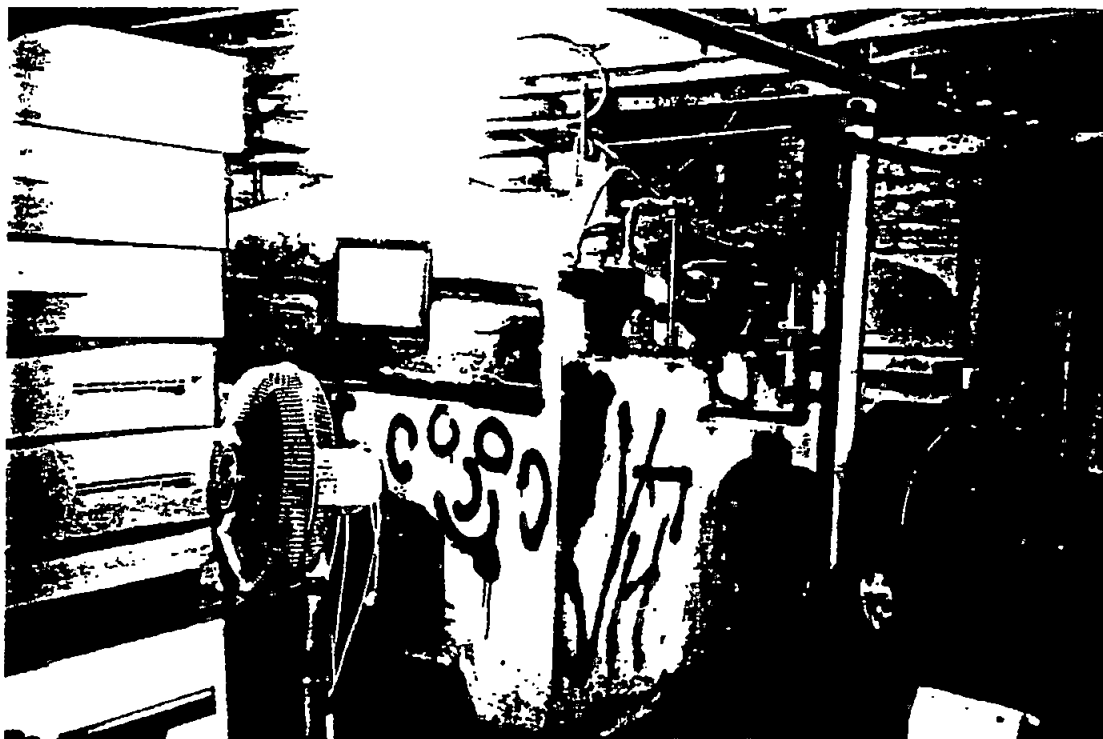
Photo 3 Boiler containing ACM in southeast corner of sub-basement, looking southeast.
