December 9, 2021
Project 2004-0003

Re: Quarterly Groundwater Monitoring and Remedial Operations Report – November 2021, Former Provisioner’s Express, Inc. Facility, 2102 West Valley Highway North, Auburn, Washington, Ecology Facility ID 91612121, Cleanup Site ID 6847, VCP Project No. 3206

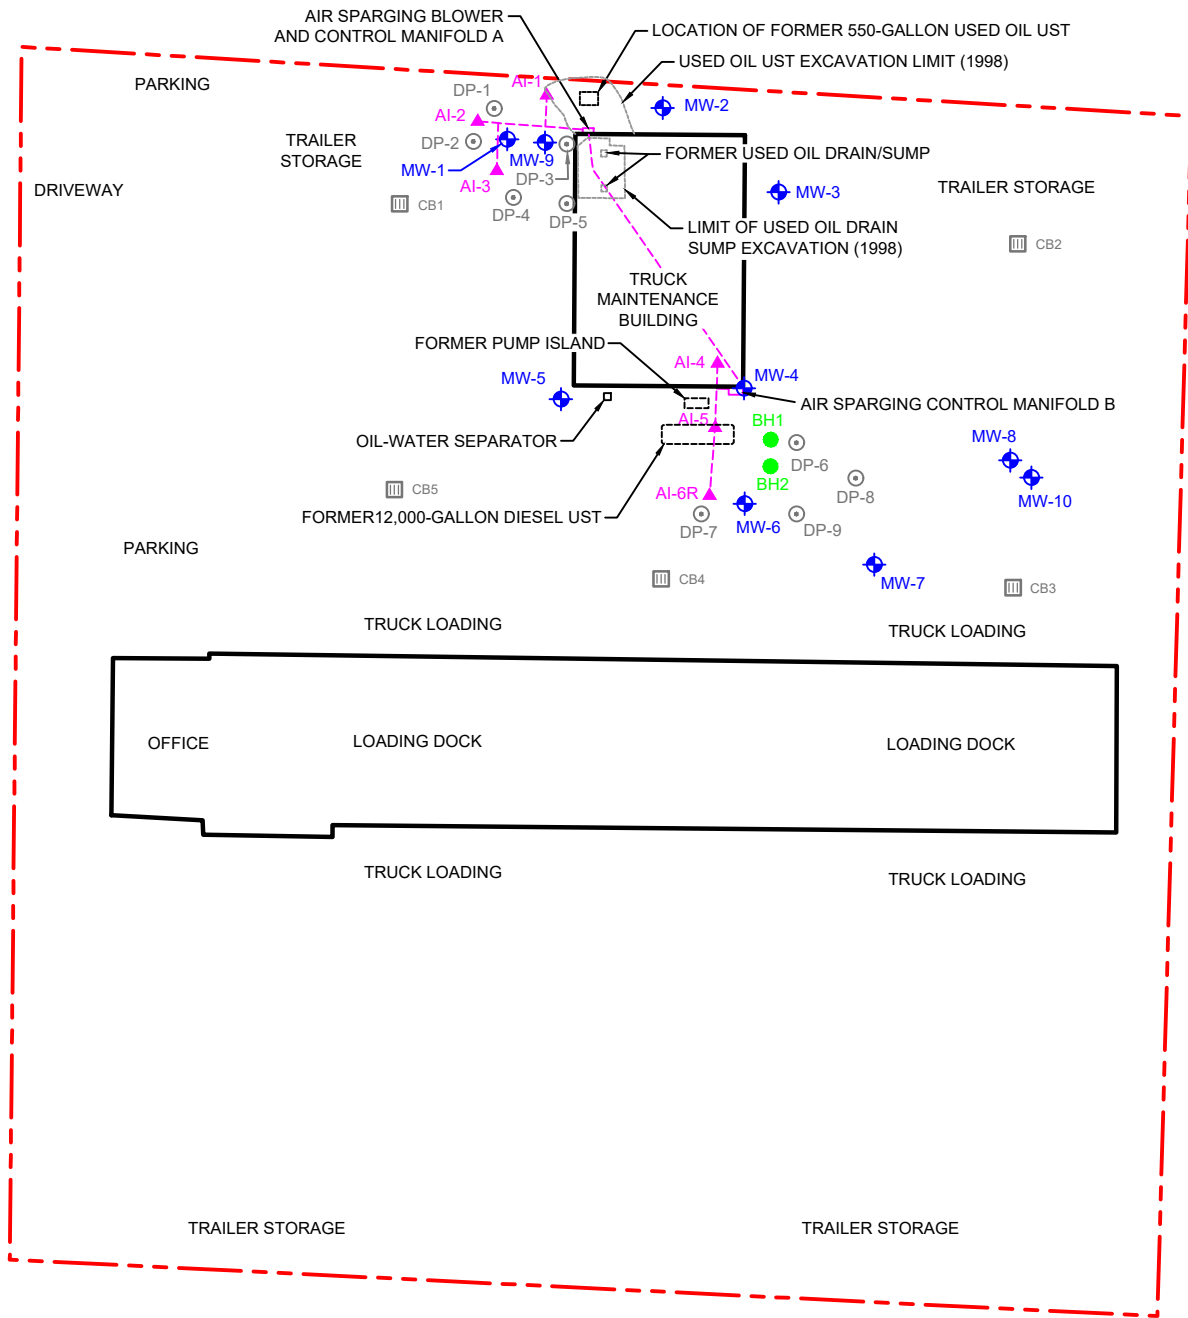
SCALE: AS SHOWN	DATE: 12/2/21	FIGURE NO. 2
APPROVED BY: DJL	DRAWN BY: SRM	PROJECT NO. 2004-0003

On November 28, 2012, a 12,000-gallon diesel fuel UST was decommissioned by removal south of the truck maintenance building (Figure 2). According to available information, the UST was emptied and removed from service in 1998 when the 550-gallon waste oil UST was decommissioned and had not been operated between 1998 and 2012. EPI personnel oversaw the UST decommissioning activities and collected nine (9) soil samples and a water sample from the excavation. The diesel contaminated water was reported in the water from the excavation and was reportedly rinseate from the UST that was spilled as the UST was removed from the excavation due to improper rigging and hoisting. EPI prepared the *Underground Storage Tank Site Assessment Report* (EPI, 2013a), dated January 4, 2013, for submittal to Ecology's Underground Storage Tank Division.

In October 2013, EPI performed a site investigation at Ecology's request. The investigation included advancing nine (9) direct-push soil borings DP-1 through DP-9 (Figure 2); five were located around MW-1 and four were located downgradient of MW-6. Laboratory analytical results indicated soil impacts around MW-1 were limited to location DP-3, which was immediately adjacent to the exterior wall of the

On August 26, 2016, EPI directed the advancement of two soil borings, designated BH-1 and BH-2 for soil sample collection, and construction of two conditional point of compliance (POC) monitoring wells, designated MW-7 and MW-8. BH-1 and BH-2 were advanced east of the former 12,000-gallon diesel UST to evaluate subsurface conditions immediately downgradient of the former UST. Well MW-7 was installed southeast and downgradient of the former 12,000-gallon diesel UST and existing well MW-6. Well MW-8 was installed northeast of MW-7, also downgradient of the former 12,000-gallon diesel UST and existing well MW-6. The purpose of the POC monitoring wells was to monitor groundwater conditions downgradient of the former 12,000-gallon diesel UST (EPI, 2017a). The soil boring and monitoring wells locations are presented on Figure 2.

On August 11, 2017, monitoring well MW-9 was installed by Holt Services near the northwest corner of the truck maintenance building (Figure 2). The additional well was requested by CRT as part of their environmental due diligence prior to their purchase of the property. Historical direct-push sampling data from this location indicated TPH-d and TPH-o was above MTCA Method A in a groundwater sample collected from the boring (EPI, 2017b).

In May 2014, EPI installed three shallow air injection (AI) wells at locations upgradient of MW-1 (Figure 2) to add dissolved oxygen (DO) to the groundwater. The increased DO concentrations in groundwater would stimulate existing aerobic bacteria by providing the oxygen necessary for those bacteria to metabolize dissolved petroleum hydrocarbons in groundwater at a higher rate.

SITE MAP
 QUARTERLY GROUNDWATER MONITORING REPORT - NOVEMBER 2021
 FORMER PROVISIONERS EXPRESS FACILITY
 2102 WEST VALLEY HIGHWAY NORTH, AUBURN, WASHINGTON

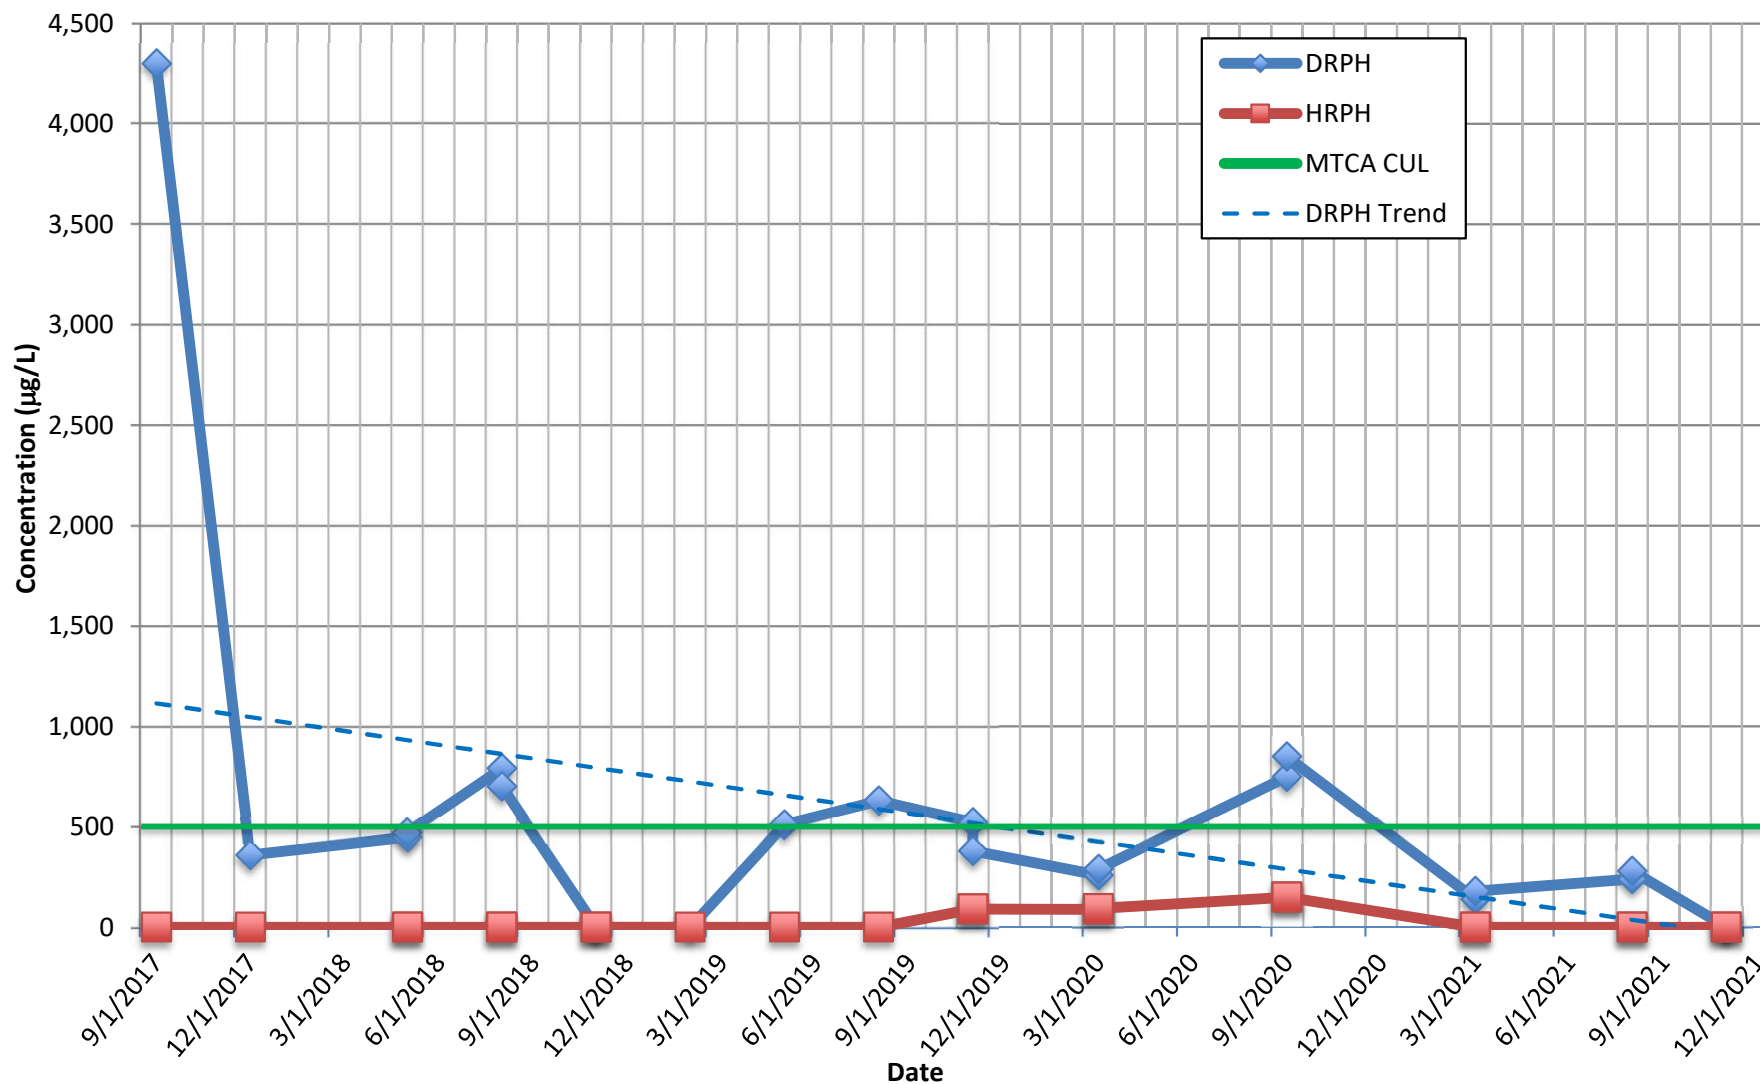
MW-9 DRPH and HRPH Concentration Time Series

In Ecology's Opinion Letter dated December 20, 2018 (Ecology, 2018) groundwater analysis trend charts were requested for monitoring wells MW-1, MW-3, MW-6, MW-8, and MW-9. Currently, only MW-9 is being monitored. A copy of the groundwater analysis trend chart for MW-9 is provided as Attachment C. The trend chart indicates the following:

- Laboratory analyses for samples collected from MW-9 indicate an overall declining trend since well installation in September 2017. TPH-o has never been reported in groundwater samples collected from MW-9 at concentrations above the MRL. Groundwater quality data for TPH-d were compliant with Ecology MTCA Method A during the August and November 2021 monitoring event.
