## TECHNICAL MEMORANDUM: Sub-Slab Soil Vapor Assessment

| Project Name: | West View Mart | Date: | August 20, 2021 |
| Subject: | Sub-Slab Soil Vapor Assessment | Prepared By: | Zipper Geo Associates, LLC (ZGA) |

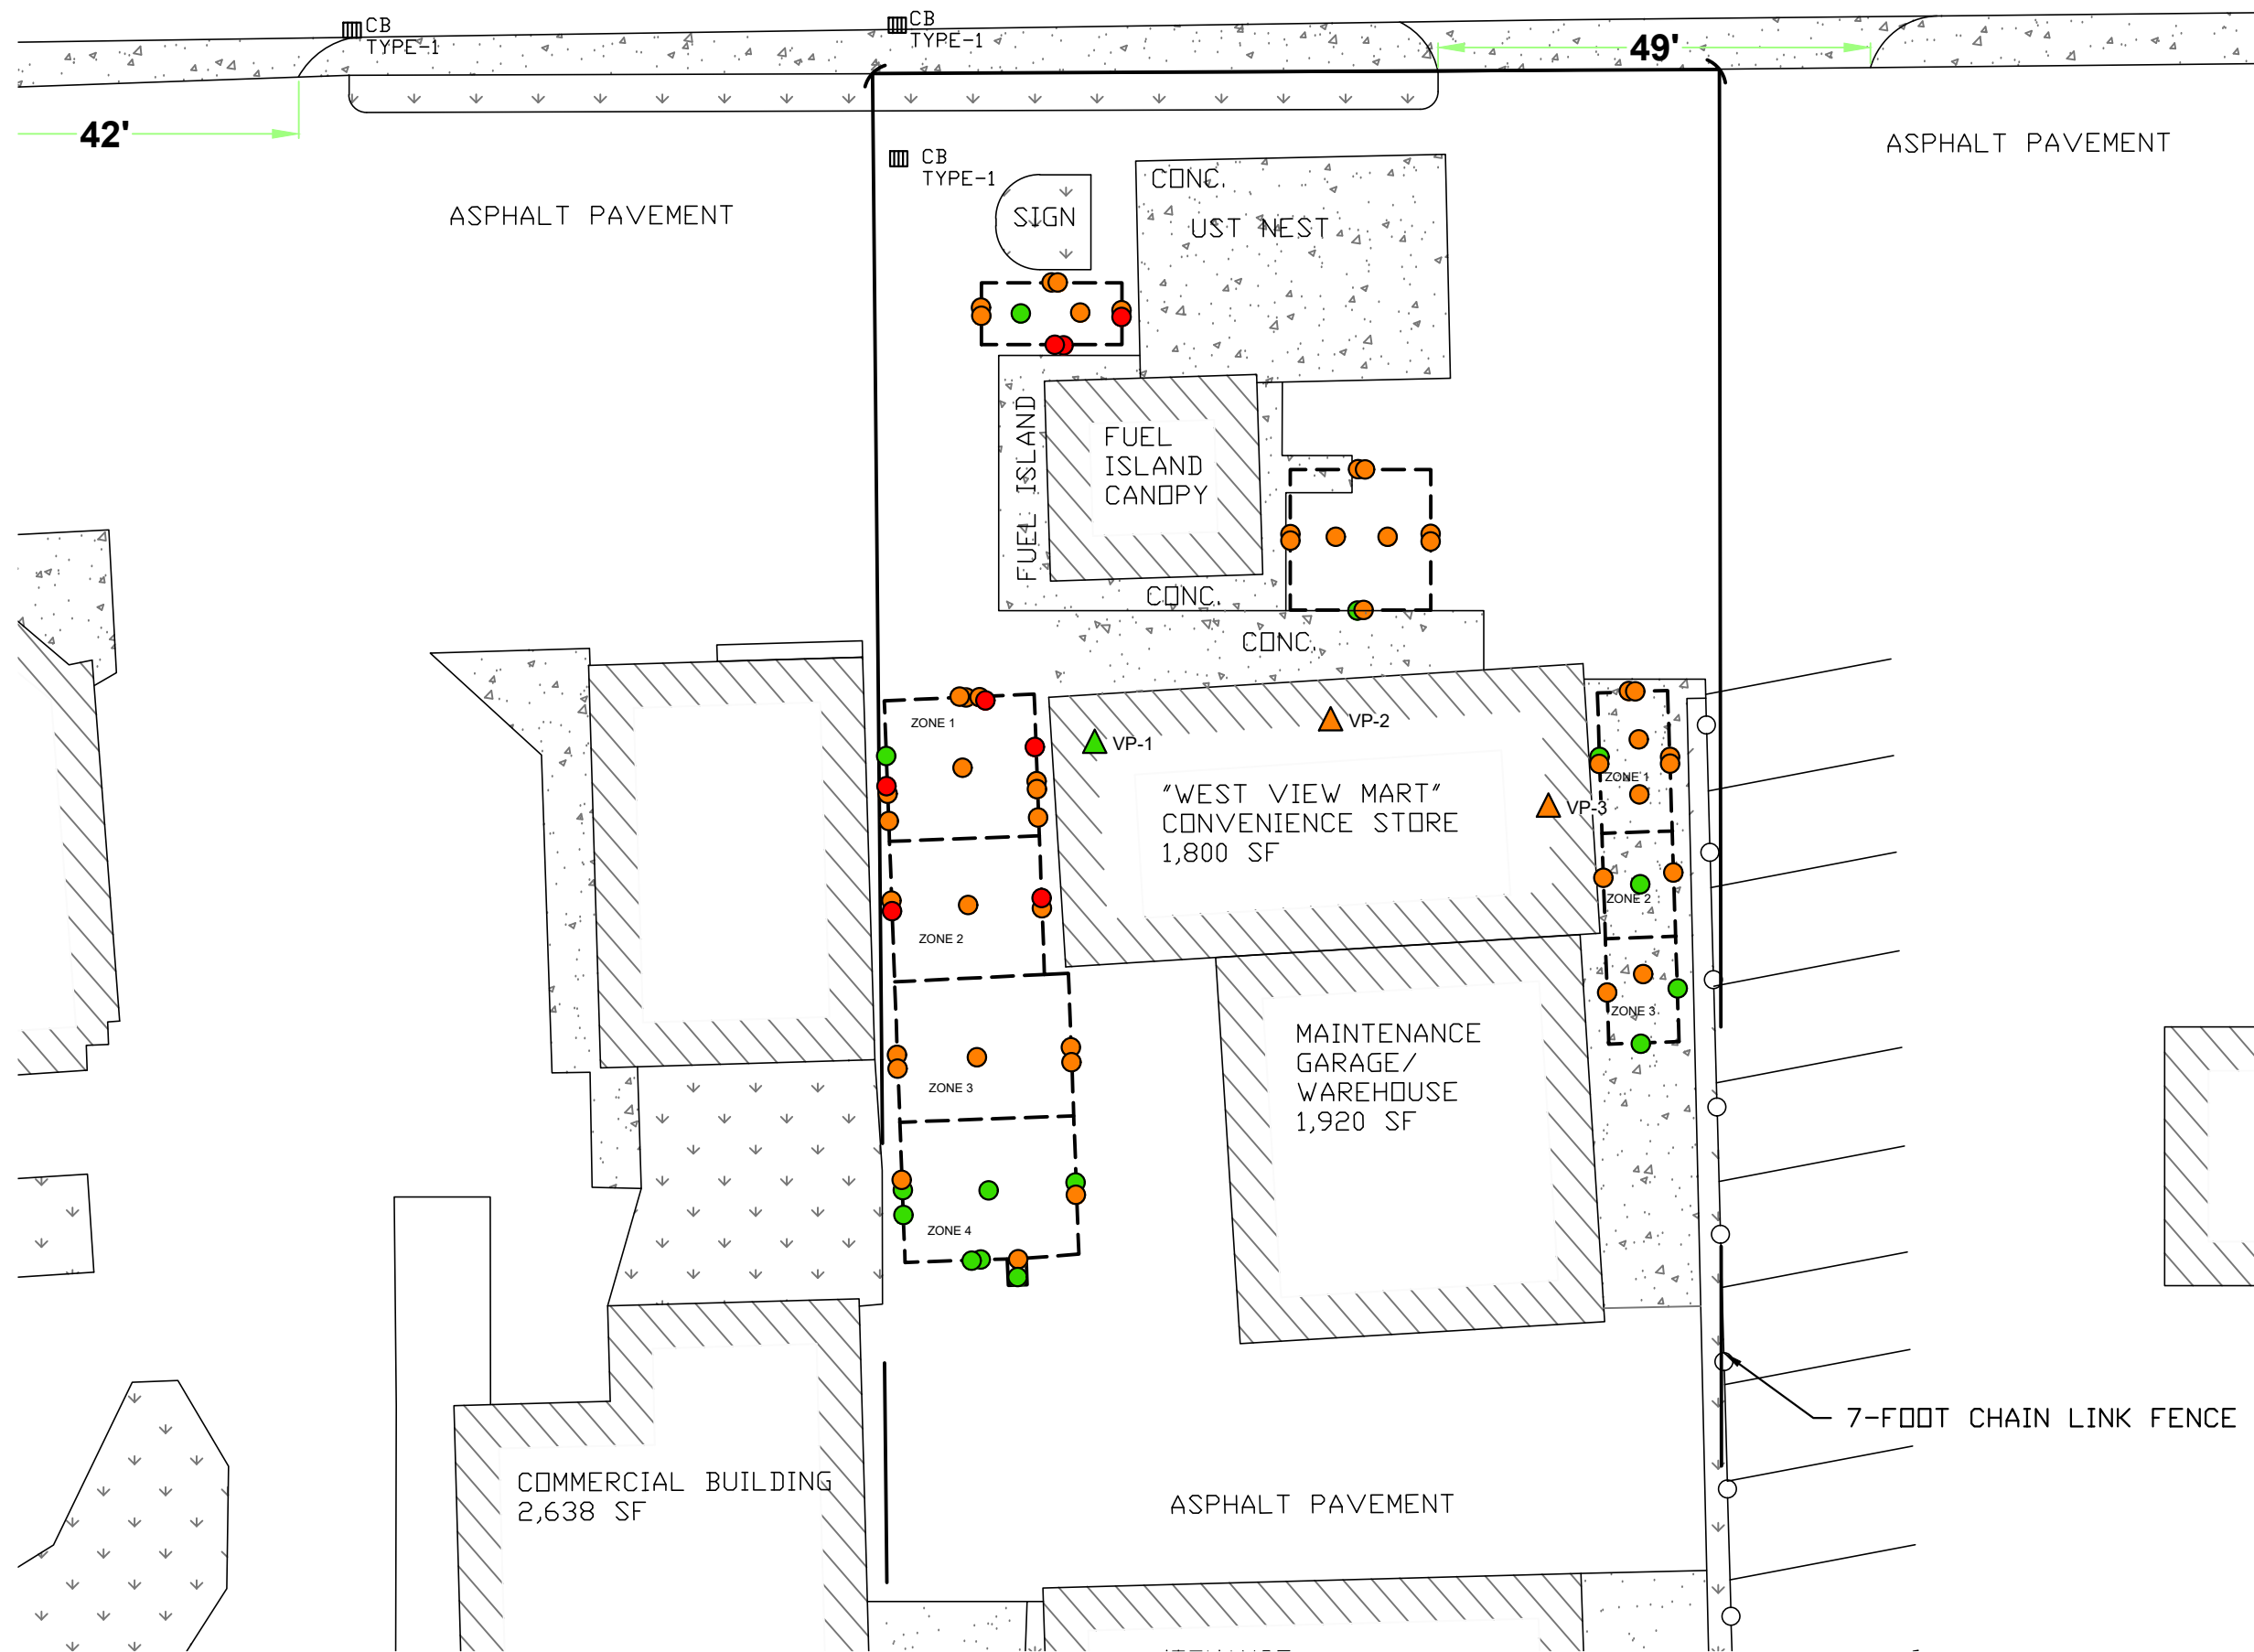
| Zipper Geo Associates, LLC<br>19019 36th Ave. W., Suite E<br>Lynnwood, WA | FIGURE | 1 |

▲/▲/▲ APPROXIMATE LOCATION OF SUB-SLAB SOIL VAPOR SAMPLE

●/●/● APPROXIMATE LOCATION OF POST-REMEDATION SOIL SAMPLE

| POST-REMEDATION SOIL RESULTS AND<br>SUB-SLAB SOIL VAPOR RESULTS<br>(SSSV JULY 29, 2021) | | |

Laboratory results are summarized on Table 1. Except for benzene, reported concentrations of chemicals of concern were compared to Default MTCA Method B Sub-Slab Screening Levels as presented by the Washington State Department of Ecology's (Ecology's) Cleanup Level and Risk Calculation (CLARC) resource page. Reported benzene concentrations were compared to a Modified MTCA Method B Screening Level adjusted for a commercial exposure scenario (10 hours/day for 250 days compared to default residential scenario of 24 hours/day for 365 days). Our Modified MTCA Method B Screening Level for benzene was calculated using parameter values derived from MTCA Equation 750-2 and the CLARC database. The Modified Method B Screening Level for benzene calculated by ZGA is  $35.61 \mu\text{g}/\text{m}^3$ .

- Benzene was detected at a concentration of  $2.1 \mu\text{g}/\text{m}^3$  in sample VP2-20210729. This concentration does not exceed the Default Method B Screening Level for benzene of  $11 \mu\text{g}/\text{m}^3$ , nor does it exceed the Modified Method B Screening Level for benzene of  $35.61 \mu\text{g}/\text{m}^3$ .
- Benzene was detected at a concentration of  $19 \mu\text{g}/\text{m}^3$  in sample VP3-20210729. This concentration exceeds the Default Method B Screening Level for benzene of  $11 \mu\text{g}/\text{m}^3$  but does not exceed the Modified Method B Screening Level for benzene of  $35.61 \mu\text{g}/\text{m}^3$ .

ZGA has completed a SSSV assessment in general accordance with the scope of services outlined in our Work Plan dated July 23, 2021. Three SSSV samples were collected from VaporPins installed in the West View Mart building proximal to PCS identified in remedial excavation sidewalls. Laboratory analysis of three SSSV samples determined that contaminants of concern (COCs) were either not detected above laboratory RDLs or did not exceed applicable, risk based, MTCA Method B Sub-Slab Screening Levels for SSSV. Therefore, we conclude that residual PCS beneath the West View Mart building does not pose a vapor intrusion risk to the building's occupants under a commercial exposure scenario.

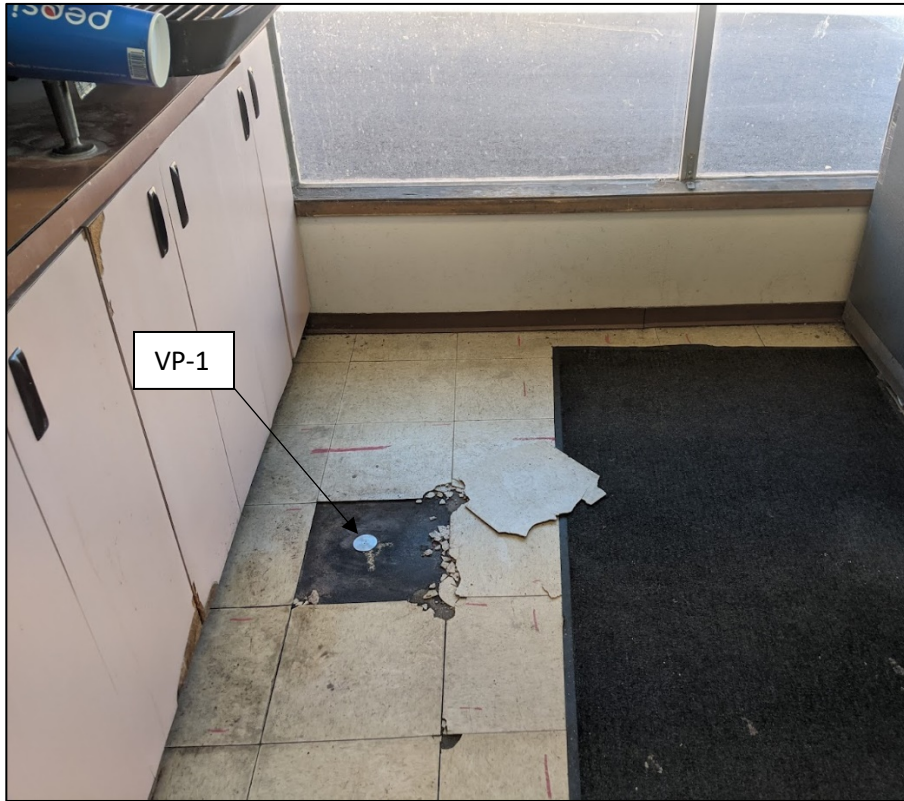
Photo #1.

View facing west towards VP-1 equipped with a flush mount monument.

VaporPins consist of a stainless-steel sampling device with a protruding hose barb that is installed through the building's slab to allow for collection of SSSV. Each VaporPin is installed into a ½-inch diameter slab penetration, which was created by ZGA with a roto-hammer. The annular space between the VaporPin and the surrounding concrete slab is sealed by an expanding silicone sleeve. Each VaporPin is equipped with a screw-on, flush-mount

monument to protect the VaporPin and allow for resampling, if necessary. A representative photograph of a VaporPin after installation is provided as *Photo. #1* in the enclosed photograph appendix.
