# MEMORANDUM

Project No. 100094

**Re: Crownhill Elementary School Site: Garden Inspection**

**Site Plan**  
Crownhill Elementary School Site  
Garden Inspection  
Bremerton, Washington

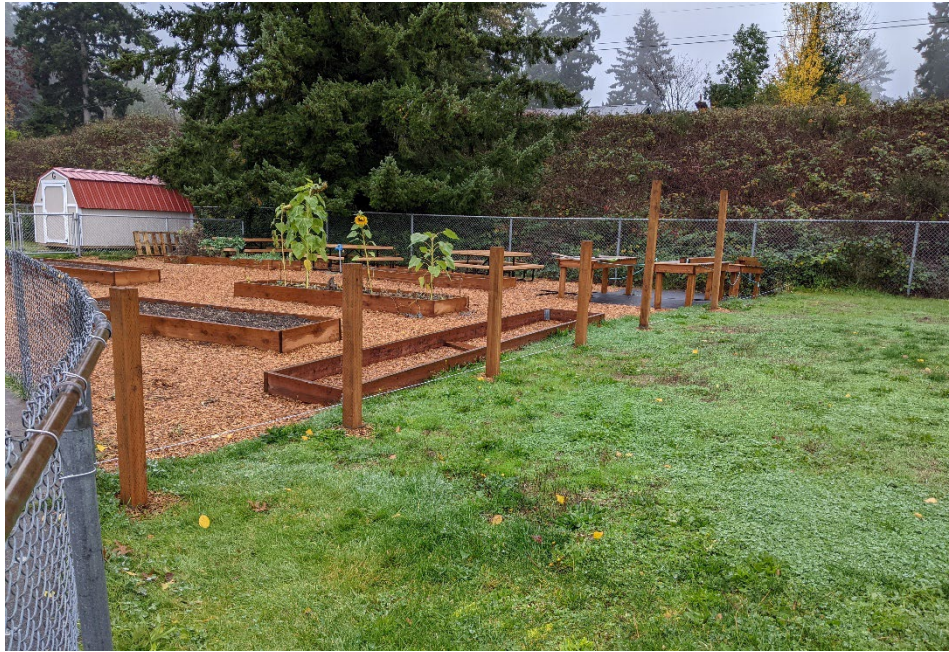
A new garden area is being installed at Crownhill and consists of several raised garden beds, tables, garden hoses, and a layer of woodchips (See Photograph 1). On Monday, October 18, 2021, Teneka Morley (Principal at Crownhill Elementary School) first observed the fence posts, notified David Herrington, and Garth Steedman with BSD, who then interviewed the volunteer who installed the fence posts. The garden area is located within the Environmental Covenant Area, therefore invasive soil work is prohibited according to Agreed Order No. DE11107.

**Photograph 1. Fence posts and garden area, facing northeast.**

Ecology issued its decision on the garden area on December 22, 2021, which is attached for reference. It recommends that the garden fence posts be removed, the soil cap restored to its original condition, and the garden beds replaced with containers that prevent contact with the ground (pending approval by Ecology).

Ecology recommends that the garden beds and fence posts be removed to ensure the original containment portion of the remedy (soil cap with institutional controls) remains protective of human health and the environment. The raised beds should be removed and the original soil cap restored to bring it back to its original condition before the garden was cultivated. The fence posts should be removed and clean soil returned to the post holes. The school district may propose alternatives for the garden such as a container garden, in which plants are grown in soil that is completely contained, where neither garden soil nor roots will contact the ground.

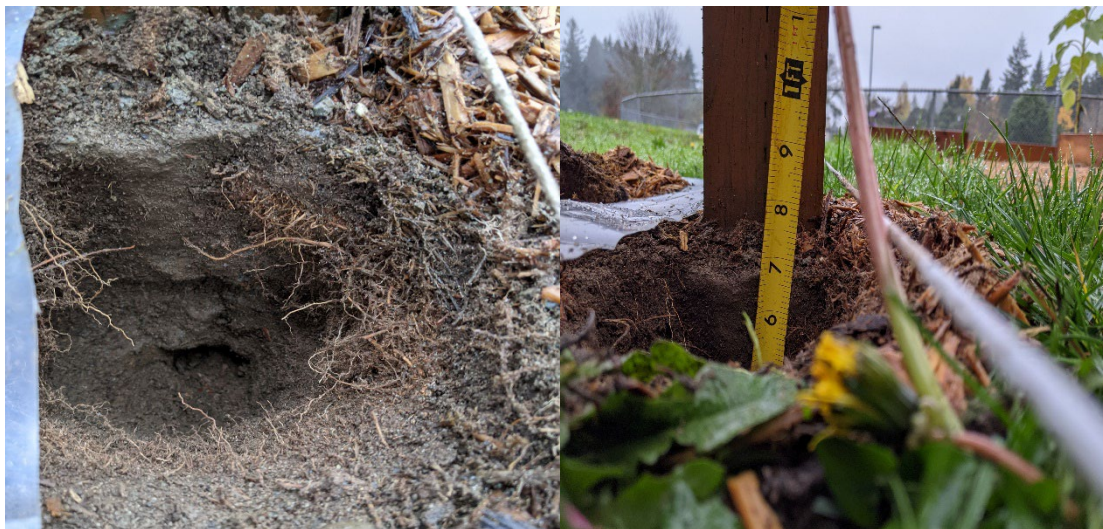
- All fence-post holes were dug to less than 1 foot deep within the clean soil cover. They do not fully penetrate the cover, nor was any geotextile encountered, and the posts were installed outside of the geotextiled areas constructed during the 2013 Interim Action.
- The soil cuttings from the clean soil cover were mixed with other soils at the volunteer's home and are not recoverable.
- The garden area is covered with wood chips and consists of raised garden beds, tables, and garden hoses. No part of the garden was observed to penetrate the clean soil cap.
- There are no prohibitions against growing vegetables in the Agreed Order.

Aspect conducted a site investigation on November 11, 2021, to document the fence construction and the conditions of the garden area. An Aspect field representative dug down to the base of each fence post with a shovel to confirm the installation depth with a measuring tape. There were six fence posts installed and all of them were observed to be installed to depths ranging from 0.7 to 0.85 feet below ground surface (bgs). Each 4x4-inch wooden post appears to have been installed by digging a hole about 6 inches in diameter and cementing in place using concrete. All soils dug up during this inspection were briefly stored on plastic sheeting and replaced immediately afterwards before moving to the next post. Disturbed soils were tamped down and woodchips were replaced on top.

**Photograph 2. Depth of post holes and concrete.**
