UNDERGROUND STORAGE TANK REMOVAL AND SITE ASSESSMENT REPORT

5400 Airport Way South
Seattle, Washington

May 2015

Project No. 0146970060

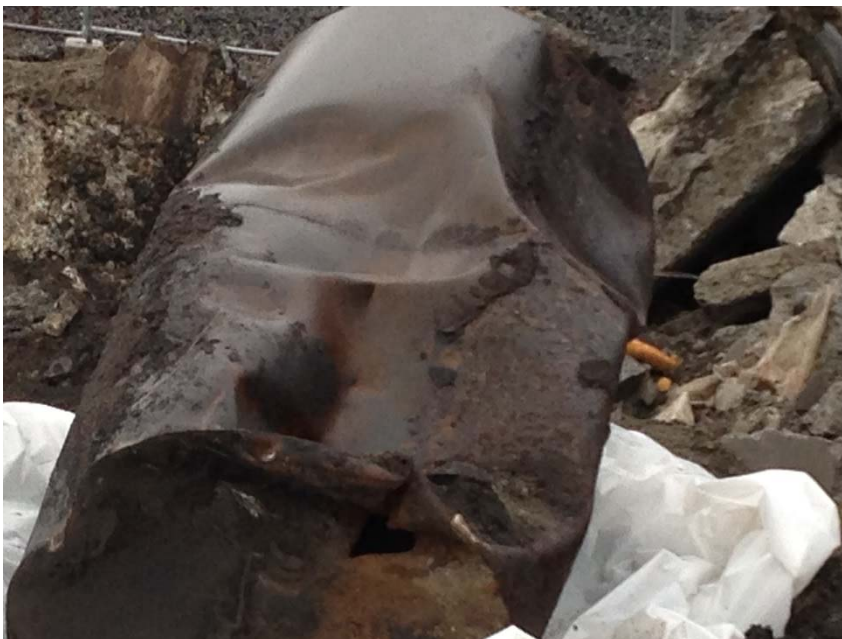
Photograph 1 Close-up of the underground storage tank (UST) after moving to temporary staging area.

Because the tank was hit inadvertently with a large excavator, the tank was dislodged and was partially damaged. Upon inspection, a small quantity of fluid was visible through a hole ripped in the top of the tank, and several small pin-holes were visible through the rusted metal tank walls. The fluid in the tank appeared to be rusty water, and some of it was observed leaking through the pin holes in the lower portion of the tank walls. To prevent further releases from the tank, the tank was carefully moved with an excavator and placed onto a visqueen liner in a shallow containment berm. Later in the day on March 5, the contents of the tank and the visqueen containment berm were pumped out by Ingenium, a waste disposal company based in Kent, Washington. The tank liquids were pumped into a 55-gallon drum, which was labeled and left on site for later removal.

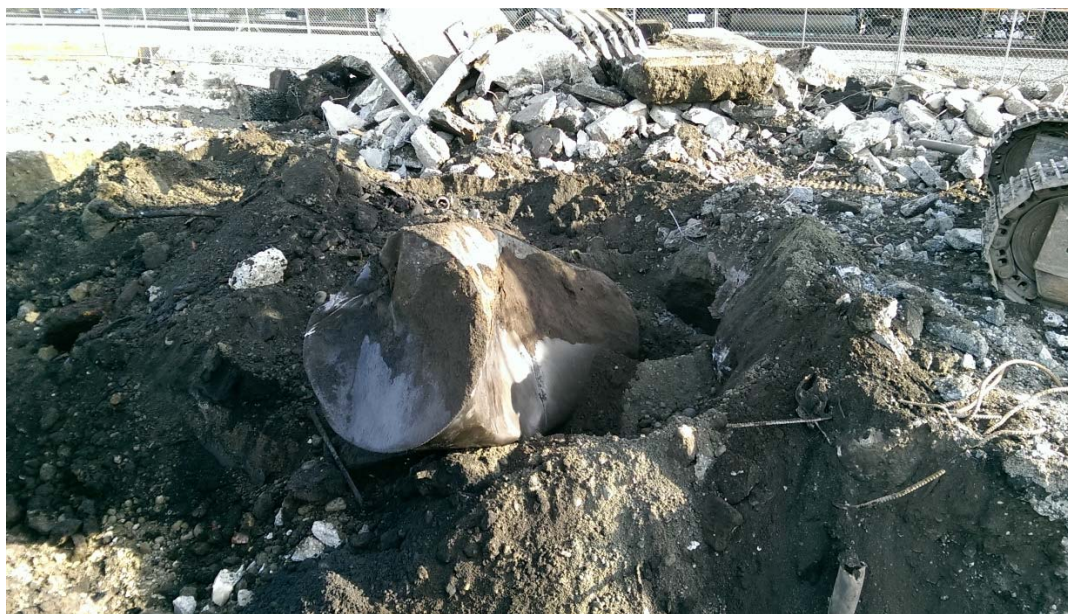
Photograph 2 UST after discovery on March 5, 2015. View is to the east.

The UST was discovered on March 5, 2015. Ecology UST staff were immediately notified via telephone. On the same day, additional information was sent to Mr. Andrew Imke of Ecology regarding property and UST ownership, including details on the construction and capacity of the tank and the Site Assessor and UST Decommissioning license numbers of the Amec Foster Wheeler field supervisor. Due to the unplanned nature of the UST discovery, Mr. Imke granted a waiver of the 30-day waiting period normally required prior to decommissioning a UST. A copy of the waiver of the 30-day notice requirements is included in Appendix A.

The UST was located approximately 5 feet east of a series of underground pipes that were awaiting removal, along with associated petroleum contaminated soil. These pipes were left in place following the decommissioning of nine USTs in 2009 (AMEC Geomatrix, 2010). The pipes could not be removed completely at that time because they ran beneath a building. That building was demolished in February 2015, allowing for the remaining piping and associated contaminated soil to be removed (Figure 2). Because the UST was covered by two separate concrete slabs, the tank is assumed to predate the buildings constructed above it. There was no piping connected to the UST or in the immediate vicinity. Soil surrounding the tank is a sandy fill material.

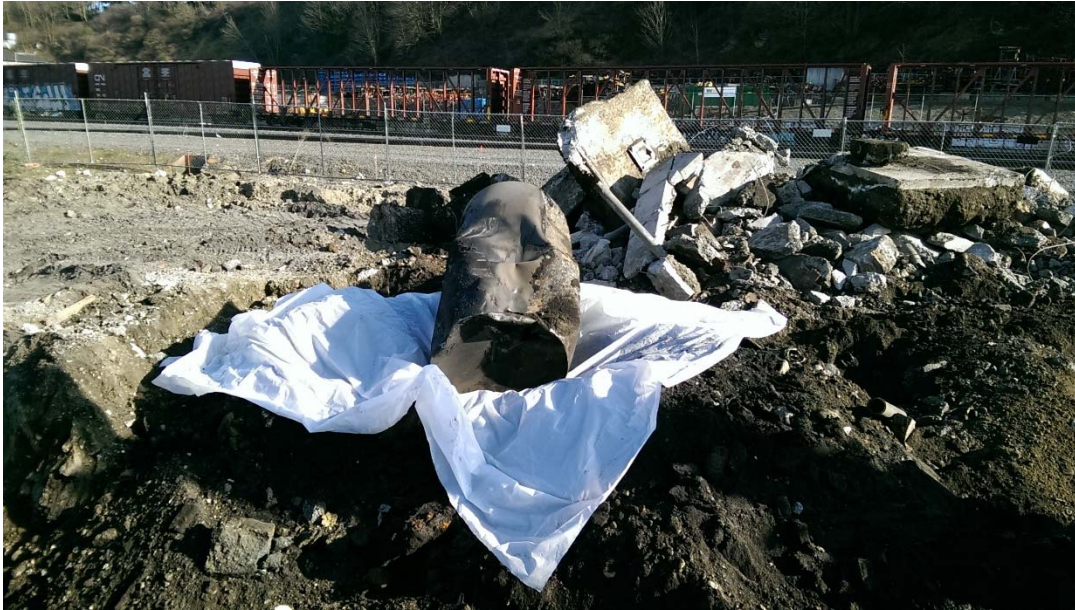
Photograph 3 UST after moving to temporary staging area. View is to the east.
