# SEMMATERIALS L.P. SPOKANE SITE REMEDIAL INVESTIGATION/ FEASIBILITY STUDY REPORT

***Public Review Draft***

Prepared for: SemMaterials Potentially Liable Persons Group

Project No. 090190-003-07 • January 31, 2013

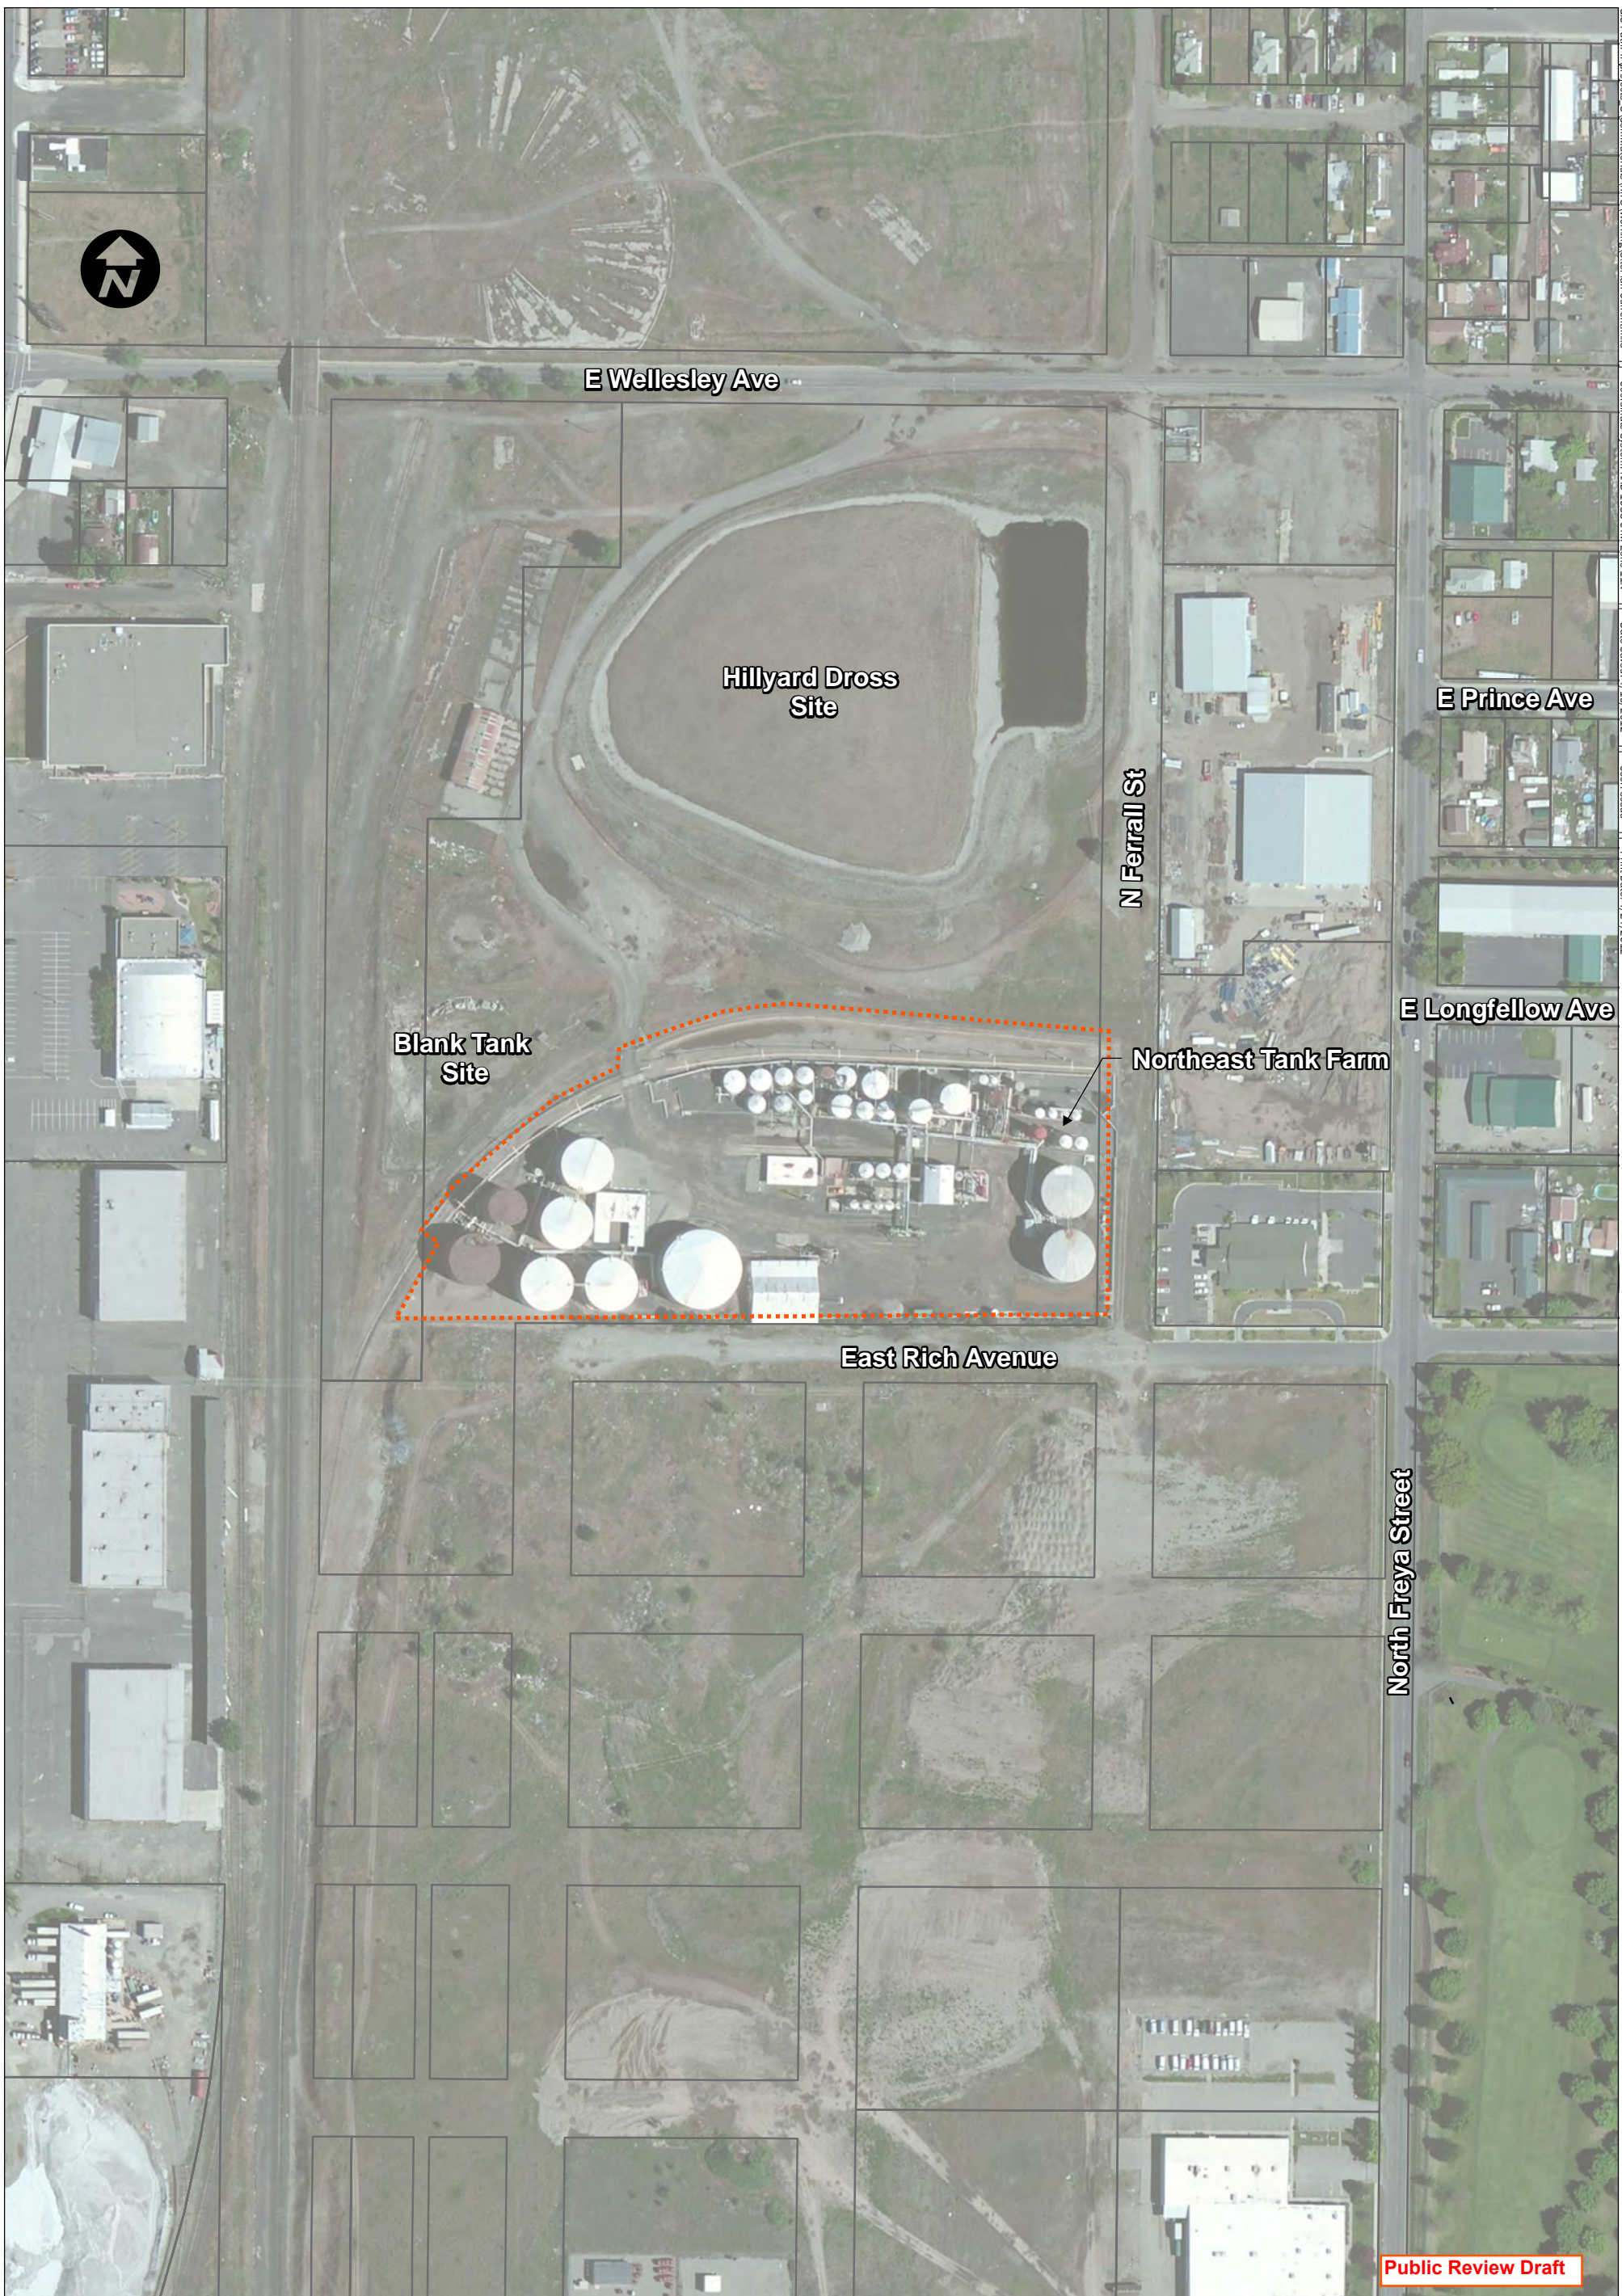
FIGURE NO.  
**2.3**

The Hillyard Dross and Black Tank sites are located immediately downgradient of the SemMaterials Site. The locations of these sites are illustrated on Figure 2.3 and details about the sites are provided in the subsequent sections. No CSCSs or Leaking Underground Storage Tanks (LUSTs) were identified within 1 mile upgradient of the Site. Therefore, there appears to be little potential for subsurface contamination to migrate to the Site from known upgradient sources.

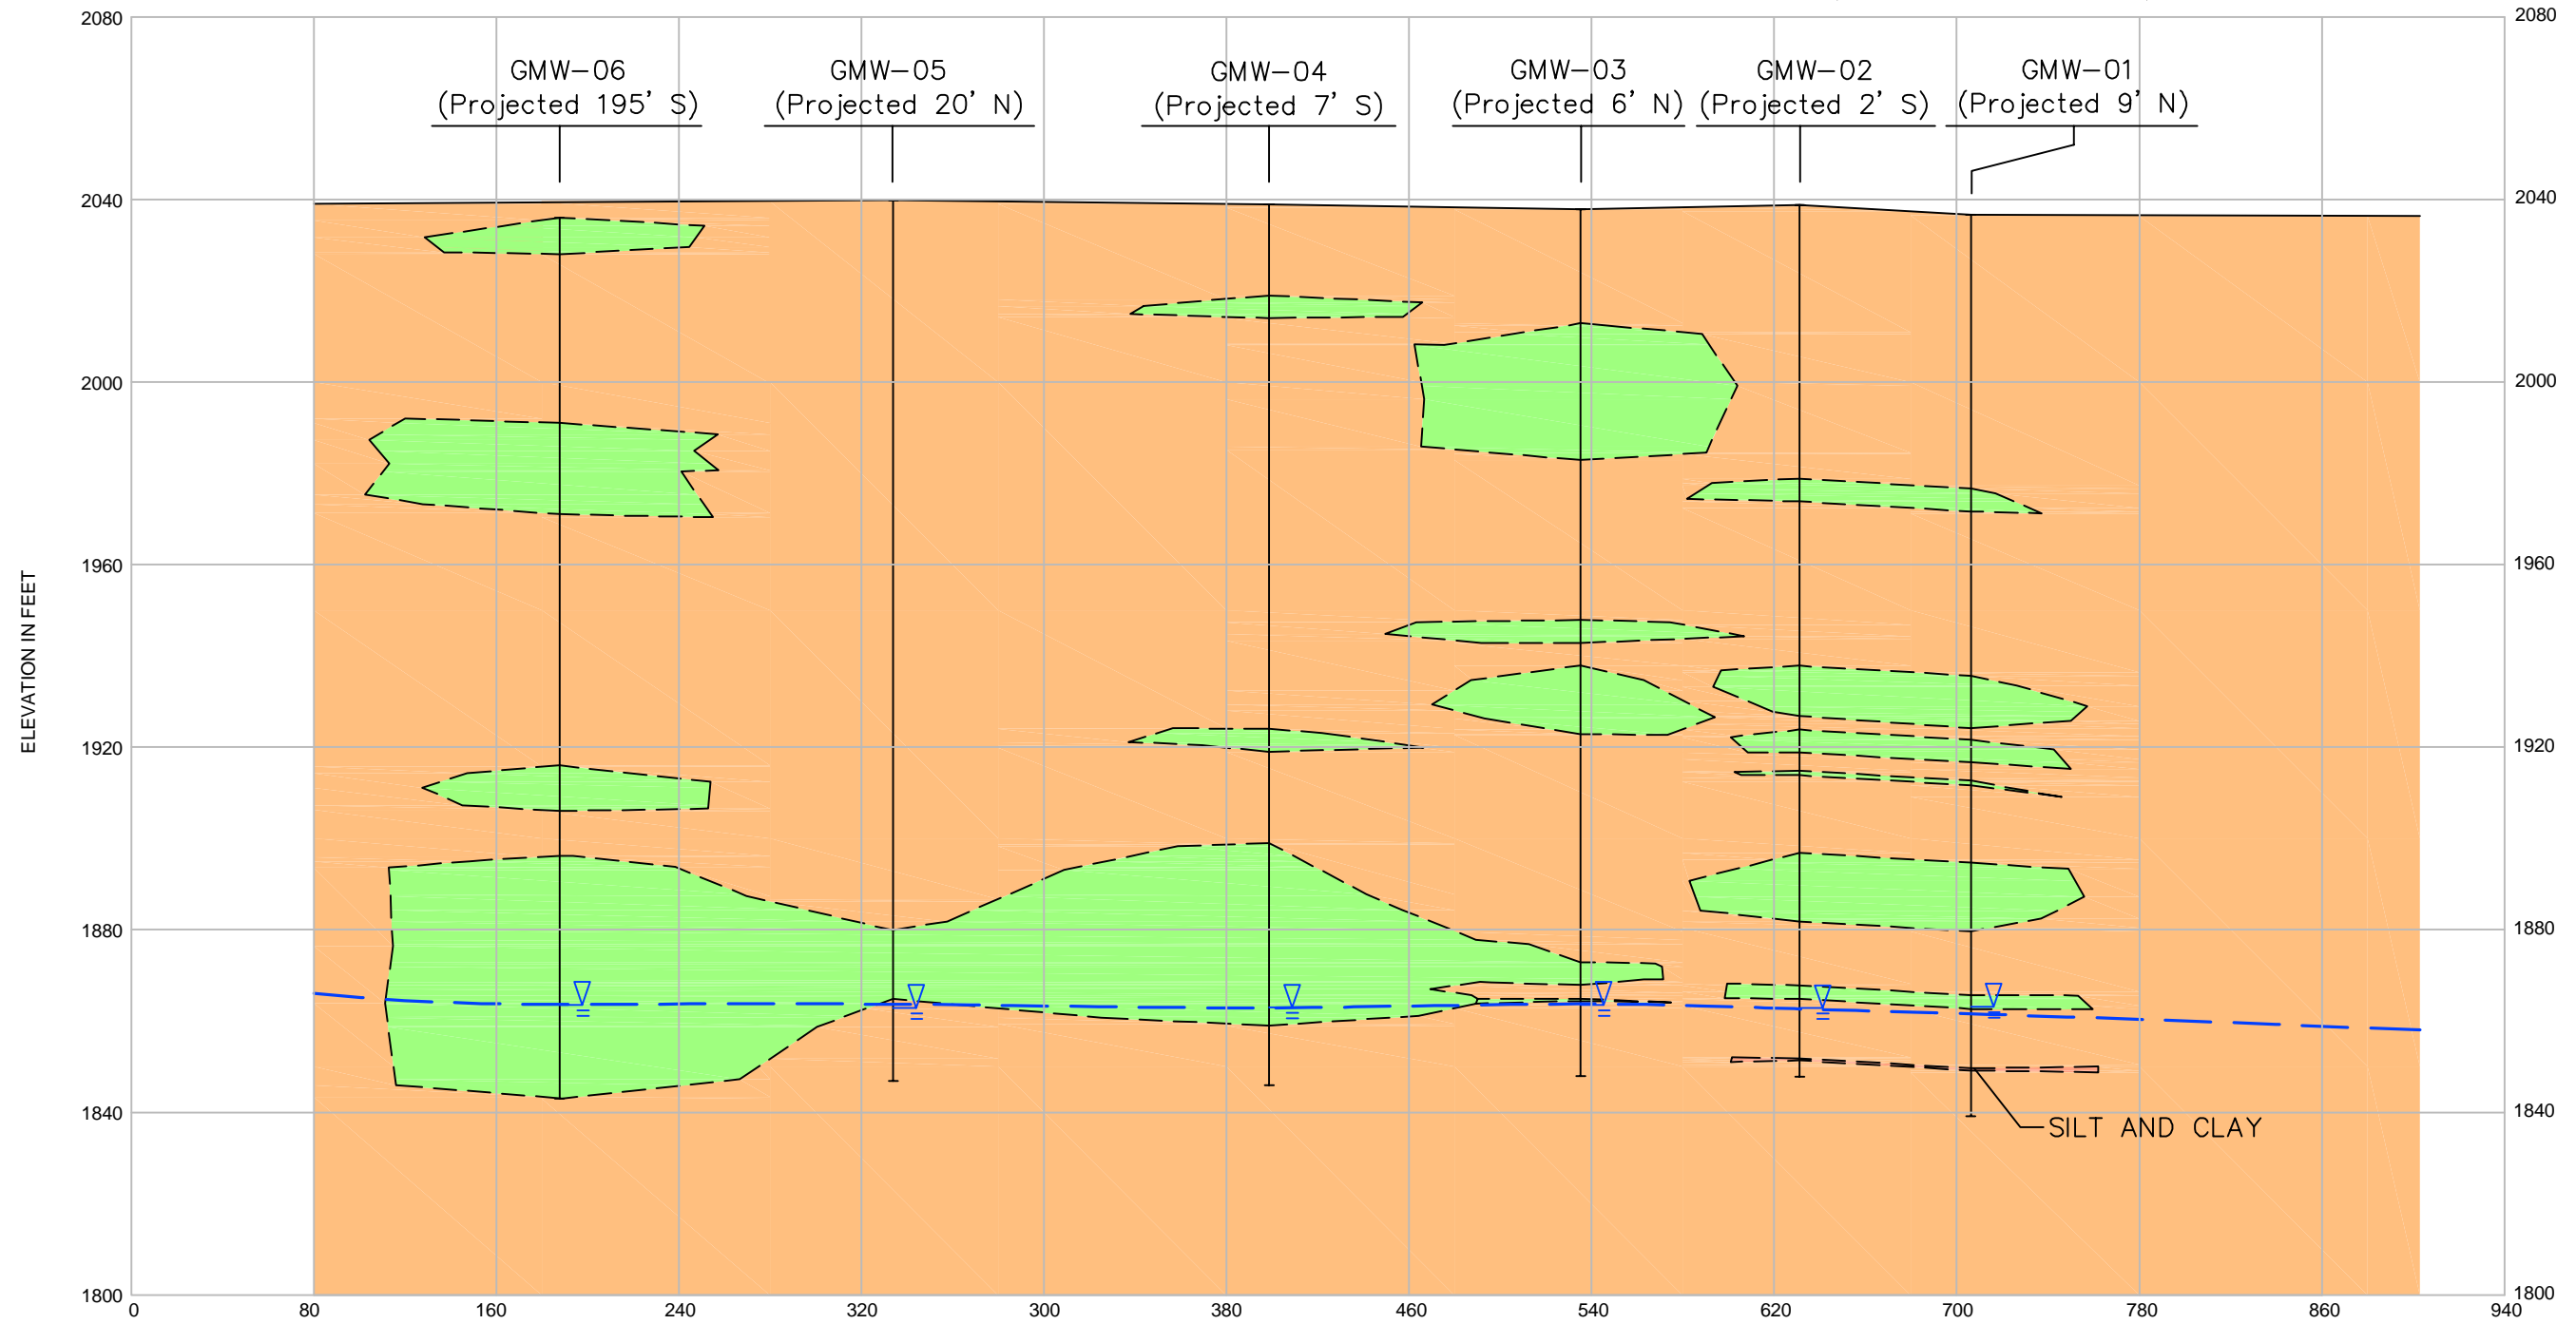
FIGURE NO.  
**3.1**

Results of the RI at the Site confirm the presence of the glaciofluvial deposits that comprise the SVRP aquifer. The soil boring and well construction logs from the RI are presented in Appendix B. Based on these logs, a geologic cross section of the Site is presented on Figure 3.1, with the location of the cross section presented on Figure 2.4. Based on the boring logs, the glaciofluvial deposits in the vicinity of the Site consist of loose, grey, fine to coarse gravel with cobbles, silt, and sand to depths of between 60 and 120 feet bgs. The amount of silt and sand observed generally increased with depth, with beds of fine to coarse sand encountered throughout each of the borings. Between approximately 85 and 197 feet bgs the glaciofluvial deposits generally consisted of loose, brownish-gray fine to coarse sand with silt and fine gravel. Beds of gravel were also occasionally encountered from 85 to 190 feet bgs. In borings MW-1 and MW-2, a silt lens was encountered between a depth of 172 and 174 feet bgs and a clayey silt lens was encountered at a depth of 187.0 to 187.5 feet bgs.

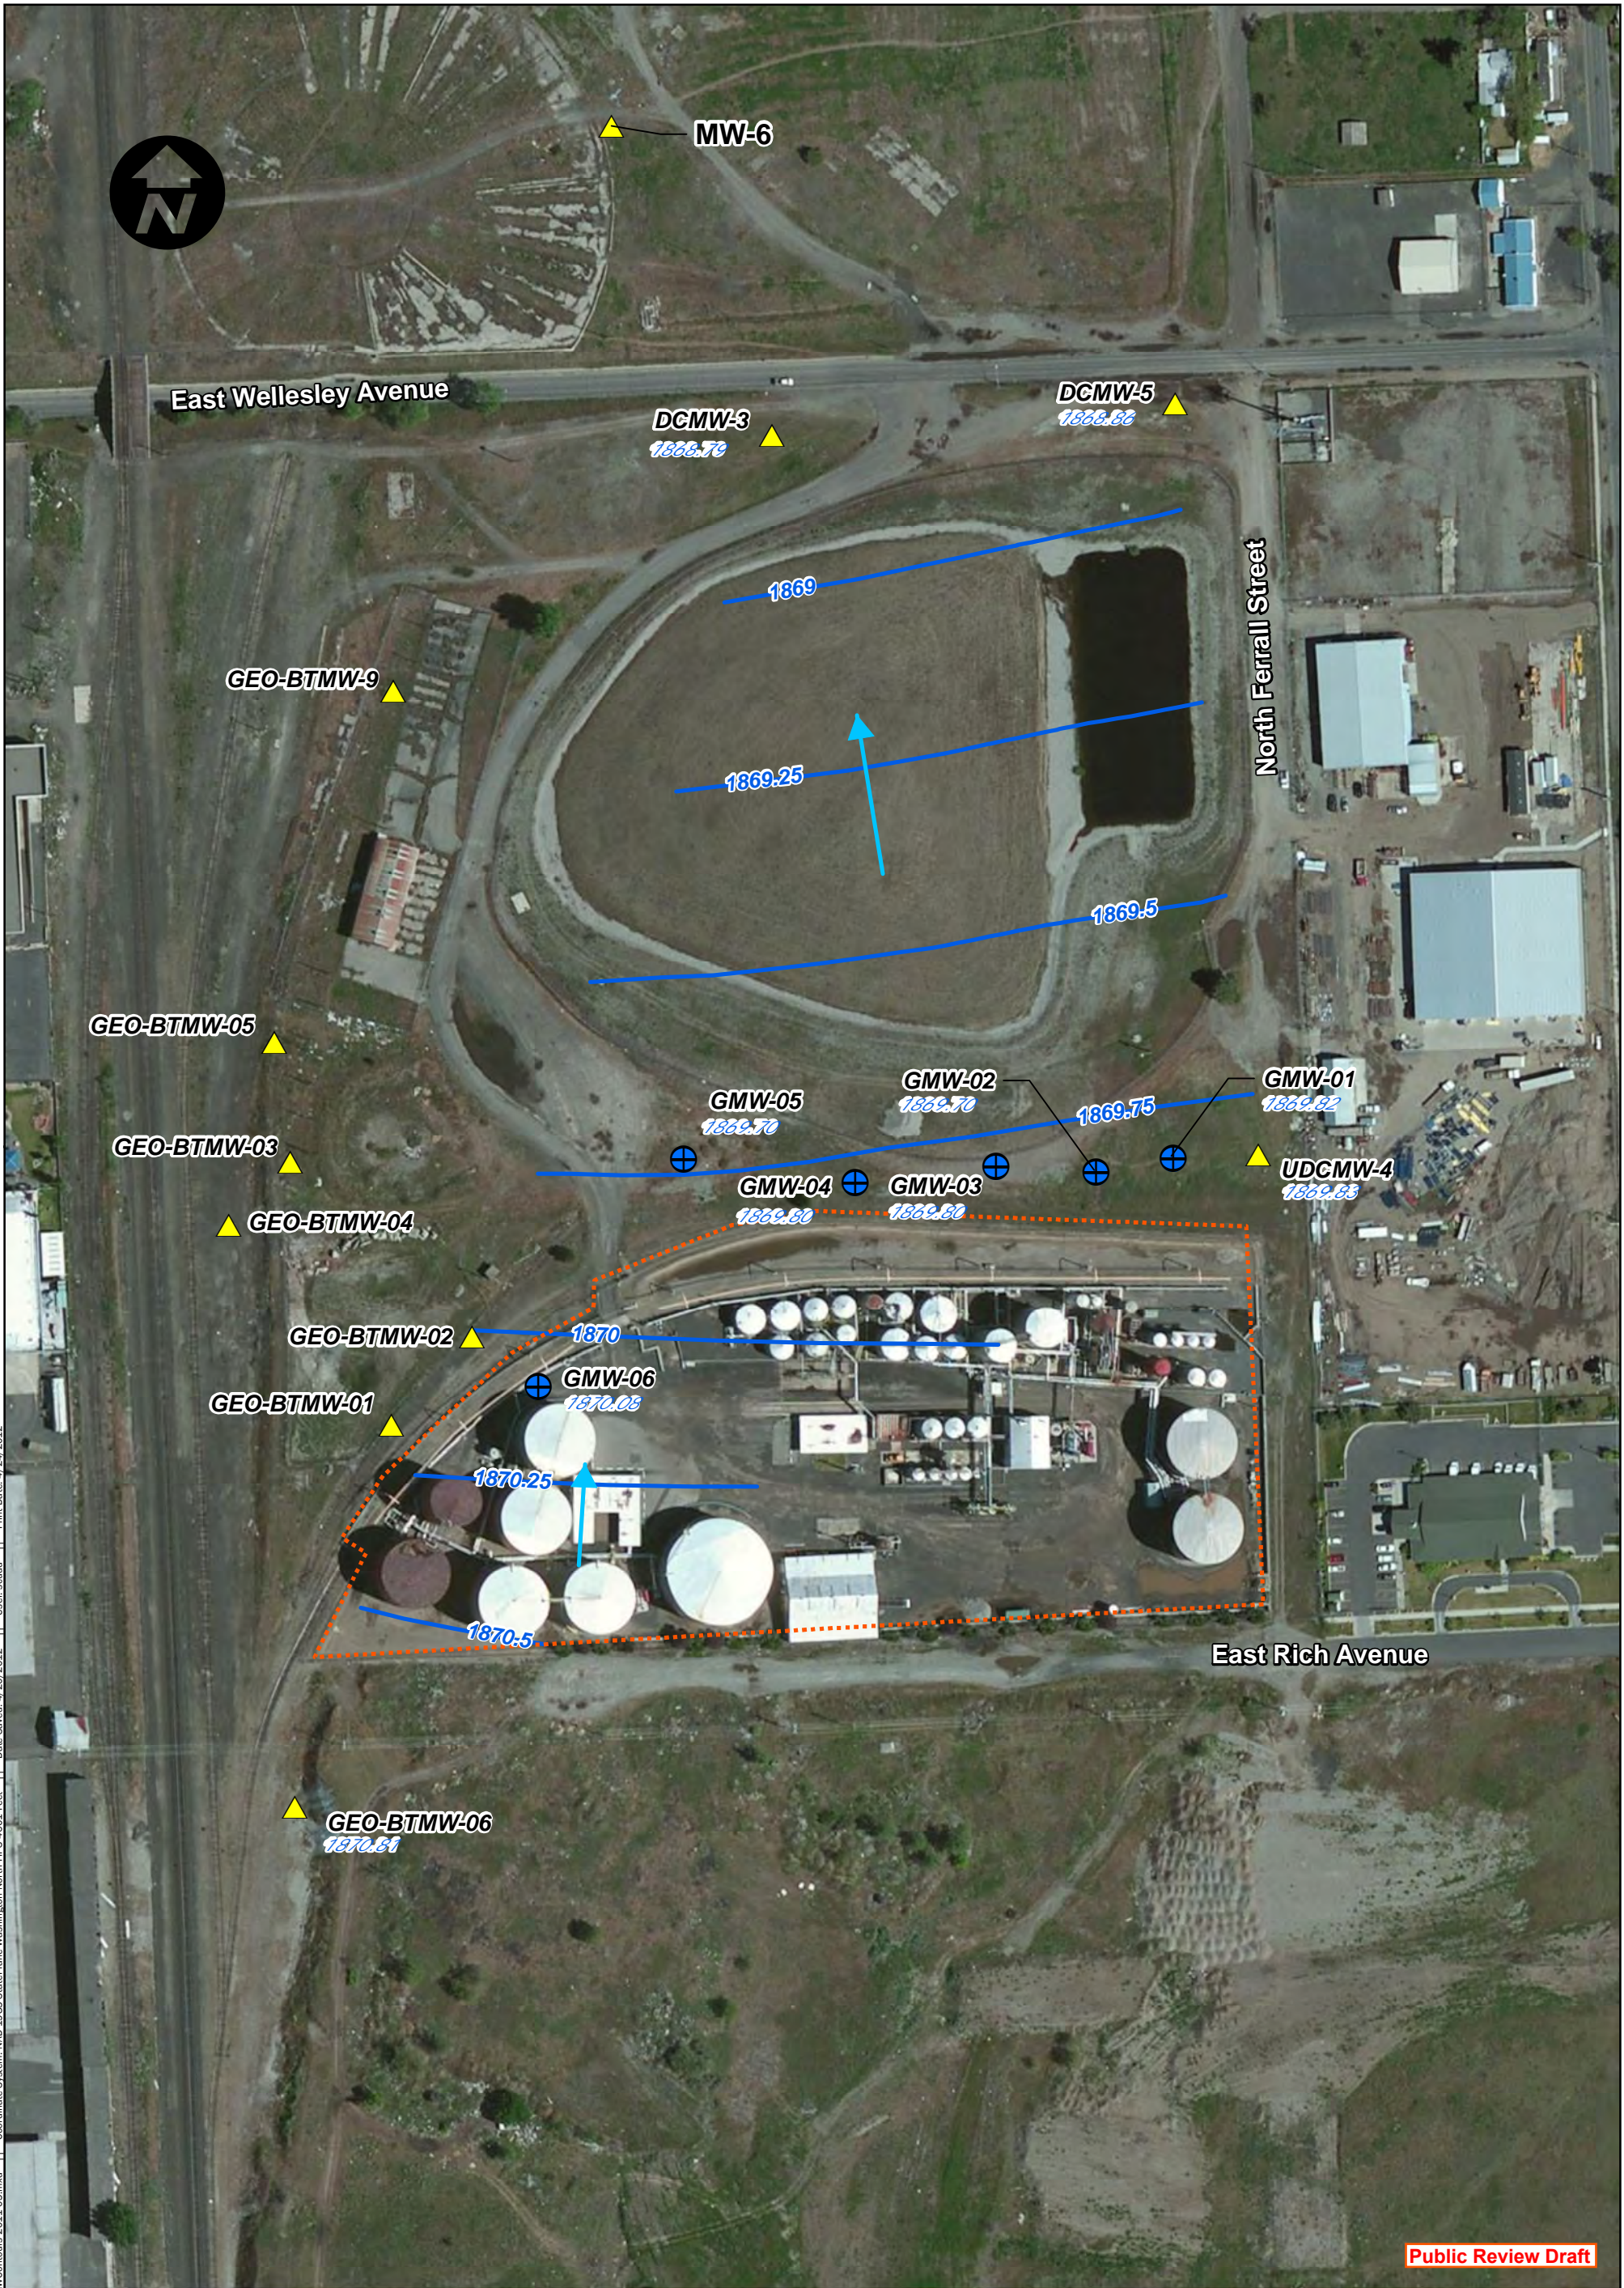
**Figure 3.2**  
**Groundwater Hydrographs**  
SemMaterials L.P. Spokane Site RI/FS  
Spokane, Washington

Groundwater levels were monitored at the Site during both Phase I and Phase II of the RI, and are summarized in Table 3.1 and shown on Figure 3.2. Groundwater levels in May 2011 ranged between 165.6 feet bgs (GMW-06) and 172.8 feet bgs (GMW-05). Seasonally, groundwater levels vary between 5 and 7 feet, with the highest groundwater levels generally occurring in spring (April or May) and the lowest groundwater levels generally occurring in late summer or fall (August or November).
