BLUE SAGE ENVIRONMENTAL, INC.  
*Environmental Project Management*

RE: Curt Heikell Property, VCP Project No.: CE0350  
Cleanup Work Plan Summary

**TITLE** Curt Heikell Property  
Cle Elum, WA  
Areas with Petroleum Hydrocarbon Spills

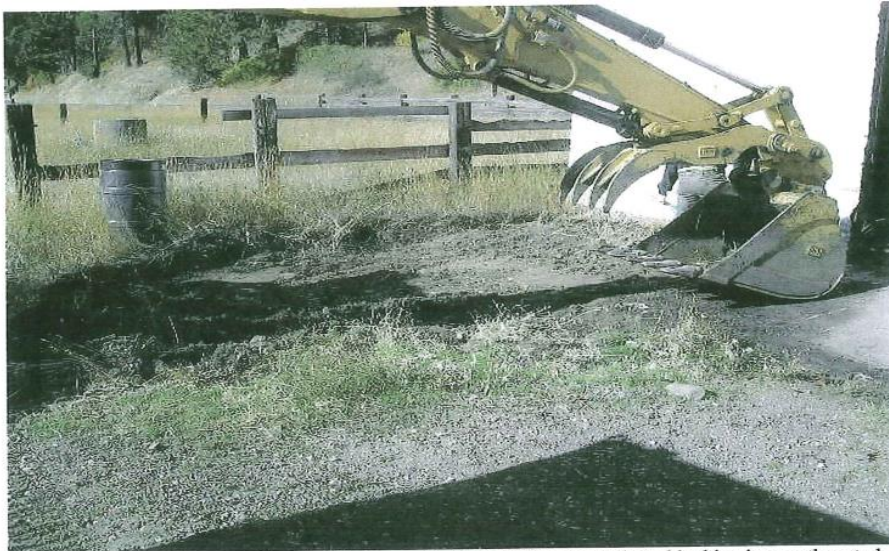
DWG. NO.  
**Photo 1**

Petroleum hydrocarbon contaminated soil was removed from stained area #1 in 2011 (**Photo 1**) by Able Cleanup Technologies, Inc. (ACT). Soil samples SAO-1, SAO-1A, and SAO-1B were collected (**Figure 2**) at 2 feet below ground surface (bgs). SAO-1A and SAO-1B were analyzed for diesel range organics (DRO) by method NWTPH-Dx and carcinogenic polycyclic aromatic hydrocarbons (cPAH) by method 8270. No concentrations of diesel/lube oil were detected above their MTCA Method A cleanup levels (CUL). Sample SAO-1B detected an elevated concentration of cPAH (0.018 mg/kg) above the CUL. No groundwater was present in the shallow excavation.

This picture shows the excavation at stained area #1. This picture was collected looking in a northwesterly direction.

Additional removal of potentially contaminated soil will be done in stained area #1 next to the building (reference soil sample CH-SAO-1B, elevated cPAH). This area will be resampled following this cleanup action.

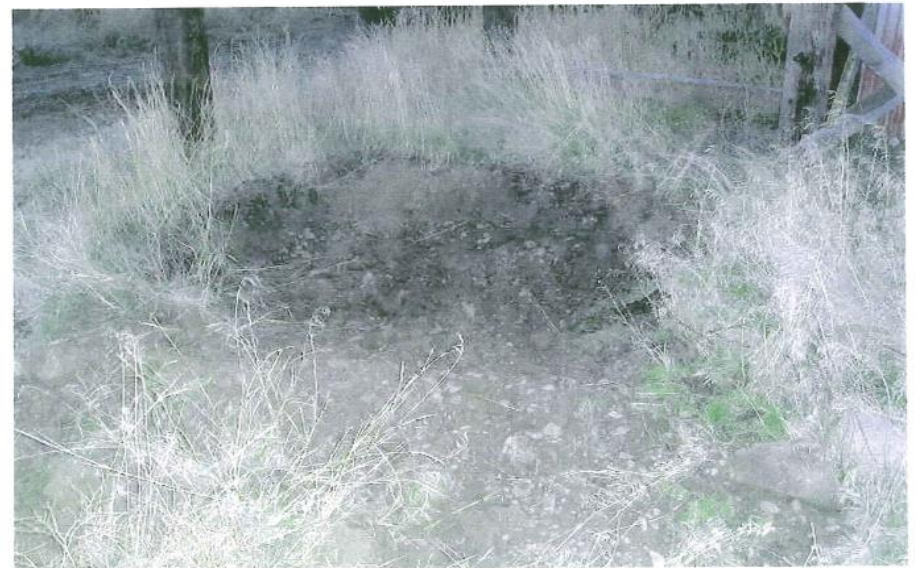
Petroleum hydrocarbon contaminated soil was removed from stained area #2 in 2011 by ACT (**Photo 1**). A single soil sample, CH-SAO-5, was collected from the excavated area at a depth of 3 feet bgs (**Figure 2**). No groundwater was present in the shallow excavation. This sample was analyzed for petroleum hydrocarbons by method TPH-HCID. Lube oil range organics were detected at 7,000 mg/kg. BSE resampled this area on 7/18/2017. The soil sample (AREA 2-EXC @3 ft bgs) was analyzed for DRO by method NWTPH-Dx. Diesel and lube oil range organics were not detected above laboratory reporting limits.

This picture shows the excavation at stained area #2. This picture was collected looking in a northeasterly direction.

Stained area #2 has a small footprint where ACT removed petroleum hydrocarbon stained soil in 2011. ACT collected a soil sample from this area. However, they used method TPH-HCID to analyze the sample for petroleum hydrocarbon organics. BSE collected a soil sample from the middle of this excavated area in 2017. This soil sample (Area 2 – EXC) was analyzed for diesel/lube range organics by method NWTPH-Dx. DRO was not detected above CUL. BSE recommends that this area has been sufficiently characterized and requires no further remediation.

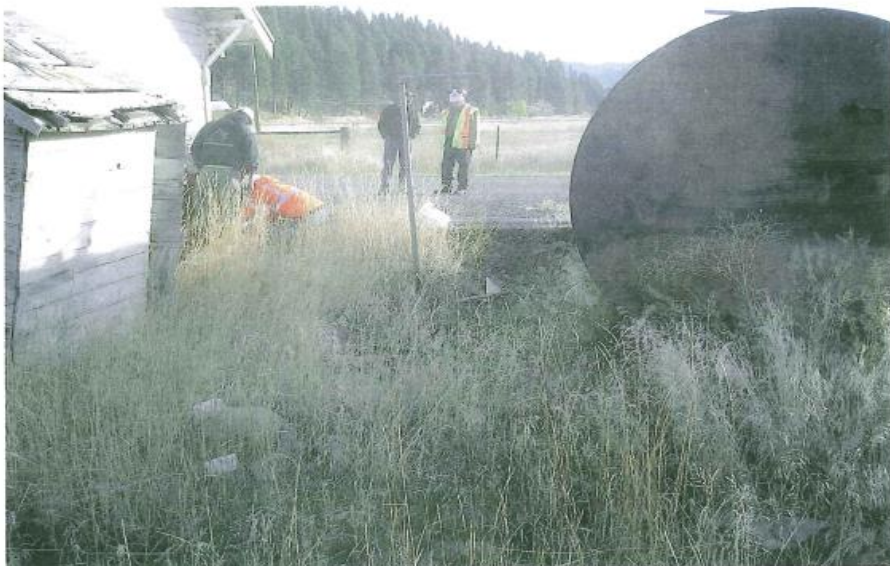
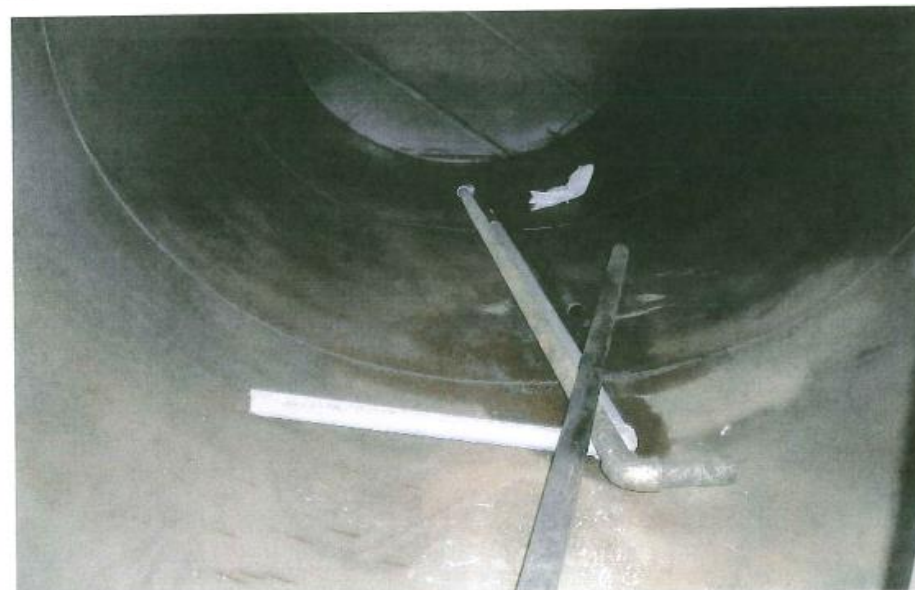
**DWG. NO.**  
**Photo 2**

A 4,000-gallon above-ground storage tank (AST) system that formerly contained diesel fuel was decommissioned by ACT in October 2011 (**Photo 2**). The AST was connected to a dispenser pump that was located approximately 15 feet north of the tank by steel piping. Details of the

This picture shows the site when ACT first arrived & removed the dispenser. This picture was collected looking in a northeasterly direction.

This picture shows the inside of the cleaned UST.

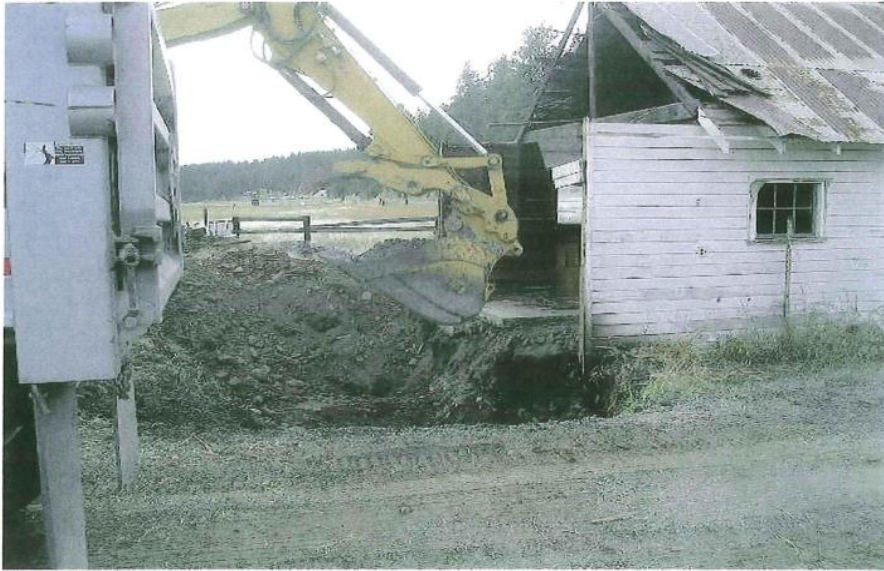
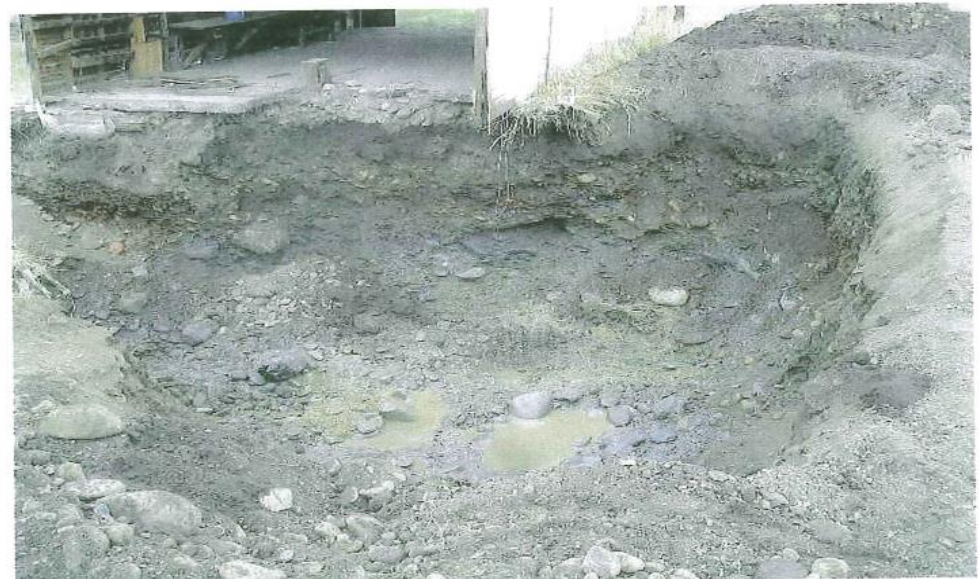
DWG. NO.  
**Photo 3**

Following removal of the AST system (tank, piping, and dispenser), petroleum contaminated soil was noted around the dispenser. Remediation of contaminated soil by excavation was done by ACT (**Photo3**). Soil samples were collected from the sidewalls and floor of the excavation (**Figure 3**). Depth at the floor of the excavation was approximately 11.5 feet bgs. Elevated concentrations above CUL for diesel were detected in sidewall soil samples CH-SAD-10 (3,200 mg/kg @ 8ft bgs) and CH-SAD-12 (680 mg/kg @8ft bgs). Floor soil samples CH-SAD-8 (10.5 ft bgs) and CH-SAD-9 (11.5 ft bgs) did not detect diesel/lube oil concentrations above laboratory reporting limits. BSE collected sidewall samples UST East and UST West in 2017 from approximately the same locations as ACT sidewall samples CH-SAD-10 and CH-SAD-12 that were collected in 2011. Concentrations of diesel/lube oil were below laboratory reporting limits.

Groundwater seeped into the open excavation at a depth below 10 feet bgs. No groundwater samples have been collected by either ACT or BSE. Characterization of groundwater will need to be completed around the excavated area where the AST system was formerly located.

This picture shows the continued removal of the contaminated soils from around the dispenser. This picture was collected looking in a westerly direction.

This picture shows the finished excavation the tan soils at the bottom of the excavation are not contaminated. This picture was collected looking in a northerly direction.

The AST system contained diesel fuel that was used for farm equipment. The floor of the excavation (CH-SAD-8 @10.5ft, and CH-SAD-9 @11.5 ft) did not detect diesel range organics above the laboratory detection limit. However, side wall samples (CH-SAD-10 and CH-SAD-12 @8ft bgs) detected elevated levels of diesel above the CUL. BSE resampled both sidewalls (UST-East and UST-West @8ft bgs) in 2017. The samples were analyzed for DRO by method NWTPH-Dx. Concentrations of diesel/lube oil range petroleum hydrocarbons were not detected above laboratory reporting limits. No additional excavation of soils is planned for this area.

The second phase of the cleanup remediation will be to characterize groundwater around the former AST system. This will be accomplished by using a direct push rig to advance a minimum of three borings around the excavation. Soil and groundwater samples will be collected from each boring. The borings will be completed as monitoring wells in case the grab samples
