RE: Technical Memorandum – Vapor Mitigation System Installation
Lacey Urban Center
7131-7269 Martin Way East
Olympia, Washington 98516
AEG Project Number: 18-236

Technical Memorandum – Vapor Mitigation System Installation

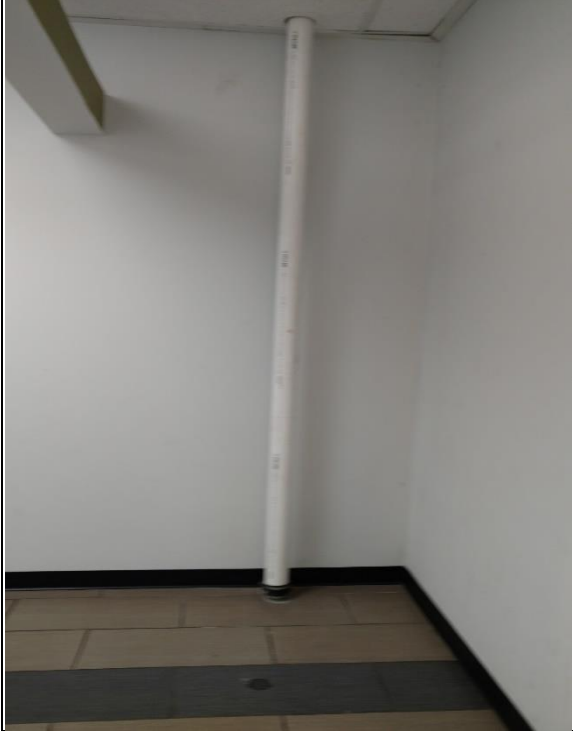
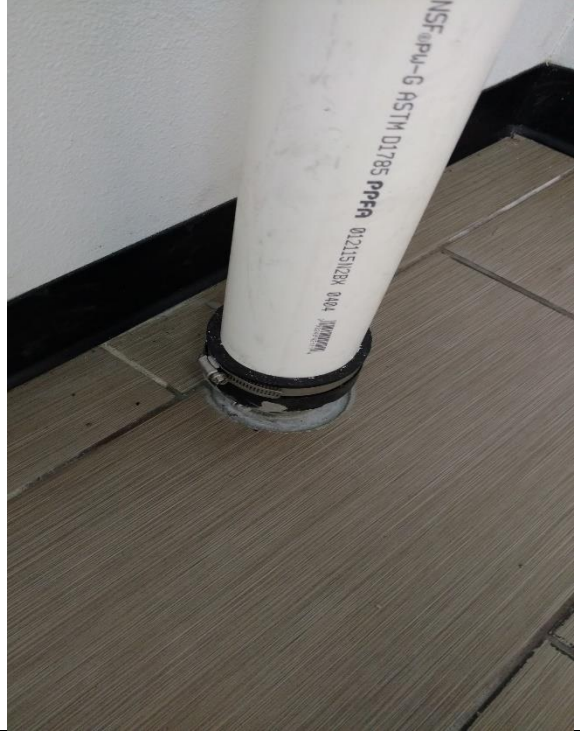
Photo # 1	SSD-1	Photo # 2	Bottom of SSD-1

On December 8, 2021, AEG personnel along with a Washington licensed contractor installed two vapor mitigation points (SSD-1 and SSD-2) in the occupied laundromat. The SSD points provide a pressure differential (vacuum) using vertical vapor collection points installed through the concrete floor, while connecting the points to air conveyance piping to an outlet pipe on the building's roof. The Site's current layout and SSD locations are illustrated in Figure 2, *Site Map*, and photographs of the installation are included in Appendix A, Supporting Documents, *Site Photographs*.

- Advanced a 4-inch concrete boring bit to a sufficient depth to bore through the existing building floor in each of the two areas.
- Hand-excavated a 14-inch sump horizontally and vertically beneath the concrete, installed a 2-inch slotted PVC extraction pipe, and backfilled each sump with clean pea gravel followed by a concrete seal.
- Installed PVC conveyance piping to allow access to the building wall and attached the piping to the outside of the building, extended to 3 feet above the roof line.
- Cut in wall penetrations and installed a 3-inch diameter schedule 40 PVC pipe for the conveyance piping, an in-line weather-proof radial blower (KTA-150 LV Fan) equipped with a condensation bypass, explosion-proof motor, and control box with status display.
