# UNDERGROUND STORAGE TANK DECOMMISSIONING

**FRONTIER COMMUNICATIONS - KIRKLAND**  
**12055 SLATER AVENUE NE**  
**KIRKLAND, WASHINGTON 98033**  
(FACILITY ID NO. 2555)

May 23, 2013

ENW Project No. 351-13010-01

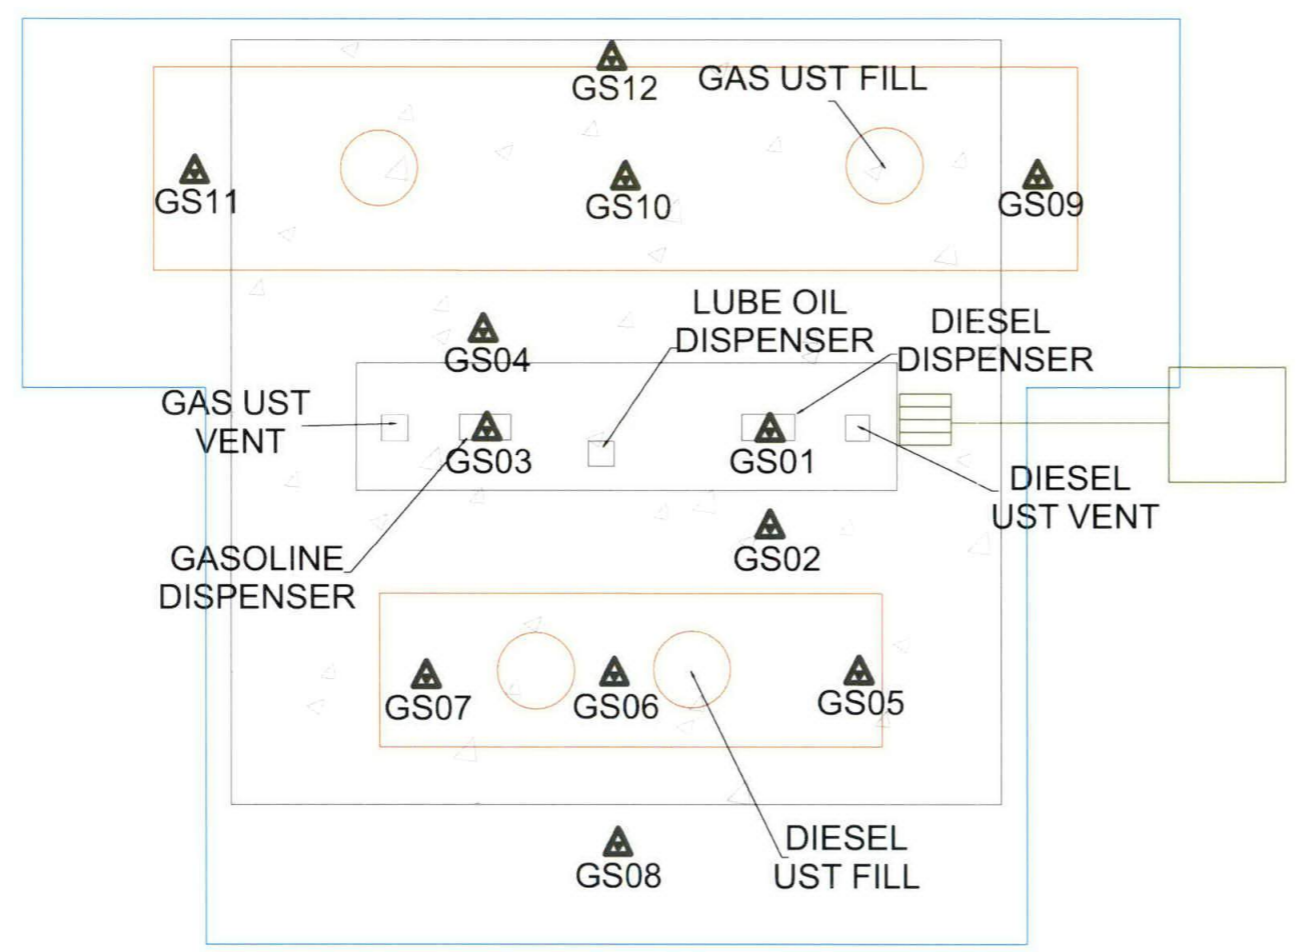
**FIGURE 4**  
**SAMPLE LOCATION DIAGRAM**  
**(ASSESSMENT SOIL SAMPLES)**  
 FRONTIER KIRKLAND SUPPORT CENTER  
 12055 NE SLATER AVENUE  
 KIRKLAND, WASHINGTON

Laboratory analytical results are summarized in Tables 1 and 2 (following Tables Tab after text). Sampling locations are depicted on Figures 4 and 5.

No field indications of petroleum impacts were observed in association with the tank systems. Assessment soil samples were collected below the ends and middle of each tank, from the soil / ground-water interfaces at 8 feet below ground surface, below the product lines, and below the two product dispensers. Laboratory analytical results confirmed that all soil samples were below the detection limits for all ranges of petroleum hydrocarbons by NWTPH-HCID (Table 1).

- LEGEND:
- APPROXIMATE LOCATION OF UST
  - APPROXIMATE MARGINS OF UST EXCAVATION
  - APPROXIMATE ENW GRAB SAMPLE LOCATION (2013)
  - CATCH BASIN (REMOVED AND CAPPED)
  - SPILL CONTROL VAULT (REMAINS)

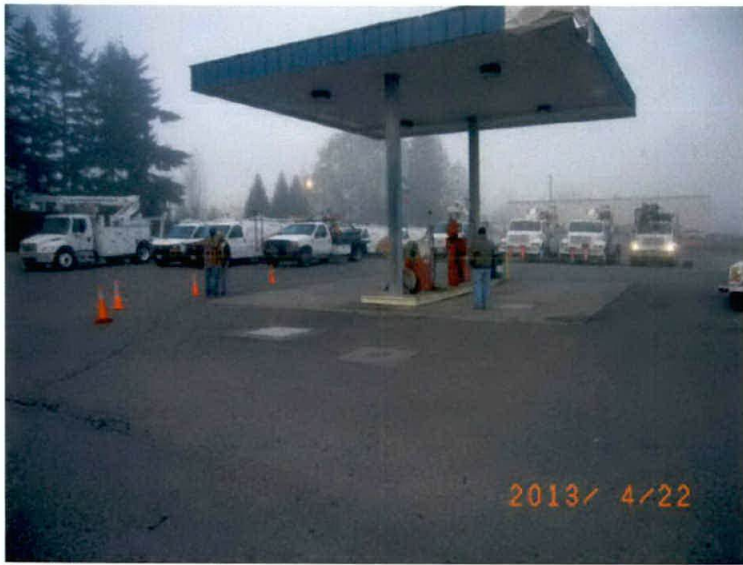
Fuel dispensers and transition sumps under canopy, monitoring well in foreground

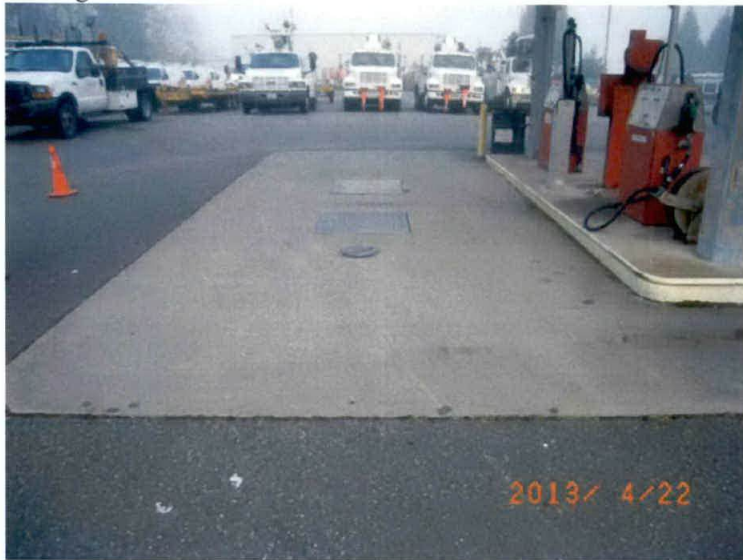
Transition sumps on either side of dispenser island

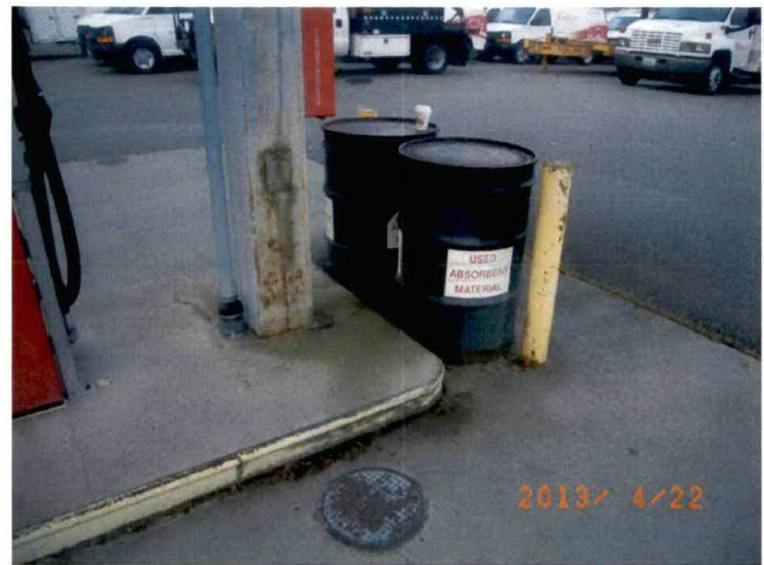
Vent pipe along canopy support

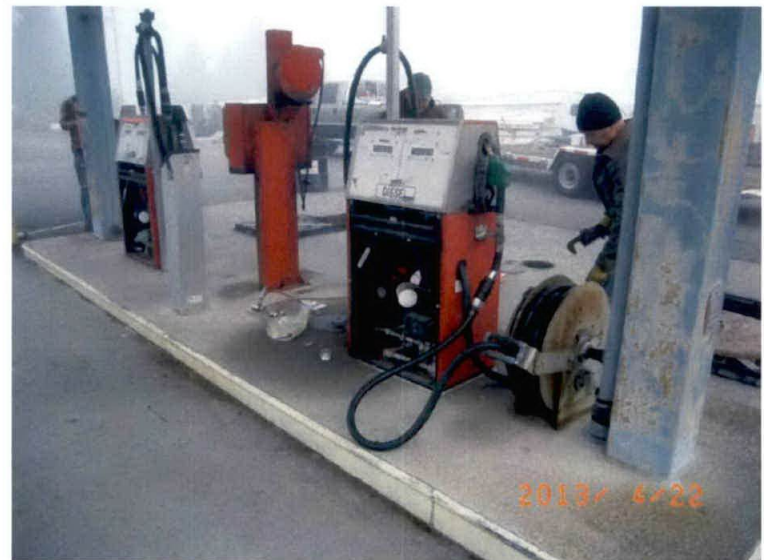
Beginning to dismantle dispensers

- The power to the dispensers was turned off, and the dispensers were dismantled. Both diesel and gasoline tanks were pumped out by Emerald Services. Product lines to the dispensers were drained back into the tanks and flushed with detergent and water.
- The tanks were pumped out and rinsed to remove all product and sludge.
- The tanks were inerted with dry ice.
- Due to the presence of shallow pit water during tank excavation, pit water was pumped into each UST to ballast the UST prior to removal. Once the elevation of water in the tank was equal to the elevation of water in the excavation, the tank was rigged to the excavator and the tank anchors (to deadmen) were cut. The water was then pumped from the tank, and as the tank rose in the excavation, the excavator adjusted tension to

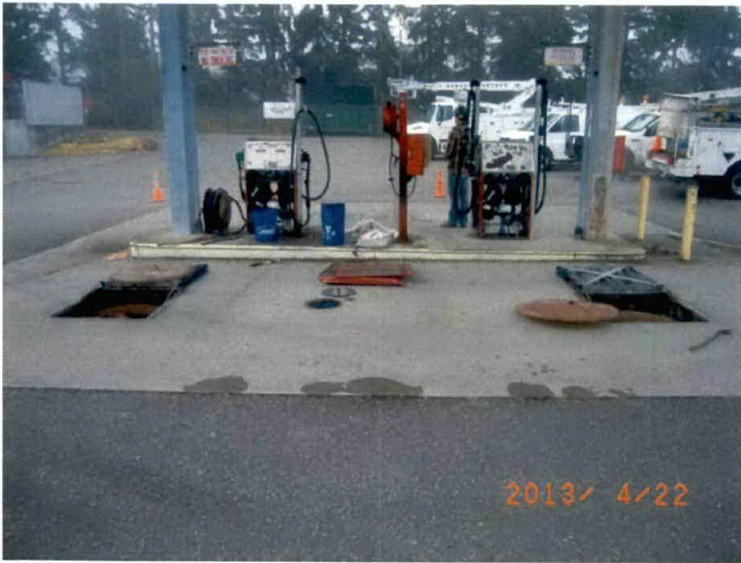
Transition sumps opened

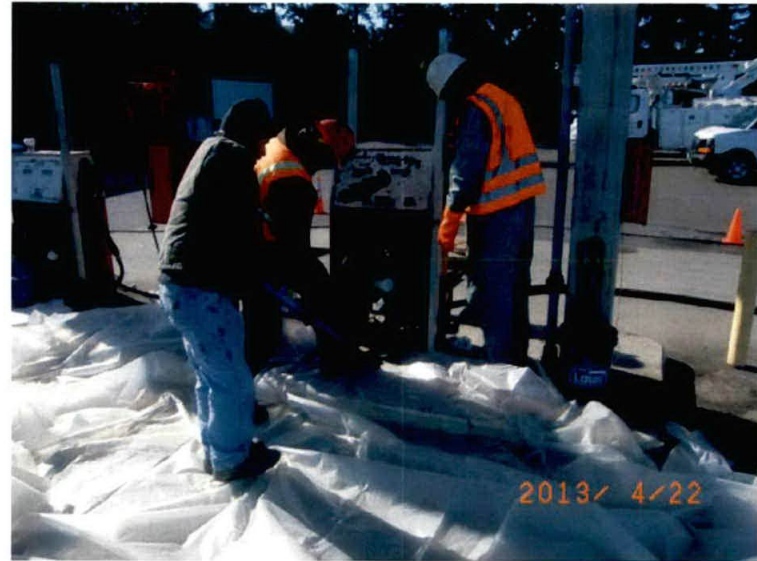
Draining product lines

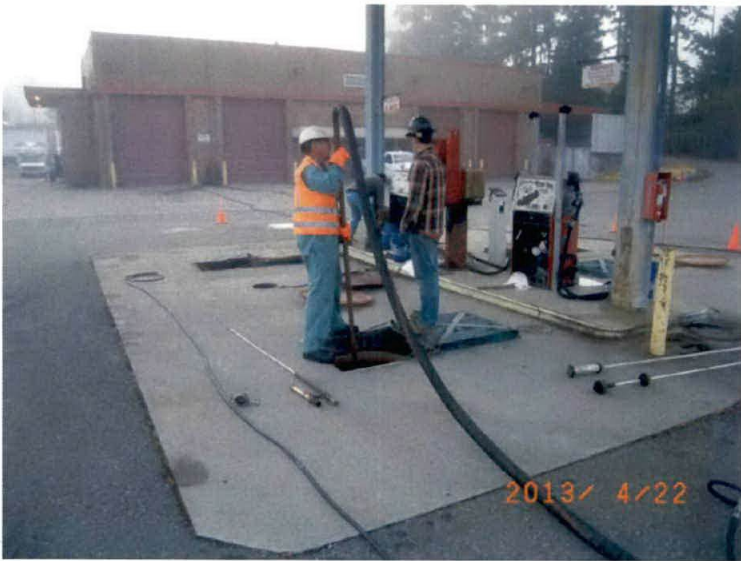
Pumping tanks

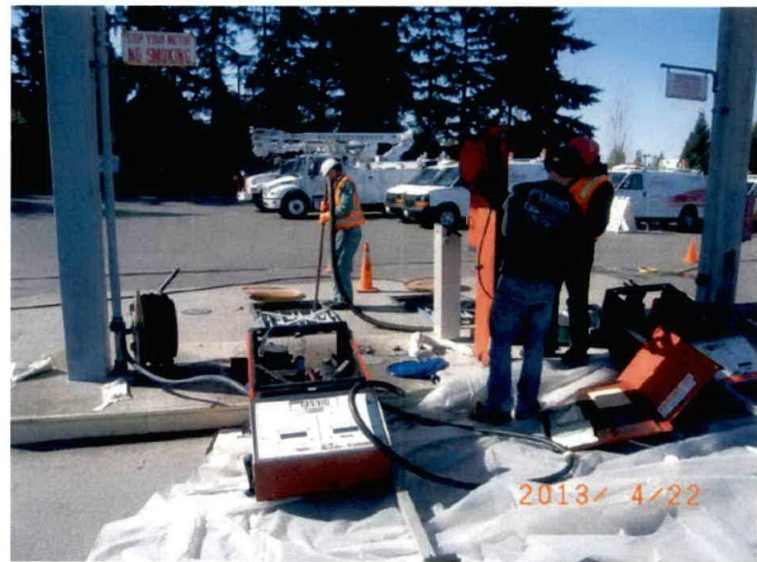
Dispensers removed from island

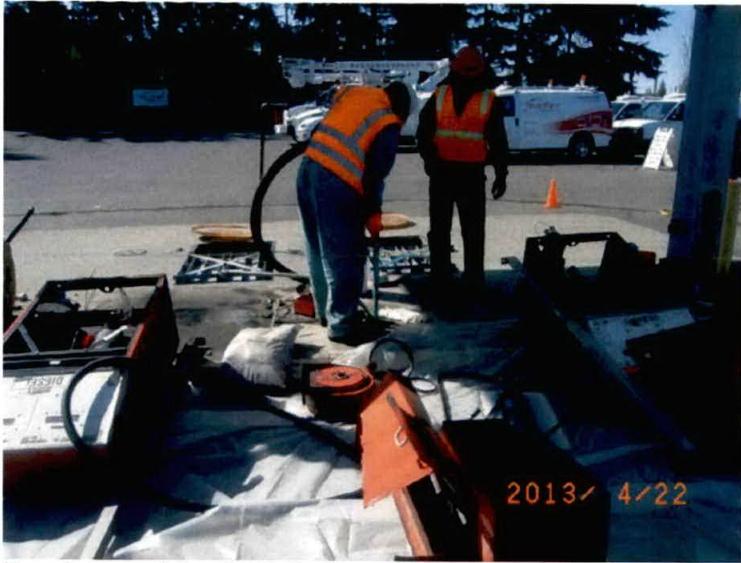
Pumping remaining fluids from tank

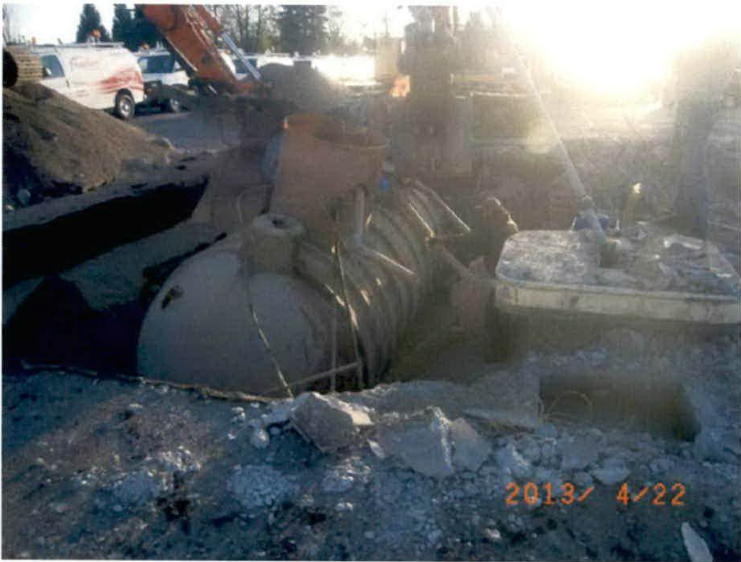
Tank being removed from excavation, assisted by buoyant forces

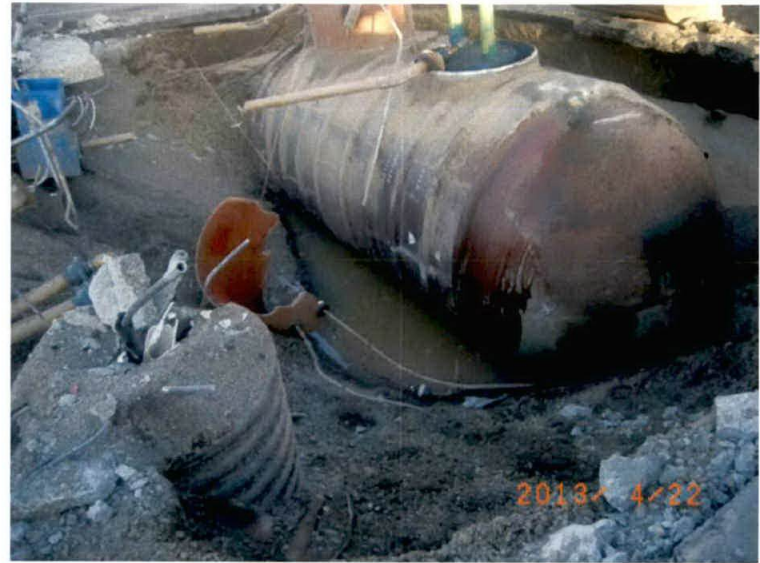
A shallow water-bearing unit was encountered at approximately 8 feet below ground surface during the decommissioning activities described in this report. Based on topography and hydrology, ground-water flow direction should be toward the northeast.

Ground water was encountered at approx. 8 feet depth; deadman strap failure caused the tank to rise buoyantly in the excavation.

keep the tank steady. Once all the water was pumped from the UST the tank was removed from the excavation and set on sheet plastic.

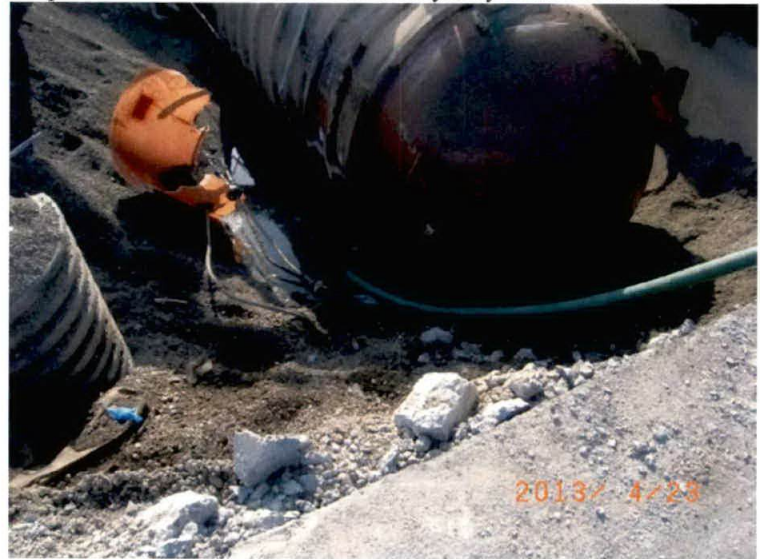
Pumping the excavation

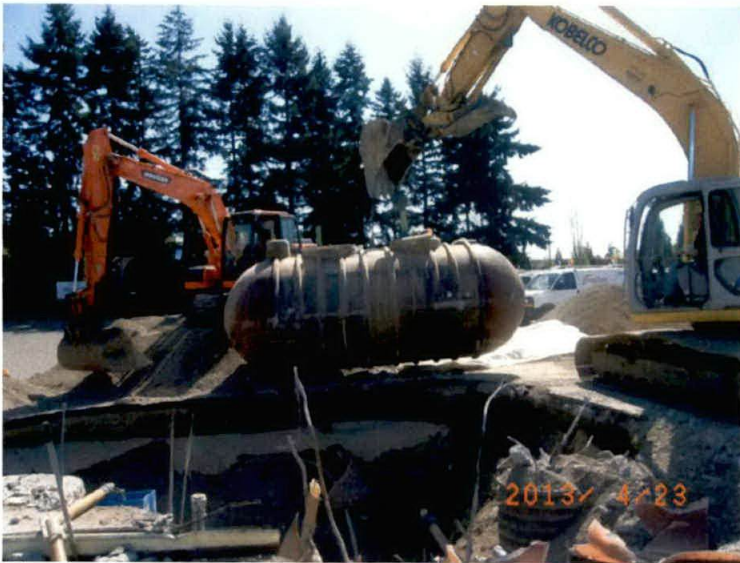
Diesel tank being removed from excavation

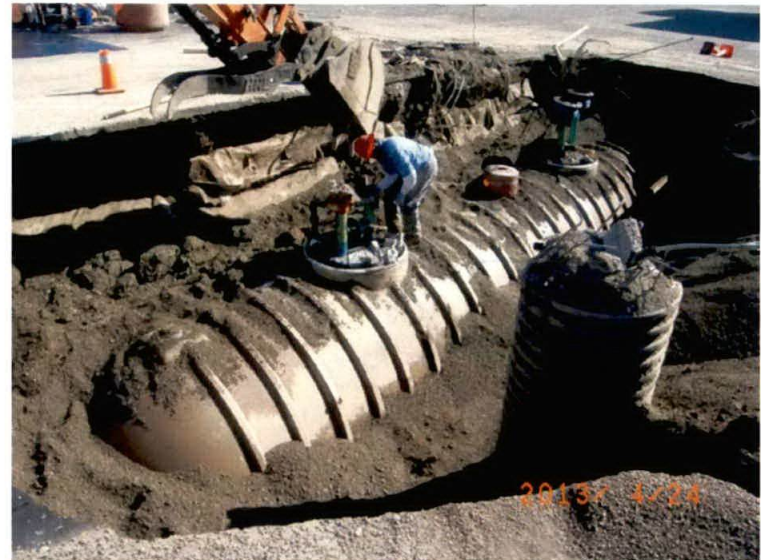
Preparing gasoline tank for removal

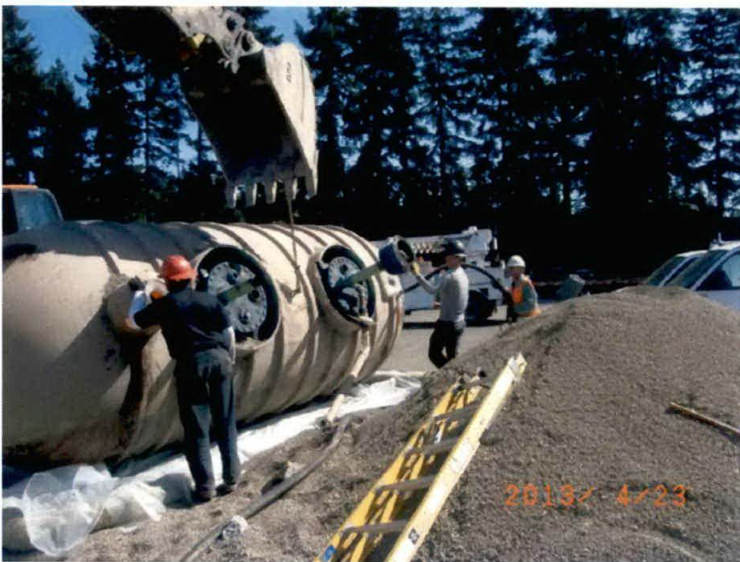
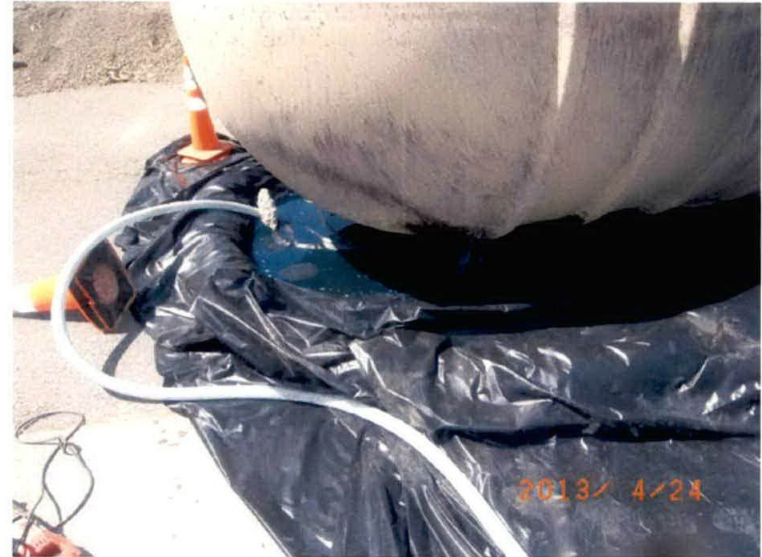
Removing interstitial fluids

- The leak-detection fluid (propylene glycol) present in the interstitial space was then pumped through holes cut in the outer shell of each UST.
- The tanks were then placed in drop boxes for offsite disposal.
- The excavations were backfilled with clean materials and compacted in lifts.
- The pavement surface was restored.

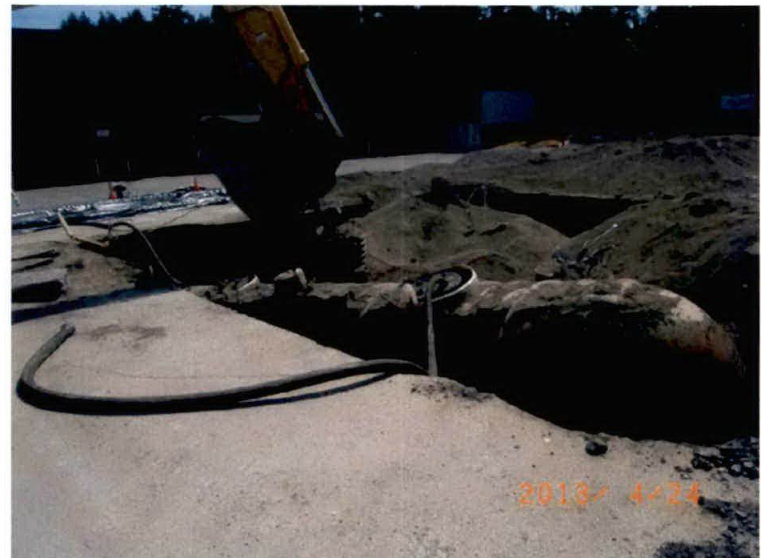
Preparing to lift gasoline tank

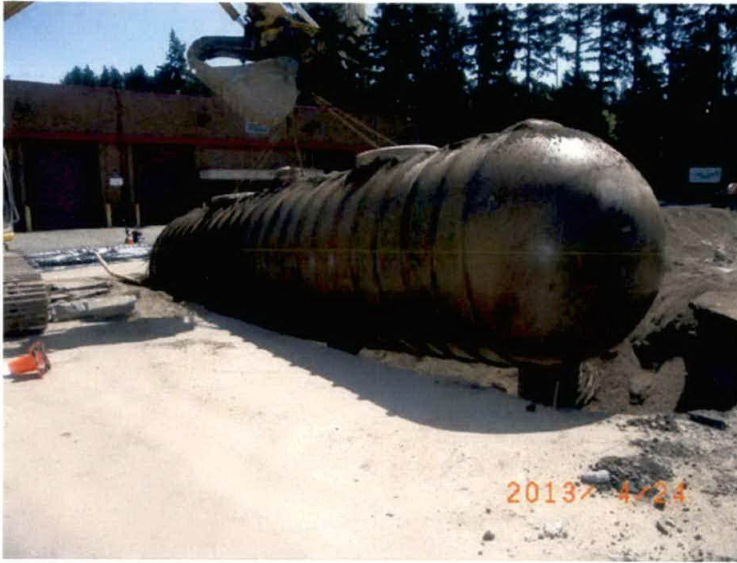
Lifting gasoline tank out of excavation

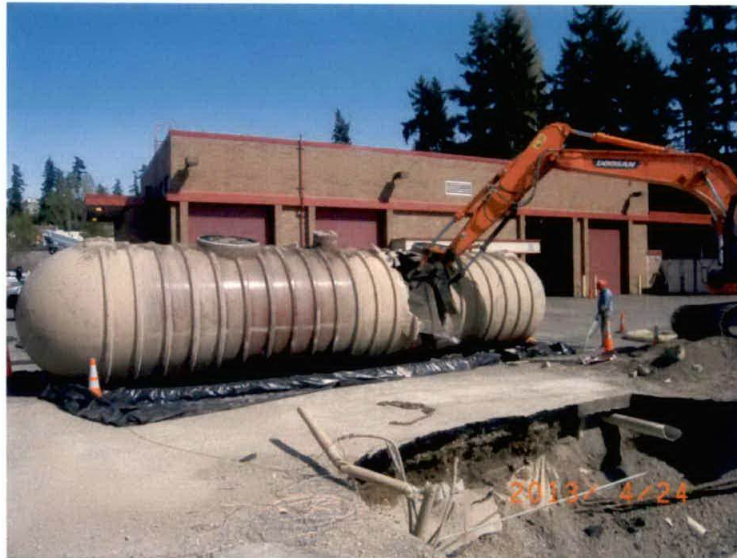
Ventilating the gasoline tank before removal from site to disposal facility

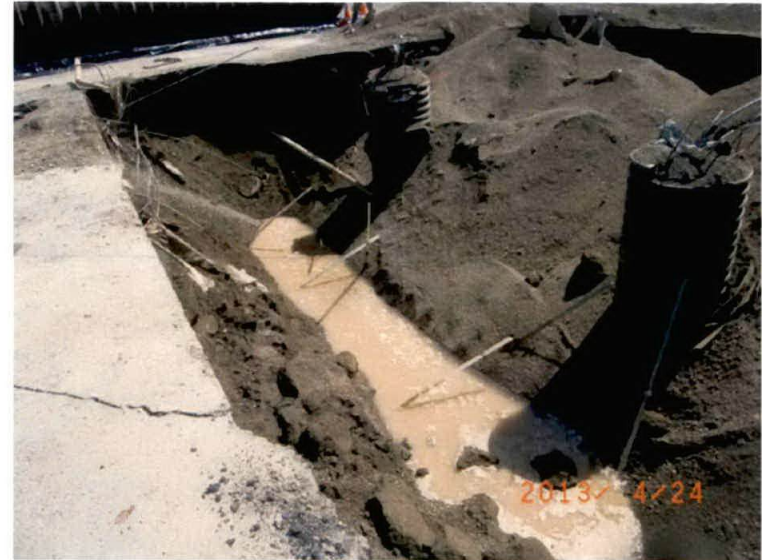
Ground water was present in the tank excavation at 8 feet below ground surface. A reconnaissance ground-water sample was collected from the excavation and analyzed by the laboratory. The water sample was "nondetect" for all ranges of petroleum hydrocarbons by NWTPH-HCID and for benzene, toluene, ethylbenzene, and xylenes (Table 2). Therefore ground water did not have any detectable petroleum impacts.

Reconnaissance ground water was sampled during decommissioning activities

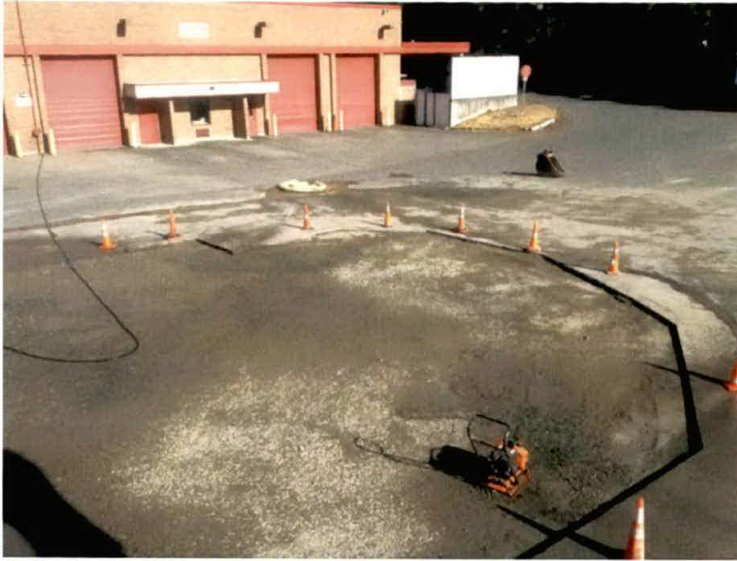
Refueling facility excavation backfilled with clean materials and compacted
