U.S. ENVIRONMENTAL PROTECTION AGENCY  
TECHNICAL ENFORCEMENT SUPPORT  
AT  
HAZARDOUS WASTE SITES

FIELD SAMPLING AND LABORATORY ANALYSIS REPORT  
FOR OVERSIGHT OF  
GROUND WATER AND SURFACE WATER SAMPLING  
AT  
THERMAL REDUCTION COMPANY, INC.  
FERNDALE, WASHINGTON

NOVEMBER 1990

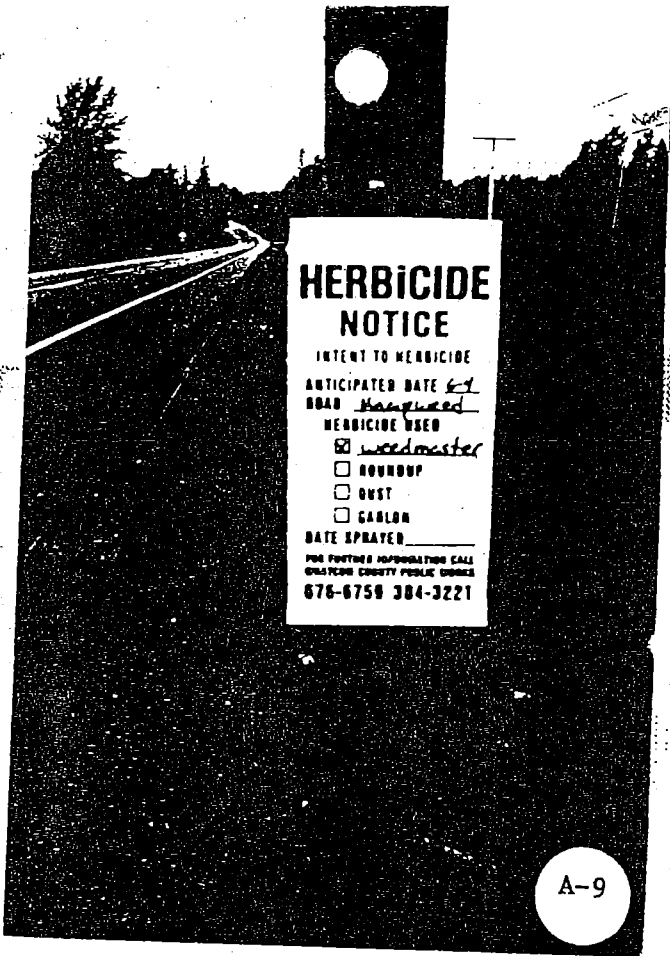
- A-8 Herbicide spraying notice on speed limit sign west of I-5 exit near TRC entrance
- A-9 Close-up shot of herbicide spraying notice
- A-10 Determining secchi depth in canoe in Claypit Pond with Tom Smayda (HLA), Roy Lundgren (TRC/RECOMP), and John Kane (SAIC)
