## **REMEDIAL INVESTIGATION / FEASIBILITY STUDY**

**Rainier Mall Property**

**4208 Rainier Avenue South, Seattle, WA 98118**

September 7, 2021

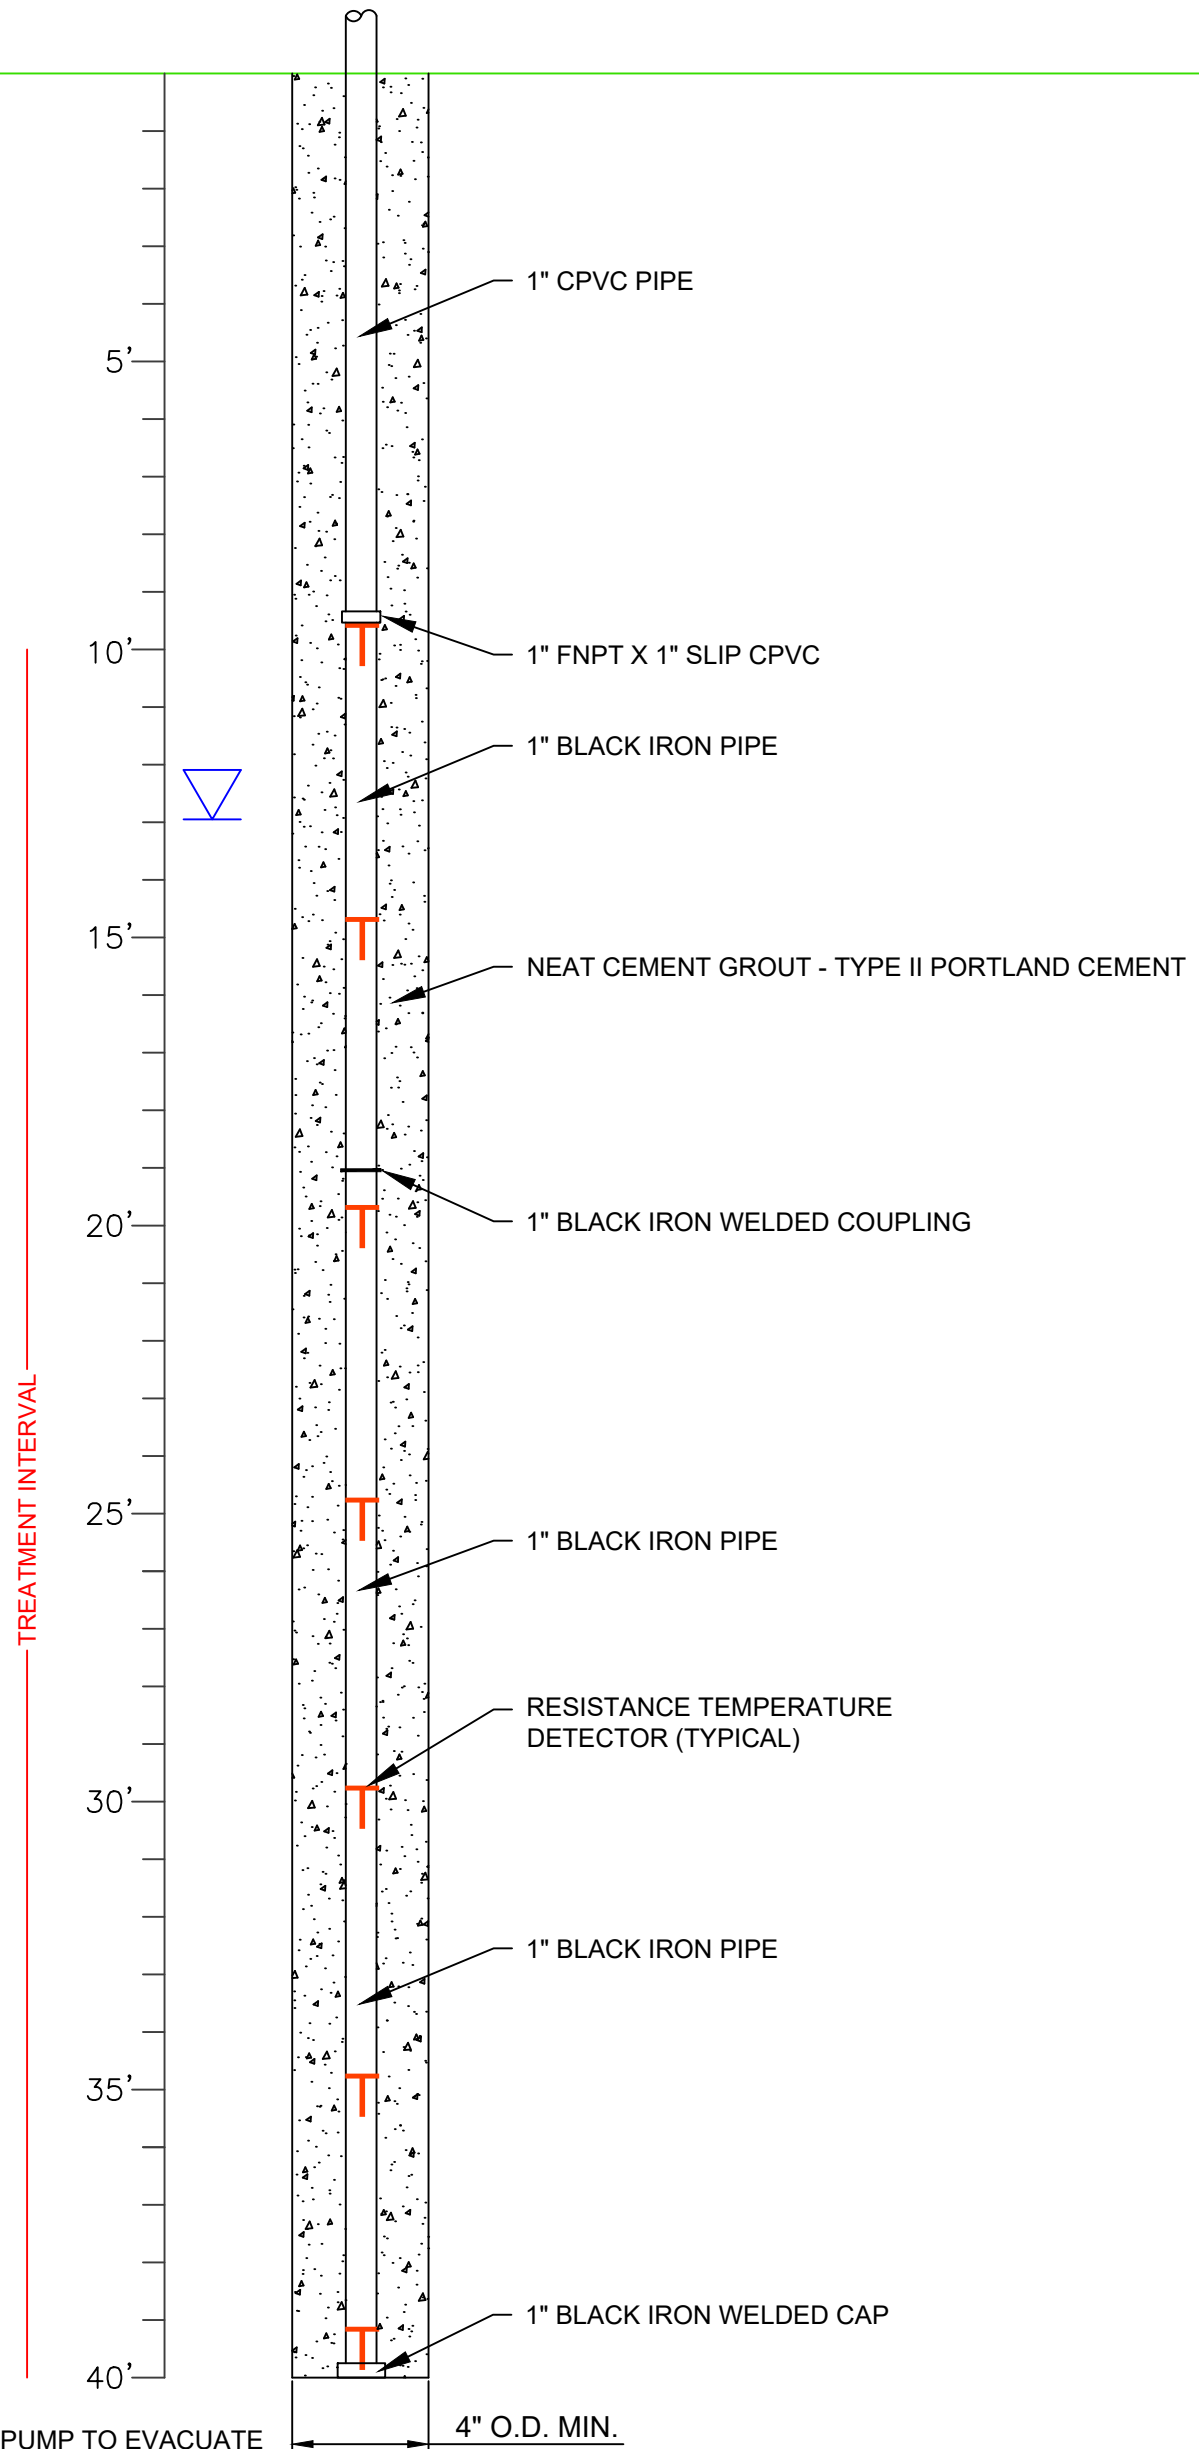
## ABOVE GRADE TEMPERATURE MONITORING POINT TYPE A (TYPICAL OF 2)

NOTE:  
USE A WATER PUMP TO EVACUATE  
WATER FROM THE TMP CASING, IF  
WATER IS OBSERVED.

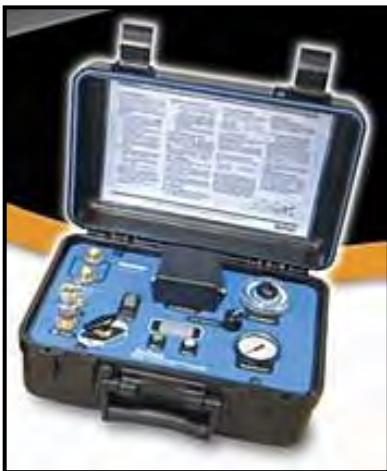
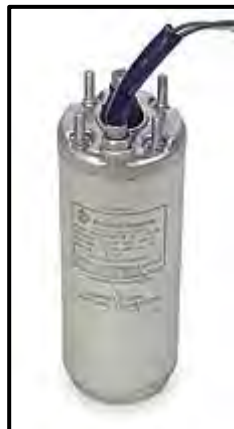
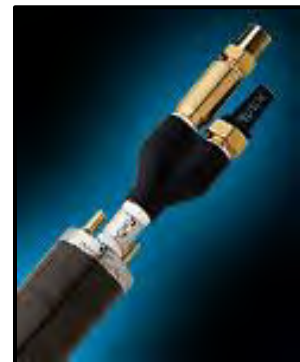
#### Bladder Pump

Submersible pump with external control unit used for pumping fluids at greater depths. The bladder pump consists of an internal flexible bladder that is positioned within a rigid pump body constructed of stainless steel. The inner bladder is equipped with one-way inlet and outlet valves and passively fills with water when the pump is at depth by virtue of hydrostatic pressure. Following the fill cycle, compressed air from a cylinder or compressor at the wellhead is delivered to the pump through tubing and is used to compress the bladder. The applied pressure then causes the flexible bladder to compress and closes the bottom check valve, forcing water from the bladder into the discharge tubing. During a vent cycle, the pressure is released from the drive tubing. The bladder returns to its initial state as water re-enters the pump, while the top check valve prevents water already in the discharge tubing from falling back into the bladder. The pumping sequence consists of repeated fill/compress cycles, using a pneumatic controller positioned at the wellhead.

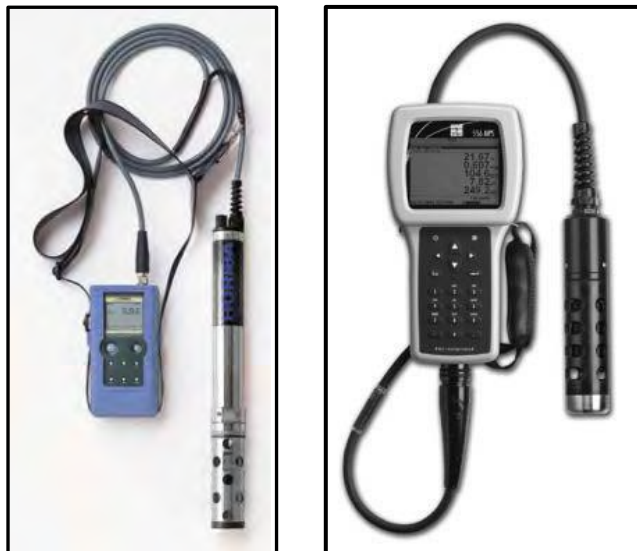
## Multi-probe and Flow-Through Cell

The flow through cell allows for in-line sampling of water quality parameters with the Multi-probe to determine stabilization for water sampling. At a minimum, groundwater quality parameters include pH, conductivity, temperature, dissolved oxygen (DO), and turbidity. Examples of multi-probes used for collecting water quality parameters include the Horiba U-22 and YSI 556 (shown below).

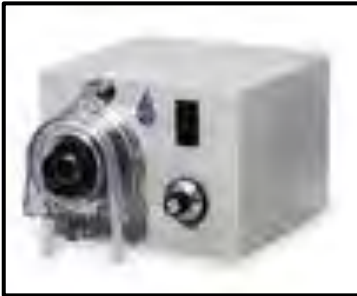
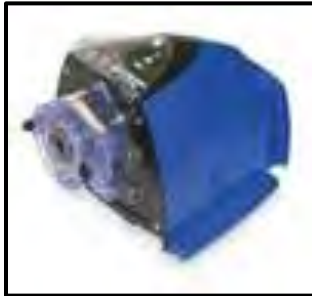
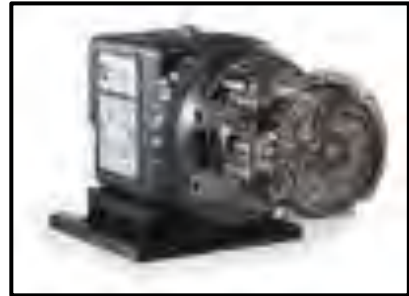
### Peristaltic Pump

A positive displacement pump used for pumping fluids. Generally, flexible tubing is fitted inside a circular pump casing. A rotor with a number of "rollers", "shoes", or "wipers" attached to the external circumference compresses the flexible tube. As the rotor turns, the part of tube under compression closes thus forcing the fluid to move through the tube.

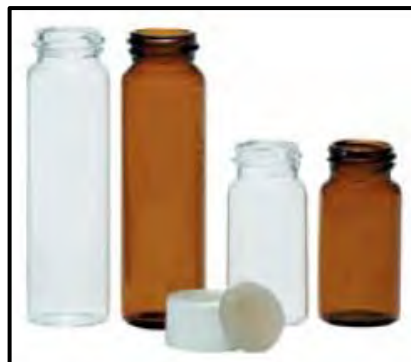
### VOA Vials

EPA recommended glass sample containers used to collect liquid samples for laboratory analysis. Volatile organic analysis (VOA) vials have a nominal volume of 40 milliliters (mL) and are manufactured of clear or amber borosilicate glass. Depending on type of analysis being conducted, the VOA vials may contain small amounts of preservative when shipped from the laboratory. When collecting samples in VOA vials, fill the vial completely full (ensure that a meniscus has formed at the top of the vial before securing the cap) and check that there are no air bubbles in the closed sample. If there is a preservative present, use caution to not overfill the vial.

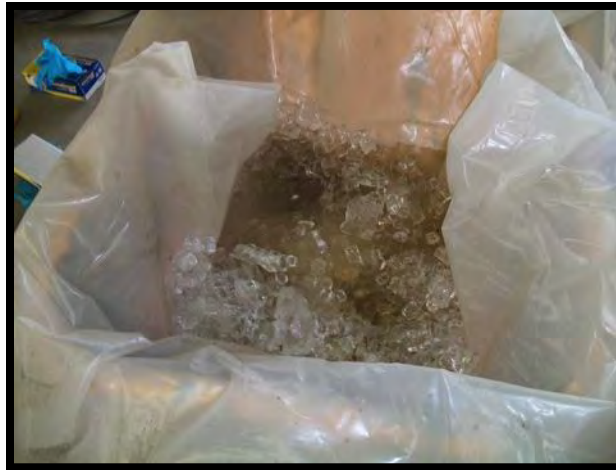
- 3) Ice bath for soil samples. An example is a cooler filled with ice. The cooler (or container) must be equipped with an opening at the bottom to allow water from melting ice to drain.

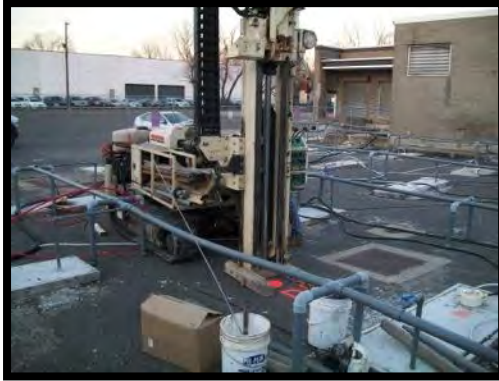
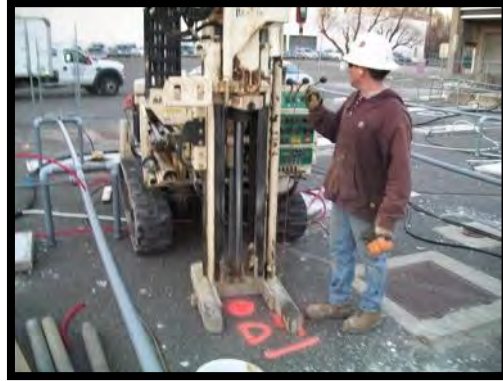
- 1) An authorized person shall apply LOTO to the ISTR PCU by site-specific instructions. Note: Only personnel who have been trained and certified by TRS in LOTO procedures can complete this procedure.
- 2) Position drill rig in the area to be sampled and perform a visual check for any safety concerns. Potential concerns include: high voltage lines, uneven terrain, underground utilities, and egress limitations with rig placement.

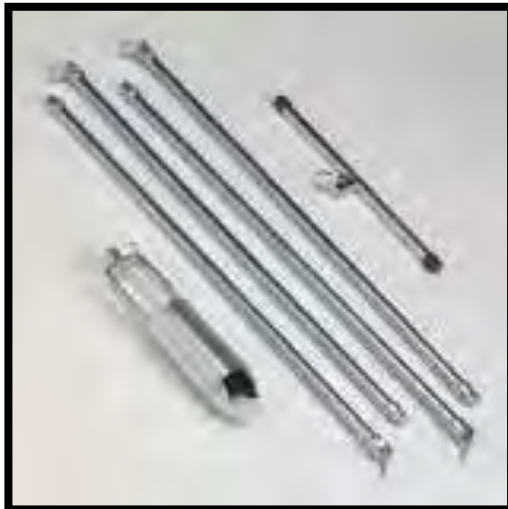
- 3) Hand auger or air knife the first five (5) feet of the boring to clear the location for potential buried utilities.

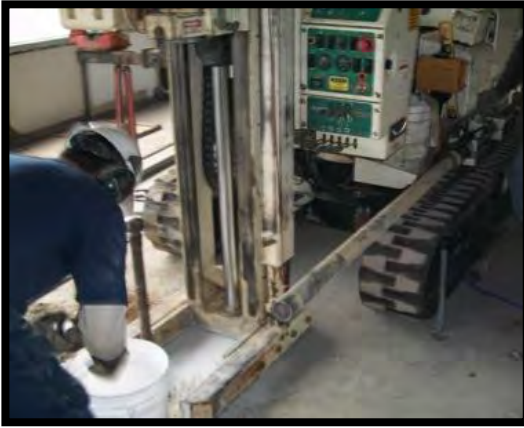
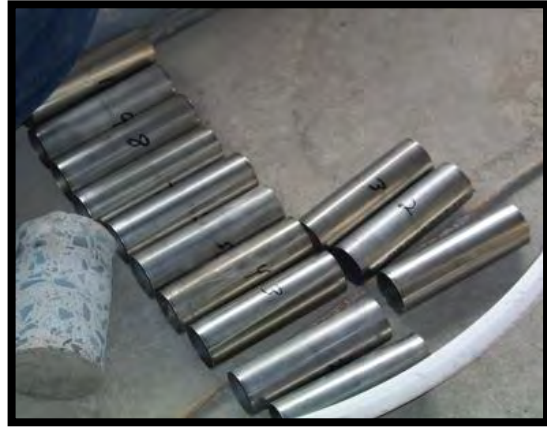
- 4) Advance the push sampler to the depth required and collect samples. If subsurface temperatures are expected to be greater than 70°C, the sample sleeves used must be made of brass or stainless steel. Sample sleeves made of acrylic or other materials can melt and bias sample results.

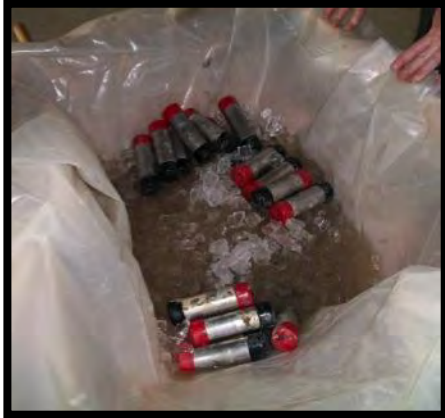
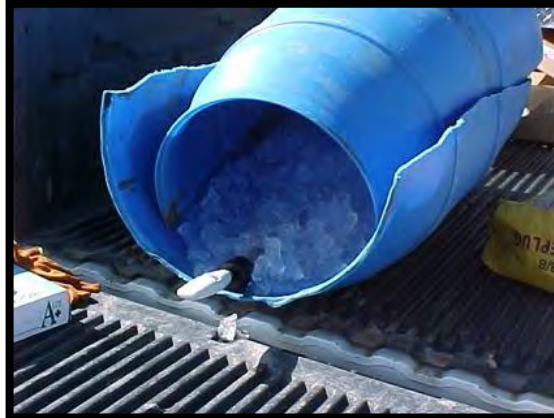
- 5) The sample sleeves must be capped immediately and placed into the ice bath to begin the cool-down process. Water from melting ice must be allowed to drain, as the sample sleeves should not be submerged at any time.

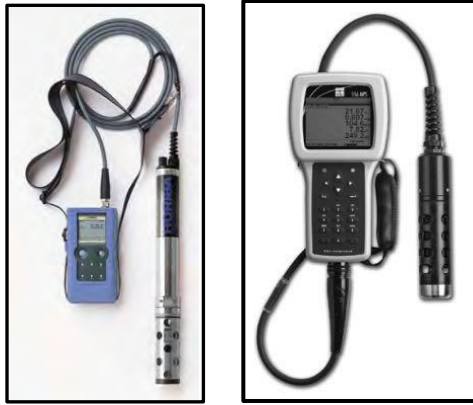
Multi-probe and Flow-Through Cell – The flow through cell allows for in-line sampling of water quality parameters with a multi-probe to determine stabilization for water sampling. At a minimum, groundwater quality parameters include pH, conductivity, temperature, dissolved oxygen (DO), and turbidity. Examples of multi-probes used for collecting water quality parameters include the Horiba U-22 and YSI 556 (shown below).

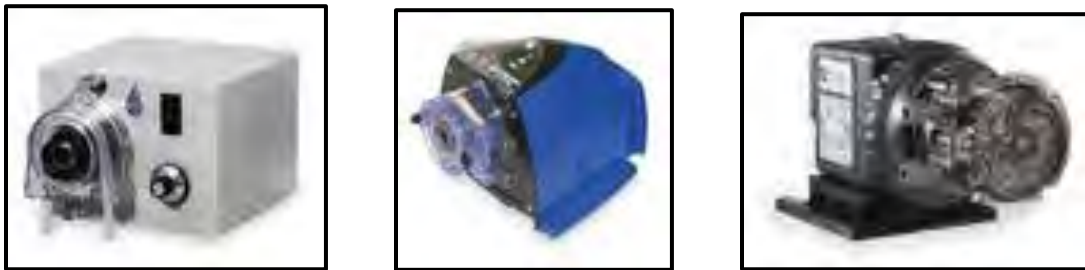
Peristaltic Pump – A positive displacement pump used for pumping fluids. Generally, flexible tubing is fitted inside a circular pump casing. A rotor with a number of "rollers", "shoes" or "wipers" attached to the external circumference compresses the flexible tube. As the rotor turns, the part of tube under compression closes thus forcing the fluid to move through the tube.

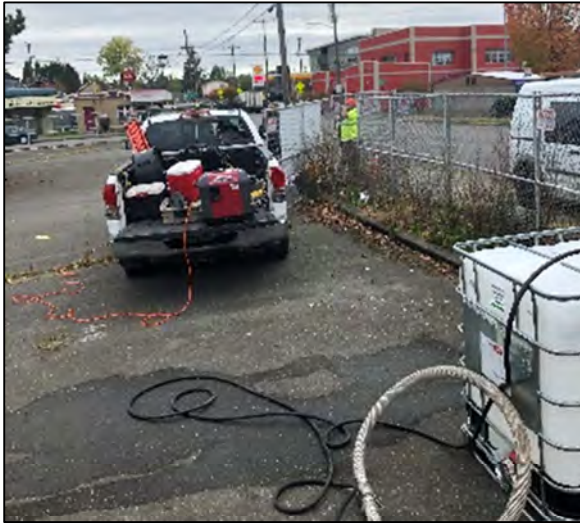
**Photo 1:** Water source storage tote and well extraction setup.

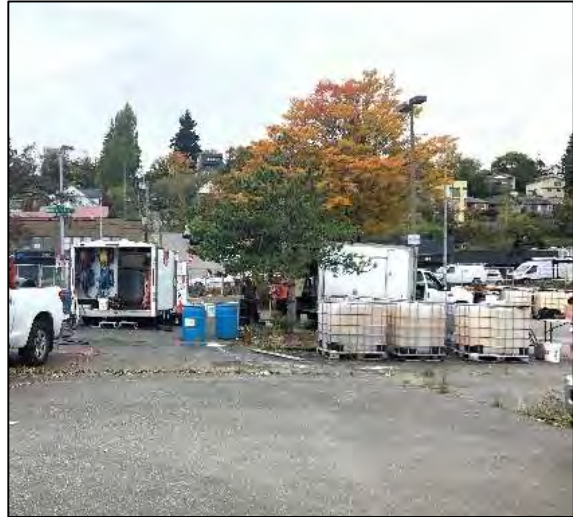
**Photo 2:** RRS trailer setup. Past product storage totes.

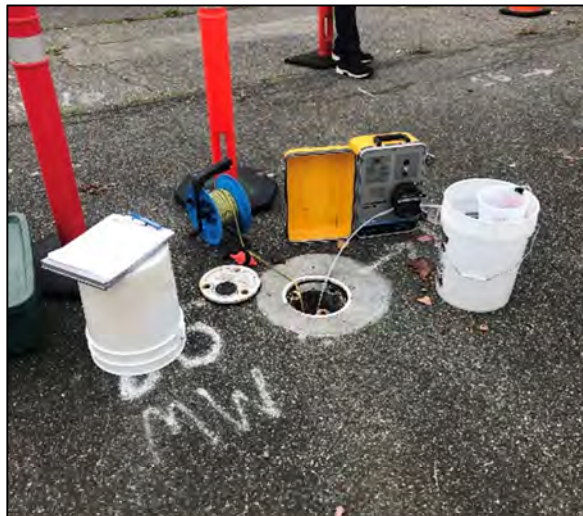
**Photo 4:** ROI data collection setup on downgradient wells.

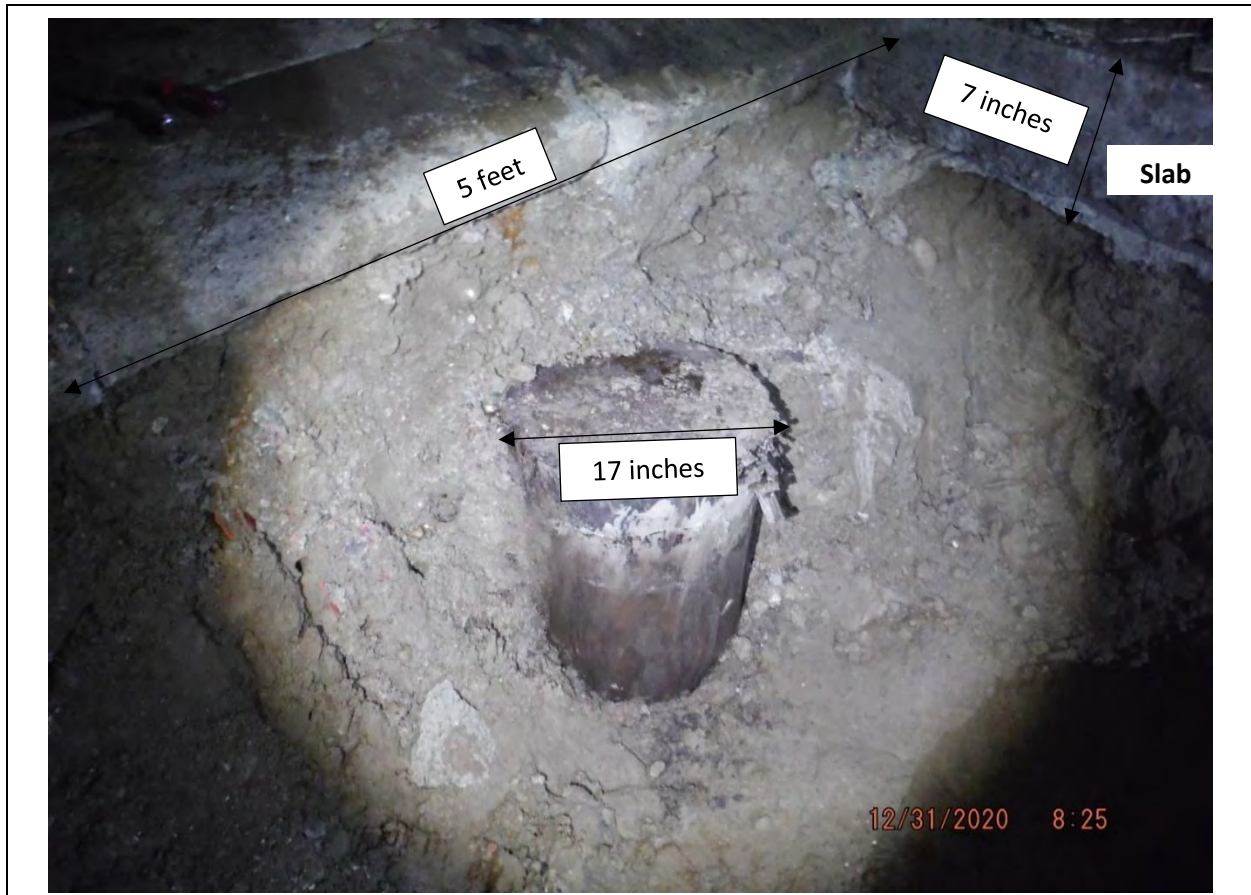
**Plate 1.** Excavation and pile condition at Pile 109. The existing concrete slab was poured directly on the existing timber pile. Top of timber pile is approximately 17 inches in diameter. Did not observe signs of decay on the existing timber pile. (12/31/2020)

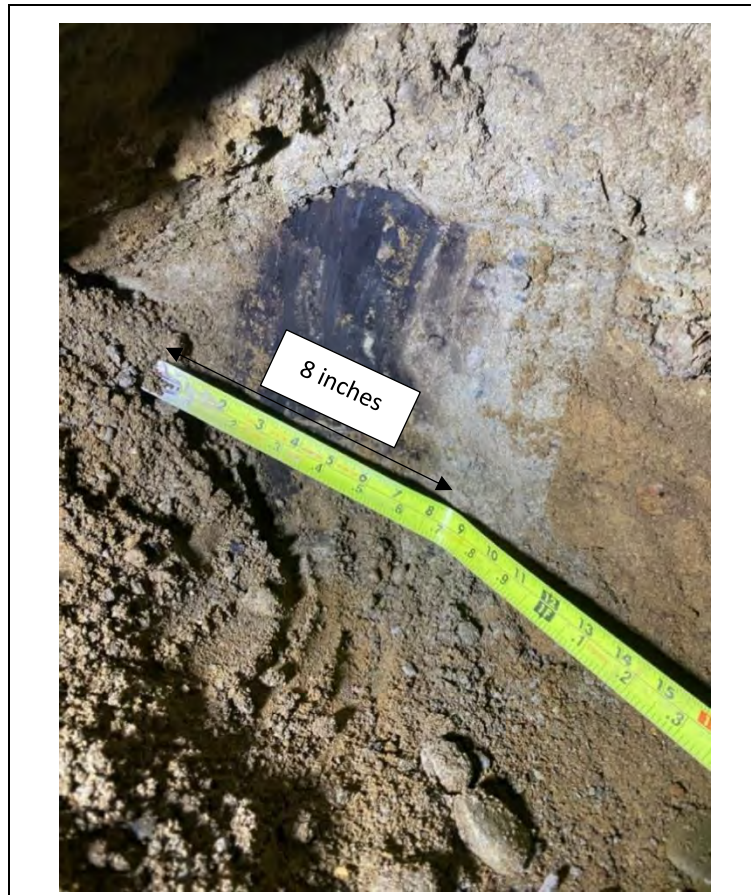
**Plate 2.** Observed Pile 2 condition. Timber pile is approximately 8 inches in diameter. Did not observe signs of decay on the existing timber pile. (12/31/2020)

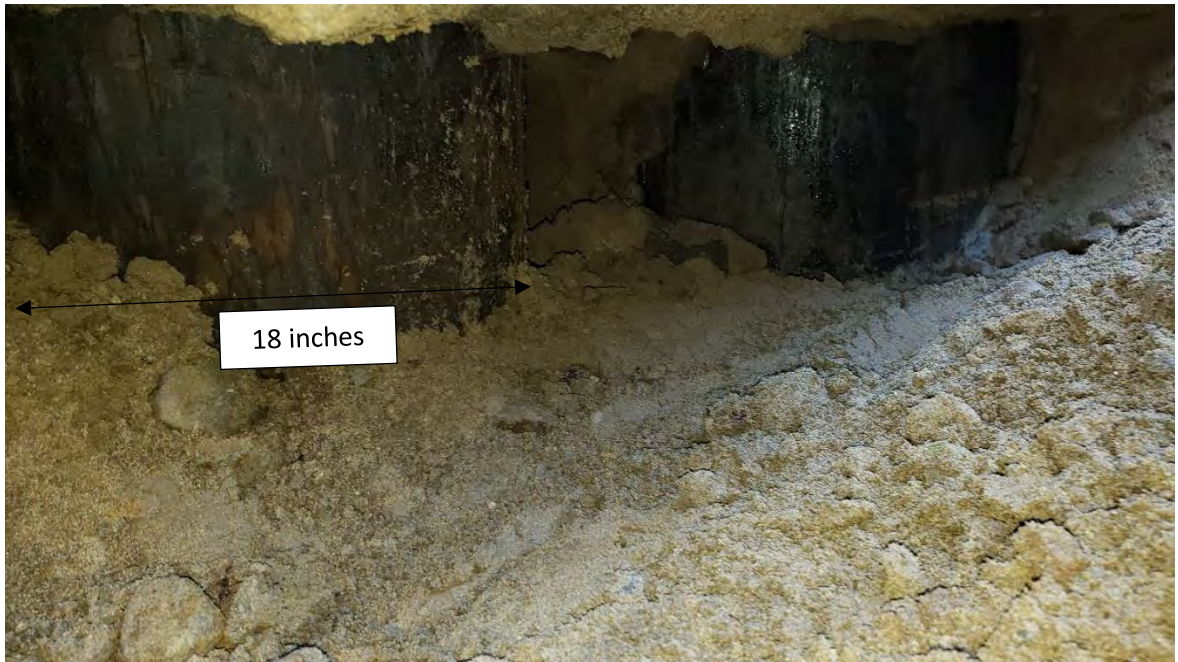
**Plate 3.** Piles observed in northwest corner of north loading dock by Urban Environmental Partners (UEP). Timber piles are approximately 18 inches in diameter. Photo provided by UEP. Do not observe signs of decay on the existing timber piles.
