Technical Memorandum

| | Bellevue, Washington 98008 | Project Name: | Former Mill E/ Koppers Facility |
| Subject: | 2021 Annual Performance and Compliance Monitoring Report | | |

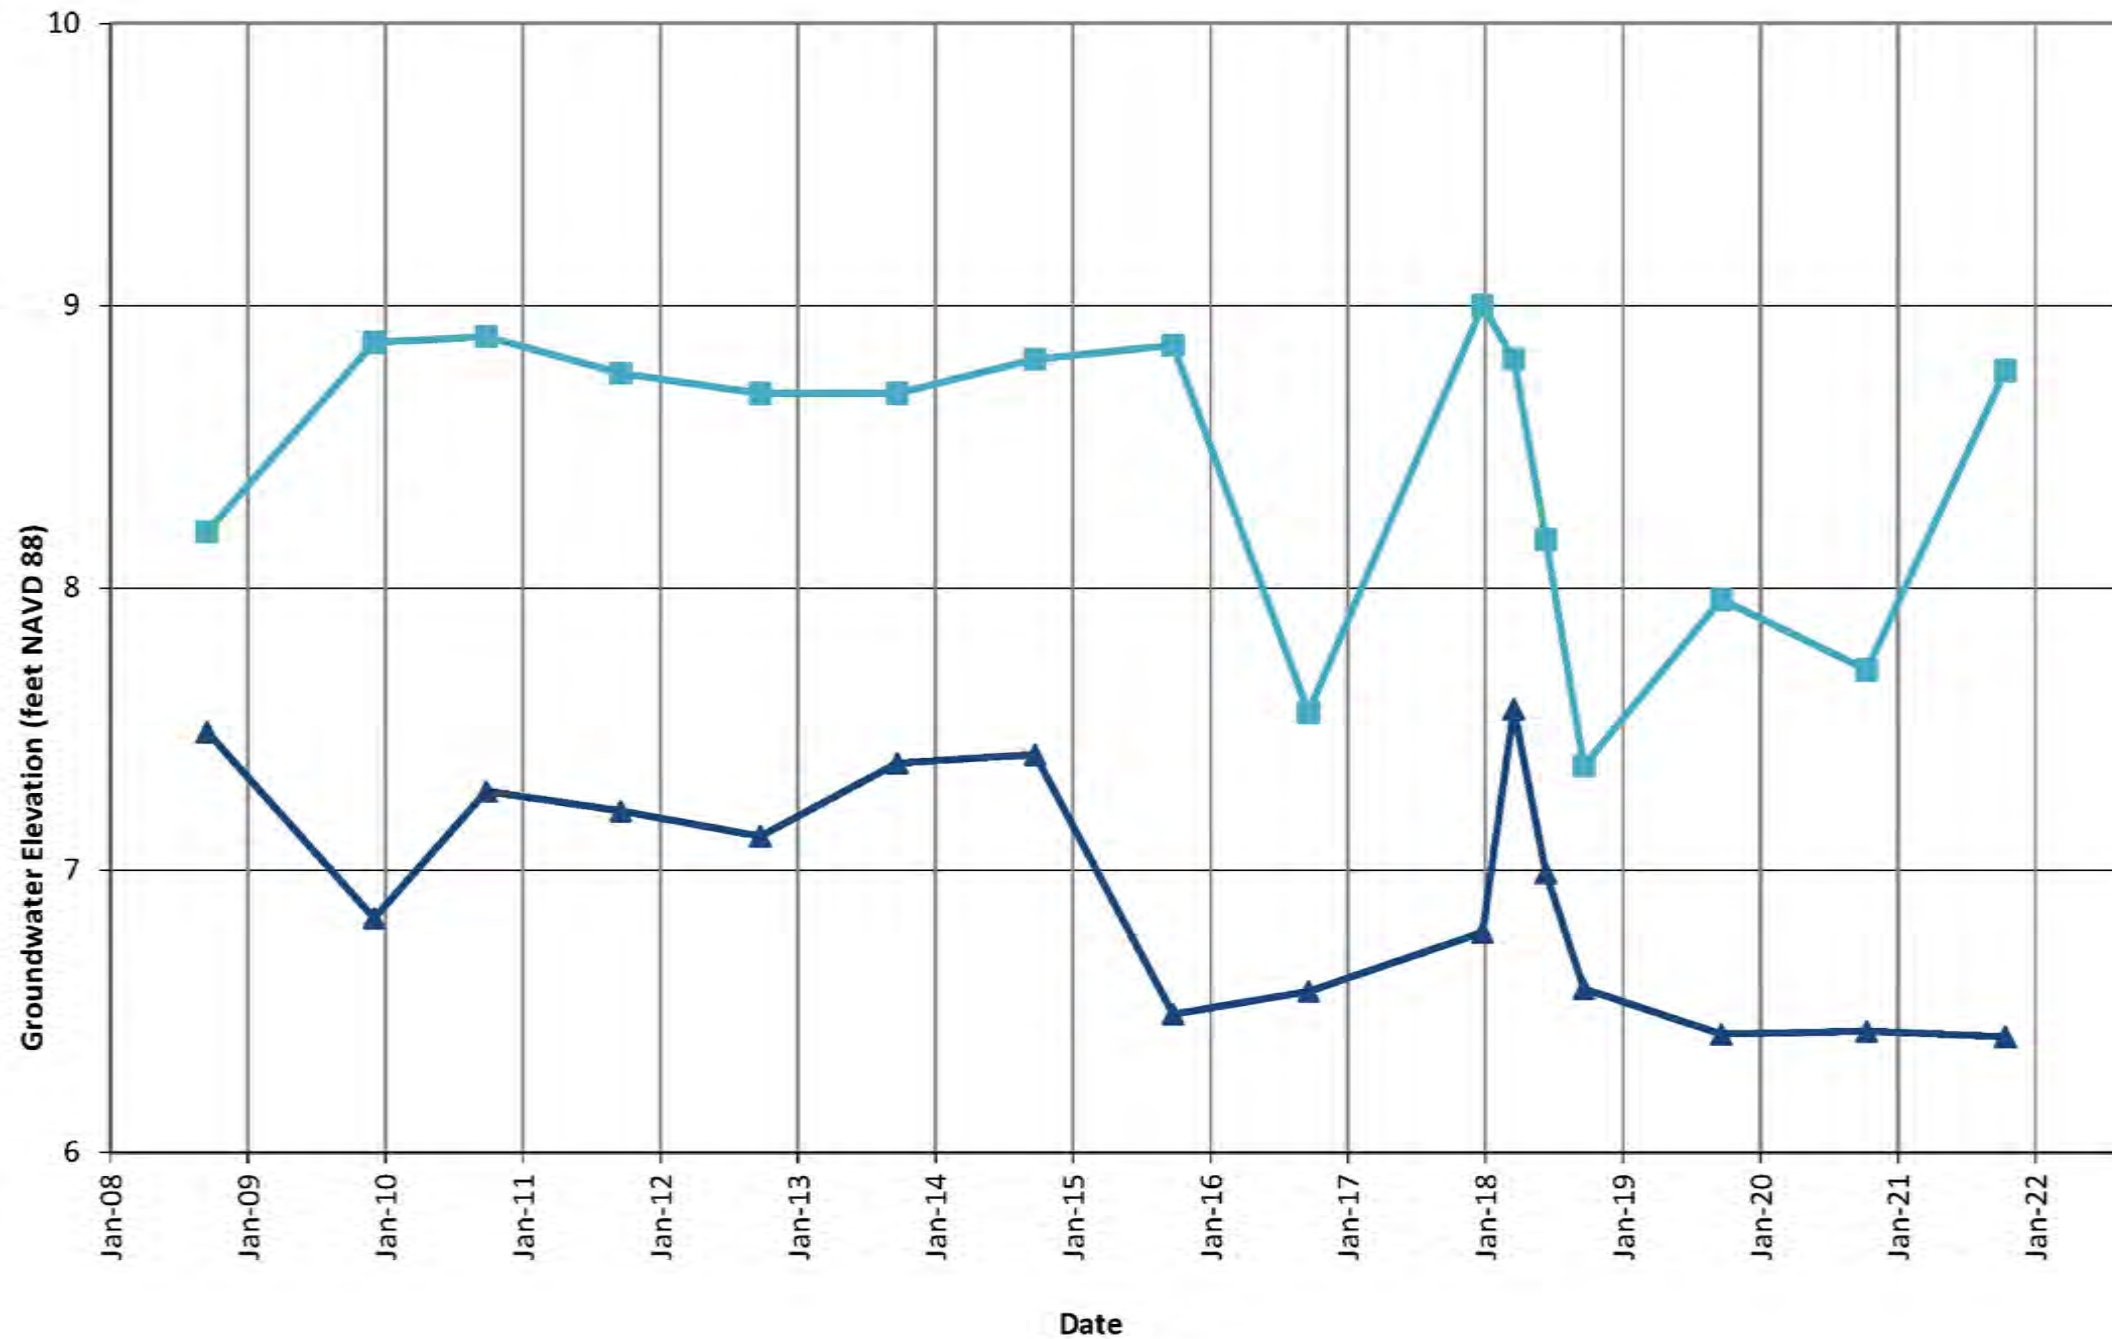
| 050654V001 | 11/21 | 3 |

- "A" WELLS ARE LOCATED INSIDE THE BARRIER WALL (IN THE UPPER SAND AQUIFER);
- "B" WELLS ARE LOCATED OUTSIDE THE BARRIER WALL (IN THE UPPER SAND AQUIFER).

**GROUNDWATER ELEVATION TRENDS
PZ-1A AND PZ-1B
FORMER MILL E / KOPPERS FACILITY
EVERETT, WASHINGTON**

Groundwater elevation trends for each piezometer pair are presented on Figures 3 through 5 and show a comparison of historical groundwater elevation data over time obtained for the Site. Review of the data indicates that consistently the groundwater elevations outside of the barrier wall are higher than inside the barrier wall with the exception for piezometer PZ-1A in 2007. The higher than expected water level in piezometer PZ-1A in 2007 was assessed and it was determined to be a result of surface water collecting in the well monument. After this observation, the top of the well monument was raised to prevent surface water from seeping into the monument (AESI; Technical Memorandum dated December 17, 2009).

The groundwater elevation data for the piezometers suggests the barrier wall is performing as intended and isolating groundwater inside the barrier from that outside the barrier.

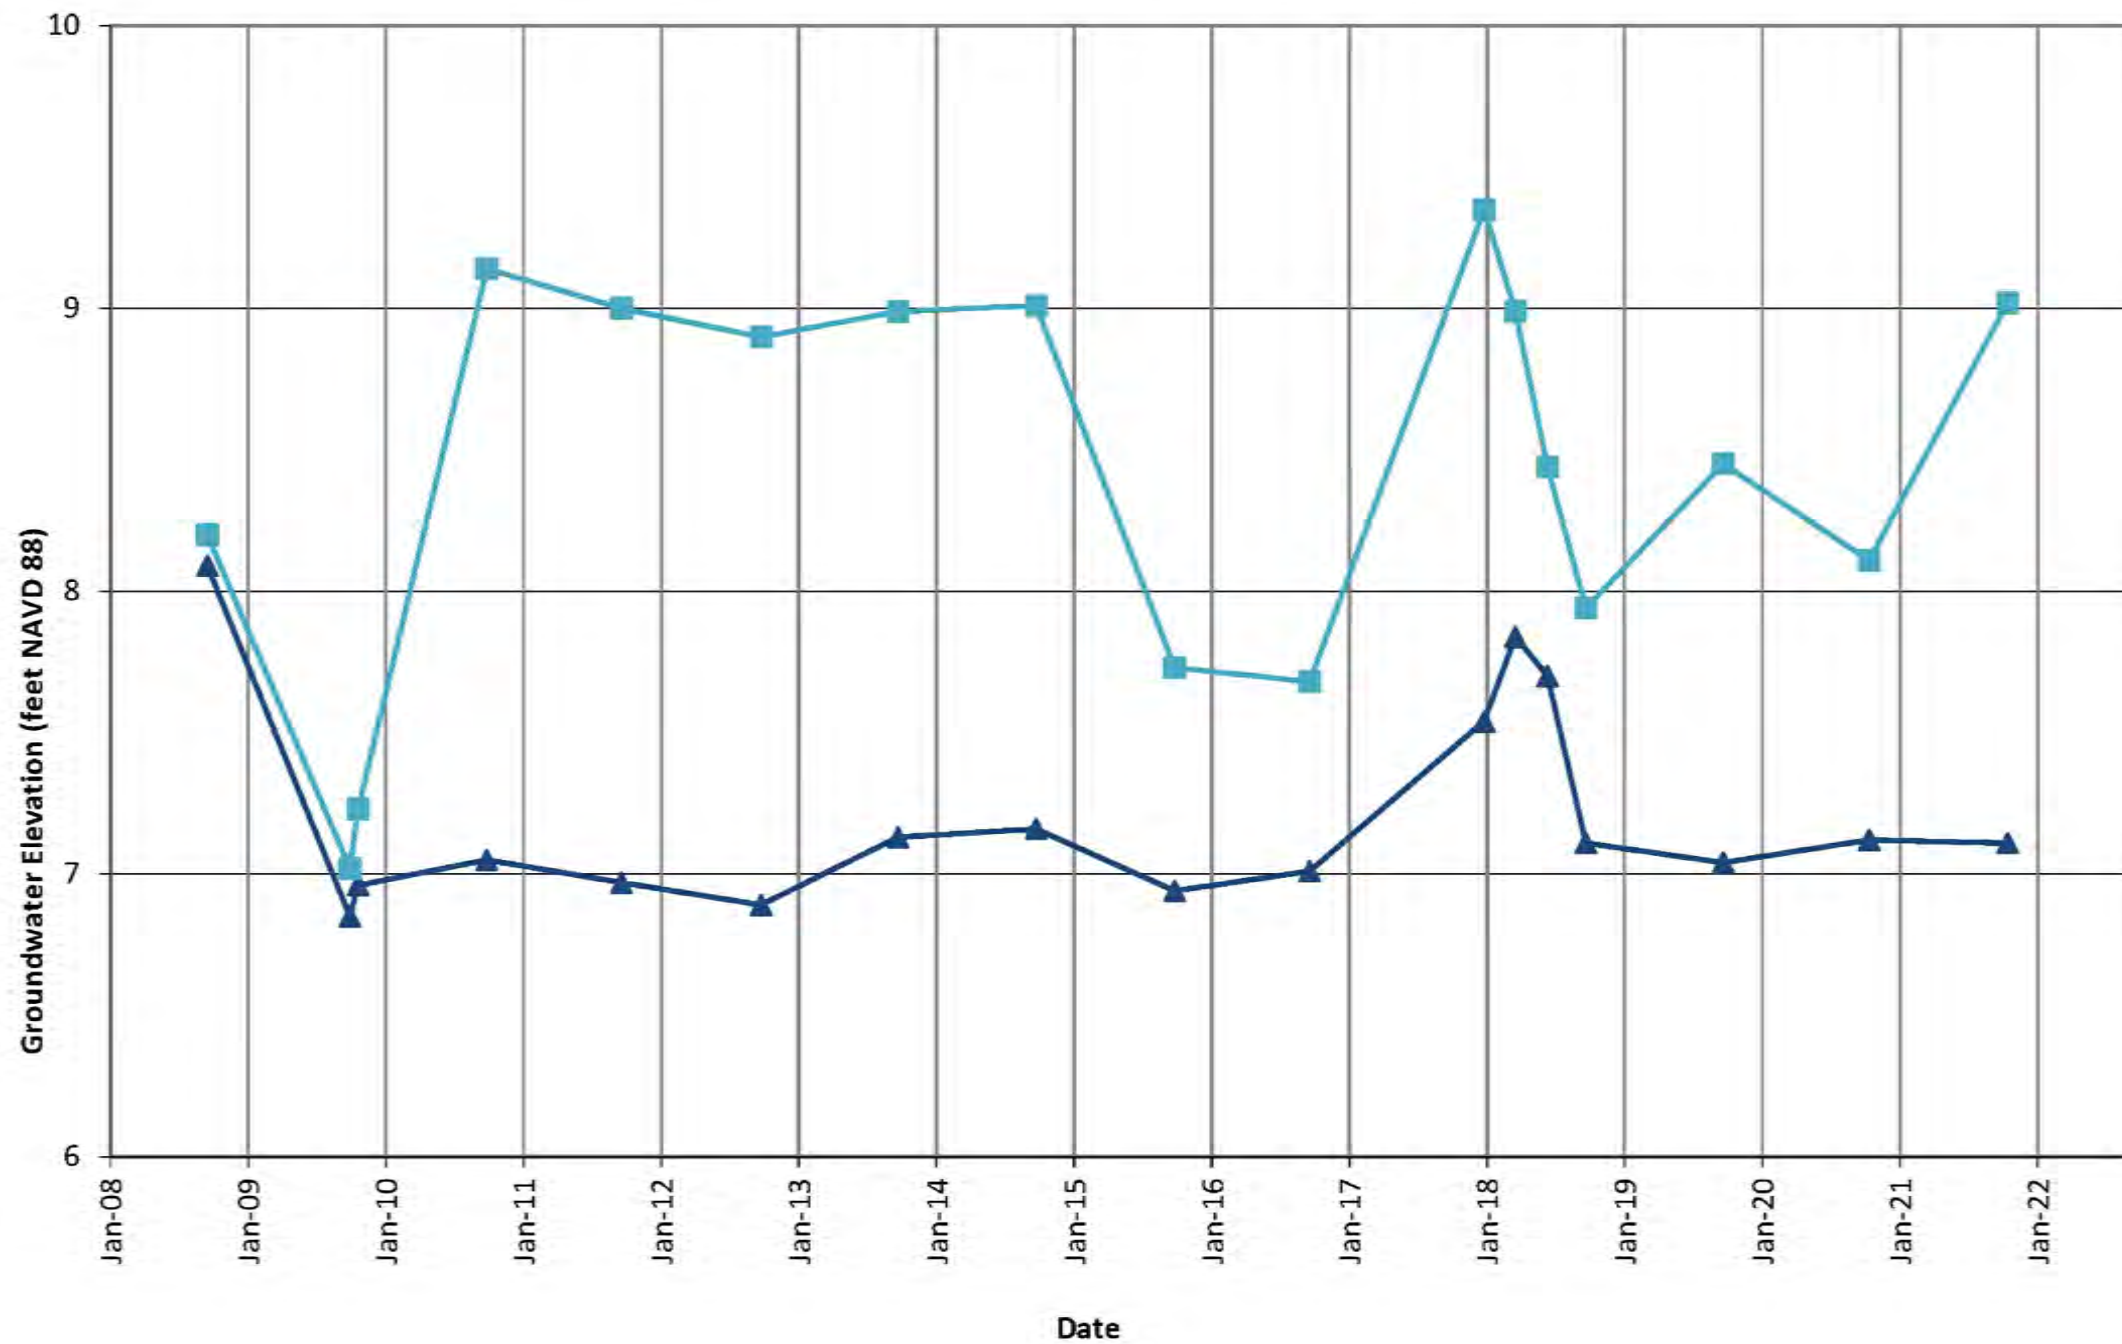
| 050654V001 | 11/21 | 4 |

1. "A" WELLS ARE LOCATED INSIDE THE BARRIER WALL (IN THE UPPER SAND AQUIFER);
2. "B" WELLS ARE LOCATED OUTSIDE THE BARRIER WALL (IN THE UPPER SAND AQUIFER).

**GROUNDWATER ELEVATION TRENDS
PZ-2A AND PZ-2B
FORMER MILL E / KOPPERS FACILITY
EVERETT, WASHINGTON**

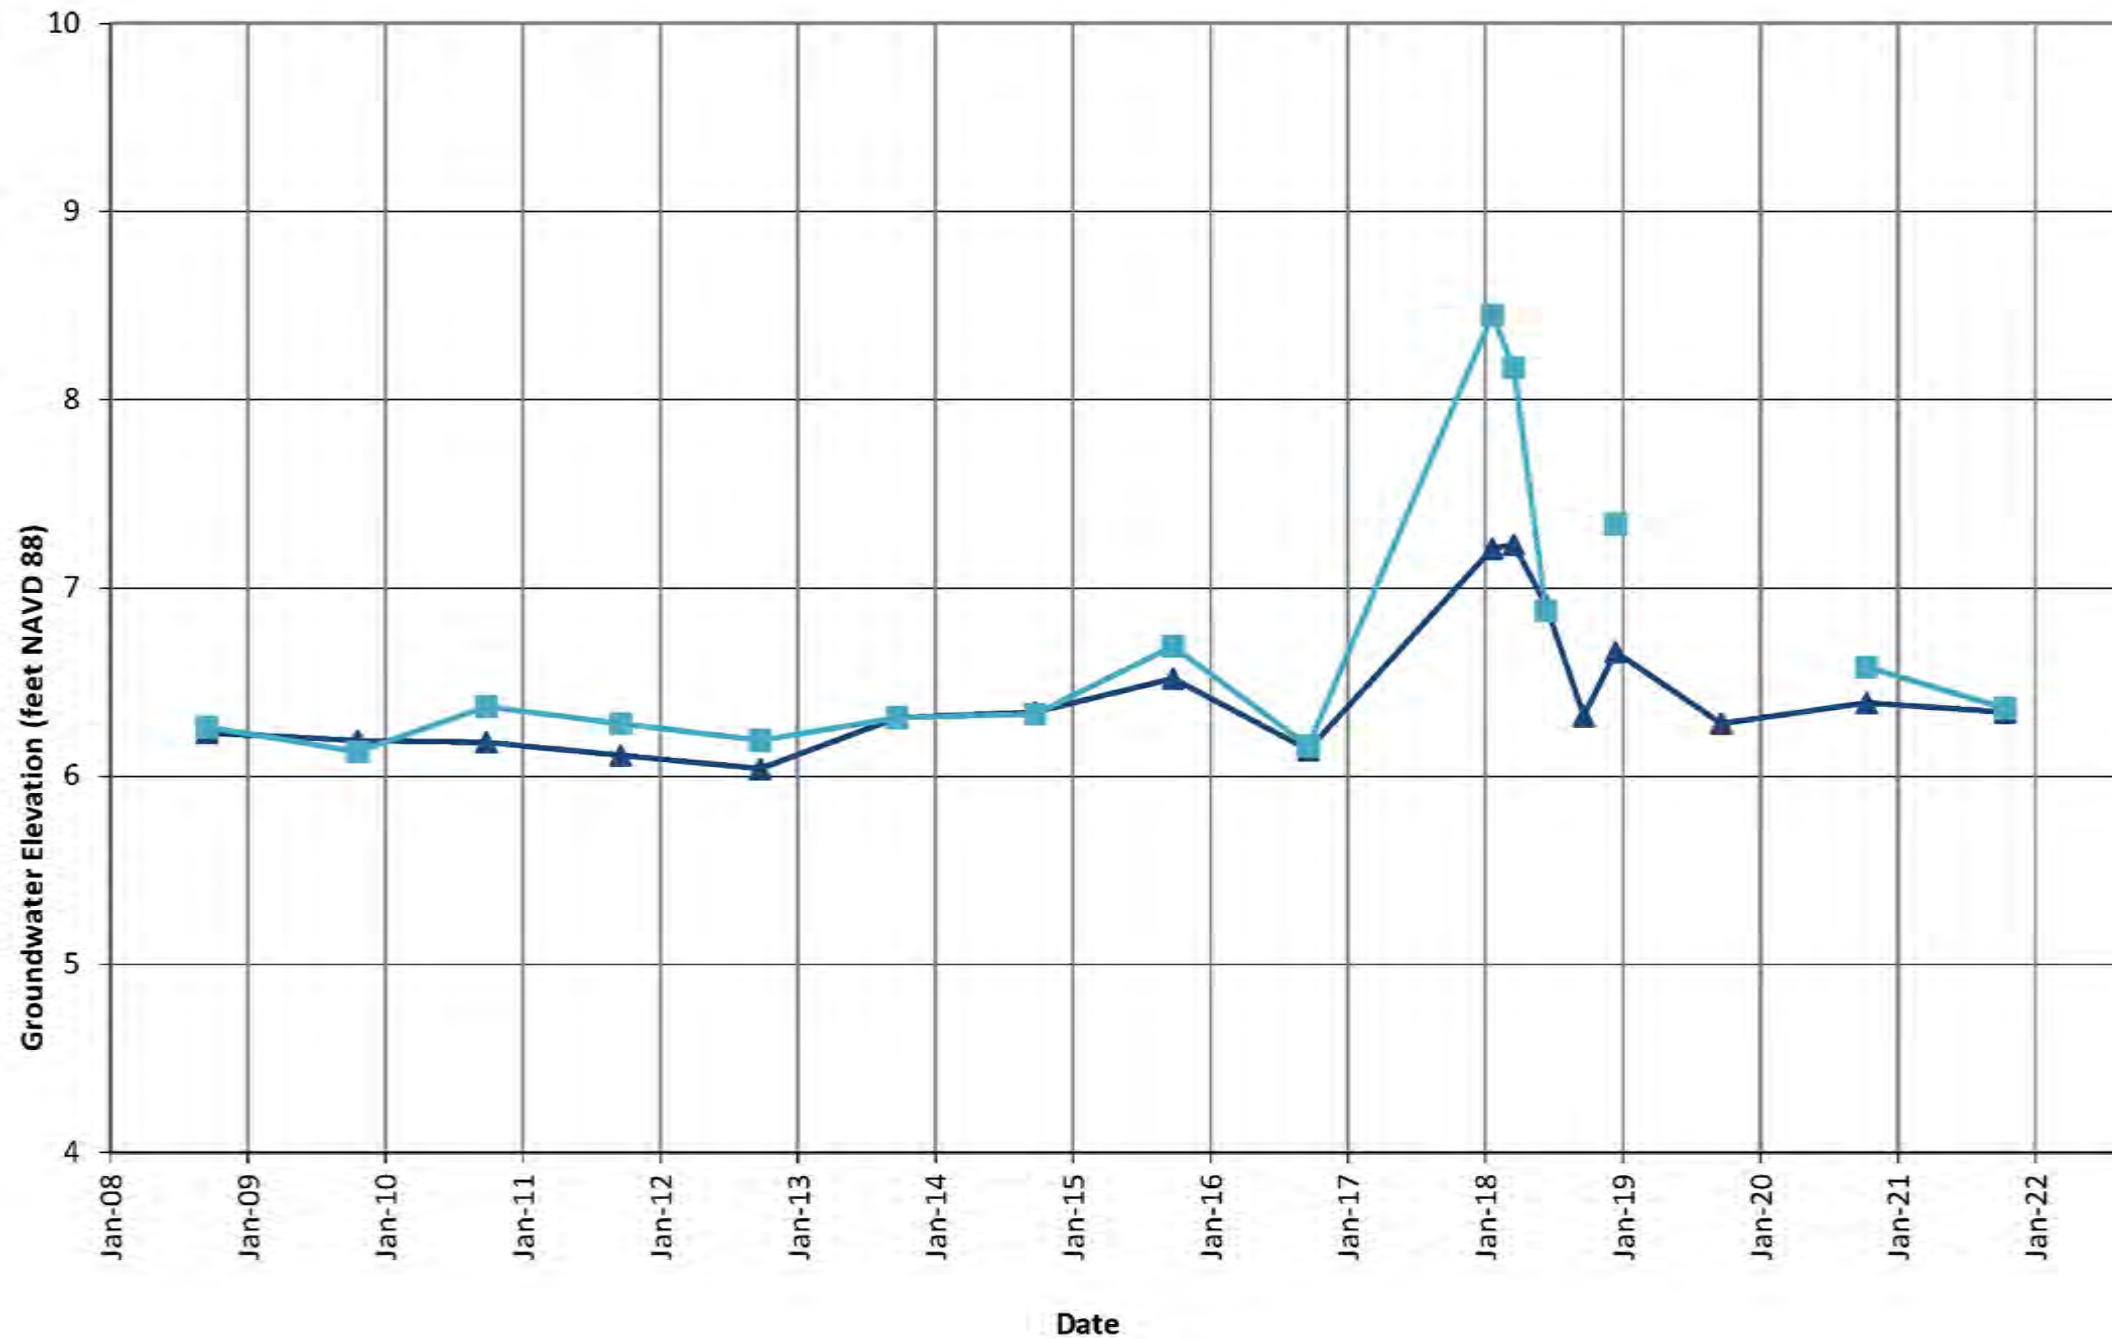
| 050654V001 | 11/21 | 5 |

1. "A" WELLS ARE LOCATED INSIDE THE BARRIER WALL (IN THE UPPER SAND AQUIFER);
2. "B" WELLS ARE LOCATED OUTSIDE THE BARRIER WALL (IN THE UPPER SAND AQUIFER).
3. PZ-3B WAS DRY DURING THE SEPTEMBER 2018 AND 2019 EVENTS.

**GROUNDWATER ELEVATION TRENDS
PZ-3A AND PZ-3B
FORMER MILL E / KOPPERS FACILITY
EVERETT, WASHINGTON**

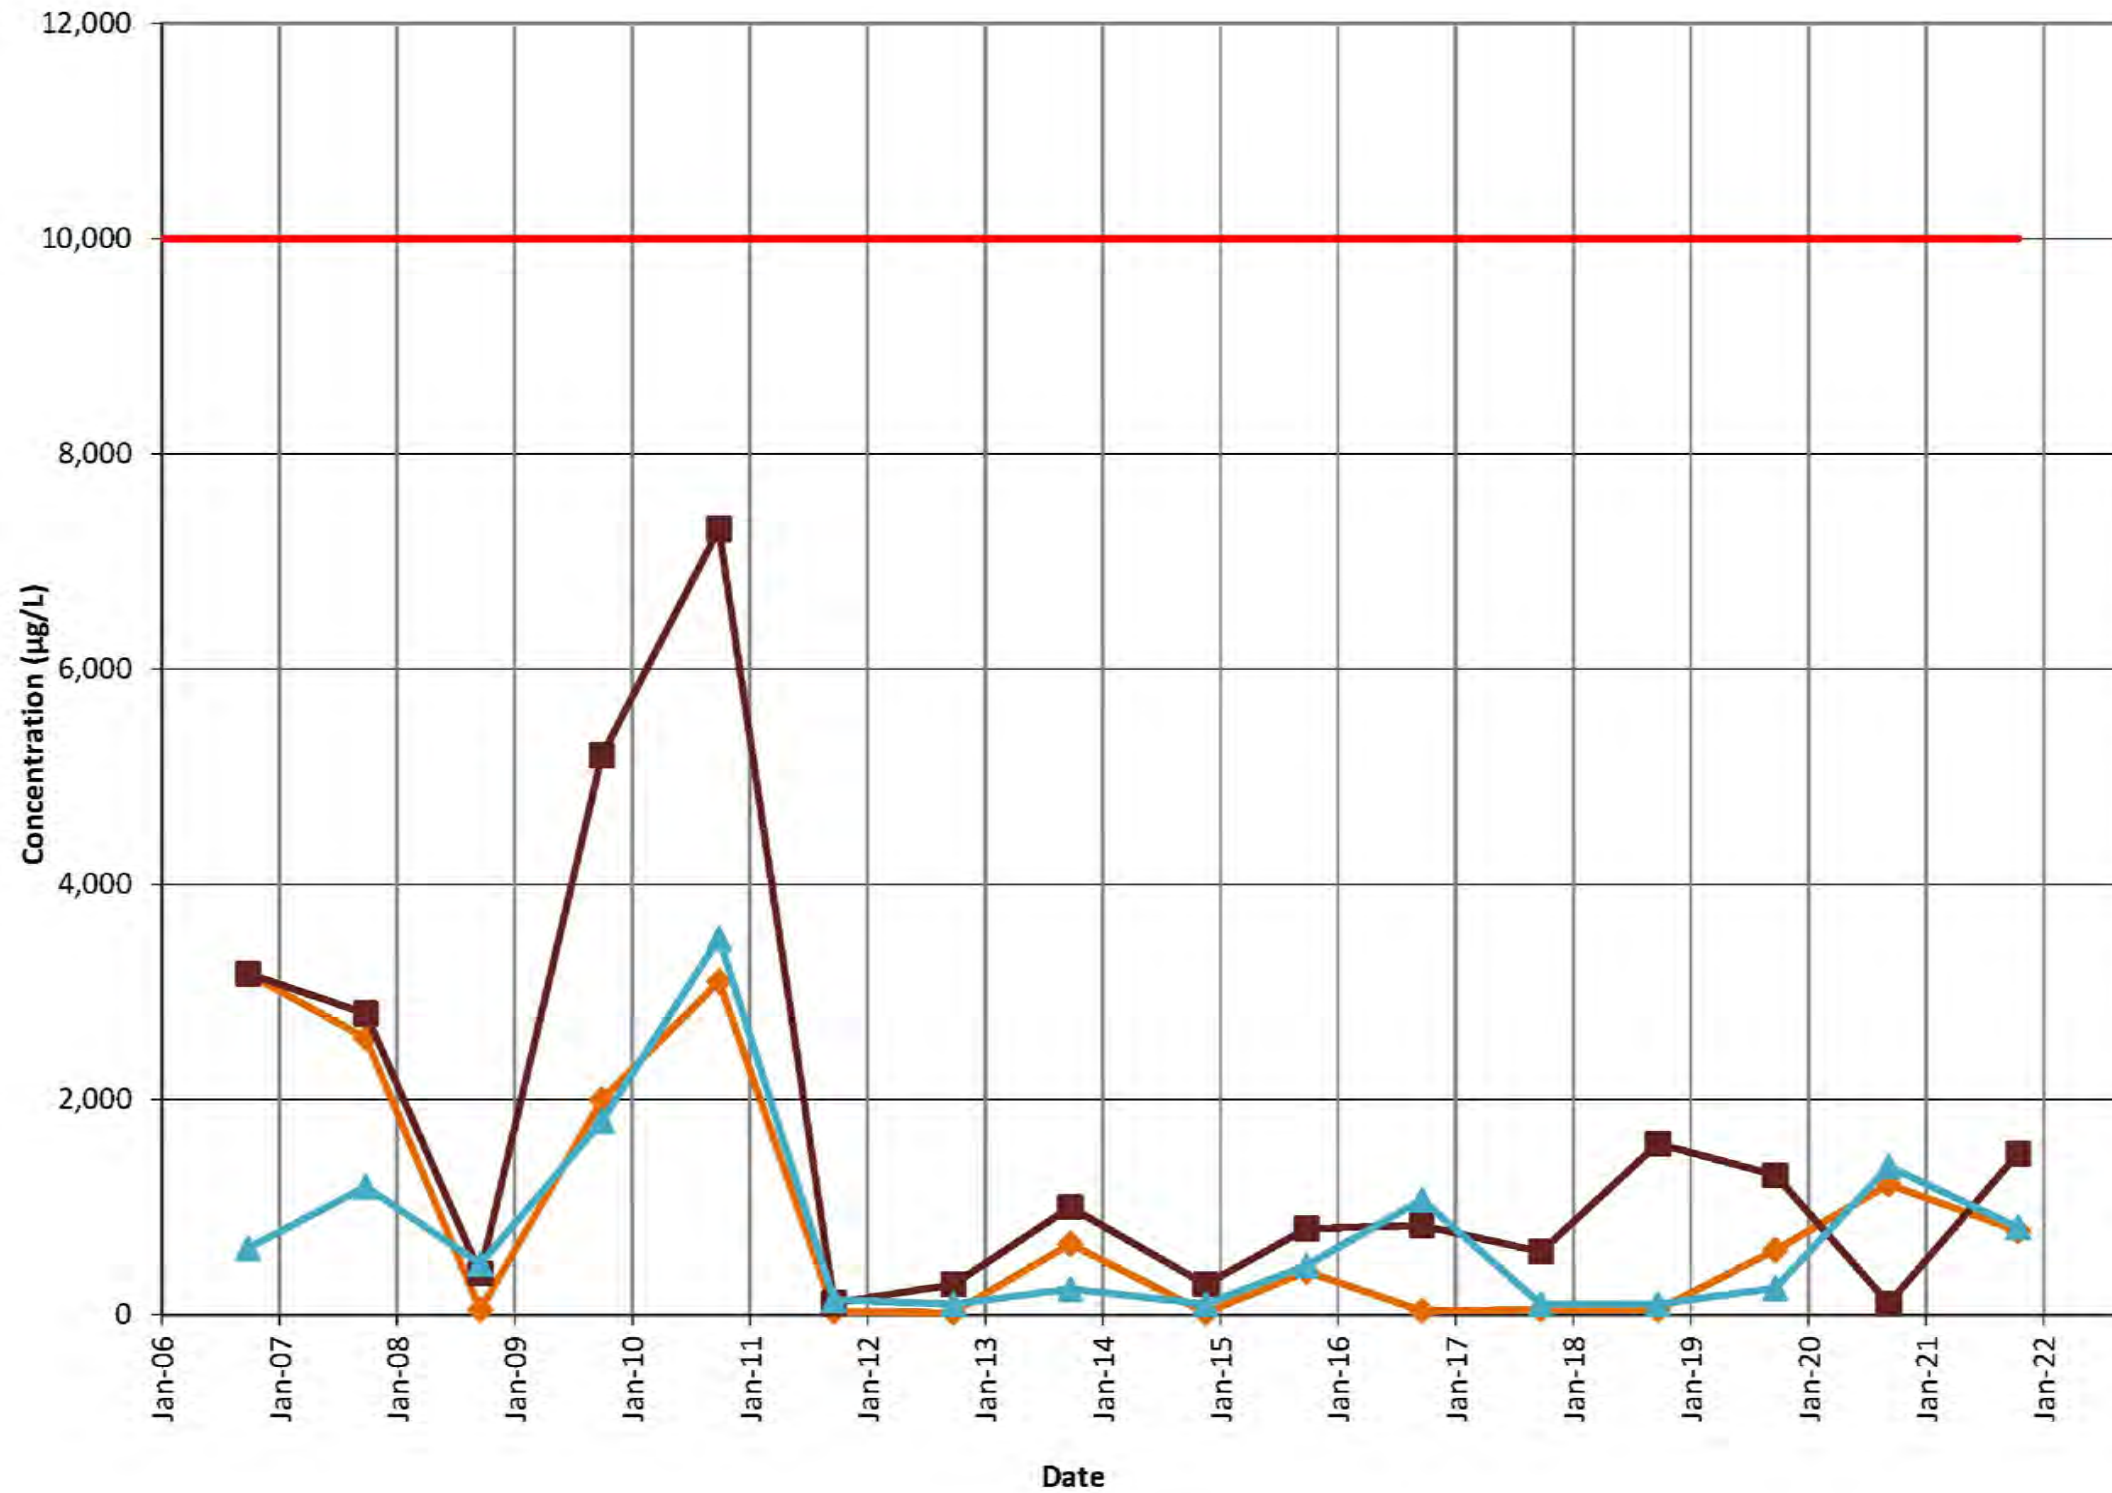
| 050654V001 | 11/21 | 6 |

Total Petroleum Hydrocarbon Concentrations

**GROUNDWATER QUALITY TRENDS
TPH
FORMER MILL E / KOPPERS FACILITY
EVERETT, WASHINGTON**

which exceeds the established MTCA cleanup level of 5 µg/L. Groundwater quality concentration trend (time-concentration) graphs over the past several years for total petroleum hydrocarbons (TPH), PCP, and arsenic are presented on Figures 6 through 8, respectively.

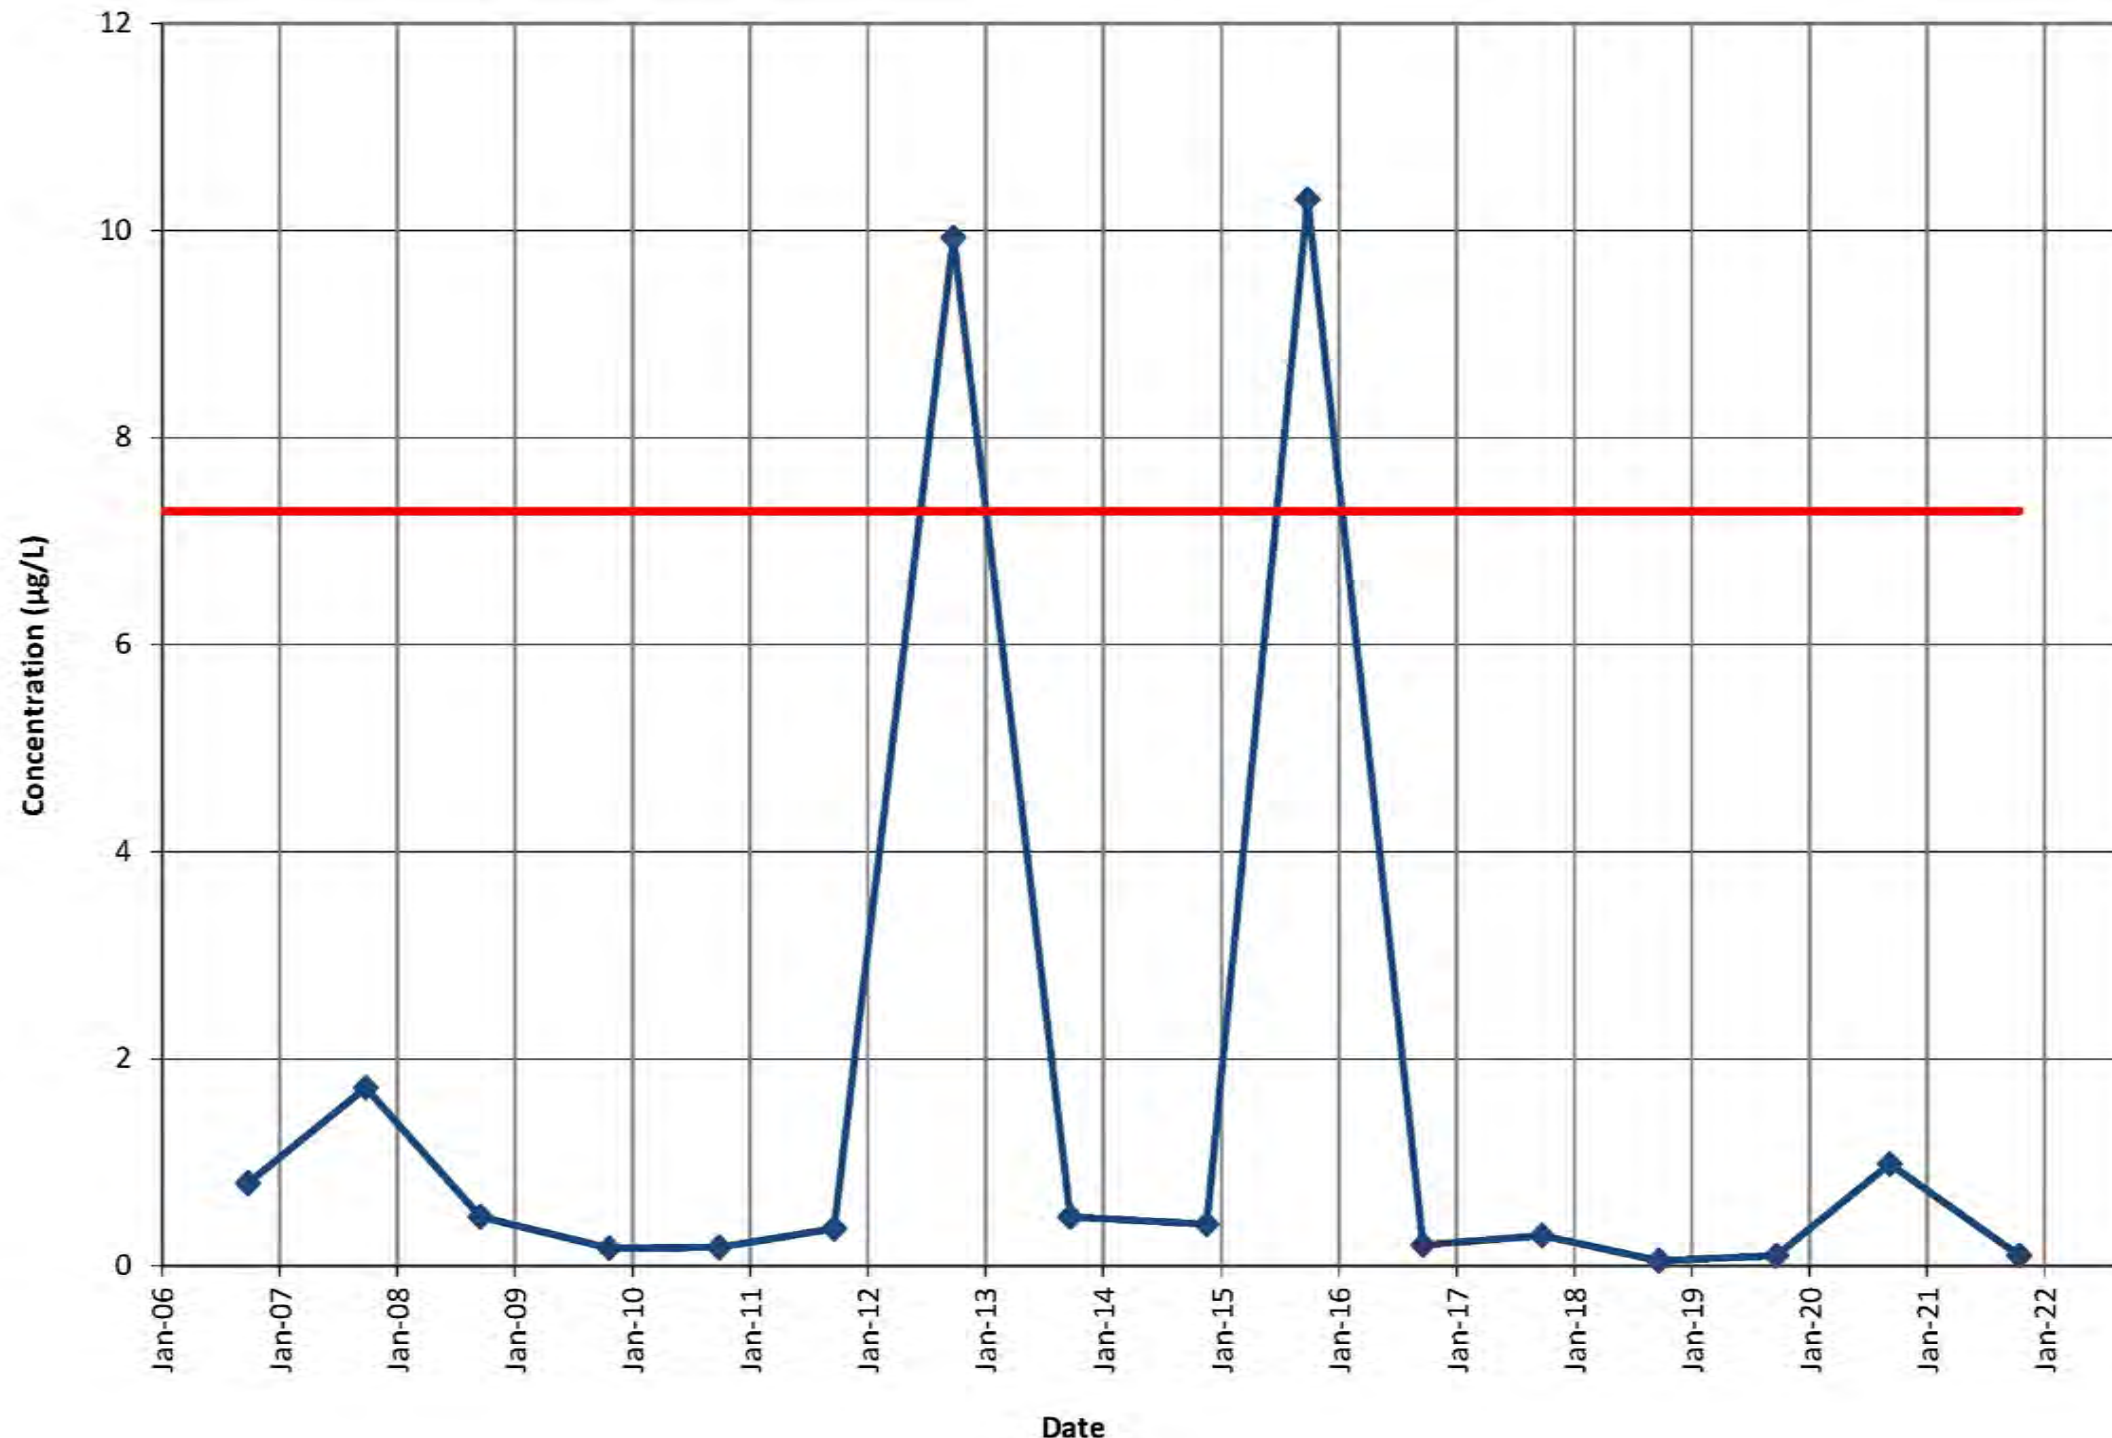
| 050654V001 | 11/21 | 7 |

Pentachlorophenol Concentrations

GROUNDWATER QUALITY TRENDS
PCP
 FORMER MILL E / KOPPERS FACILITY
 EVERETT, WASHINGTON

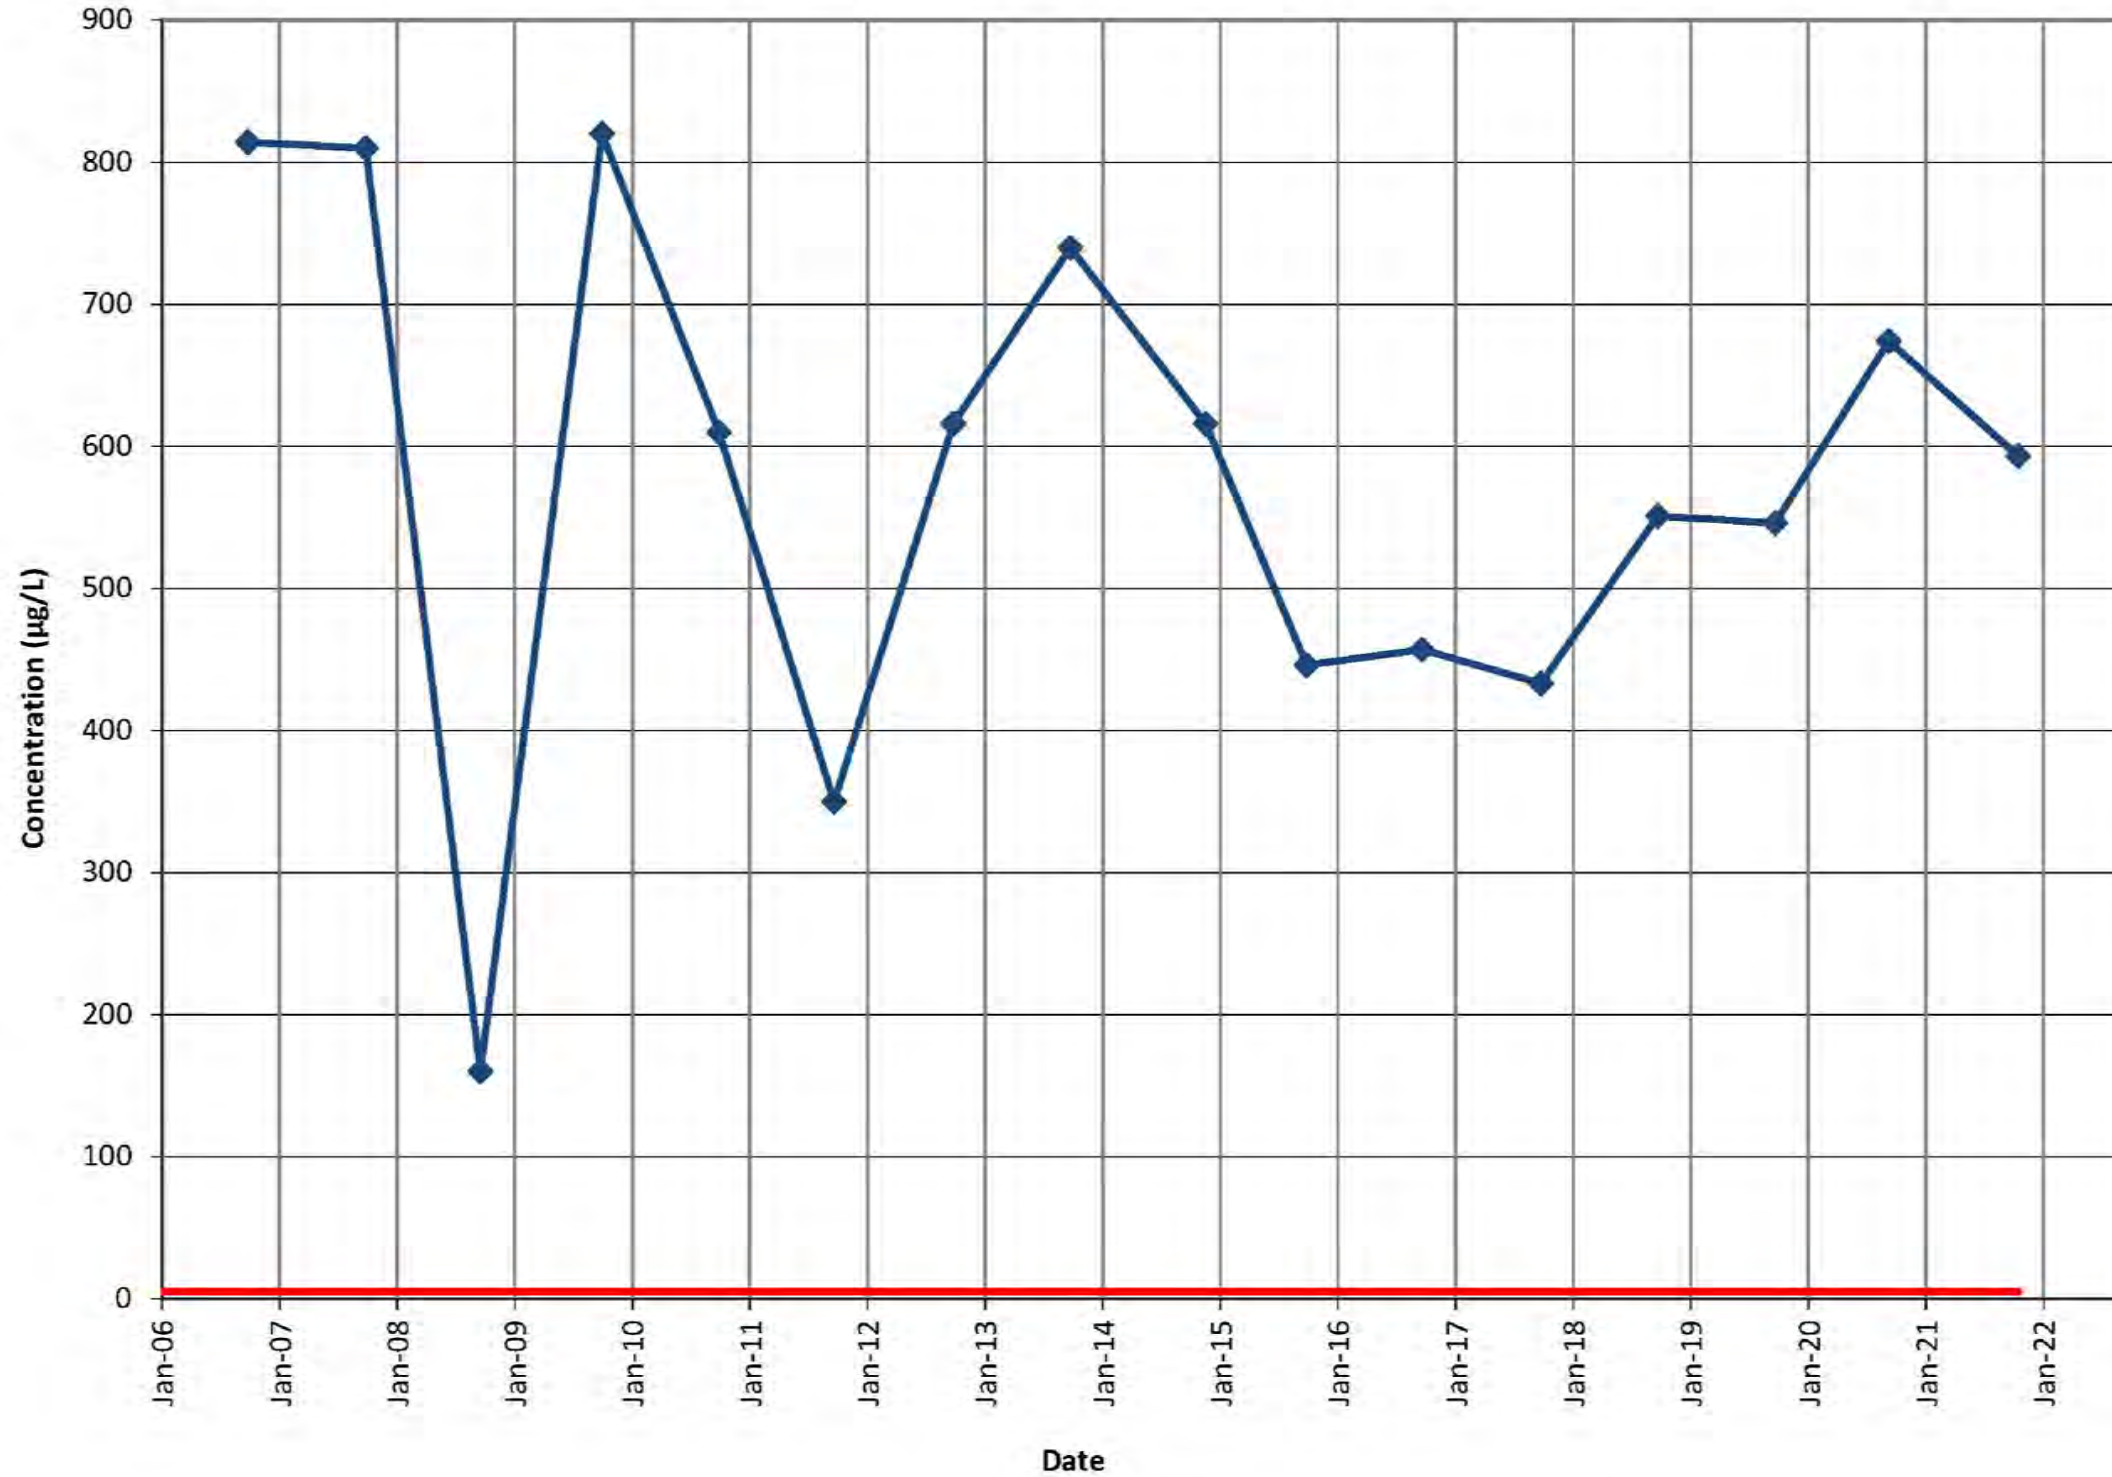
| PROJ NO. 050654V001 | DATE: 11/21 | FIGURE: 8 |

Groundwater analytical results are presented in Table 4 and a copy of the analytical laboratory report and chain of custody is included as Attachment 1. The results are compared to the Washington State Model Toxics Control Act (MTCA) Method A and Method C cleanup levels that were established for the Site during the 1998 Consent Decree (Washington State Department of Ecology [Ecology], 1998). GRPH and DRPH were detected at concentrations below the established MTCA cleanup level of 10,000 micrograms per Liter ($\mu\text{g}/\text{L}$). PCP was not detected at a concentration exceeding the laboratory reporting limit. Total arsenic was detected at a concentration of 546 $\mu\text{g}/\text{L}$,

Arsenic Concentrations

**GROUNDWATER QUALITY TRENDS
ARSENIC**
FORMER MILL E / KOPPERS FACILITY
EVERETT, WASHINGTON

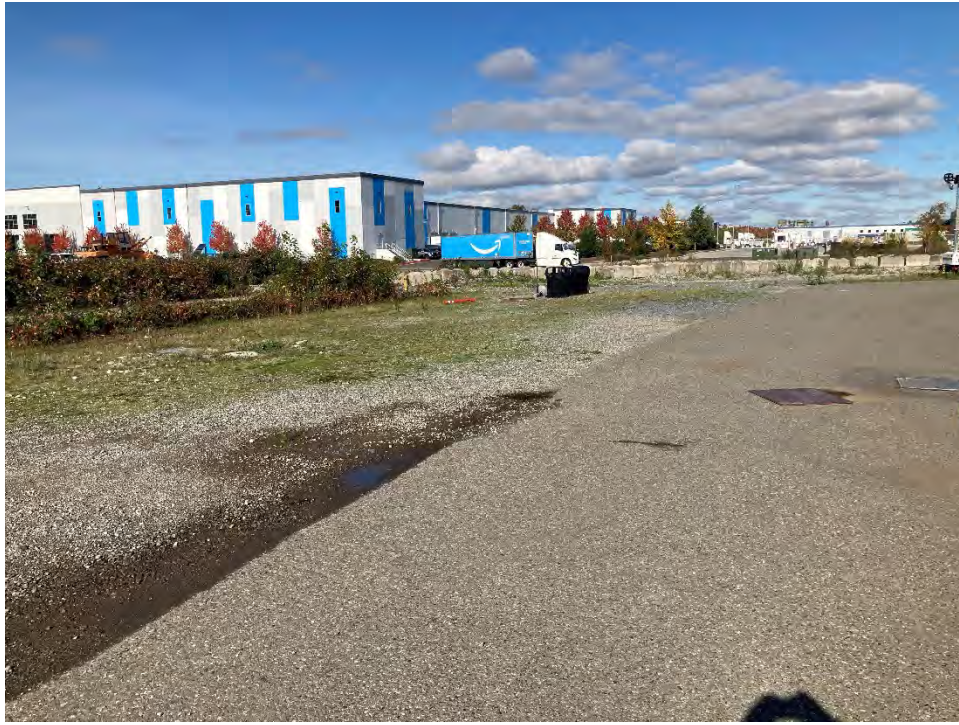
Photo 1. Looking north-northwest at the west portion of the asphalt cap.

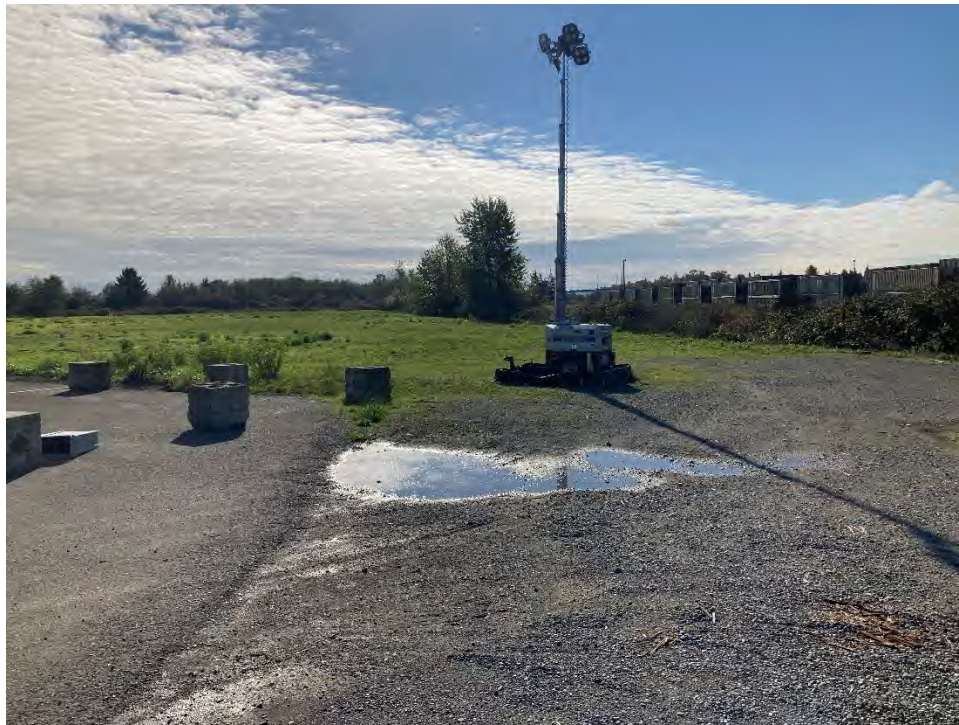
Photo 2. Looking south at the southwest portion of the asphalt cap and soil cover.

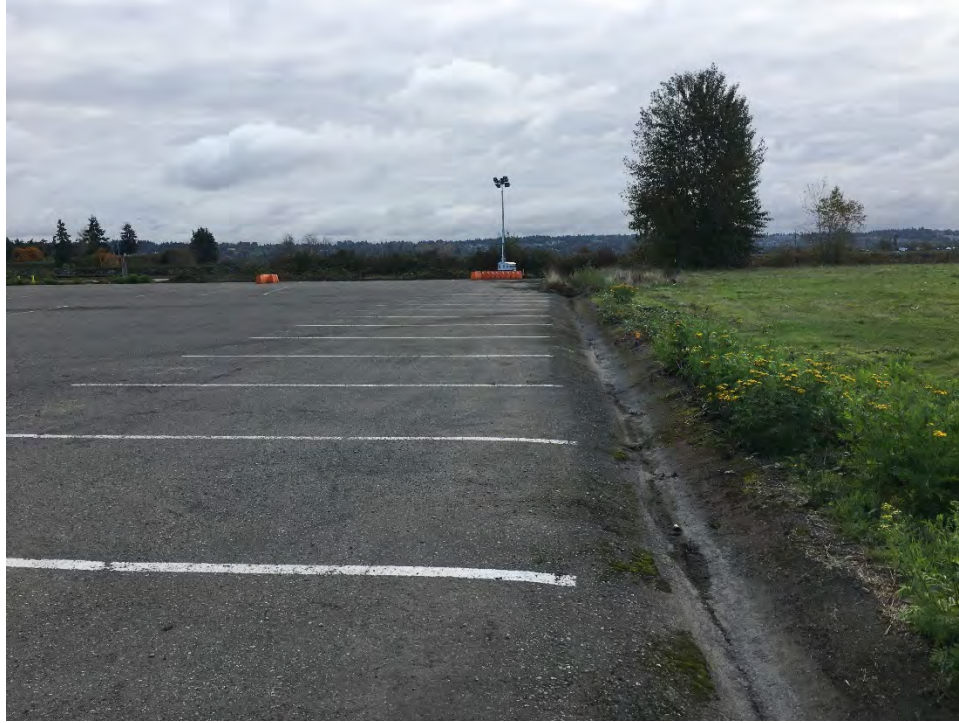
Photo 3. Looking east at the south drainage ditch. Less than 1 inch of accumulated sediment was observed.

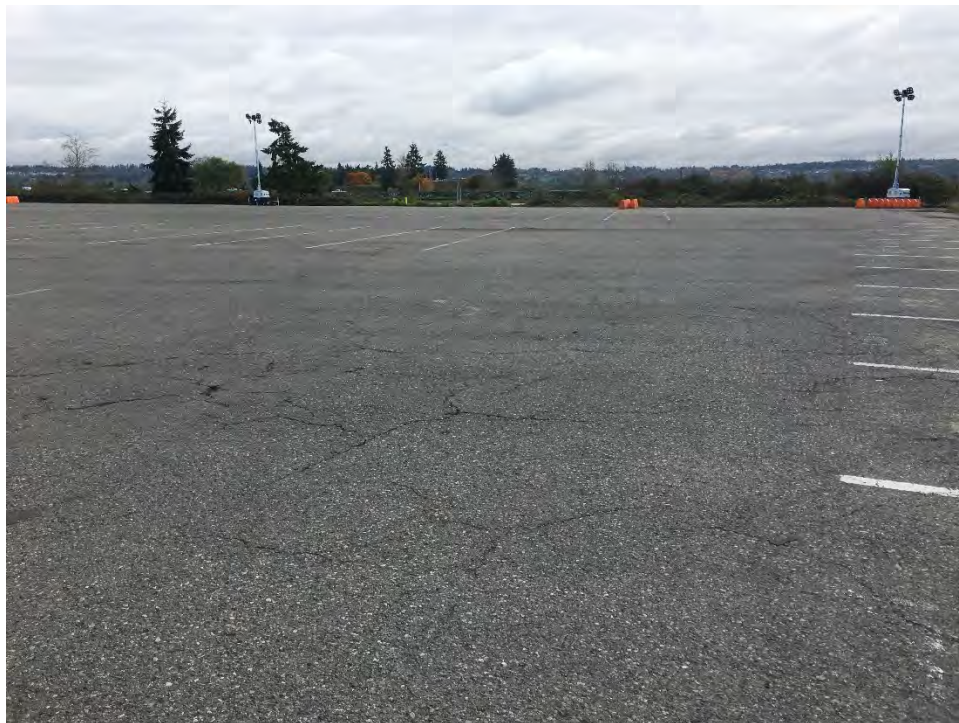
Photo 4. Observing minor cracking on the surface of the asphalt cap in the south portion of the asphalt cap.

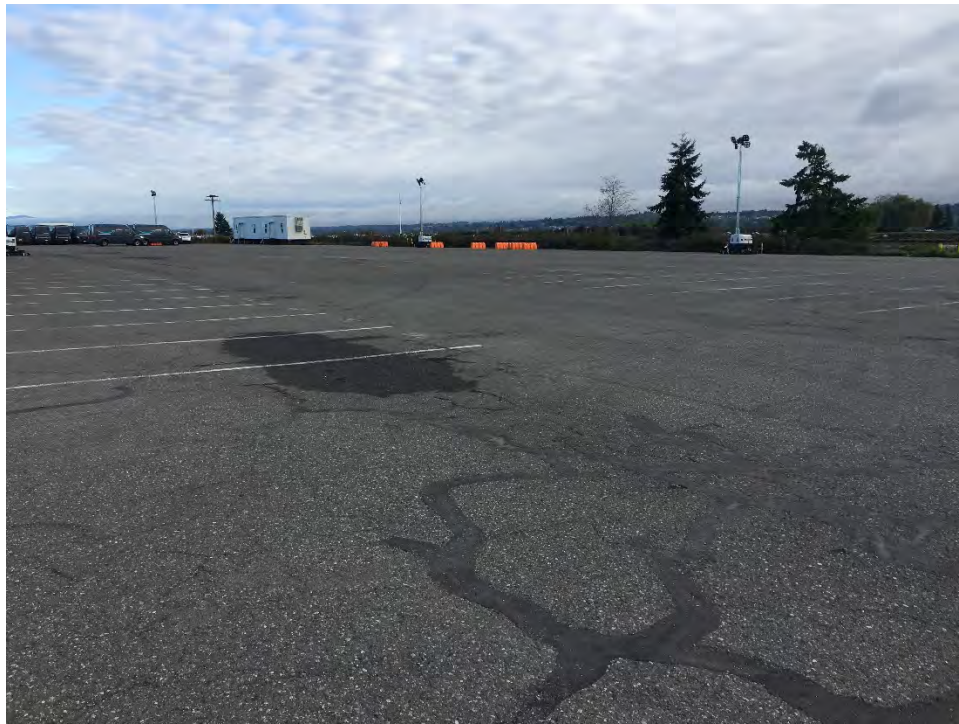
Photo 5. Facing northeast at the east portion of the asphalt cap. Repaired cracks are observed here.

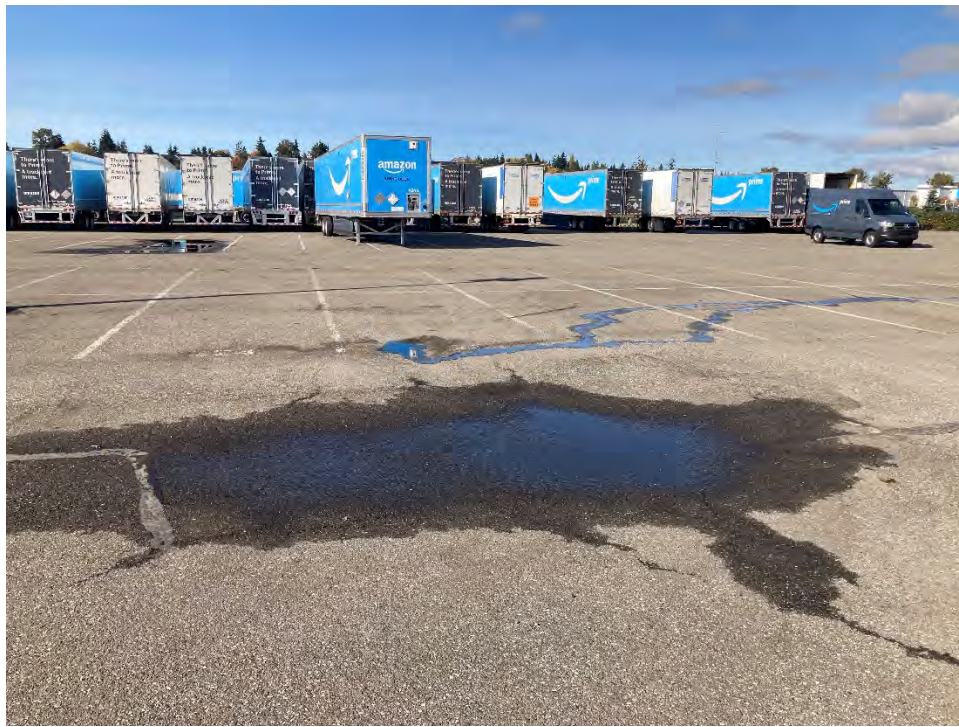
Photo 6. Observing the central portion of the asphalt cap.
