CONSTRUCTION COMPLETION REPORT

RAILROAD AVENUE

Prepared for
PORT OF RIDGEFIELD
RIDGEFIELD, WA
January 13, 2014
Project No. 9003.01.50

Prepared by
Maul Foster & Alongi, Inc.
400 East Mill Plain Blvd., Suite 400
Vancouver, WA 98660

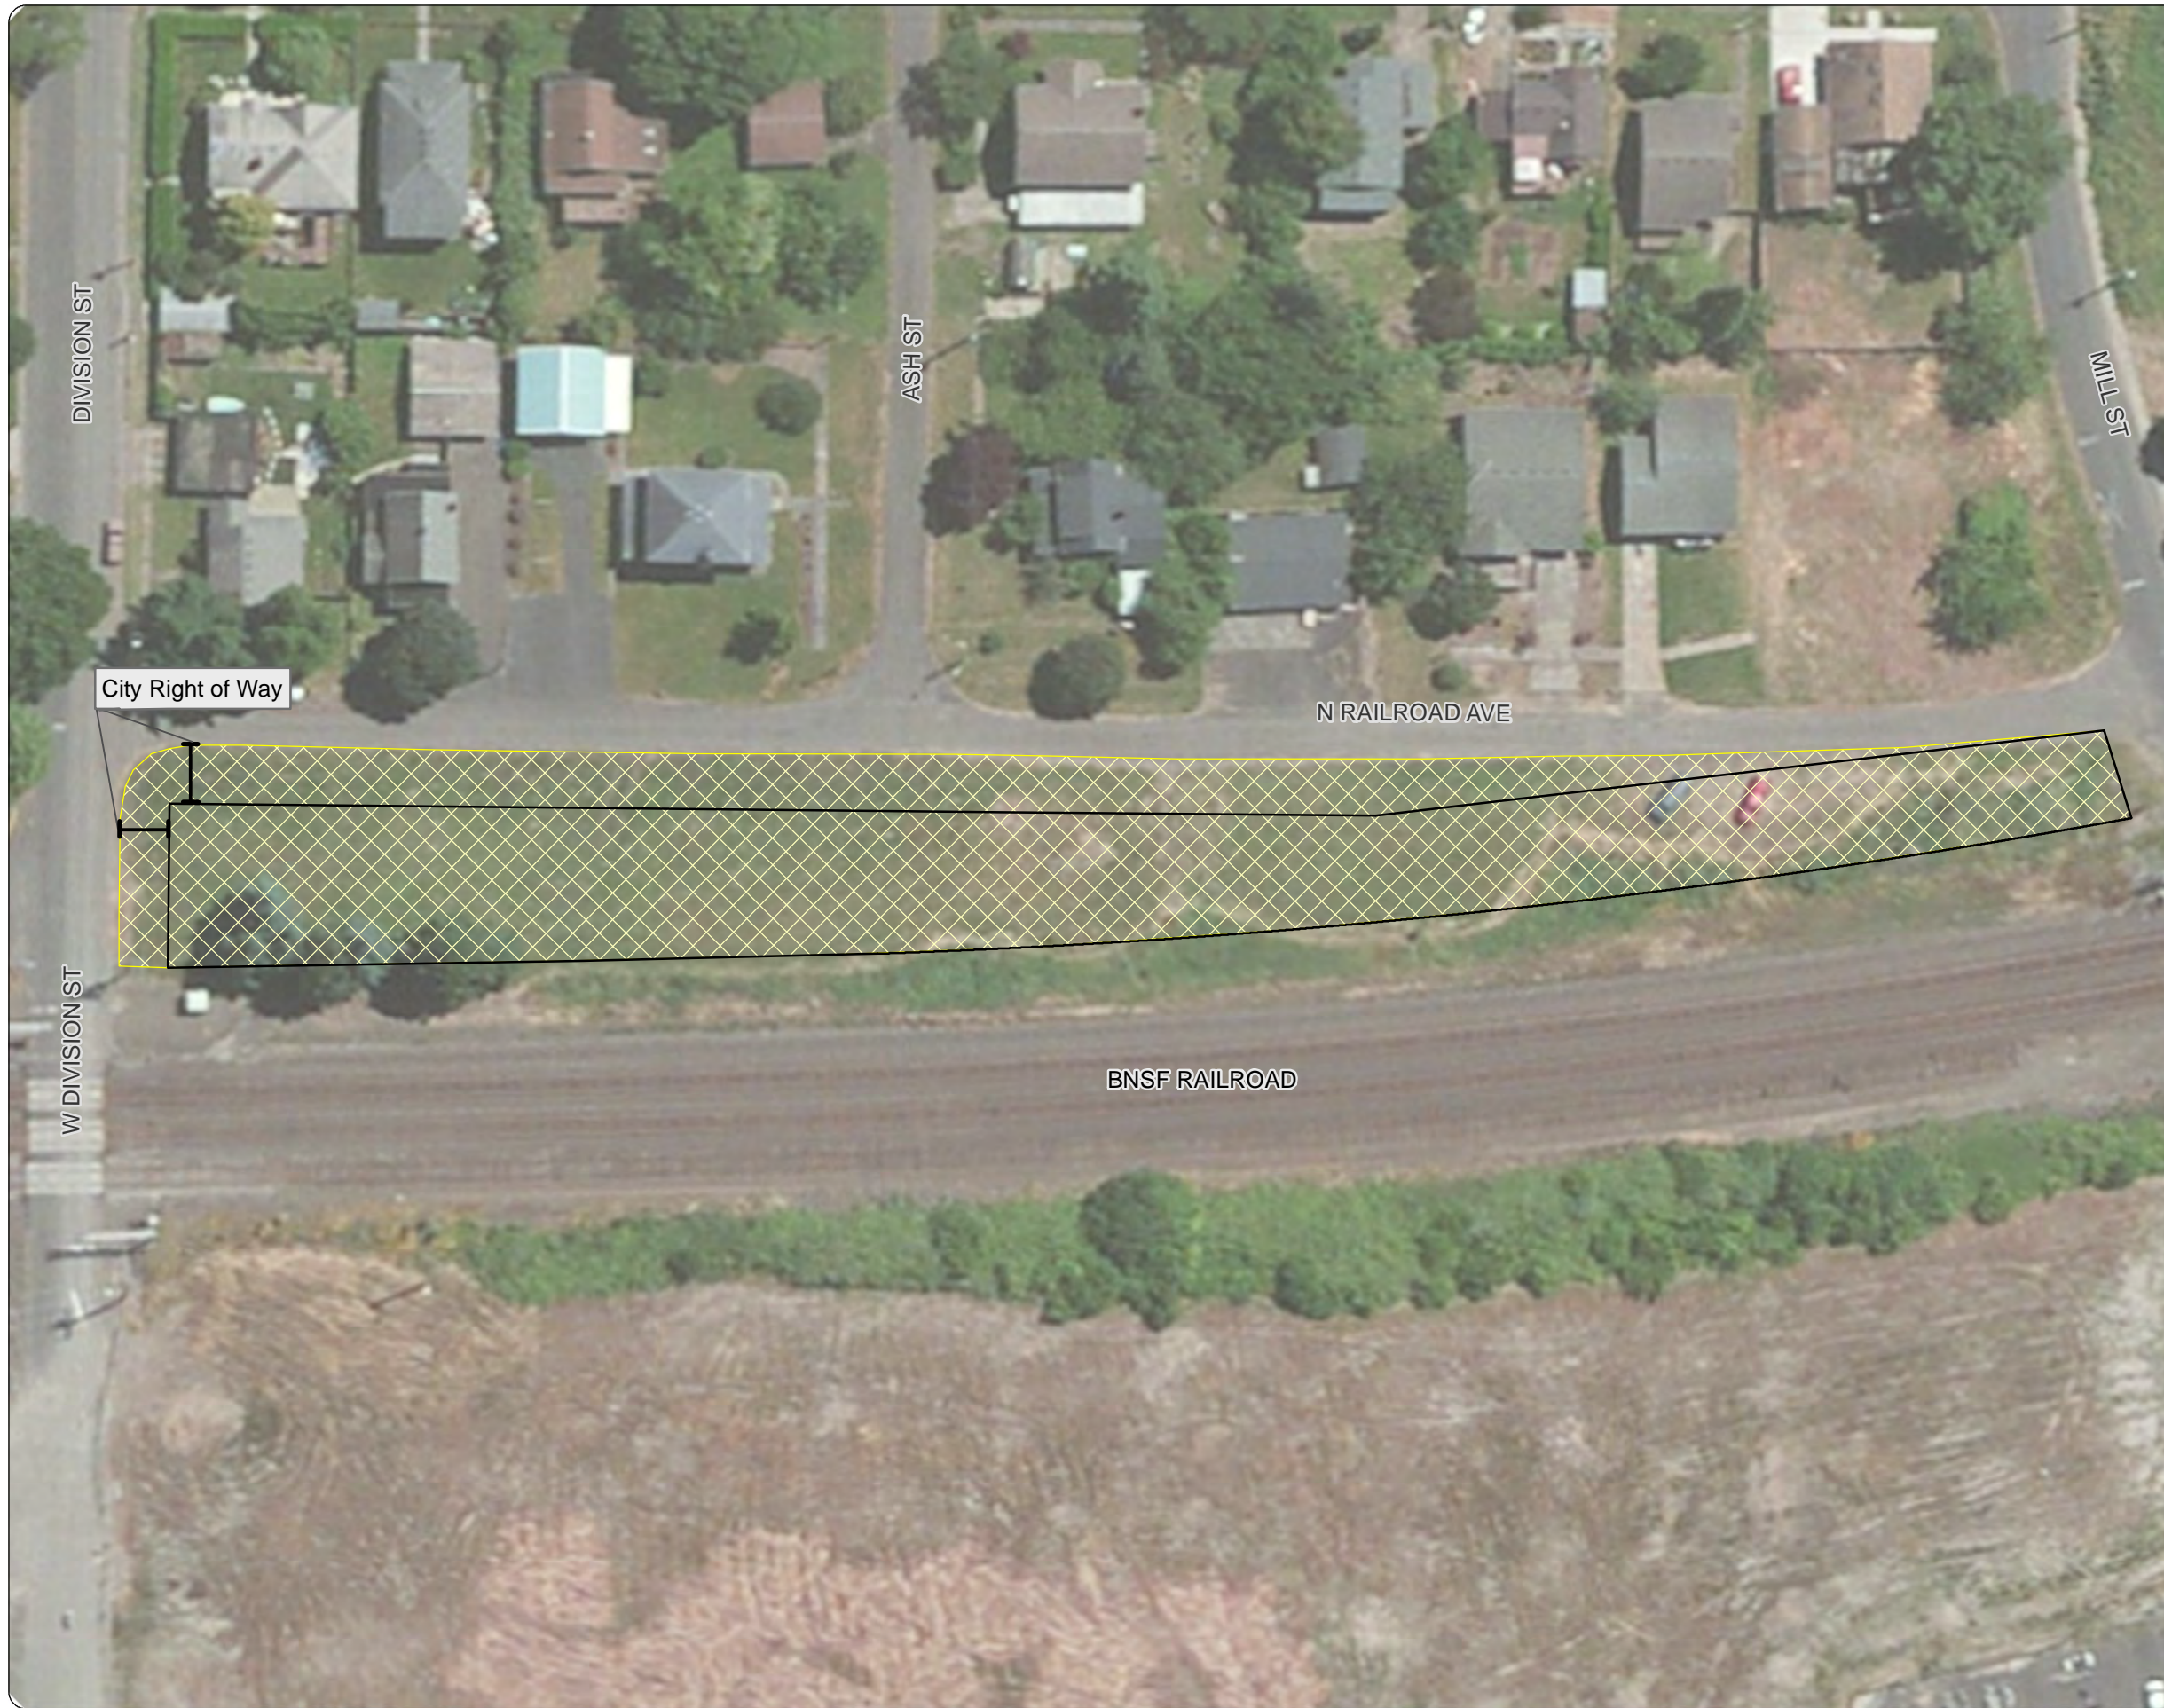
Figure 1-1 Railroad Avenue Remedial Action

The site consists of two Port-owned parcels located within the Ridgefield city limits at 325 Railroad Avenue, Ridgefield, Washington 98642 and the associated City ROWs to the north and east of these two parcels (see Figure 1-1). The site is located in the northwest quarter of the northeast quarter of section 24, township 4 north, range 1 west of the Willamette Meridian. The Clark County Property Identification Number is 67991003. The site is oriented north-south and is bordered by the Burlington Northern Santa Fe Railroad to the west, Railroad Avenue to the east, Mill Street to the south, and Division Street to the north. Railroad Avenue, Mill Street, and Division Street are City ROWs. The site is approximately 0.94 acre, and the remedy covers approximately 0.32 acre of City ROW and 0.62 acre of Port-owned property.

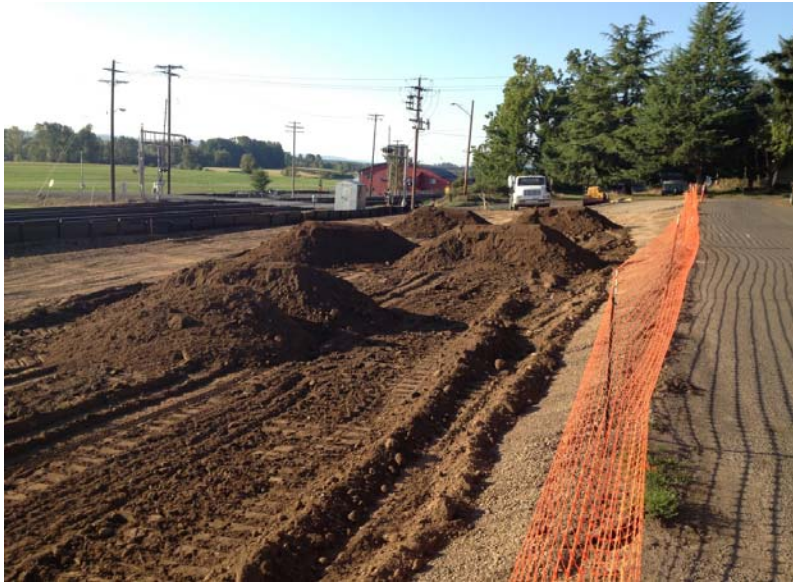
Photo 1: Material cut from high areas at the South Bench of the Railroad Avenue Site.

11:00	Mark Jones (Smith)	Correct the subgrade as described in the progress meeting.	Yes
14:30	Mark Jones (Smith)	South bench still appears too high.	No
Additional Remarks:			
See additional remarks above. At 14:30 M. Reiter (MFA) informed M. Jones (Smith) that the south bench did not appear to be sufficiently cut down. At this time three truck loads of material had been moved from south to north (approximately 30 CY) and Smith and Smith was just starting to run the roller compactor over the south bench to begin compaction again. At this time Smith and Smith elected to check grade with a level and a tape at the edge of asphalt, and secured a laser level for tomorrow. Seven additional truck loads were hauled to the north end. M. Reiter (MFA) informed M. Jones (Smith) that he would not approve grades in the field, and that the survey submittal would be the final subgrade approval mechanism.			
Equipment Onsite

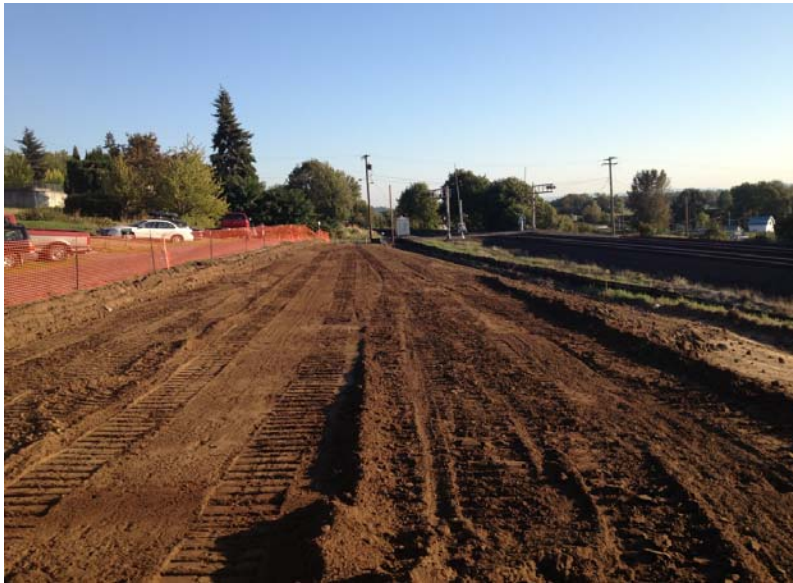
Photo 2: Reworking the subgrade at the Railroad Avenue Site.

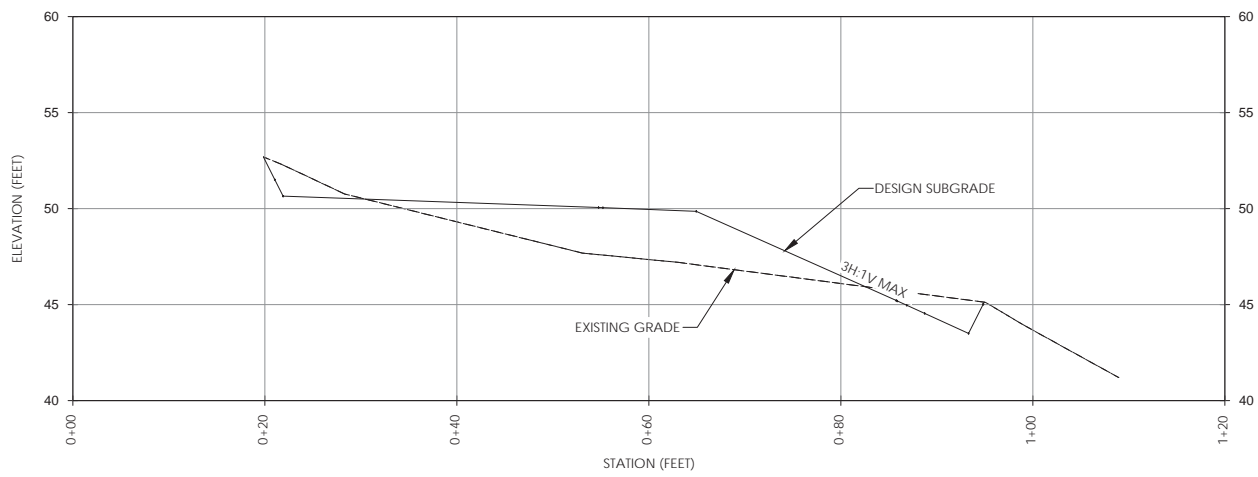
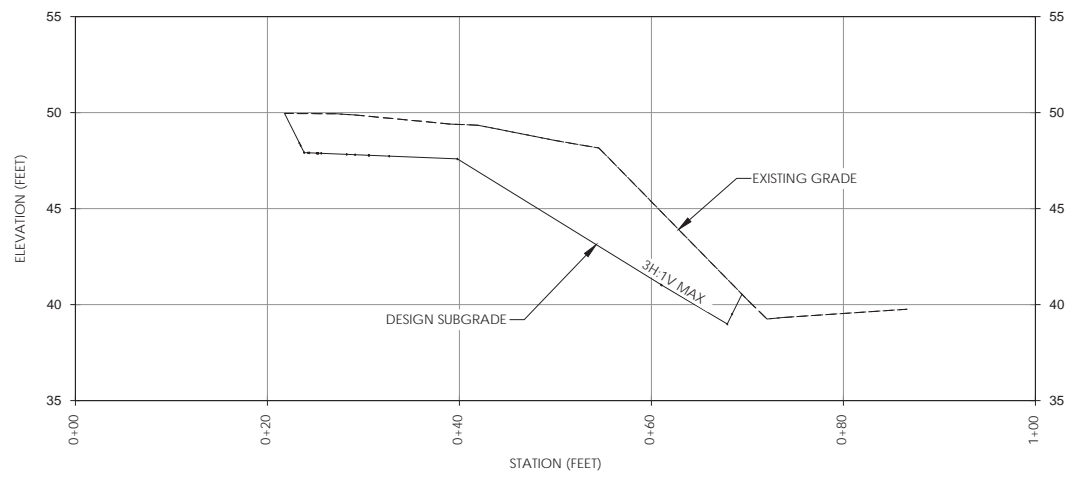
SHEET
C2.0

Minor pumping observed

PROFILE VIEW OF SECTION A-A'
HORIZONTAL SCALE: 1" = 10' VERTICAL SCALE: 1" = 5'
VERTICAL EXAGGERATION: 2

PROFILE VIEW OF SECTION B-B'
HORIZONTAL SCALE: 1" = 10' VERTICAL SCALE: 1" = 5'
VERTICAL EXAGGERATION: 2

Smith & Smith began grading the site to the lines and grades shown on the plans during the week of September 2. Subgrade material generally was excavated from the southern portion of the site and placed on the northern portion of the site. No soil was removed from the site. Subgrade adjacent to Railroad Avenue was cut away from the pavement section to a depth of approximately 2 feet and gently sloped toward the west to create a bench. Cut material was used to construct a minimum slope of 3:1 from the west extent of the property up to the newly constructed bench. The subgrade compaction was approved by GeoDesign on September 10. A copy of the field report verifying compaction results is included as Appendix B.

Two subgrade surveys were performed before MFA authorized Smith & Smith to begin constructing the clean soil cap. A topographic survey of the subgrade was first performed by MGS on September 11 and was submitted to MFA on September 12. After reviewing this initial survey, MFA determined that the subgrade was not in sufficient accordance with the lines, grades, and cross sections shown on the construction drawings. Smith & Smith performed additional earthwork over the next four days to excavate high areas, soften steep slopes, and eliminate depressions to provide positive drainage to the west. The second subgrade survey was performed by MGS on September 13. MFA approved the survey and authorized Smith & Smith to place demarcation fabric and proceed with construction of the clean soil cap on September 14.

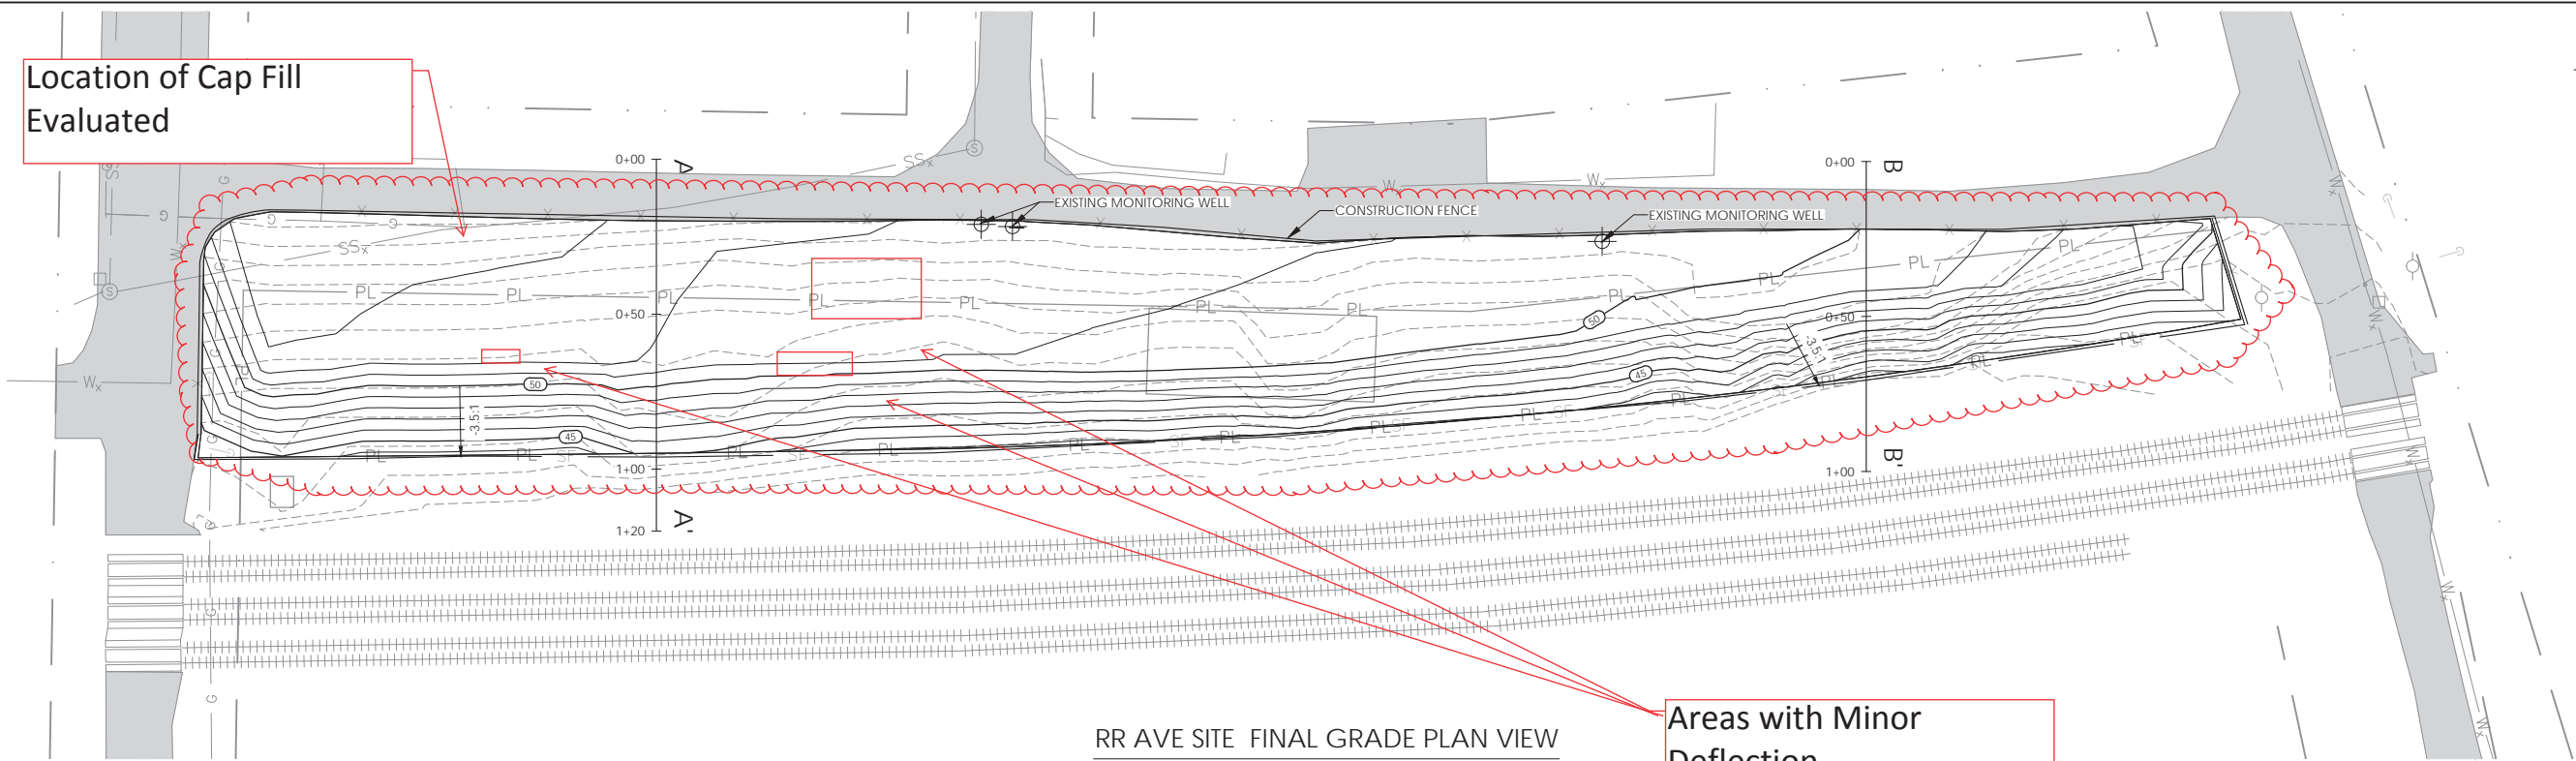
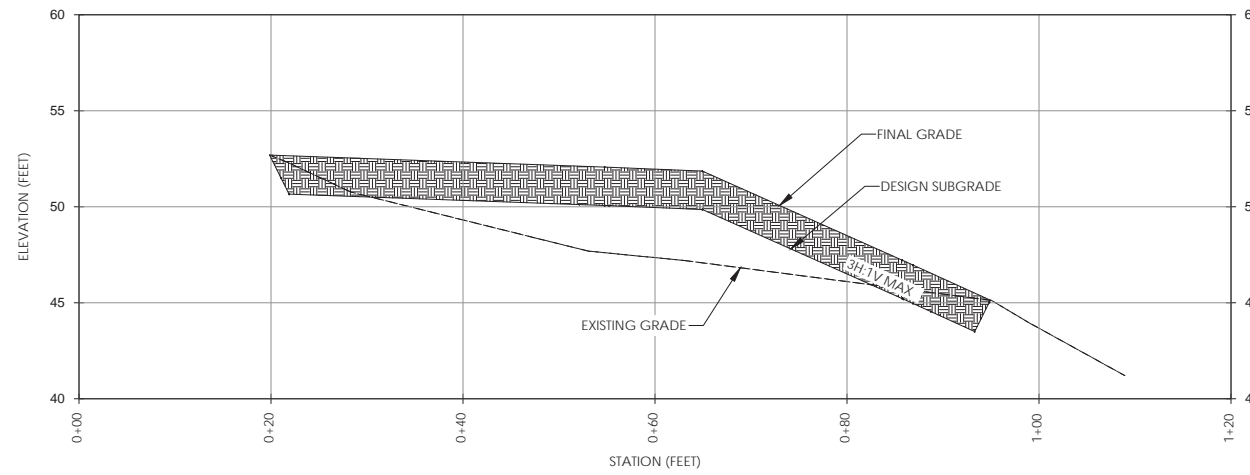
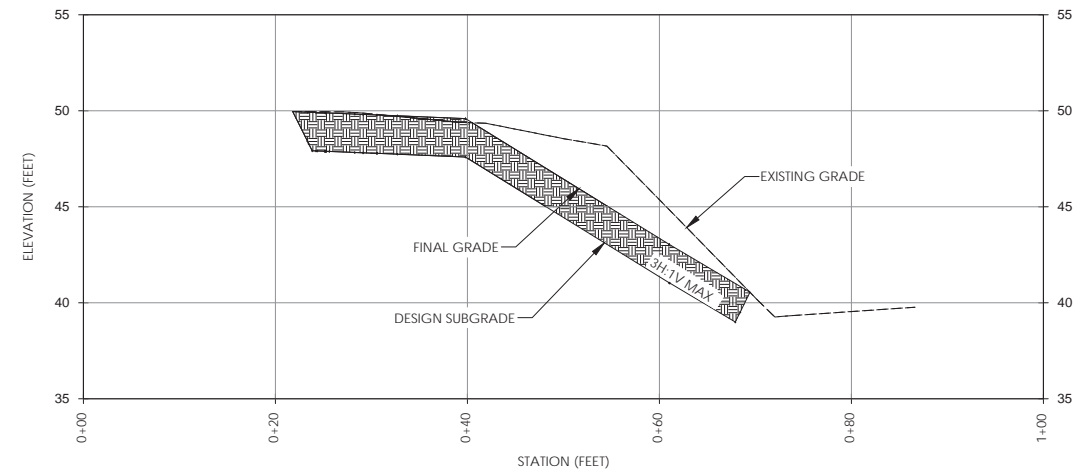
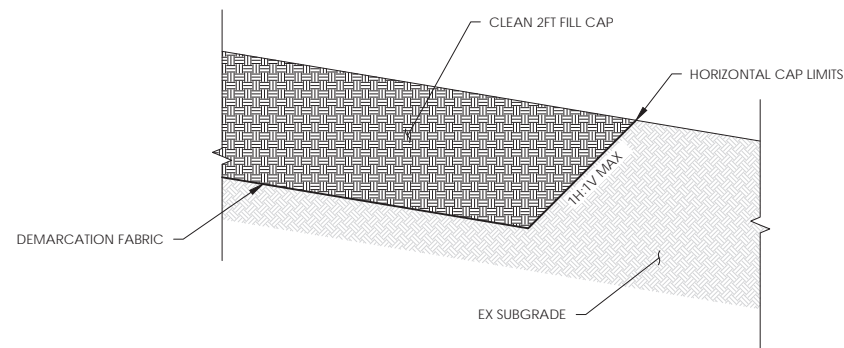
SHEET
C2.1

RR AVE SITE FINAL GRADE PLAN VIEW
1" = 30'

Areas with Minor Deflection

PROFILE VIEW OF SECTION A-A'
HORIZONTAL SCALE: 1" = 10' VERTICAL SCALE: 1" = 5'
VERTICAL EXAGGERATION: 2

PROFILE VIEW OF SECTION B-B'
HORIZONTAL SCALE: 1" = 10' VERTICAL SCALE: 1" = 5'
VERTICAL EXAGGERATION: 2

CAP TERMINATION DETAIL
NOTES

Installation of the clean soil cap began at the south end of the site and proceeded to the north, and was completed over the course of two weeks. Demarcation fabric was first placed over the entire site in accordance with the construction drawings and specifications. Demarcation fabric product information was submitted to MFA and approved prior to use. Approximately 3,100 cubic yards of clean material stockpiled in Cell 4 was loaded and hauled to the site, where it was placed in 12-inch lifts and compacted with a vibratory roller. Moisture conditioning of the clean fill stockpile in Cell 4 continued throughout hauling operations, drying and aerating the material to promote compaction. Compaction testing of the clean soil cap was performed and approved by GeoDesign, Inc. A copy of the field report verifying compaction results is included in Appendix B.

Two surveys of the finished grade were performed before MFA approved the cap and authorized Smith & Smith to begin hydroseeding. A topographic survey of finished grade was first performed by MGS and was submitted to MFA on September 20. After reviewing this initial survey, MFA determined that the minimum cap thickness of 2 feet had not been achieved in all areas of the site. Smith & Smith performed additional earthwork over the next week to regrade the cap and bring additional material from Cell 4 to achieve the specified cap thickness. The final finished grade survey was performed by MGS and was submitted to MFA on September 27. MFA approved the survey and authorized Smith & Smith to begin hydroseeding activities on September 28. As-built drawings showing final grade are included as Appendix C. The cap will be inspected and maintained in accordance with the soil management and cap maintenance plan (MFA, 2013a).

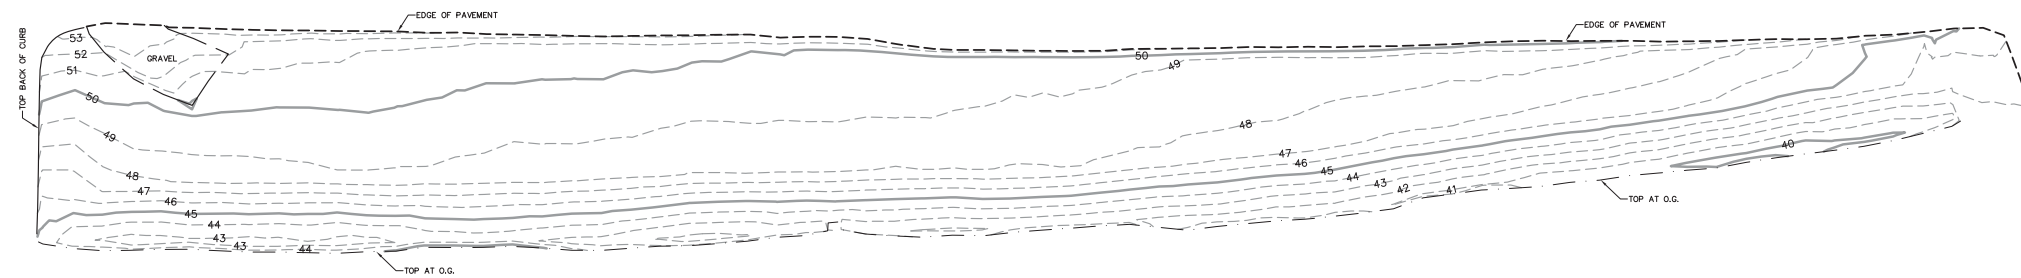
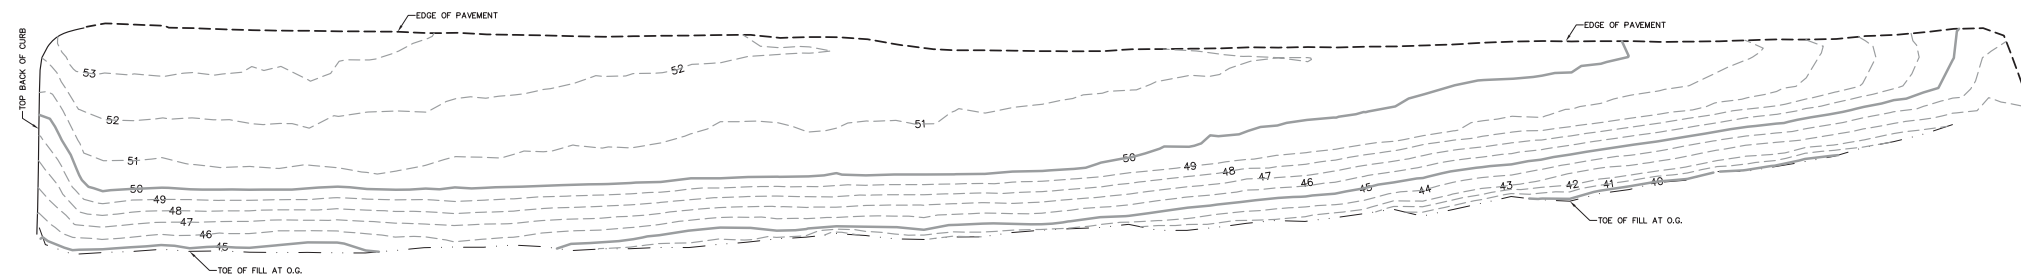
TOPOGRAPHIC SURVEY

SUB GRADE

FINISH GRADE

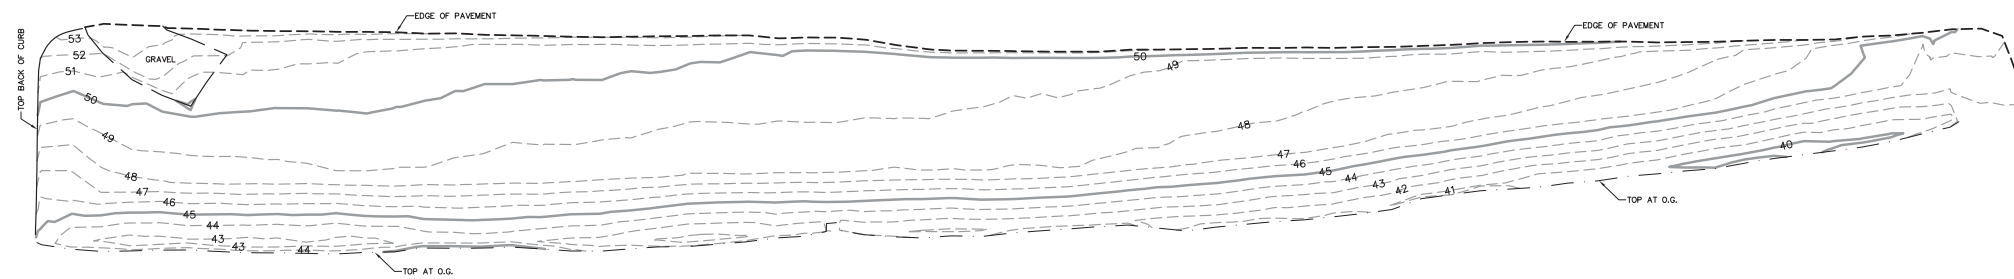
SUBGRADE SURVEY

FOR
SMITH & SMITH CONSTRUCTION
OF
2013 RAILROAD AVENUE
REMEDIAL ACTION PROJECT
JOB NO.: 13-231
DATA COLLECT: 09-11-13, 09-13-13
DRAWING DATE: 09-13-13
