FINAL PRELIMINARY ASSESSMENT AND SITE INSPECTION OF PER- AND POLYFLUOROALKYL SUBSTANCES

Yakima Training Center

Yakima, Washington

CONTRACT NO. W912DR-18-D-0004, DELIVERY ORDER W912DR1818F0685

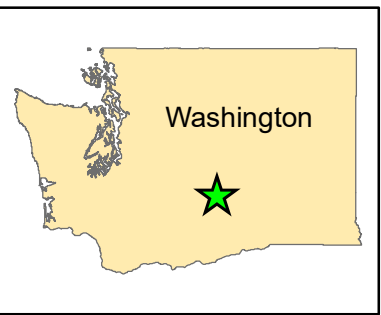
**Figure 2-1
Site Location**

YTC (originally known as the Yakima Firing Center) is a satellite installation of Joint Base Lewis-McChord (JBLM) and is located approximately 100 miles east of JBLM and about 5 miles northeast of the city of Yakima (population 75,000; **Figure 2-1**). It encompasses 327,231 acres within Yakima and Kittitas Counties in central Washington state. The eastern border of the facility is the Columbia River. The YTC population is predominantly transient soldiers performing maneuvers with a few permanent adult residents and on-site workers. Less than 500 military and civilians are permanently stationed at YTC, including active-duty service members, the Washington National Guard, the Army Reserves, and Marine Reserves members; transient units can swell the YTC population into the thousands for short periods. The most significant adjacent population center is Selah, to the west of the Yakima River from the installation (population 6,300) (YTC 2017); other sparsely populated areas adjacent to the installation (i.e., between the installation and the Yakima River) include the Pomona, Pomona Heights, and East Selah neighborhoods. The installation layout is shown on **Figure 2-2**.

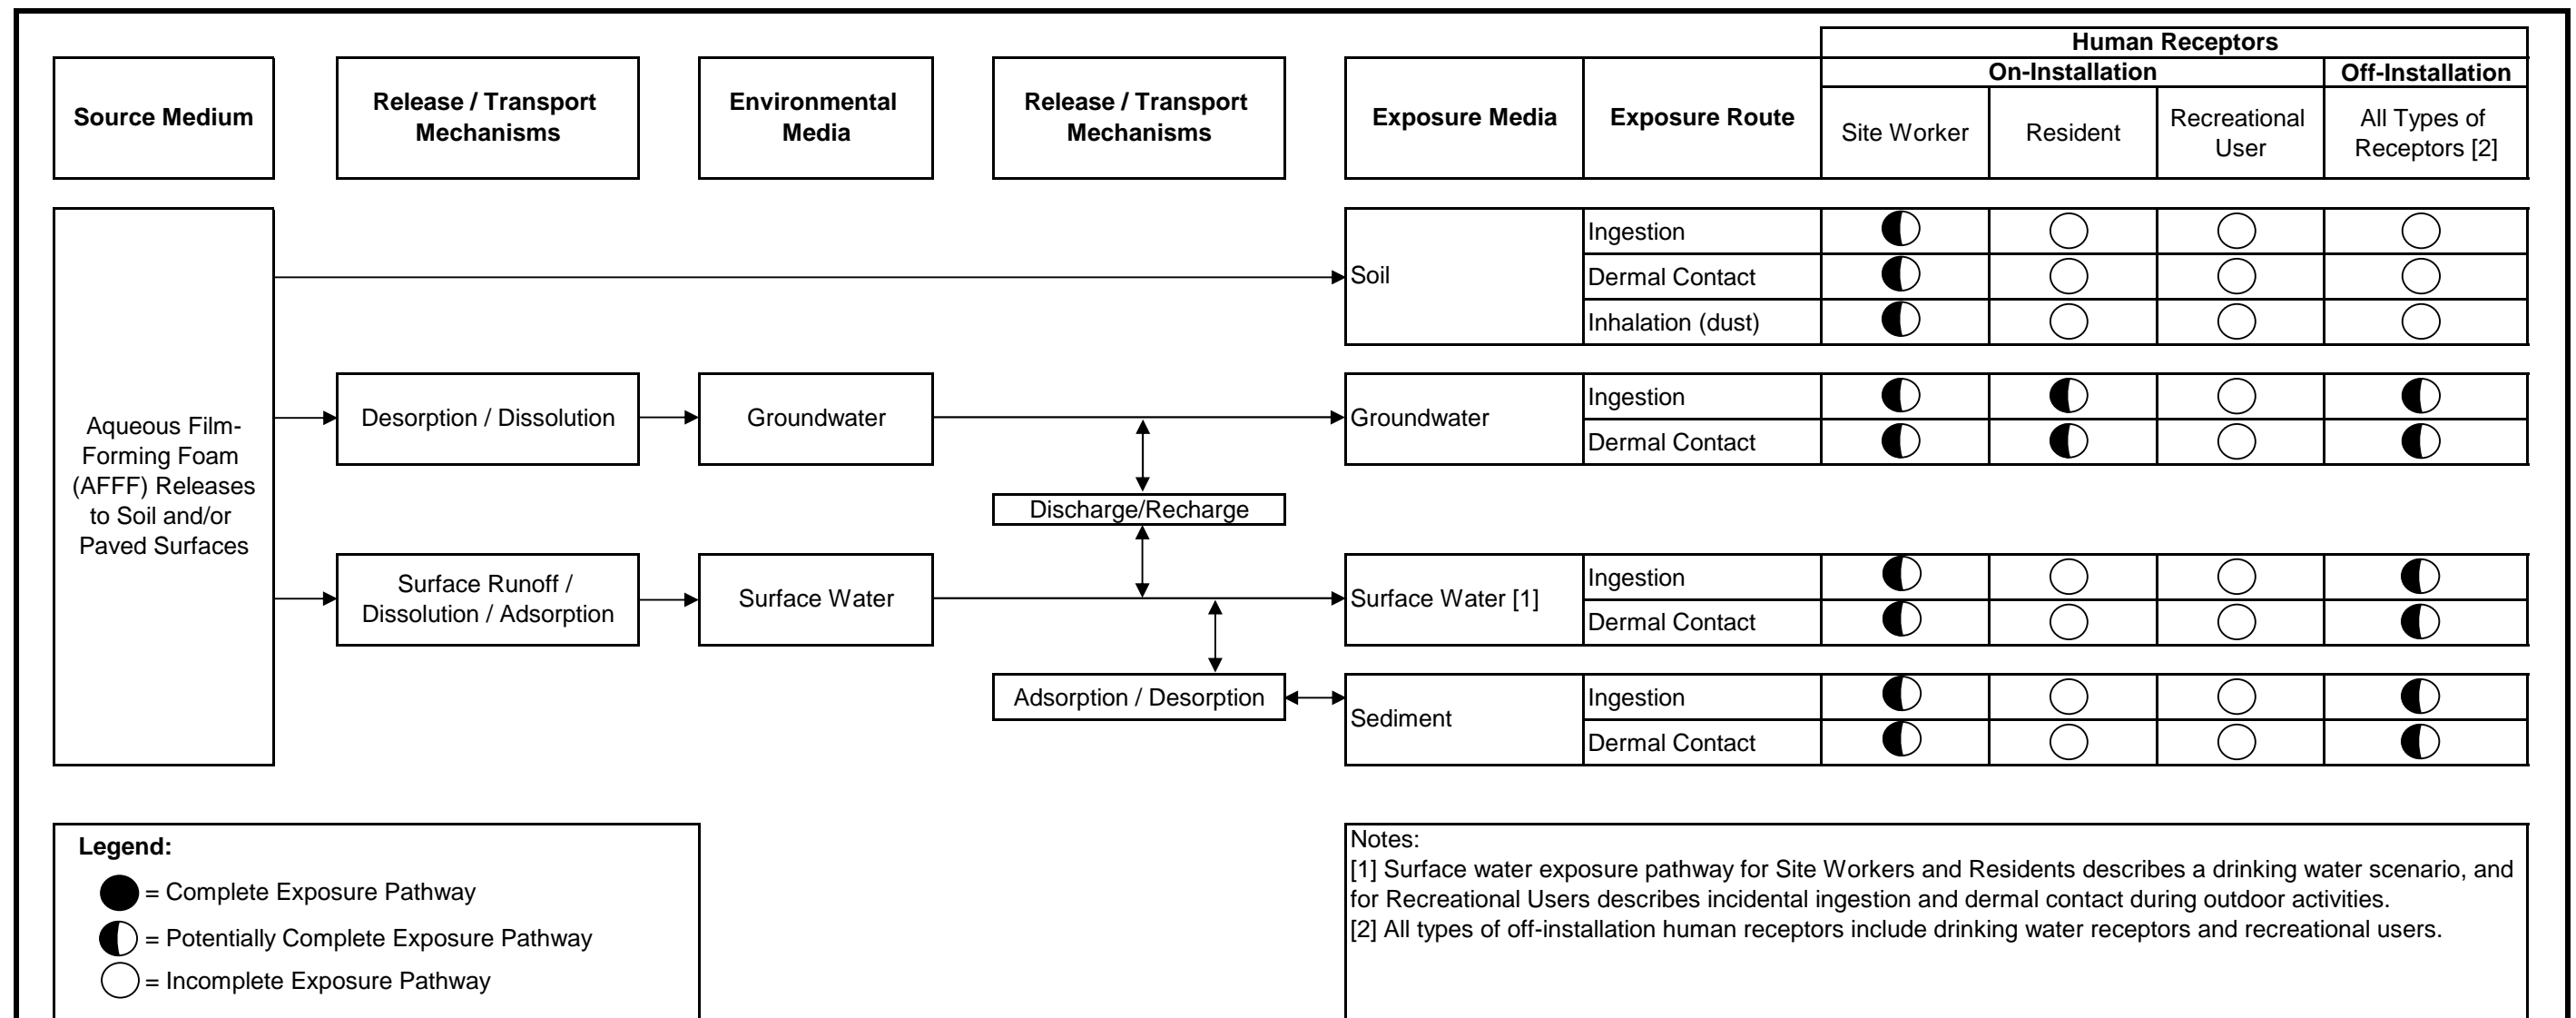
Figure 7-8

Conceptual Site Model - Former Fire Training Pit (YFCR-53) and Bird Bath Wash Rack Areas of Potential Interest
 USAEC PFAS Preliminary Assessment / Site Inspection
 Yakima Training Center, WA
