## **FINAL INTERIM ACTION REPORT**

**RGI PROJECT NO. 2017-015K  
ECOLOGY AGREED ORDER NO. 16537**

**ROYSTONE REDEVELOPMENT  
TEXACO 211577 MONTEREY SITE  
631 QUEEN ANNE AVENUE NORTH  
SEATTLE, WASHINGTON 98109**

**MARCH 21, 2022**

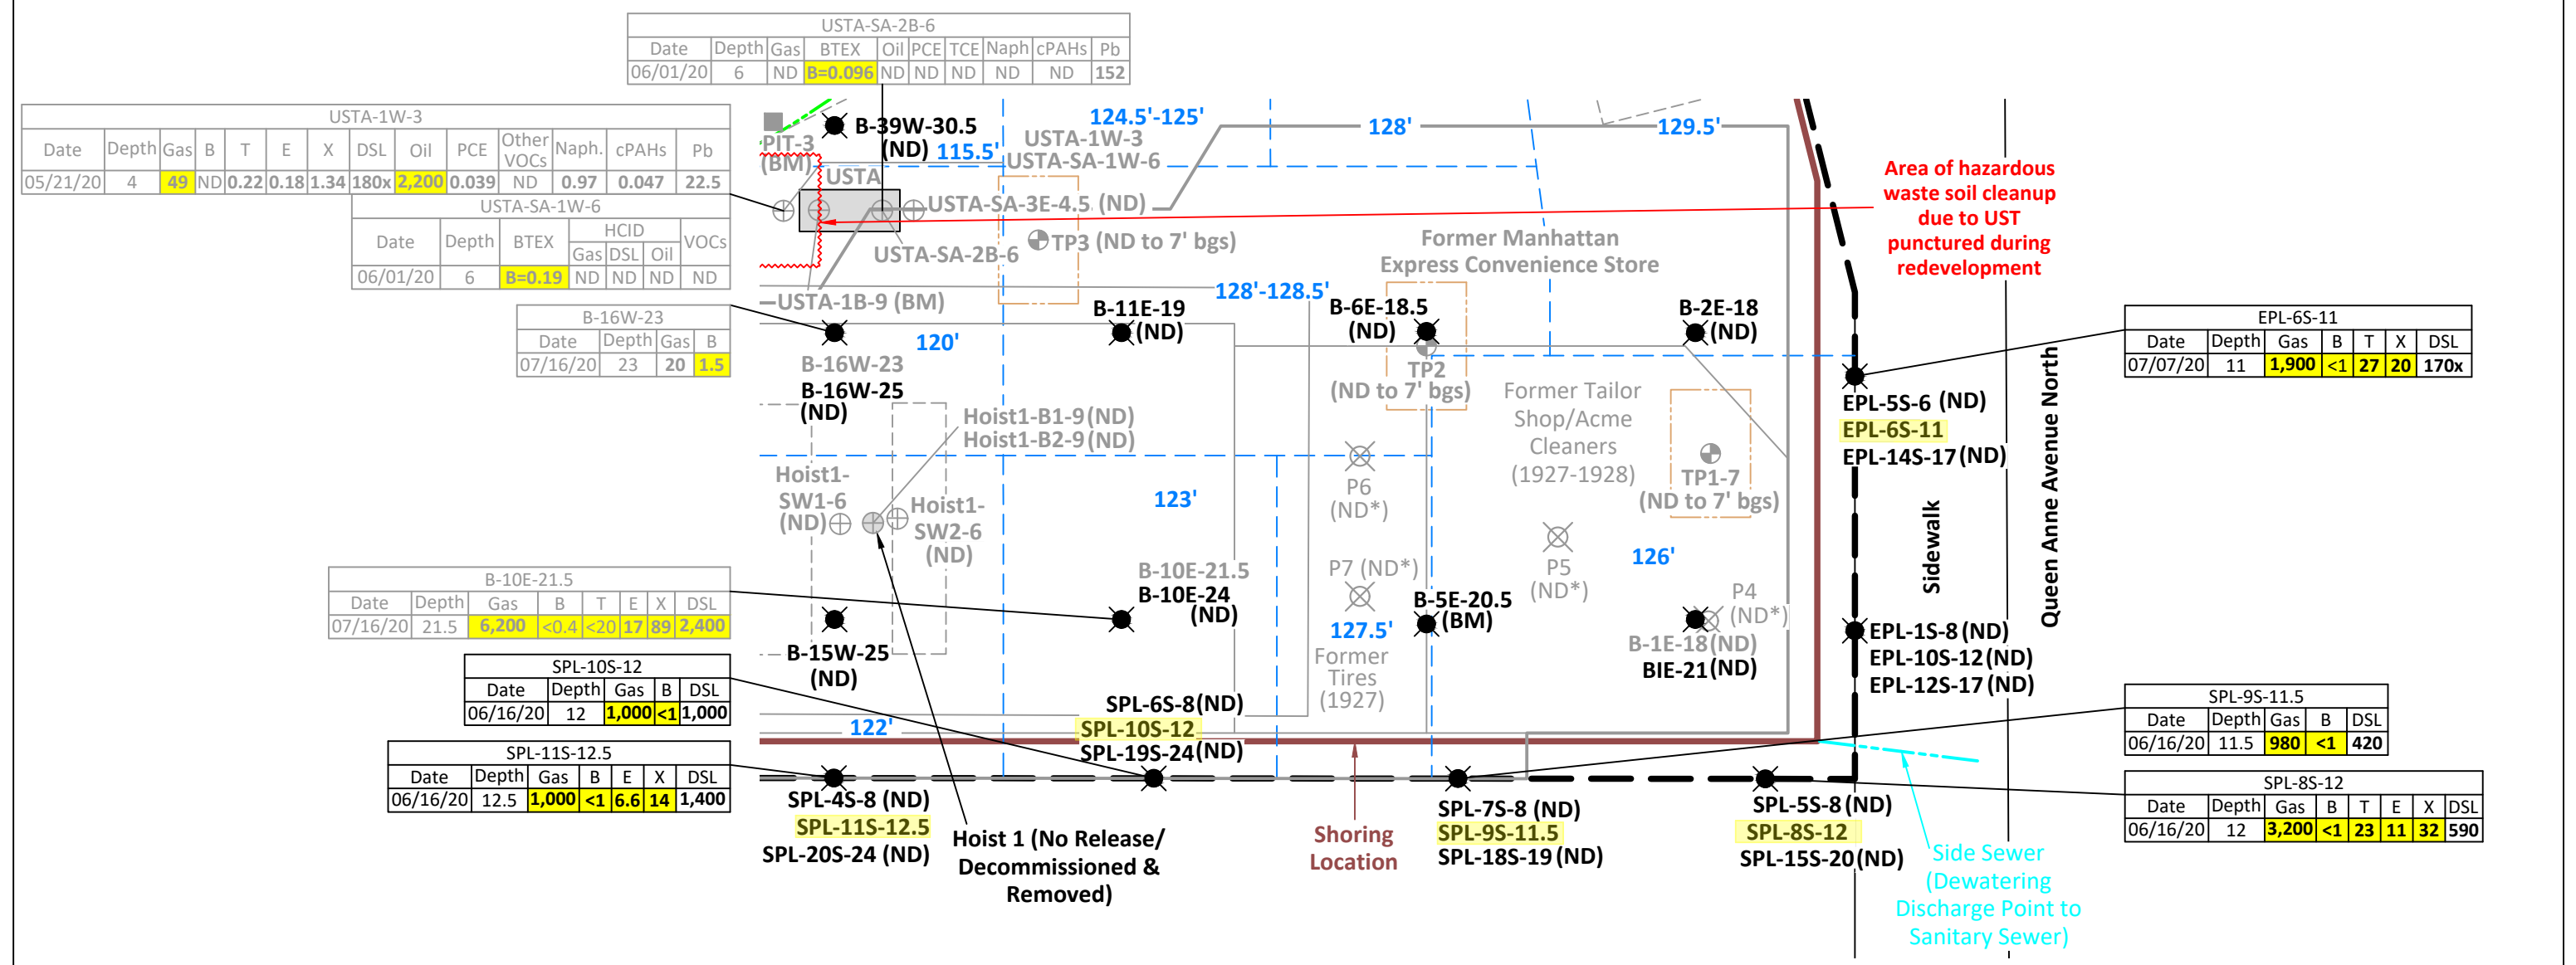
USTA: 317-Gallon Suspected Waste Oil UST (Decommissioned & Removed)

= Soil Analytical Data in mg/kg;  
 Gray data box indicates location where soil was removed during Interim Action  
 Depth = Feet below ground surface  
 Over-Ex. = Indicates sample was over-excavated and removed from the Property  
 Gas/DSL/Oil = Gasoline/diesel/oil total petroleum hydrocarbons (TPH)  
 BTEX = Benzene, toluene, ethylbenzene, xylenes  
 ND = Not detected, BM = Below MTCA Cleanup levels, D = Detected  
 Yellow highlight indicates petroleum related contaminants present in soil at concentrations exceeding MTCA soil levels or that contamination is present based on field screening

RGI quickly stopped the leak by plugging the UST with native clay. Clean soil was then placed on and around the area in order to contain the release and absorb the waste oil in preparation for immediate excavation. This soil and product were excavated from an area that was approximately 7' x 7' x 3' deep (or 6.5' below the original grade of the Property). The area of the product release was over excavated 3' to ensure all waste oil was removed. The product and soil were placed on plastic and covered with plastic.

Approximately 61 tons of hazardous waste soil were generated during the cleanup and over excavation of soil in the area of the release. A sample of this impacted soil was submitted to the laboratory for analyses. Analytical data indicated that PCE and TCE were present in soil at concentrations that required disposal as F002 listed hazardous waste. This soil was stockpiled on plastic and covered with plastic prior to arranging disposal as hazardous waste.

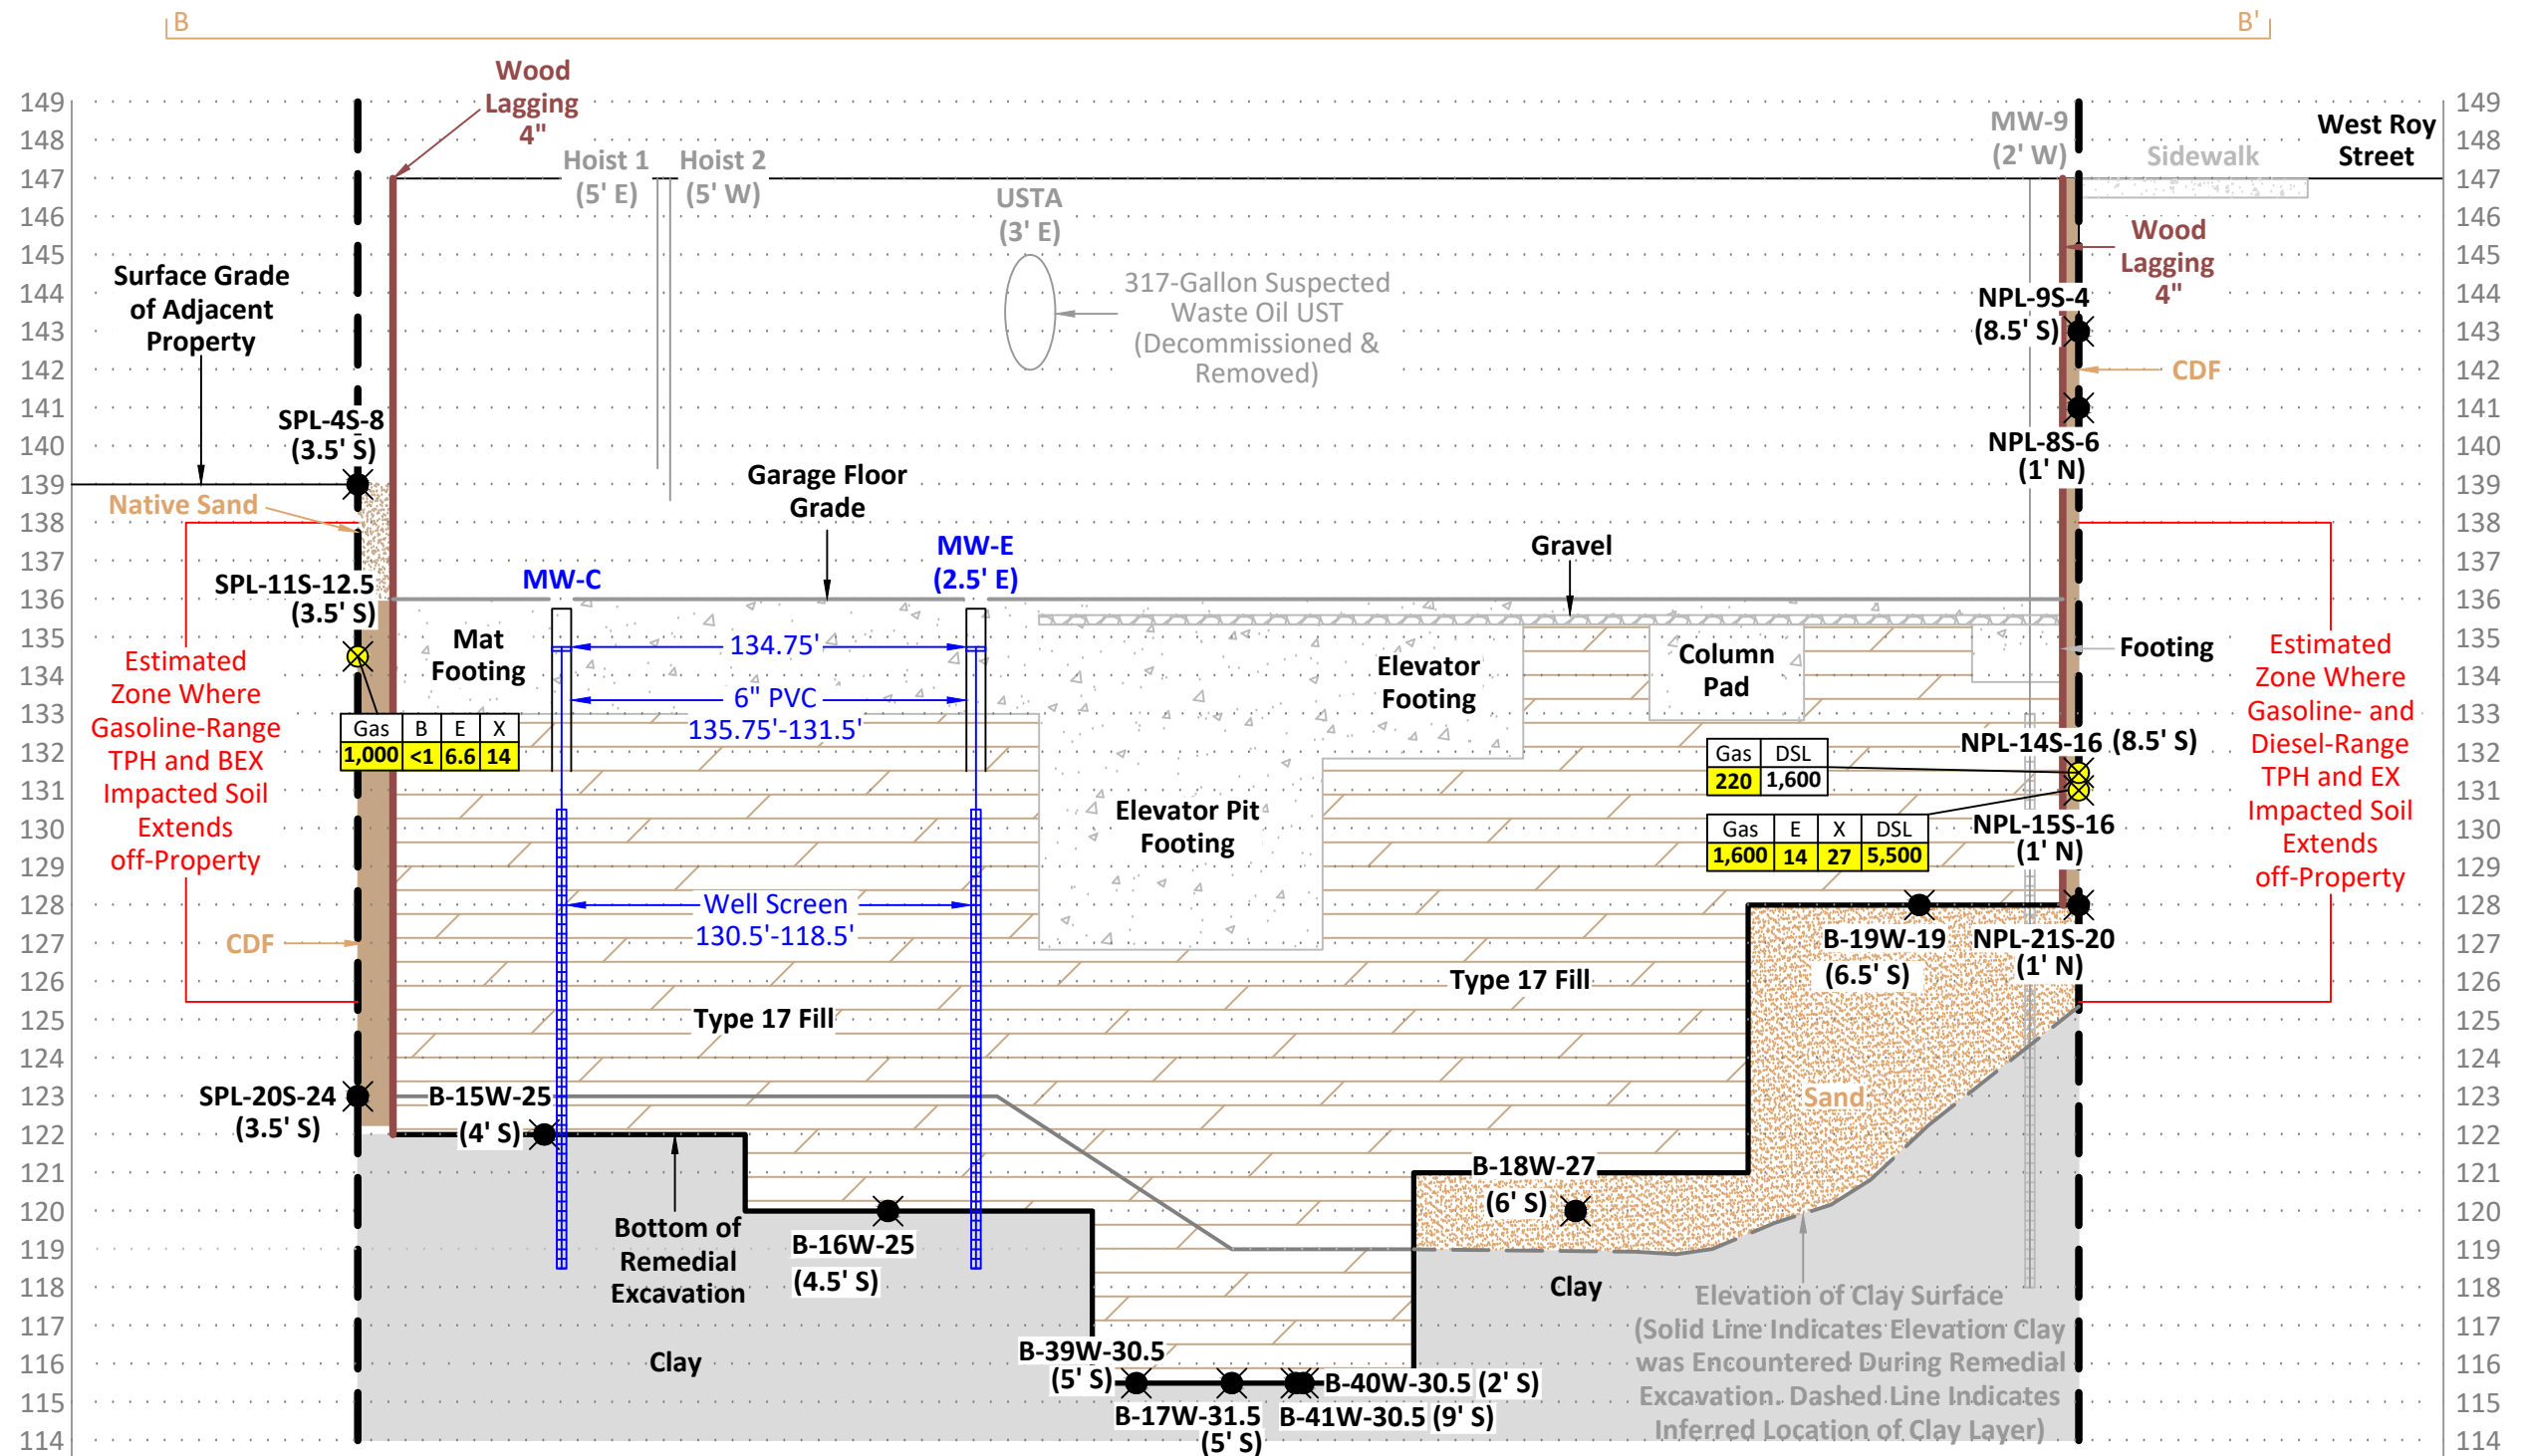
Gas	B	E	X
1,000	<1	6.6	14

= Soil Analytical Data in mg/kg;  
 Gas = Gasoline total petroleum hydrocarbons (TPH)  
 BTEX = Benzene, toluene, ethylbenzene, xylenes  
 Yellow highlight indicates petroleum related contaminants present in soil at concentrations exceeding MTCA soil cleanup levels

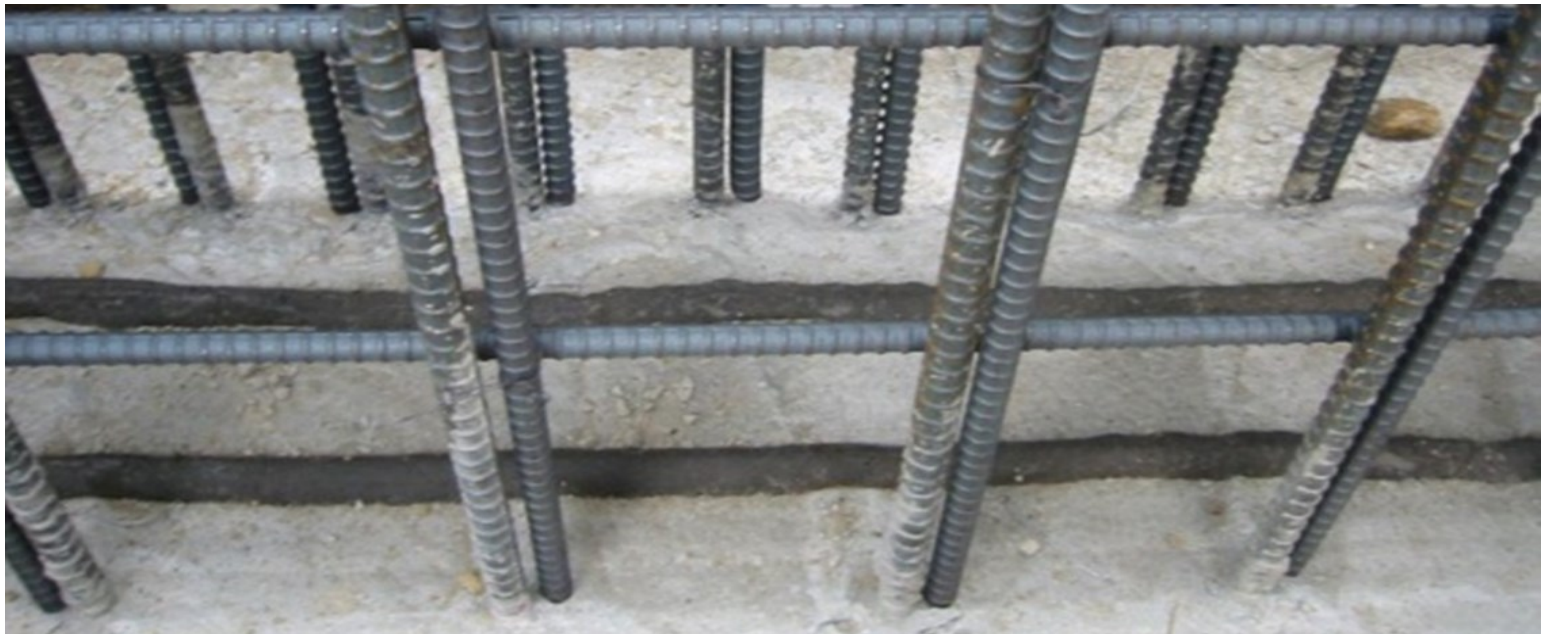
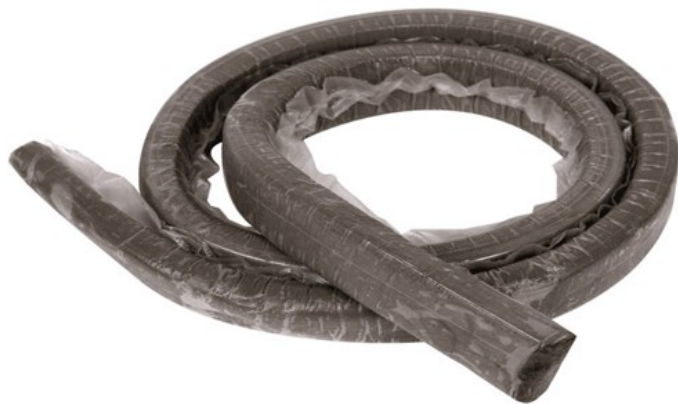
# BENTOTAK

Delayed-swell hydrophilic polymer modified bentonite waterstop strip  
Self-adhesive, swelling, water tight for construction joints and penetrations

**BentoTak** is a self-adhesive, delayed swell hydrophilic polymer modified bentonite waterstop strip specially blended from the highest grade Wyoming sodium bentonite and mineral oils. Suitable for application in construction joints and around penetrations, after wetting **BentoTak's** self adhesive film, the waterstop strip will adhere and conform to the substrate without the use of additional adhesives or mechanical fastening. **BentoTak** is not only effective in fresh water hydrostatic conditions, but also salt water and contaminated soils conditions.
