# Memorandum

**To:** Mark Nelson, Nel/Son Distributing, Inc.  
**Copies:** Dianne K. Conway, Gordon Thomas, Honeywell LLP  
**From:** Kristin Anderson, Floyd|Snider  
**Date:** March 9, 2022  
**Project No:** NelSon-Granite Falls  
**Re: One Ballard Property Remedial Excavation Summary**

**One Ballard Property  
Remedial Excavation Summary  
NelSon Petroleum Property  
Granite Falls, WA**

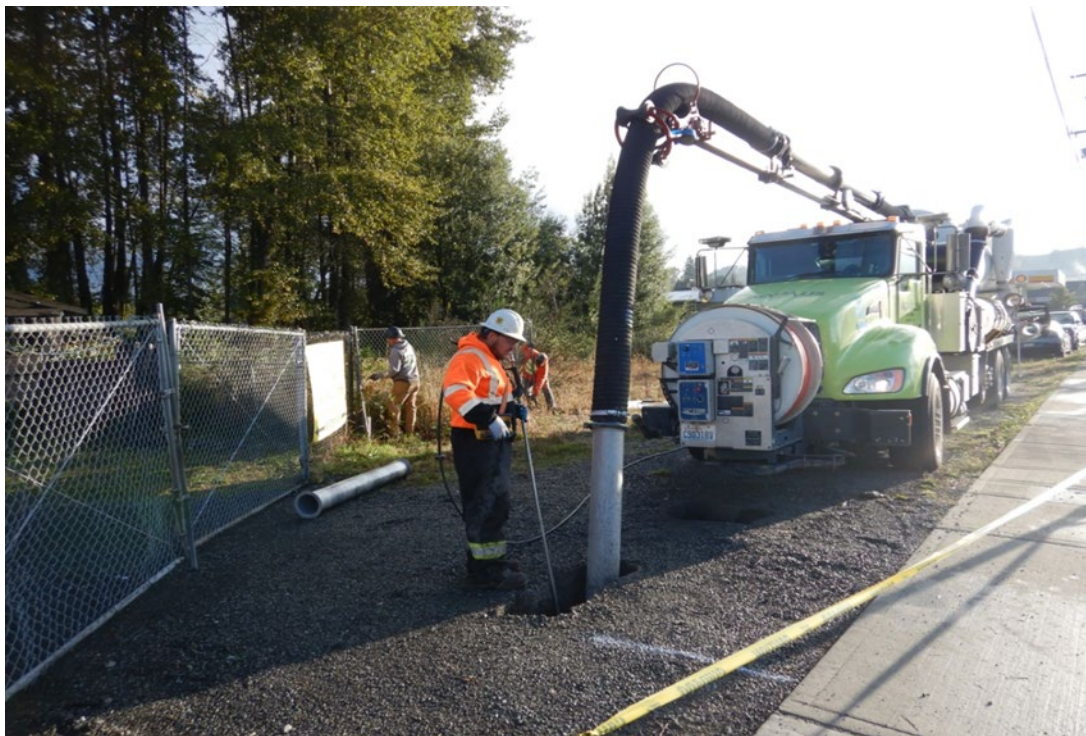
Photograph 1. Utility potholing for active water and sewer lines (facing northeast).

Potholing was performed on September 20, 2021, by AQUALIS, a subcontractor to Glacier. The sewer and water line utilities were exposed by loosening overlying soil using a high-pressure spray of potable water followed by vactoring to remove the soil. Potholing was completed along

the south One Ballard Property line, starting at the southeast corner and moving west. A sewer line constructed of 4-inch diameter polyvinyl chloride (PVC) pipe was encountered approximately 12 feet to the west of the southeast property corner (just west of the planned excavation area) at an approximate top-of-pipe depth of 4 feet bgs. The water line was encountered in an adjacent trench 2 feet west of the sewer line. The locations of the utility lines determined during potholing are shown on Figure 3.

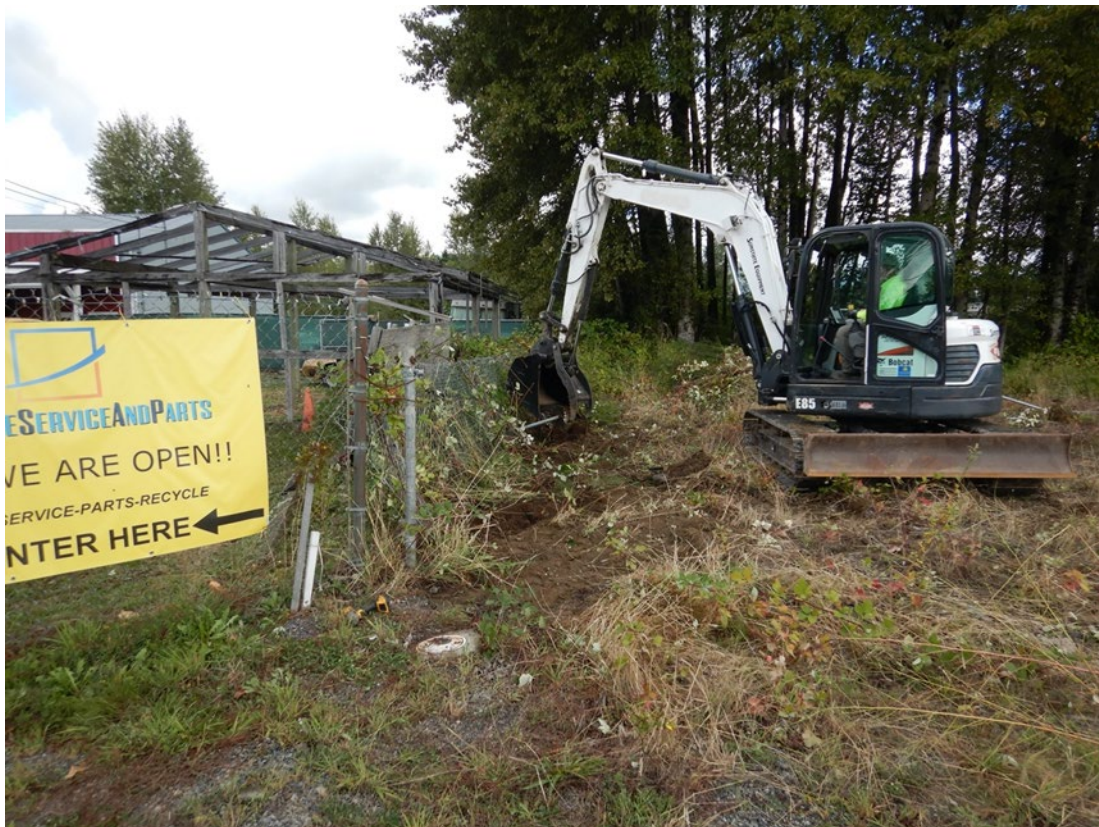
Photograph 2. Removal of property line fence (facing north).

- Removal of the framing associated with the former shed structure within the planned excavation area
- Removal of the southern portion of the property line fence between the NelSon Petroleum Property and One Ballard Property; installation of secured temporary construction fencing; and re-routing of customer and delivery vehicle traffic to the western access driveway of the One Ballard Property

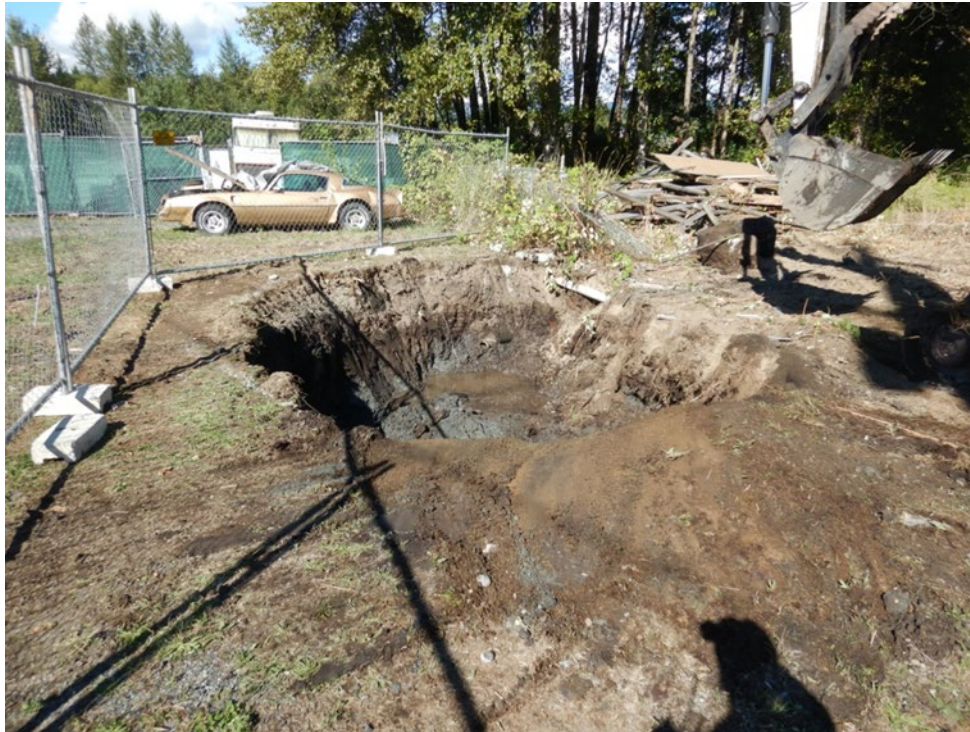
Photograph 3. Temporary fence and northwest corner of excavation area (facing north).

Excavation began at the northwest corner of the planned excavation area and continued to the south and east. Although sloped sidewalls were anticipated in the Work Plan, the native soils encountered on the One Ballard Property were well-consolidated sand with silt/silty sand, which were able to be cut with minimal slope to reduce the total volume of excavated soil.

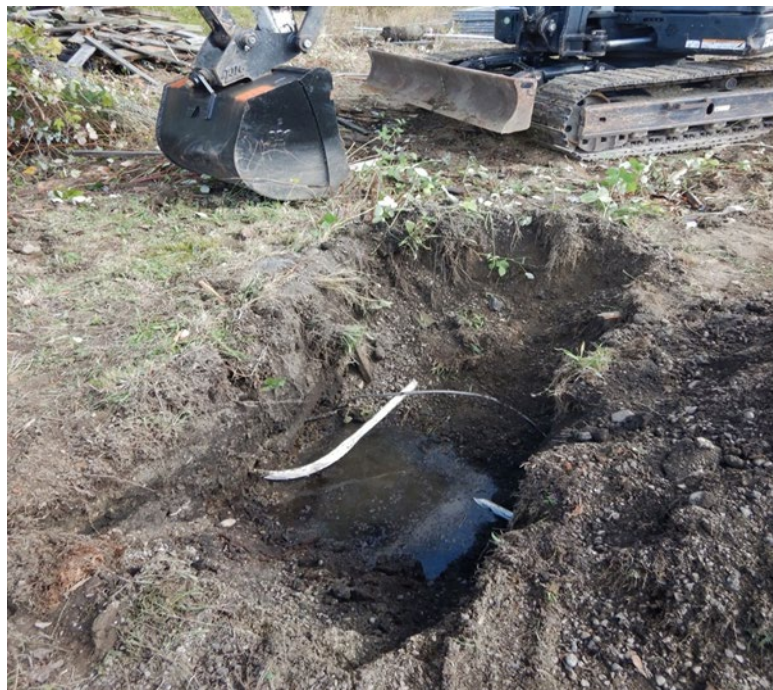
Photograph 4. Presumed 1.5-inch-diameter PVC water line and buried power (facing east).

A 1.5-inch-diameter PVC pipe and sheathed electrical wire were buried at a depth of approximately 2 feet bgs in the northern portion of the excavation. The pipe was empty, and the electrical wire did not carry any current; therefore, these utilities were presumed to be inactive and potentially associated with the former shed. The PVC pipe and sheathed wire terminated approximately 15 feet to the south of the former shed and were removed during excavation.

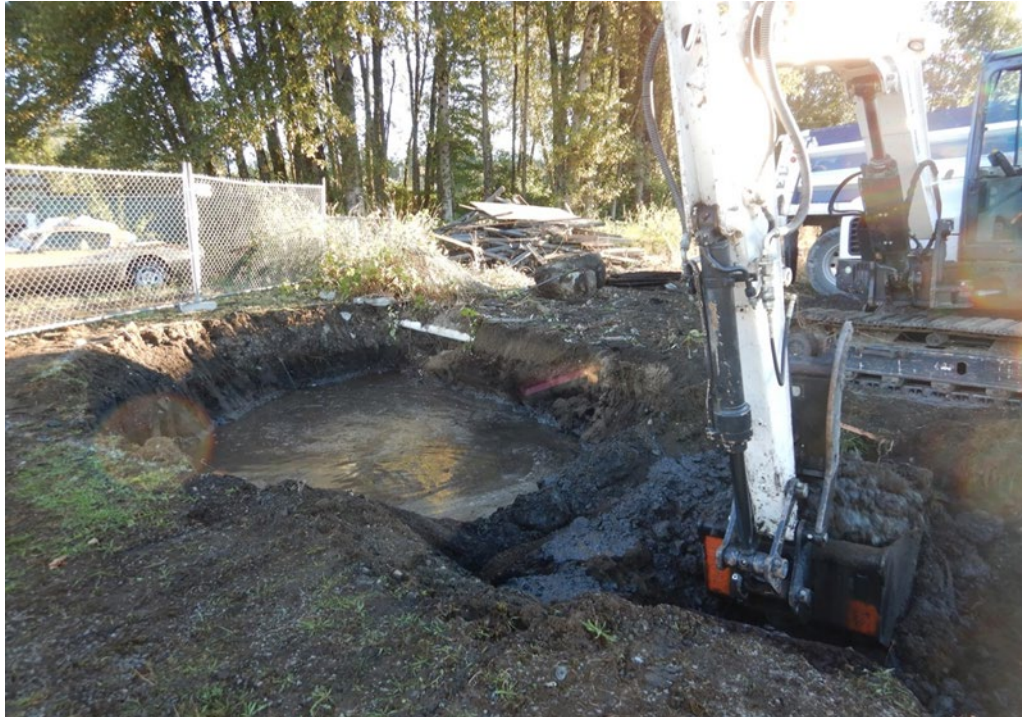
Photograph 5. Excavation with native soil buffer (facing east).

The native soil buffers were removed after confirmation samples demonstrated that excavation to remove contaminated soil was complete on the One Ballard Property (refer to the detailed description of confirmation sampling below). Completion of the eastern extent of the excavation was confirmed visually by removing the native soil buffer up to the imported backfill present on the NelSon Petroleum Property. The depth of the native soil buffer excavation was verified by monitoring the excavated soil to confirm that material was fully removed down to the silt layer where field indications of contamination were not present. Removal of the soil buffer included over-excavation of the southeast corner where quarry spall had been placed on One Ballard Property during the previous excavation; in this area, sand with petroleum odor underlying the quarry spall was removed to a depth of 7.5 feet bgs, where the silt layer was encountered. It should be noted that a 2016 excavation confirmation base sample collected in this area had a reported depth of 9 feet bgs (A2F3; refer to Figure 2). Therefore, due to this discrepancy, it is presumed that the previous reference point used to measure sample depth was higher than the reference ground surface used to measure depth during 2021 excavation activities. The excavation was extended to the southern property line at a depth of 7.5 feet bgs and immediately stabilized with imported backfill placed along the southern sidewall.

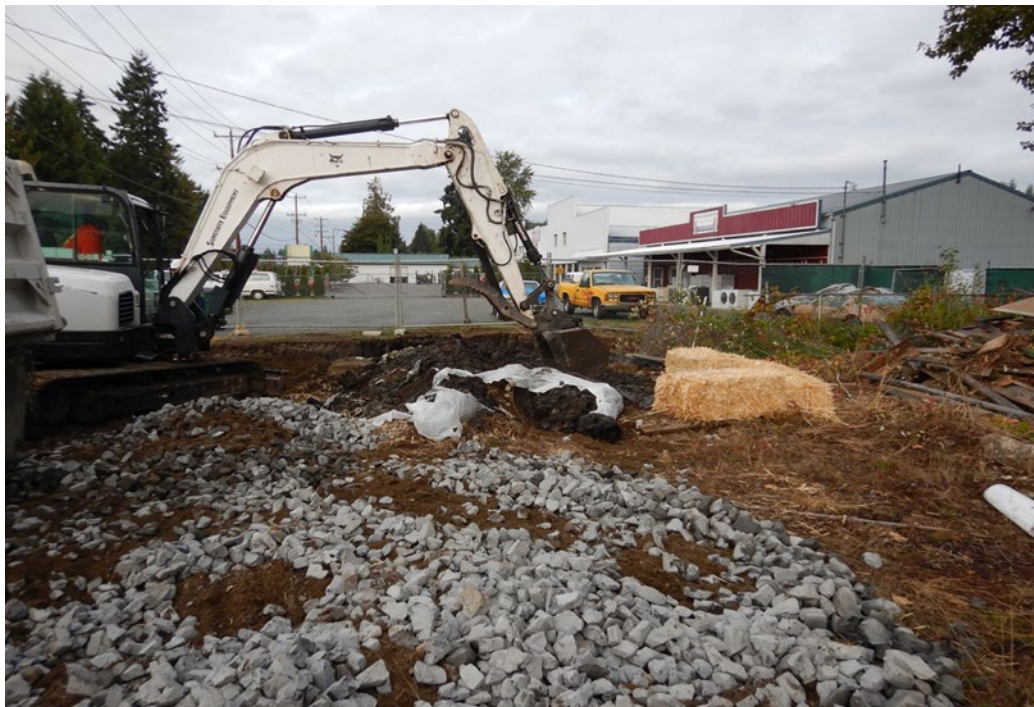
Photograph 6. Stabilized truck entrance and demolition of temporary stockpile (facing west).

A truck loading area was established on the NelSon Petroleum Property adjacent to the east side of the excavation. Excavated soil that did not contain free water was loaded directly into trucks for transport to Iron Mountain. Soil with free water was allowed to drain thoroughly before loading in a bermed, plastic-lined stockpile area at the edge of the excavation, which was sloped to allow water to run back into the excavation. The temporary stockpile was dismantled and disposed with contaminated soil after completion of excavation. The ground surface in the loading area was scraped after each truckload was hauled off-site. All truckloads of contaminated soil were covered during transport to the disposal facility.

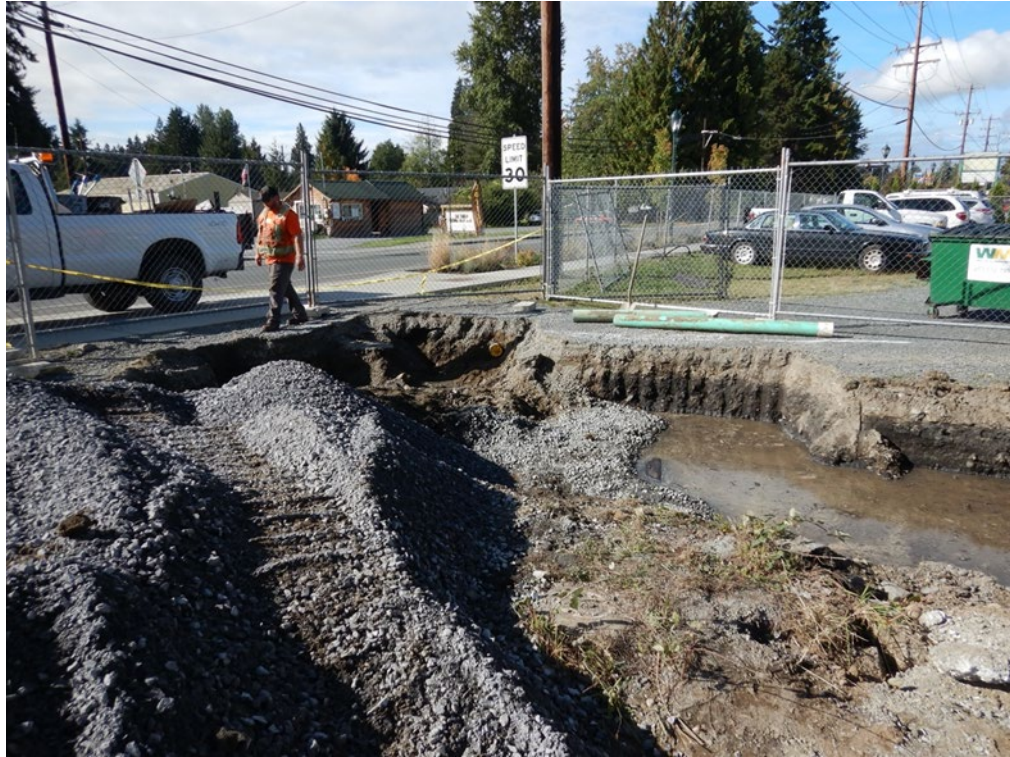
Photograph 7. Placement of backfill adjacent to City ROW (facing southwest).

After receipt of confirmation sample analytical results indicating concentrations of petroleum constituents and BTEX were less than MTCA A CULs, the excavation was backfilled with a combination of quarry spalls (placed below the water table) and imported gravel backfill from Iron Mountain Quarry. A sample of the gravel backfill material was obtained by Floyd|Snider prior to importation and analyzed for petroleum constituents, metals, selected volatile organic compounds and polychlorinated biphenyls to ensure that the material met all applicable MTCA Method A CULs for unrestricted property use. The laboratory analytical report for the backfill sample is provided in Attachment 3. The backfill was compacted using a vibratory plate compactor.

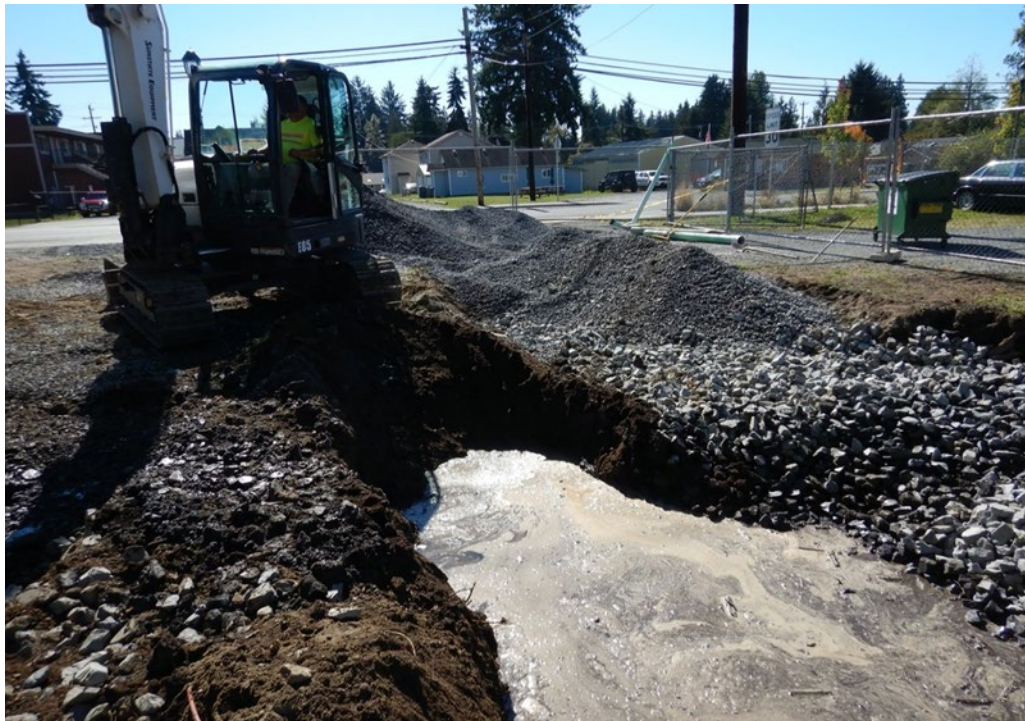
Photograph 8. Removal of native soil buffer during backfilling (facing south).

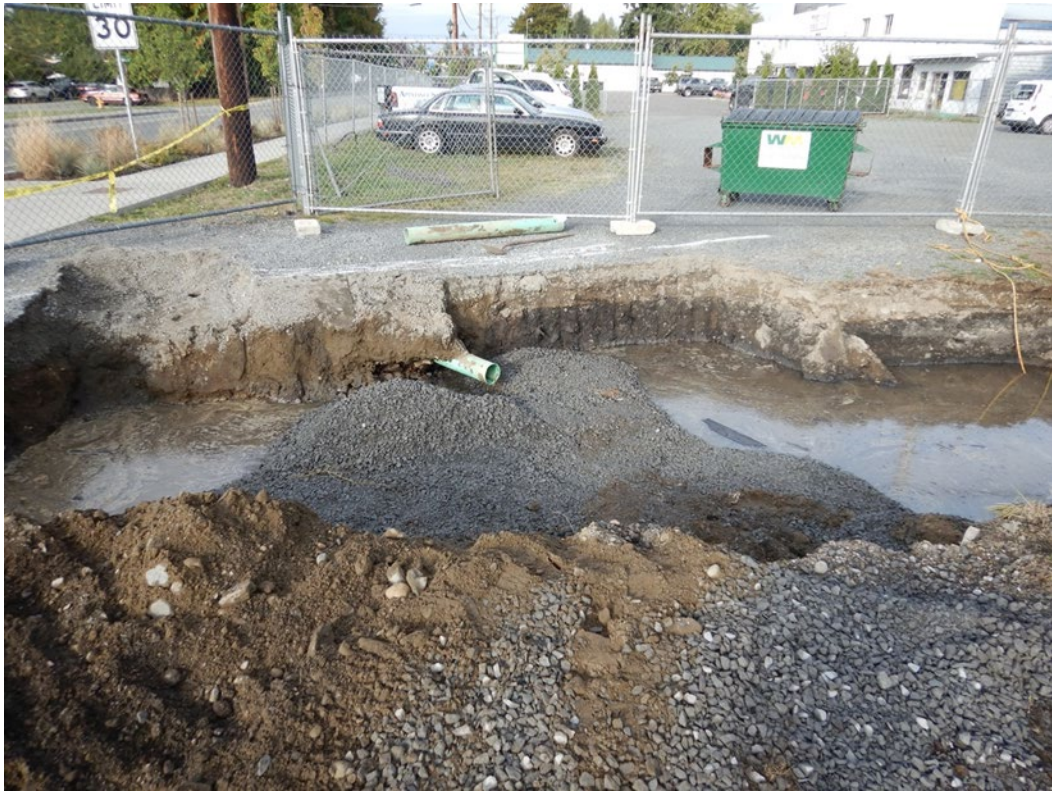
Photograph 9. Presumed 6-inch-diameter PVC drainage pipe (facing southwest).

A 6-inch-diameter PVC pipe was buried along the eastern One Ballard Property line at a depth of approximately 6 inches to 1 foot bgs. This pipe was presumed to be a storm drain structure for a former paved area on either the One Ballard Property or the NelSon Petroleum Property. The pipe crossed through the planned excavation area near the southern property line and appeared to run toward a catch basin in the adjacent City ROW. The City Department of Public Works was contacted for assistance, and a City crew performed a push camera survey and found that the pipe was not connected to the catch basin. The portion of the PVC pipe in the excavation area was removed during excavation after consultation with the Department of Public Works.

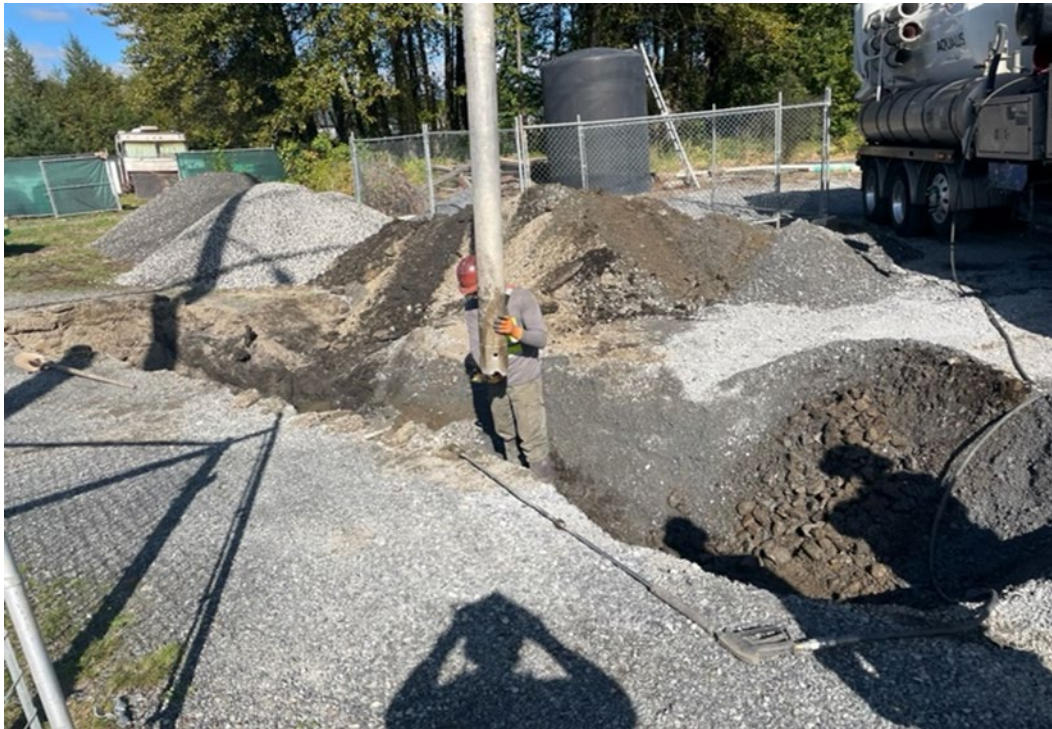
Photograph 10. Additional pothole investigation of active sewer line connections (facing north).

A follow-up potholing investigation was performed on October 4, 2021, to further assess the potential connection of the concrete pipe to existing sewer services. Potholing was completed as a continuous trench along the active PVC sewer line from the southern boundary of the One Ballard Property to the north toward the end of the concrete pipe in the excavation, approximately 25 feet north of the southern property line. No lines were found to be connected to the PVC sewer pipe, and the pipe depth was measured at 3 feet bgs at the northern end of the pothole trench (i.e., approximately 2 feet shallower than the depth of the concrete pipe). Based on the results of the additional pothole excavation, the concrete pipe discovered during excavation does not connect to sewer services on the One Ballard Property.
