RE: PHASE I ENVIRONMENTAL SITE ASSESSMENT
SUPER BLOCK
BELLEVUE, WASHINGTON

**PHASE I
ENVIRONMENTAL SITE ASSESSMENT**

**SUPER BLOCK
BELLEVUE, WASHINGTON**

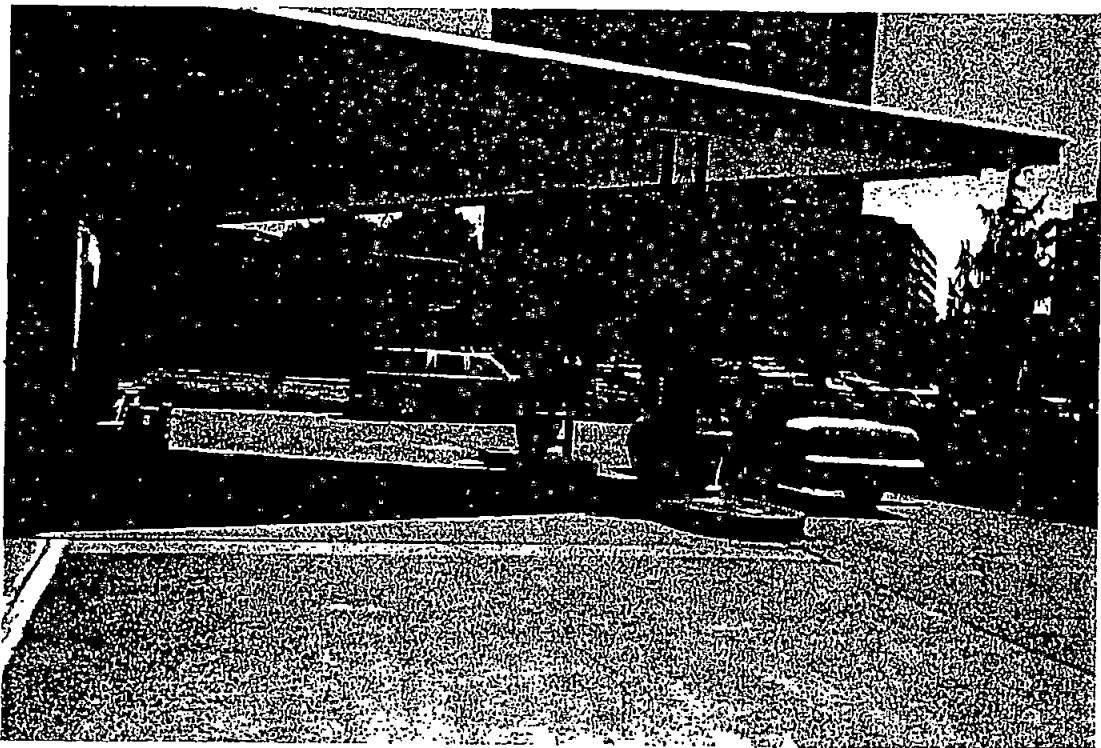
It is apparent that the building located on the northwest corner of NE 8th Street was previously a gasoline station, additional information is provided in Section 4.4. The building is currently being prepared to open as a toy store. The building is a one story brick building with a built up asphalt roof. A canopy extends out over the old gas pump islands, that are still present on the south side of the building. Fluorescent lights were noted under the canopy and are reported to be on the inside of the building. No access was provided to the building at the time of the site visit. The area surrounding the building is covered by concrete and asphalt. The underground storage tanks (USTs) associated with the service station have reportedly been removed from the site as identified in Section 4.4. However, since the gas pump islands are still present it is likely that the piping leading to the islands has not been removed. It is not uncommon for leaks to be associated with gasoline pump island pipe distribution systems.

Photograph 2. Pump islands at former service station.

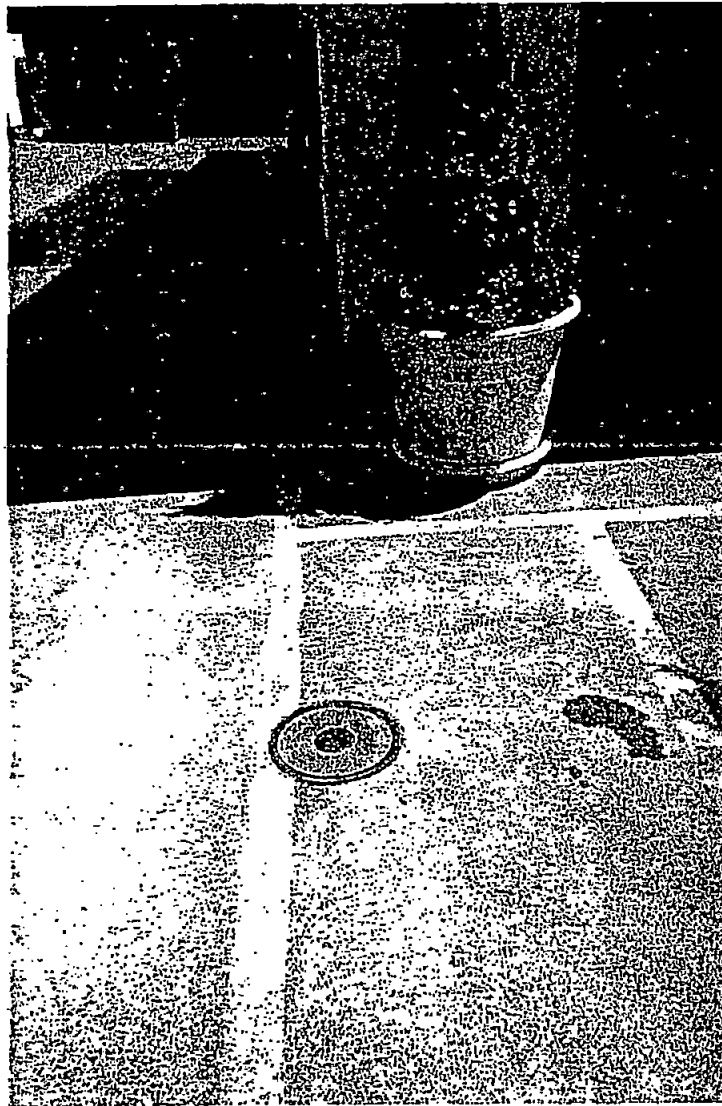
FIGURE **A2**
SITE PHOTOGRAPH
G2/SUPERBLOCK/WA

3. There was no substantive evidence found that confirmed that the gasoline USTs were removed from the former service station.
4. Two dry cleaning stores appear to have operated in two of the buildings located on the subject property. Dry cleaning operations have frequently been associated with solvent contaminated soils and groundwater. There is no evidence that this has occurred onsite, but it is a possibility and as such is a "recognized environmental condition" onsite.

Photograph 3. Abandoned fill pipe at former service station.

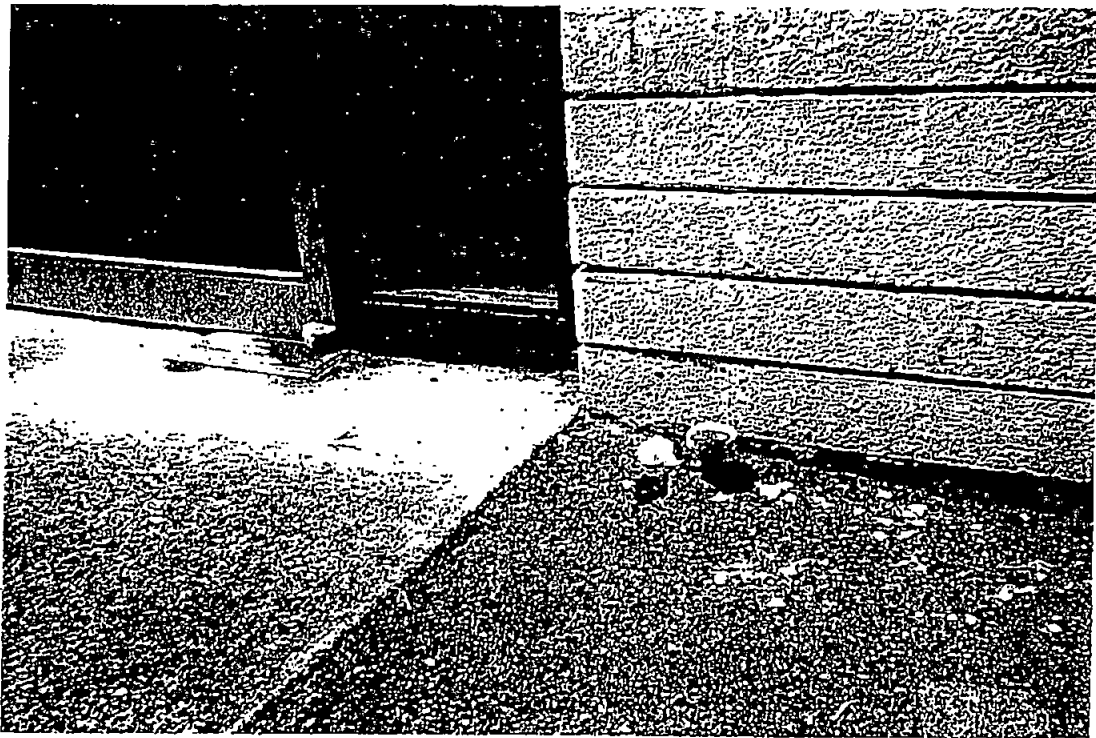
The outside of the building's paint is peeling in several locations (see Appendix A). The building is surrounded by an asphalt parking lot that is graded to drain onto 106th Avenue NE. A large sink hole approximately 4 feet in diameter is located in the south side parking lot. ~~What appeared as a vent pipe was observed just to the north of the back door of the building.~~

Photograph 4. Potential UST vent pipe at back of Carlson Building.
