VAPOR INTRUSION ASSESSMENT REPORT

Texaco Strickland Site

Prepared for: Strickland Real Estate Holdings, LLC

Project No. 180357 • March 28, 2022 • FINAL

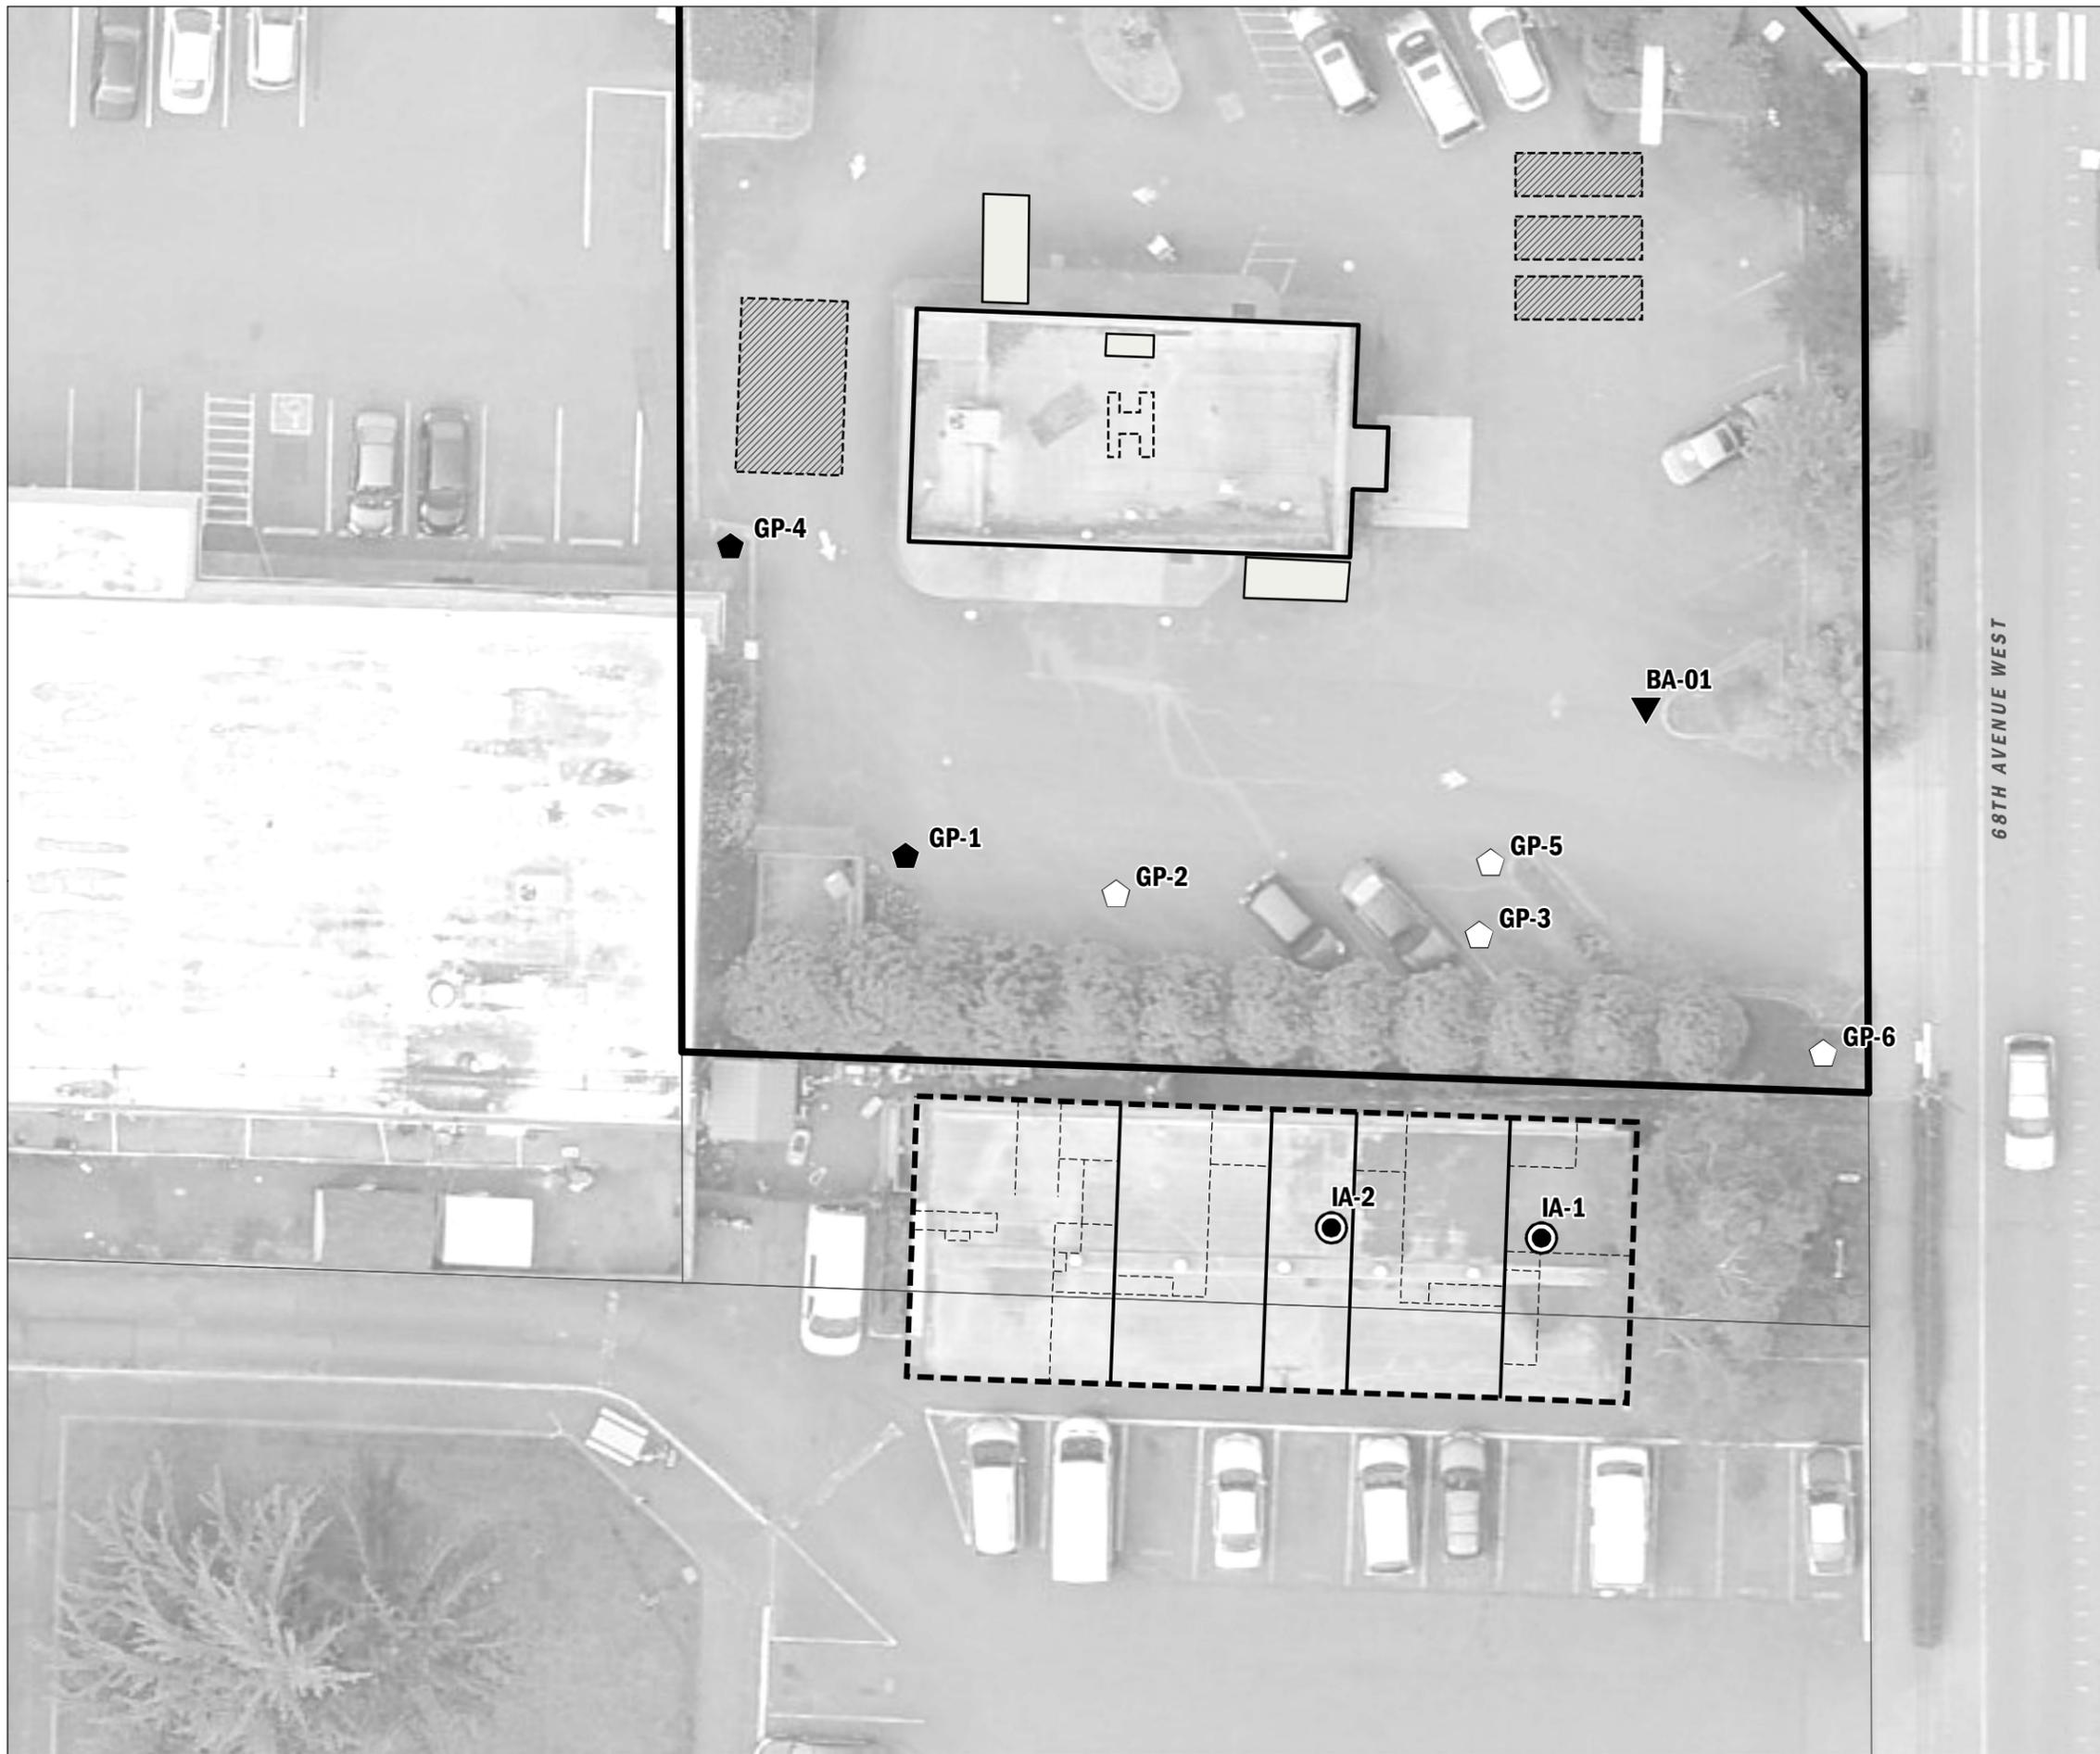
JAN-2022	BY: WVG / TDR	FIGURE NO.
	PROJECT NO. 180357	REVISED BY: WEG/SBM	1

- Crawspace Air Sampling Location
- Ambient Air Sampling Location
- Soil Gas Probe
- Soil Gas Probe (Not Sampled During This Event)
- Aloha Cafe Building
- Chri-Mar Apartment Building
- Property Boundary
- Former UST (Removed)
- Existing UST (Closed-In-Place or Abandoned)
- Tax Parcel

In June 2019, Aspect oversaw the installation of four soil gas probes (GP-01 through GP-04) at the Property (Figure 1). The gas probes were screened from 5 to 5.5 feet below ground surface (bgs). The soil gas probes were sealed, tested, and sampled in accordance with Appendix E of the RIWP in July 2019 (Aspect, 2019). No evidence of atmospheric dilution was detected in any of the soil gas samples.

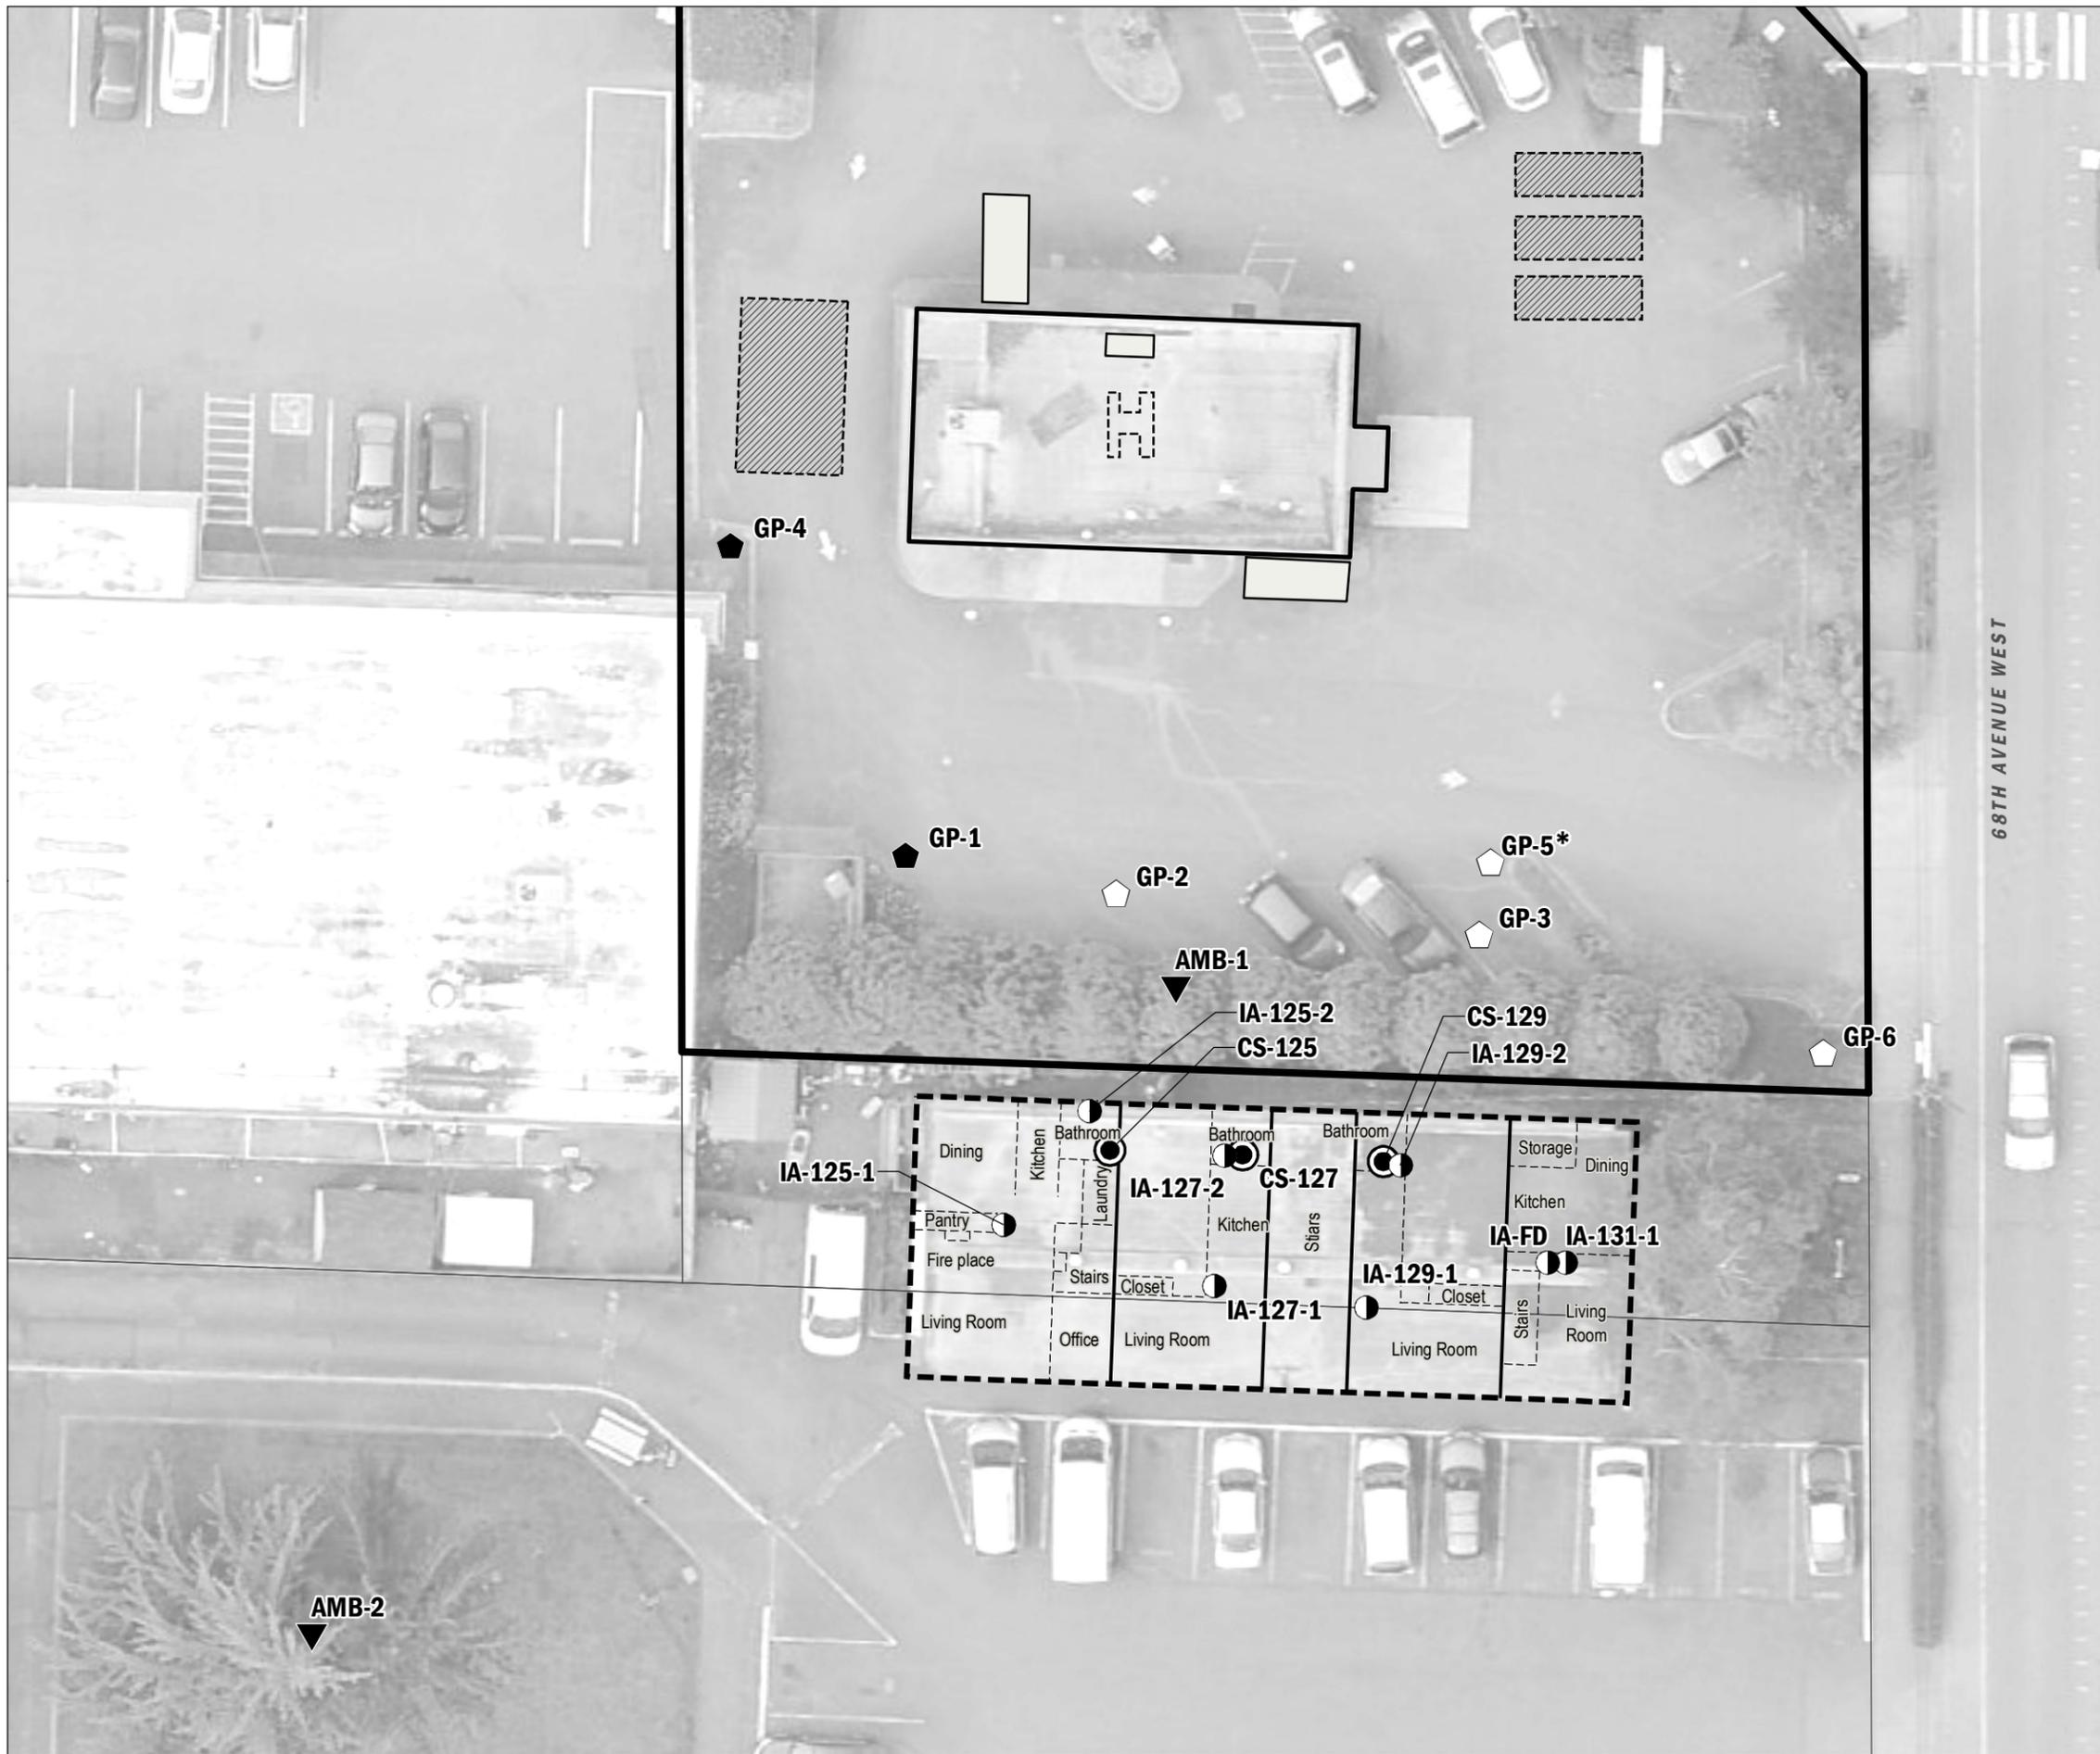
- Crawlspace Air Sampling Location
- Indoor Air Sampling Location
- Ambient Air Sampling Location
- Soil Gas Probe
- Soil Gas Probe (Not Sampled During This Event)
- Aloha Cafe Building
- Chri-Mar Apartment Building
- Property Boundary
- Former UST (Removed)
- Existing UST (Closed-In-Place or Abandoned)
- Tax Parcel

Crawlspace air samples beneath each unit were obtained concurrently with indoor air samples, except for Unit #131 (Figure 2). While placing tubing for the crawlspace air samples, multiple racoons were observed in the crawlspace, and tubing could not be placed at the final location due to health and safety concerns regarding the presence of wildlife in the crawlspace. For the crawlspace air samples collected beneath Units #125, #127, and #129, the tubing intake was placed at approximately the mid-height of the crawlspace, and the tubing intake was placed where the plumbing penetrations entered the bathroom for each of the three units.
