**FEBRUARY 1, 2022
SUBSURFACE INVESTIGATION REPORT**

**HAHN MOTOR COMPANY
1201 SOUTH 1ST STREET
YAKIMA, WASHINGTON 98901**

**Facility Site ID No. 502
Cleanup Site ID No. 4927
VCP Project No. CE0529**

March 4, 2022

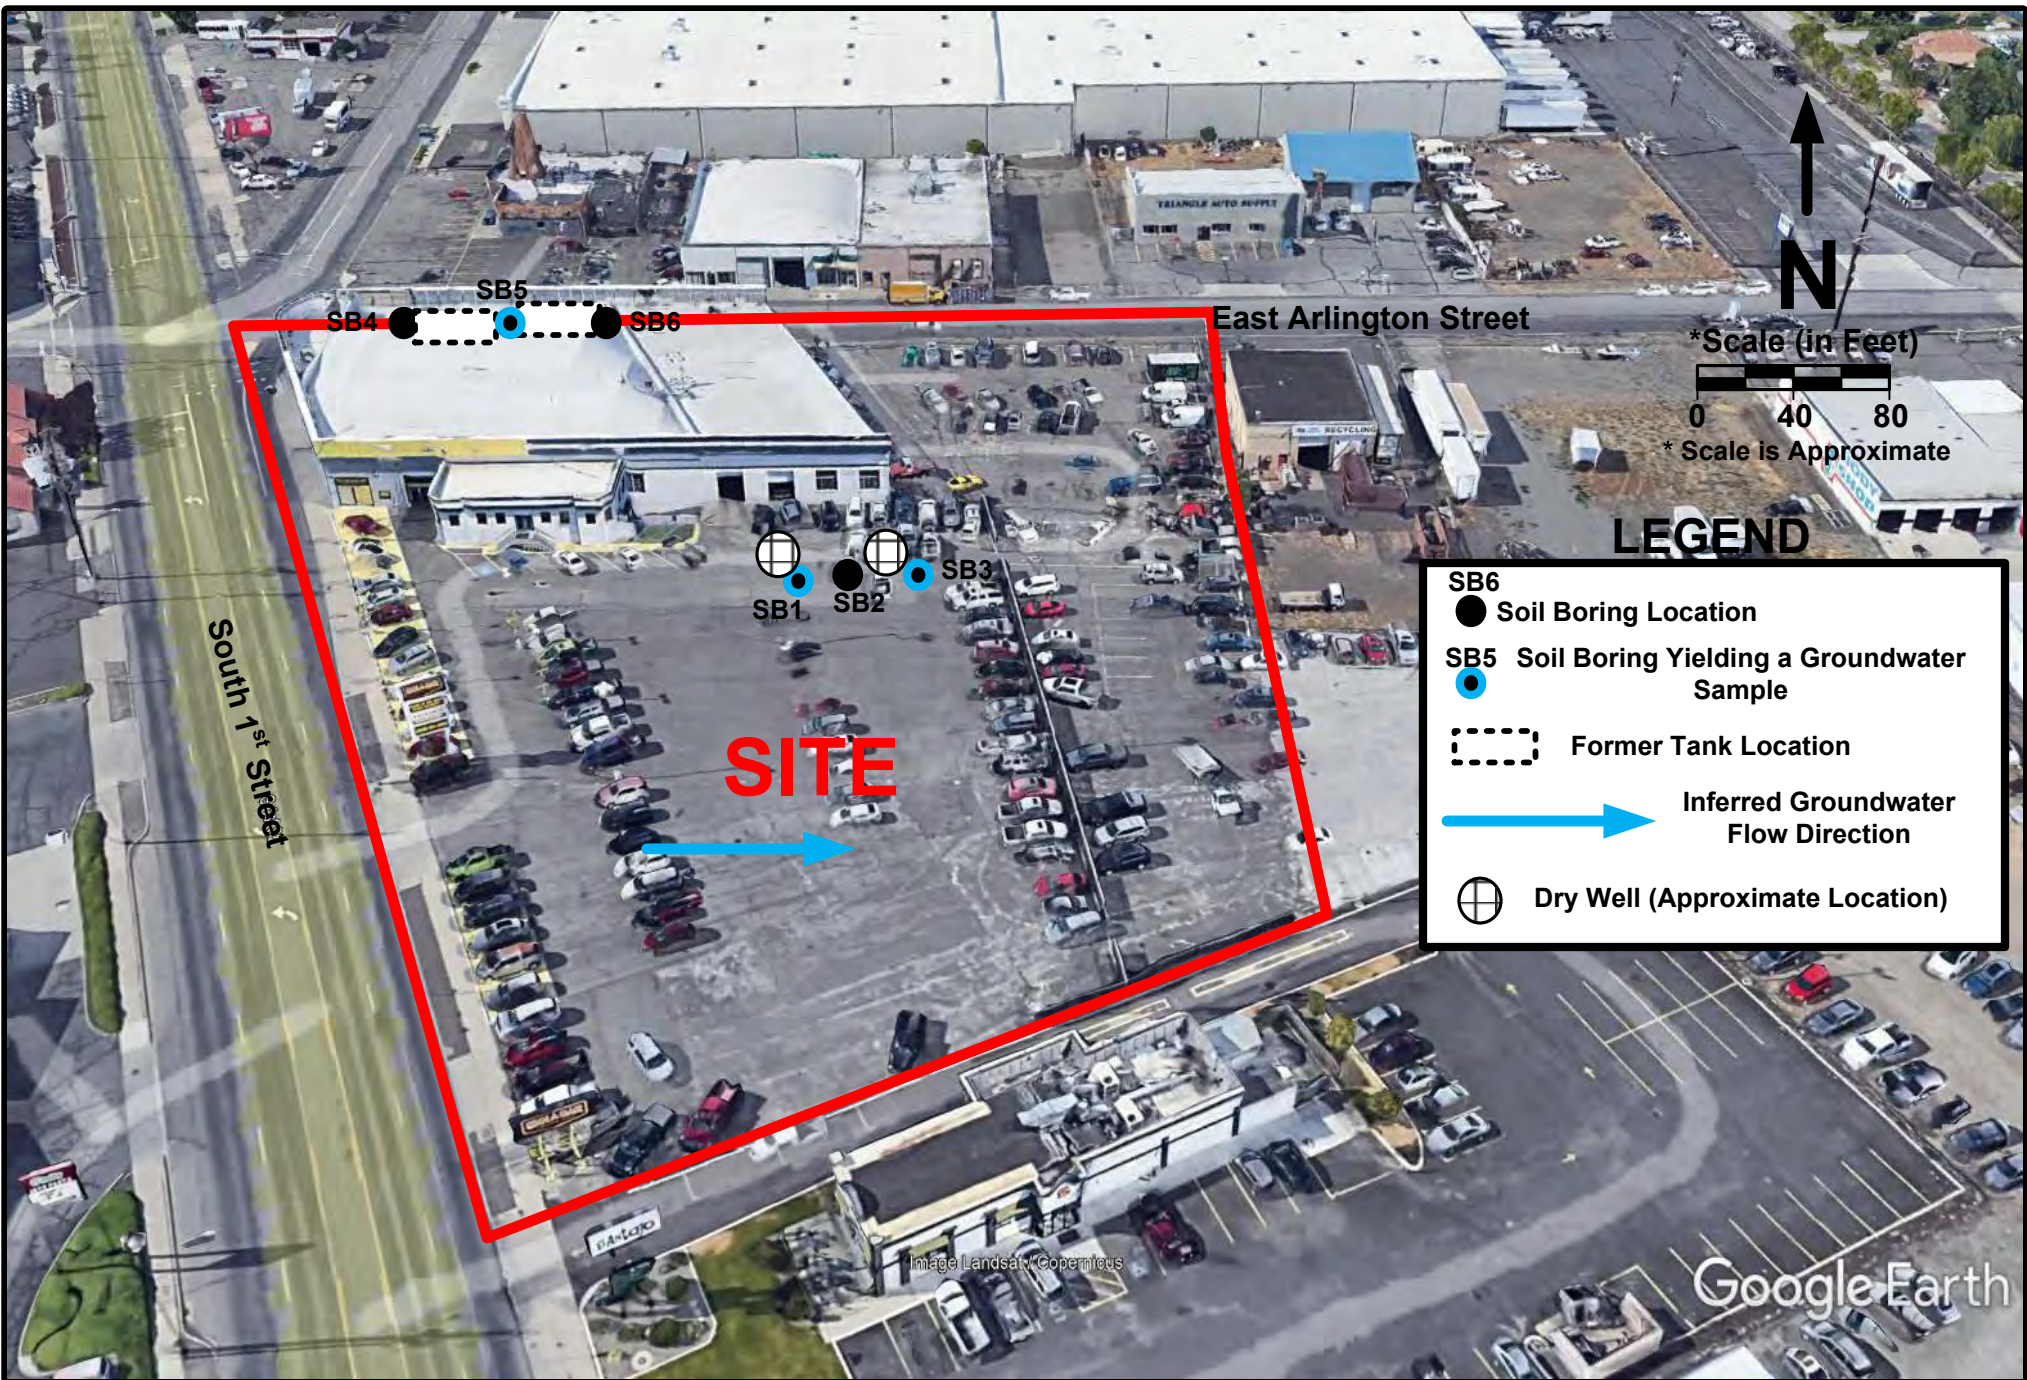
FIGURE 3 – SOIL BORINGS
FEBRUARY 1, 2022

approximate locations of the two former tanks are illustrated on **Figure 3**. Three soil samples were collected from the west, north, and east side of the eastern UST, yielding one heavy oil detection of 396 milligrams per kilogram (mg/Kg) in the west sample. Similarly, three soil samples were collected from the west, north, and east side of the eastern UST, yielding heavy oil detections ranging between 155 – 492 mg/Kg.

The 21 soil samples were collected from all six borings. Each sample was obtained in one 4-ounce soil container with Teflon-lined lid and four 40-milliliter (mL) glass vials preserved with methanol or sodium bisulfide. The locations of the six soil borings (SB1 through SB6) are illustrated on **Figure 3**.

two 500-mL, amber glass jars preserved with HCl; and one 500-mL polyethylene container preserved with nitric acid. The locations of the three soil borings from which groundwater samples were collected are illustrated on **Figure 3**.

As indicated on **Table 6**, TPH-D and/or TPH-O were detected above the laboratory MRLs in all three groundwater samples collected (SB1-2-1-22-GW, SB3-2-1-22-GW, and SB5-2-1-22-GW). Furthermore, TPH-D + TPH-O were detected in samples SB1-2-1-22-GW and SB5-2-1-22-GW at concentrations of 9800 µg/L and 770 µg/L, respectively, which exceeded the MTCA Method A Cleanup Level of 500 µg/L. Groundwater sample SB1-2-1-22-GW was collected from immediately down-gradient of the dry well outside the automobile engine washing bay and groundwater sample SB5-2-1-22-GW was collected from between the two USTs removed from the north side of the building (**Figure 3**).

ranged from 150 µg/L in SB3-2-1-22-GW to 1200 µg/L in SB1-2-1-22-GW. Cadmium was detected in groundwater samples SB1-2-1-22-GW and SB5-2-1-22-GW at 110 µg/L and 6.4 µg/L, respectively. The MTCA Method A Cleanup Level for cadmium in groundwater is 5 µg/L. Groundwater sample SB1-2-1-22-GW was collected from immediately down-gradient of the dry well outside the automobile engine washing bay and groundwater sample SB5-2-1-22-GW was collected from between the two USTs removed from the north side of the building (**Figure 3**).

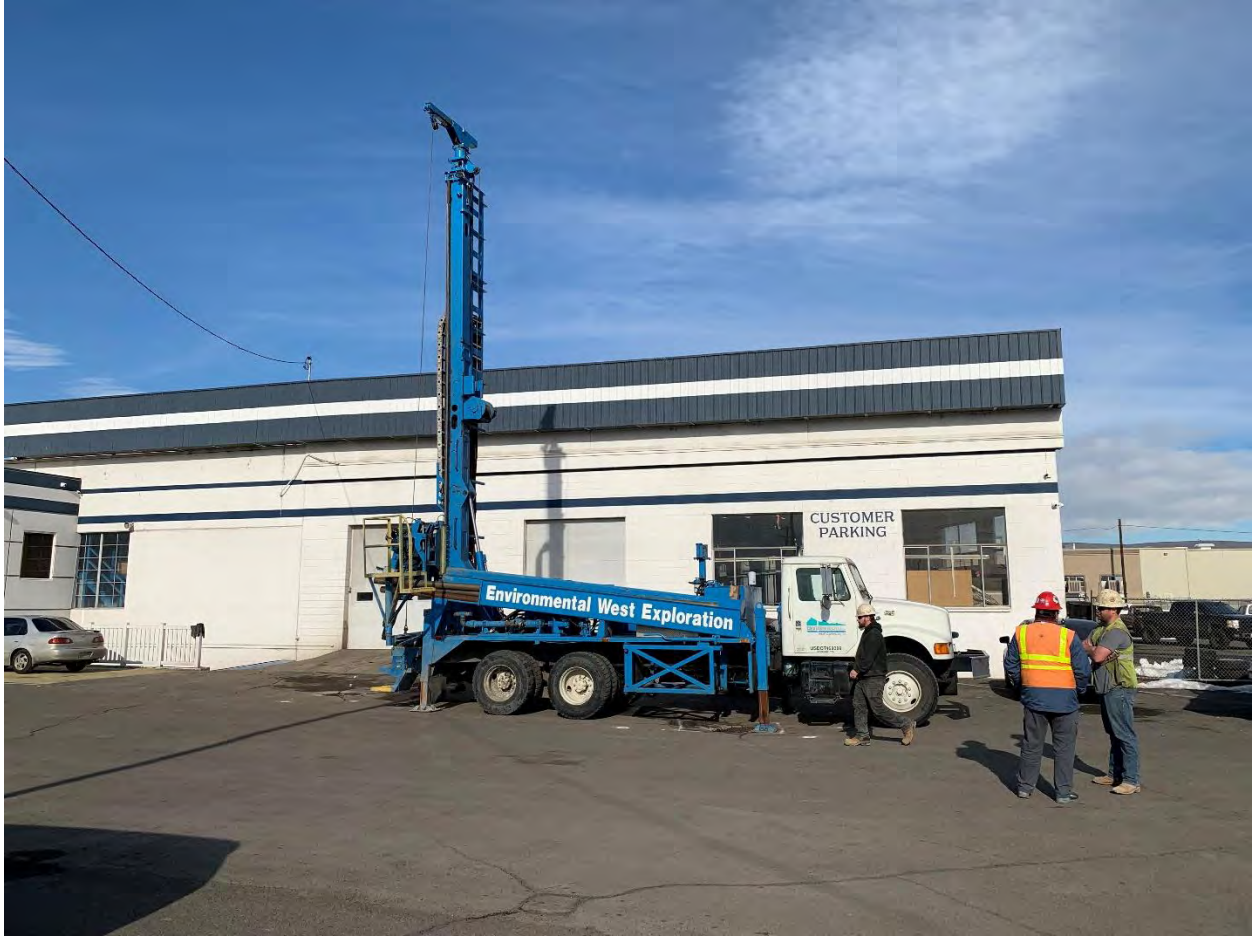
Photograph 7 – View of sonic drill rig prepared to begin drilling at soil boring SB1 on Tuesday, February 1, 2022 (facing north).

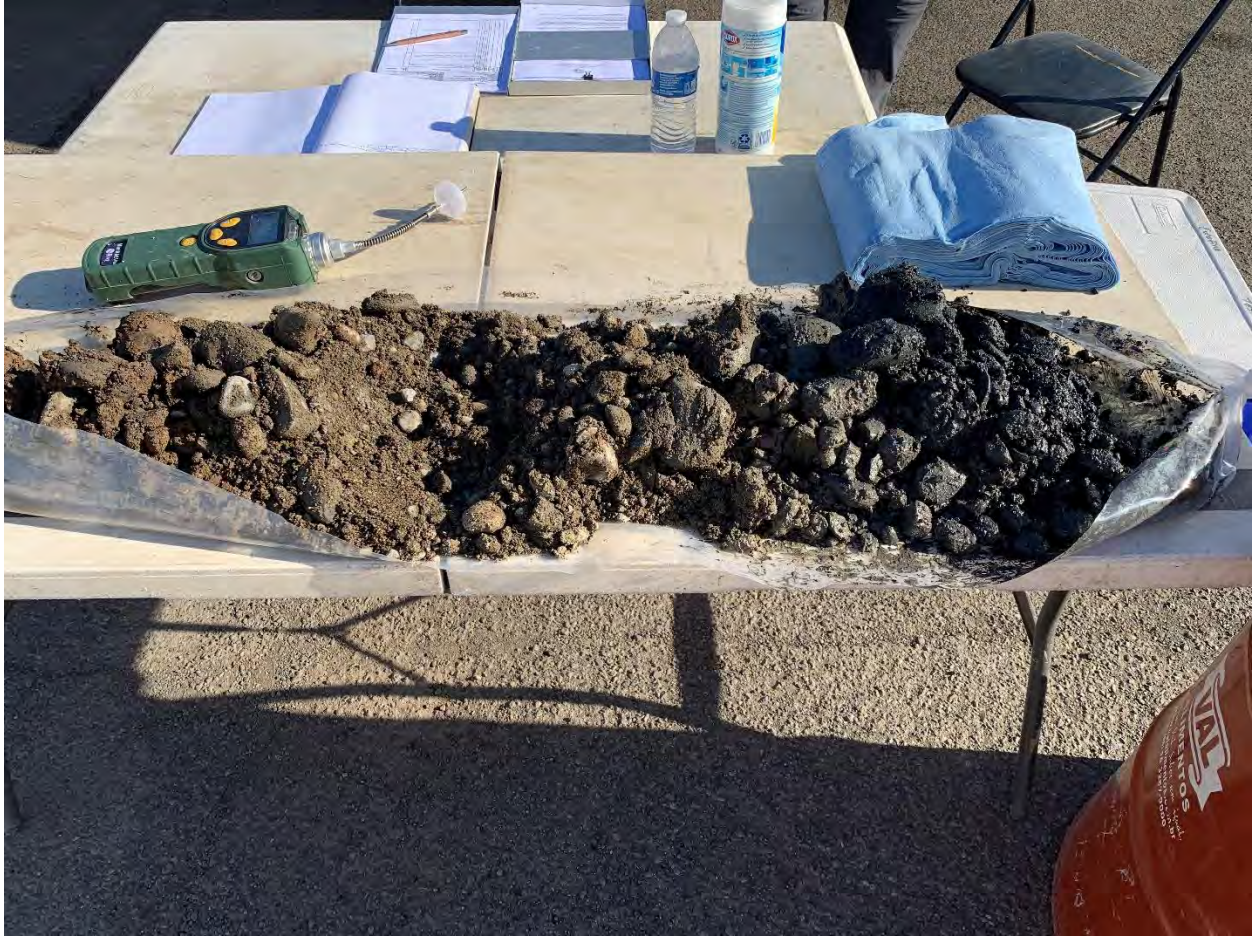
Photograph 8 – Soil lithology from 0 – 10 feet bgs in soil boring SB1. Note black, oil-stained soil from 7 – 10 feet bgs.

The MTCA Method A Cleanup Level for TPH-D + TPH-O is 2000 mg/Kg which was exceeded in samples SB1-2-1-22-10' (2070 mg/Kg) and SB5-2-1-22-10' (6900 mg/Kg).

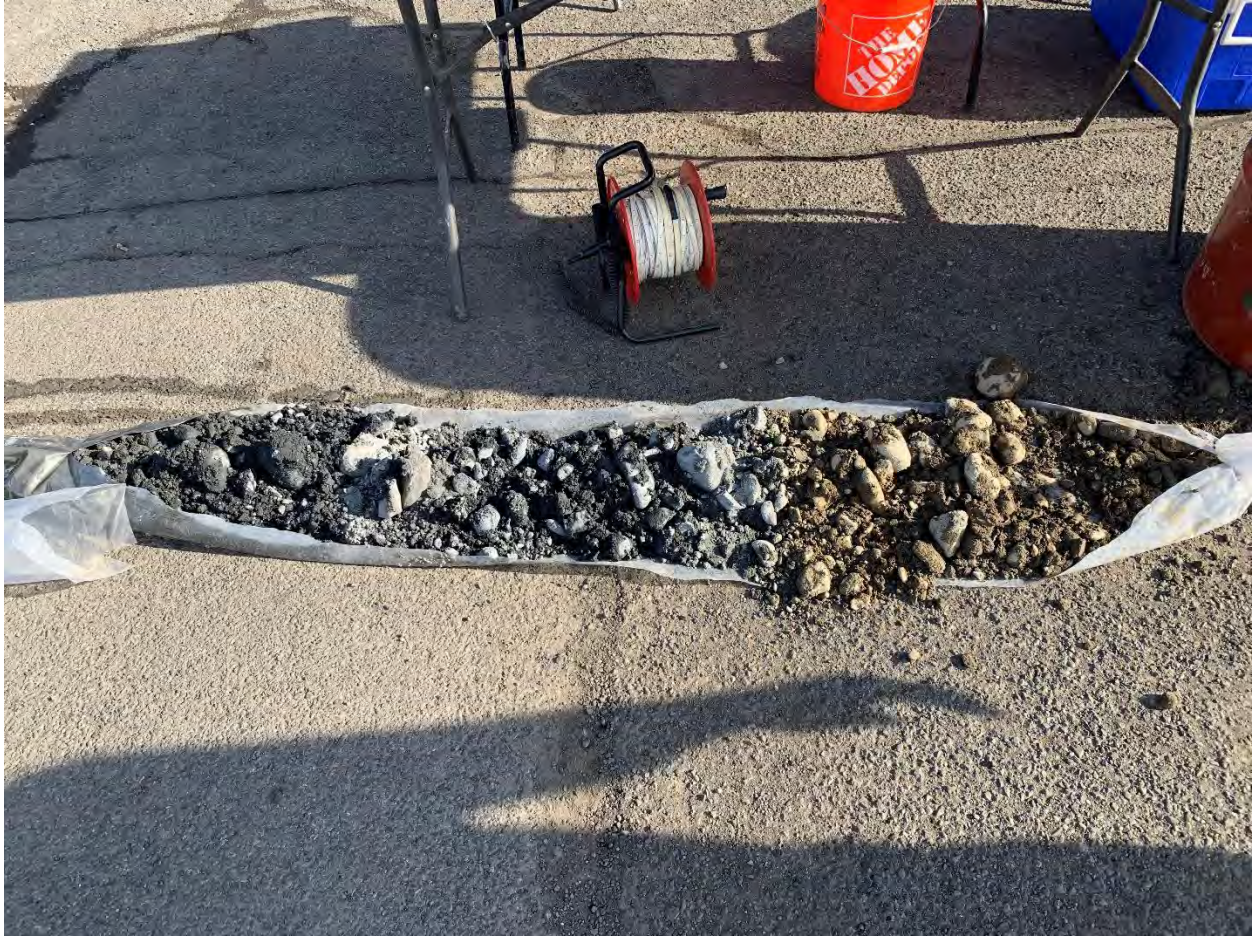
Photograph 9 – Soil lithology from 10 – 15 feet bgs in soil boring SB1. Note black, oil-stained soil from 10 – 14 feet bgs and relatively clean, brown soil from 14 – 15 feet bgs.

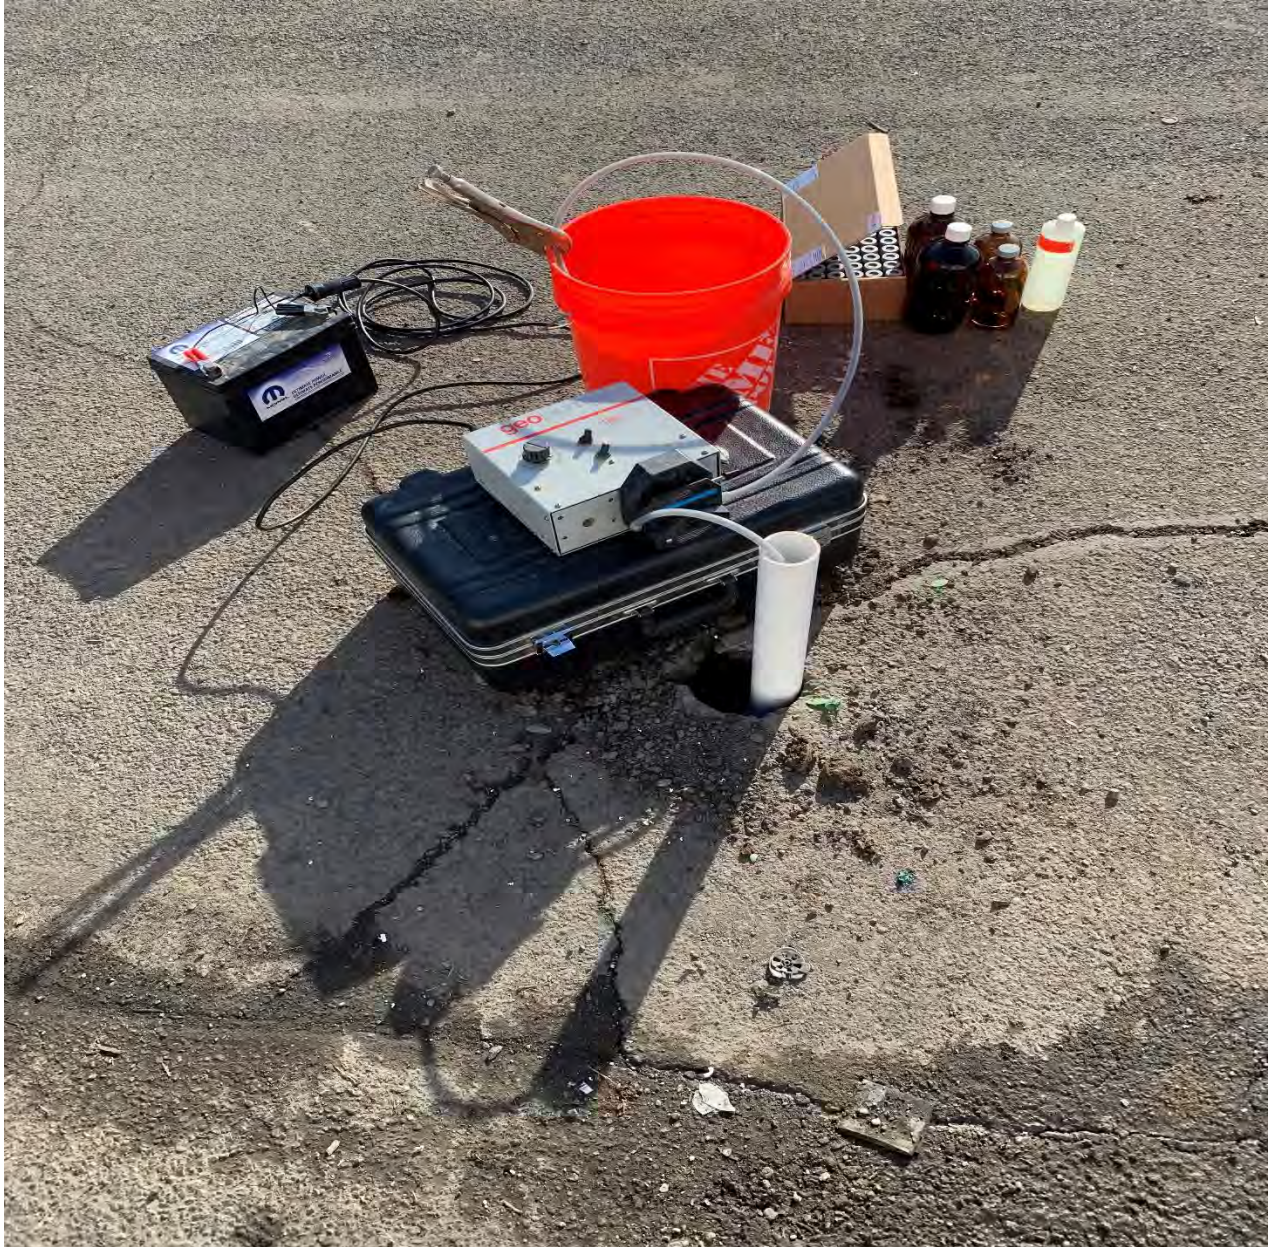
Photograph 10 – Groundwater sampling gear being utilized during the purging and collection of groundwater sample SB1-2-1-22-GW.

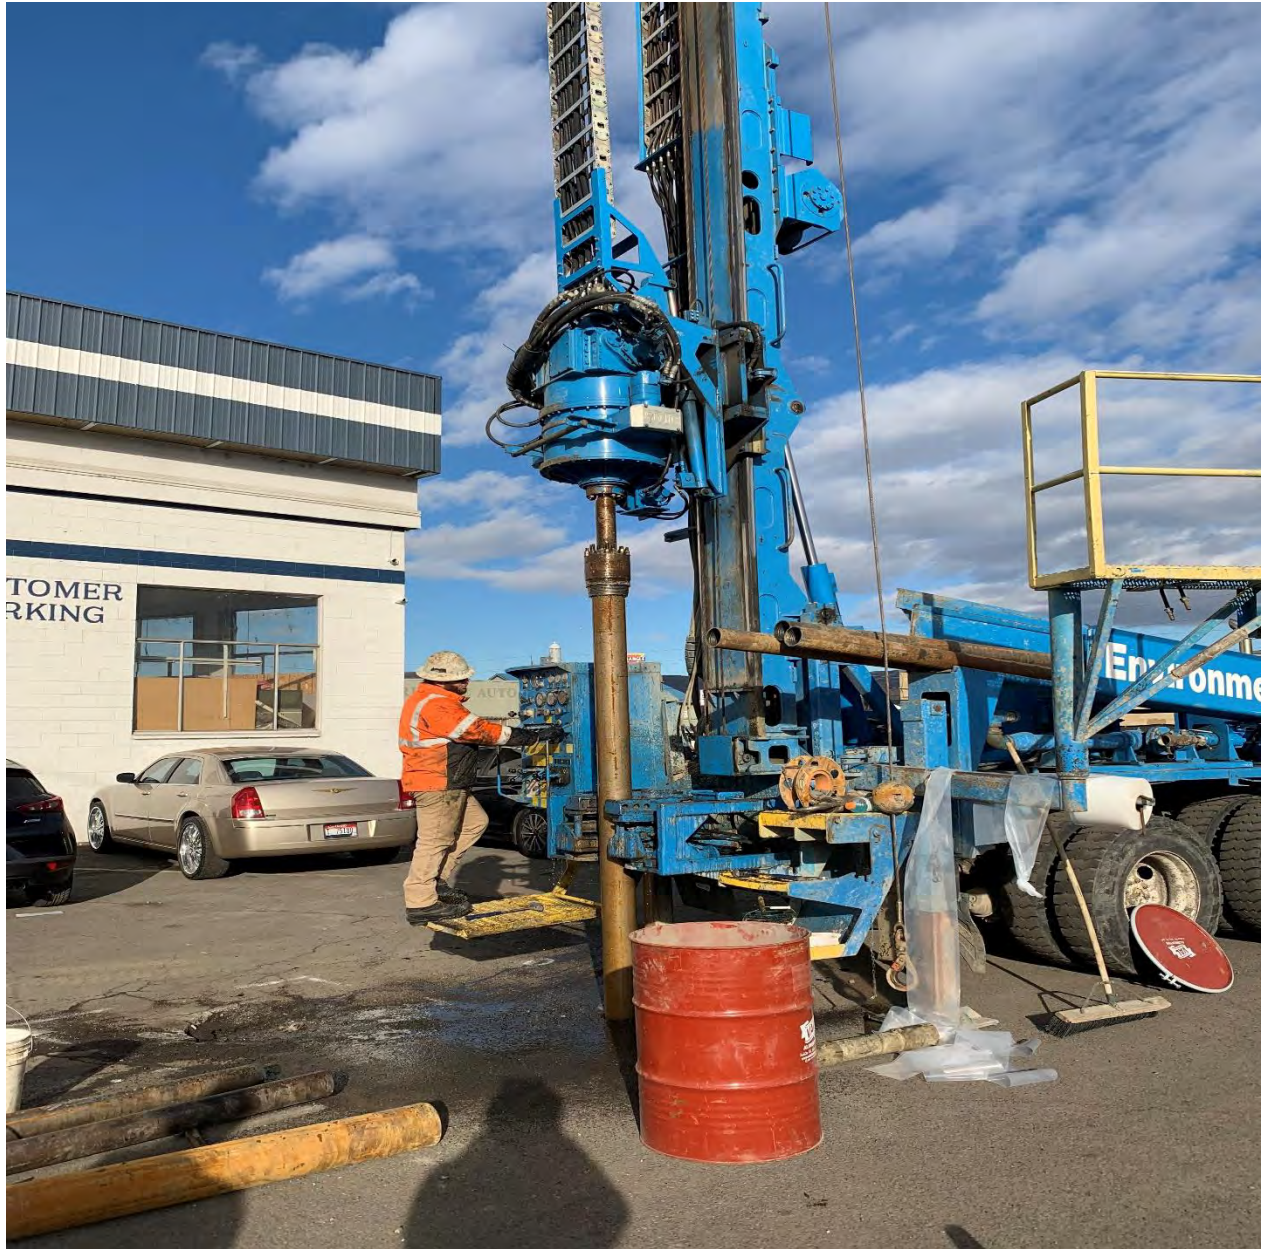
Photograph 11 – Drillers advancing sonic drilling rods at soil boring SB3 (facing northeast)

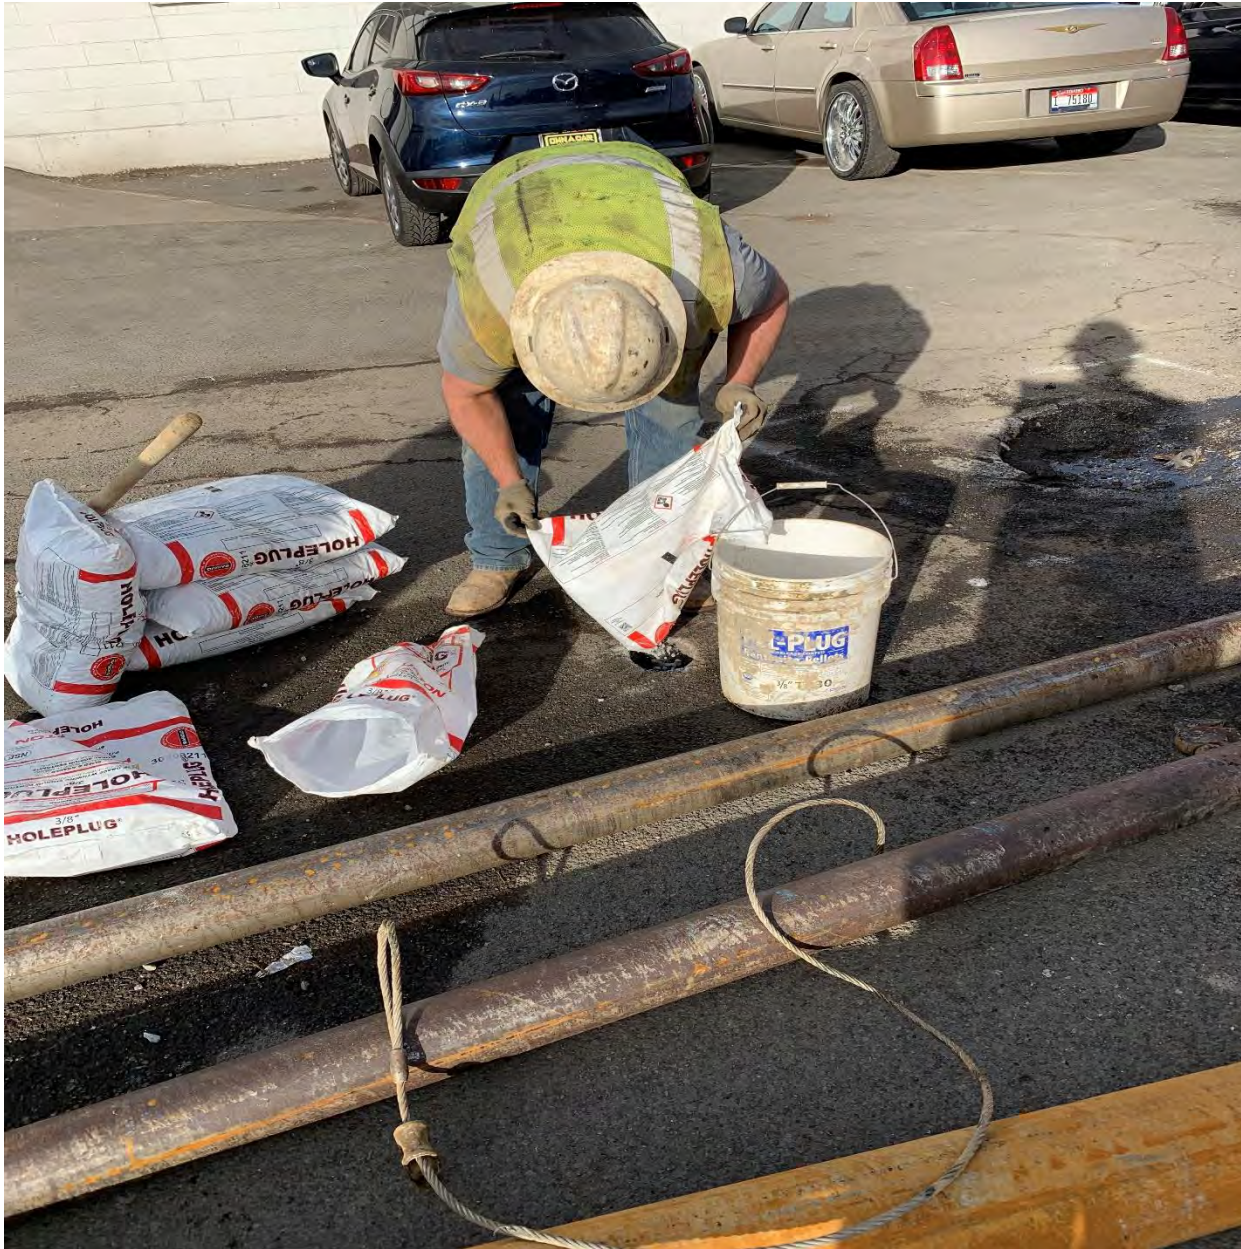
Photograph 12 – Driller’s helper pouring bentonite pellets into soil boring SB2, subsequent to soil sample collection.

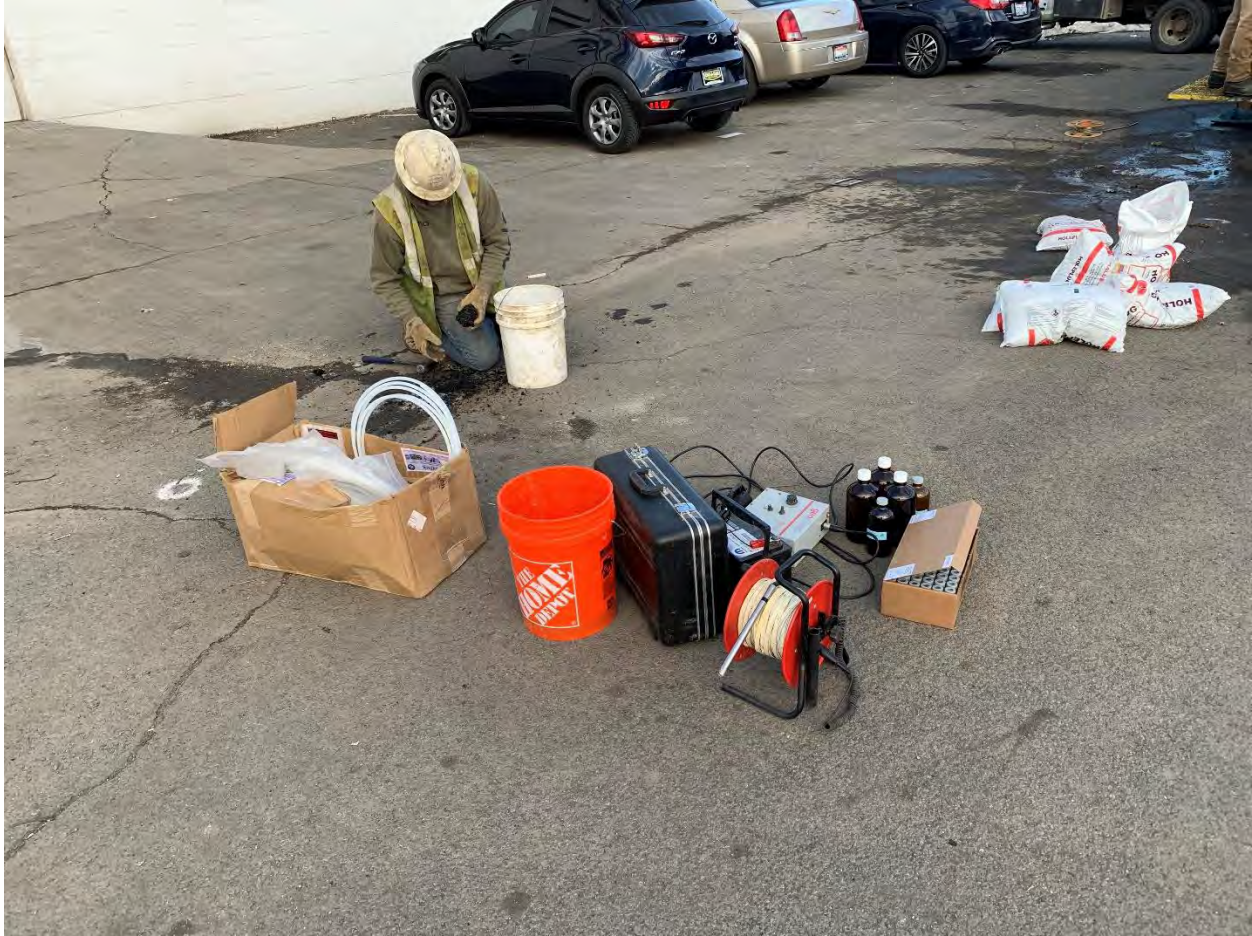
Photograph 13 – Driller’s helper replacing the asphalt patch at soil boring SB1.

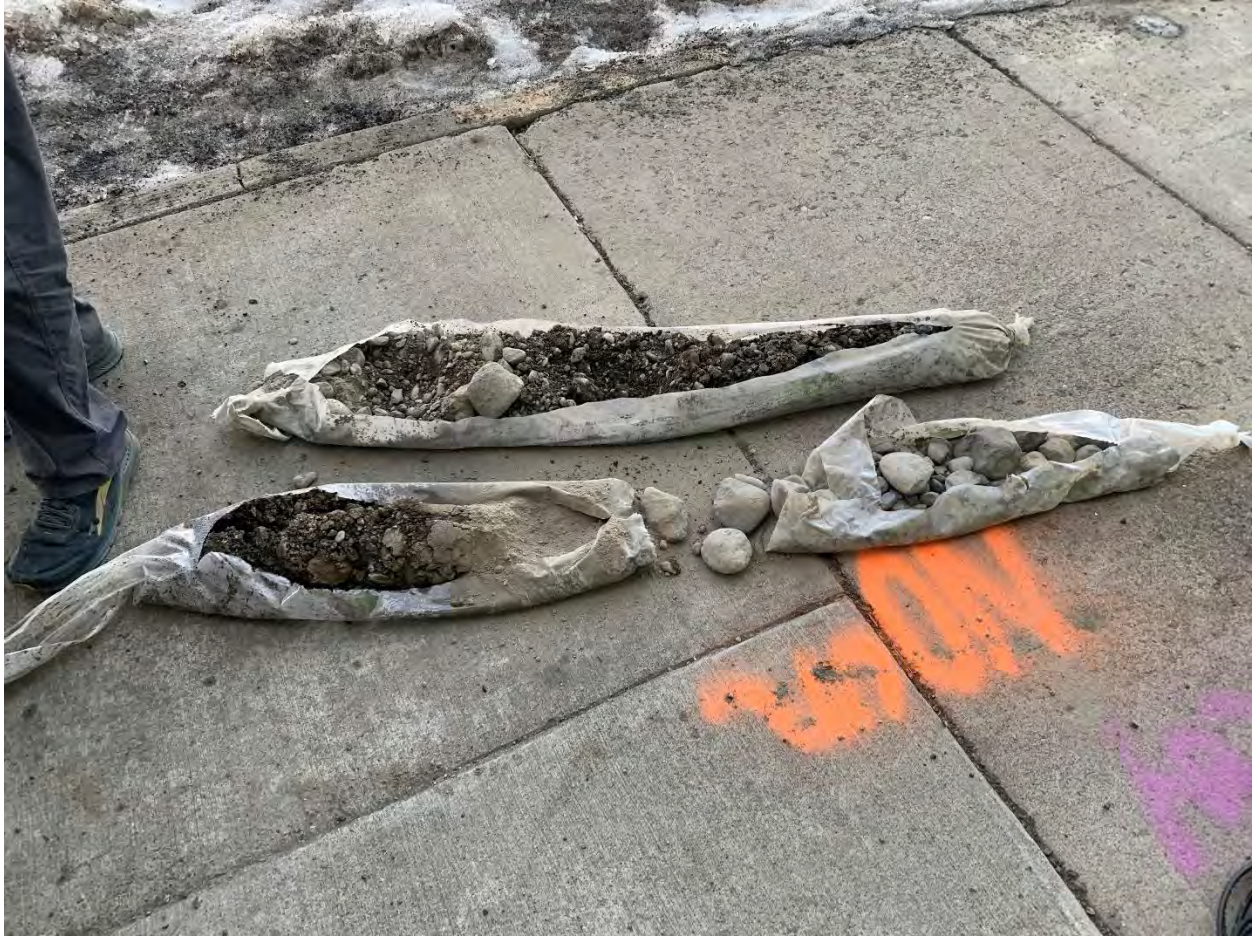
Photograph 14 – Soil lithology in soil boring SB4 from 0 – 10 feet bgs.
