RE: Everett Landfill – 2021 Landfill Gas Annual Report

2021 ANNUAL REPORT

LANDFILL GAS PERFORMANCE MONITORING
EVERETT LANDFILL SITE

Prepared by
Herrera Environmental Consultants, Inc.

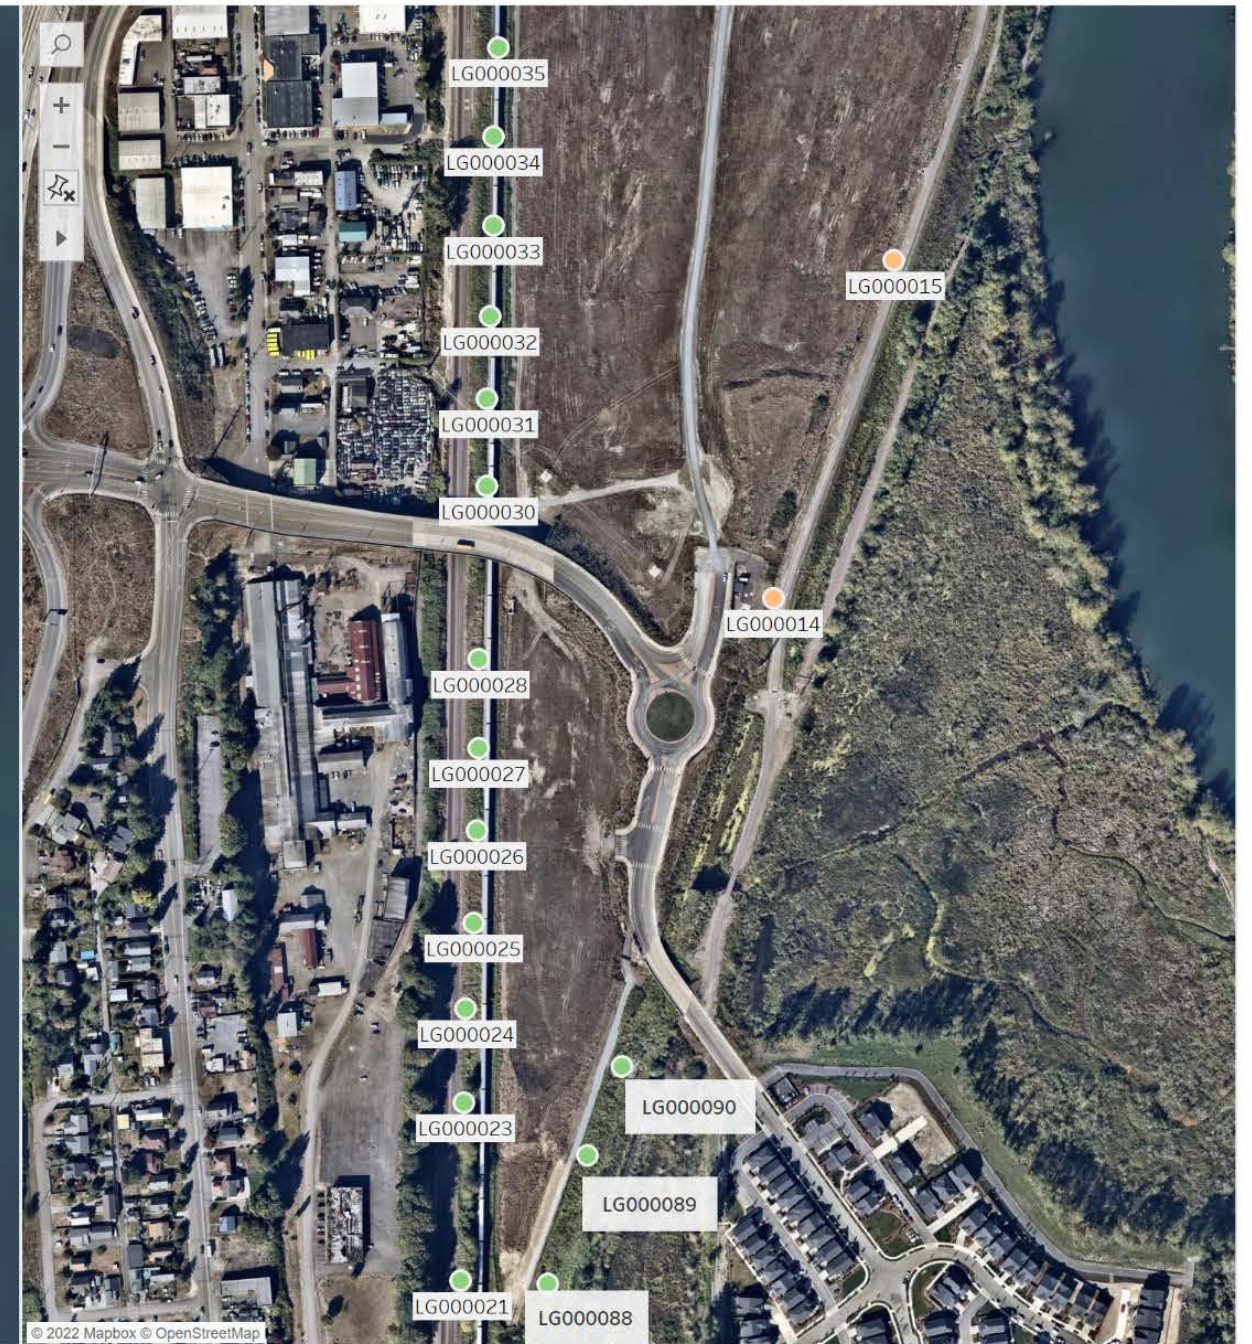
Figure 2. Monitored Perimeter Probes

The probes that were monitored for compliance in 2021 are shown on the map in Figure 2 in green. The three probes on the east perimeter trail – LG-14, LG-15, and LG-16 were not

monitored for compliance, but have been continued to be monitored to inform operations and are shown in Figure 2 in orange.

Three gas probes (LG-88, LG-89, and LG-90) were installed in October 2019 (see Figure 2) west of the wetlands to monitor the potential for gas migration east of the landfill boundary.

Many of the landfill gas probes at the north end of the landfill are on private property that has been redeveloped, with activities including building demolition and major site grading. As a result, the following probes have been buried or damaged and cannot be monitored: LG-12, LG-44, LG-45, LG-46, LG-47, LG-61, LG-67, and LG-68. LG-62 was covered for several years but was uncovered in 2020 by construction excavation in the area. The probe was found to be functional and was fitted with a new monument in March 2020, after which it continued to be monitored. Four replacement probes (LG-91, LG-92, LG-93, and LG-94) were installed in the 36th Street right of way on March 4 and 5, 2020. Replacement probes were screened at similar depths (4 to 10 feet bgs) of previously damaged or buried gas probes and consistent with waste levels to the south in the landfill. Locations are shown on Figure 2.

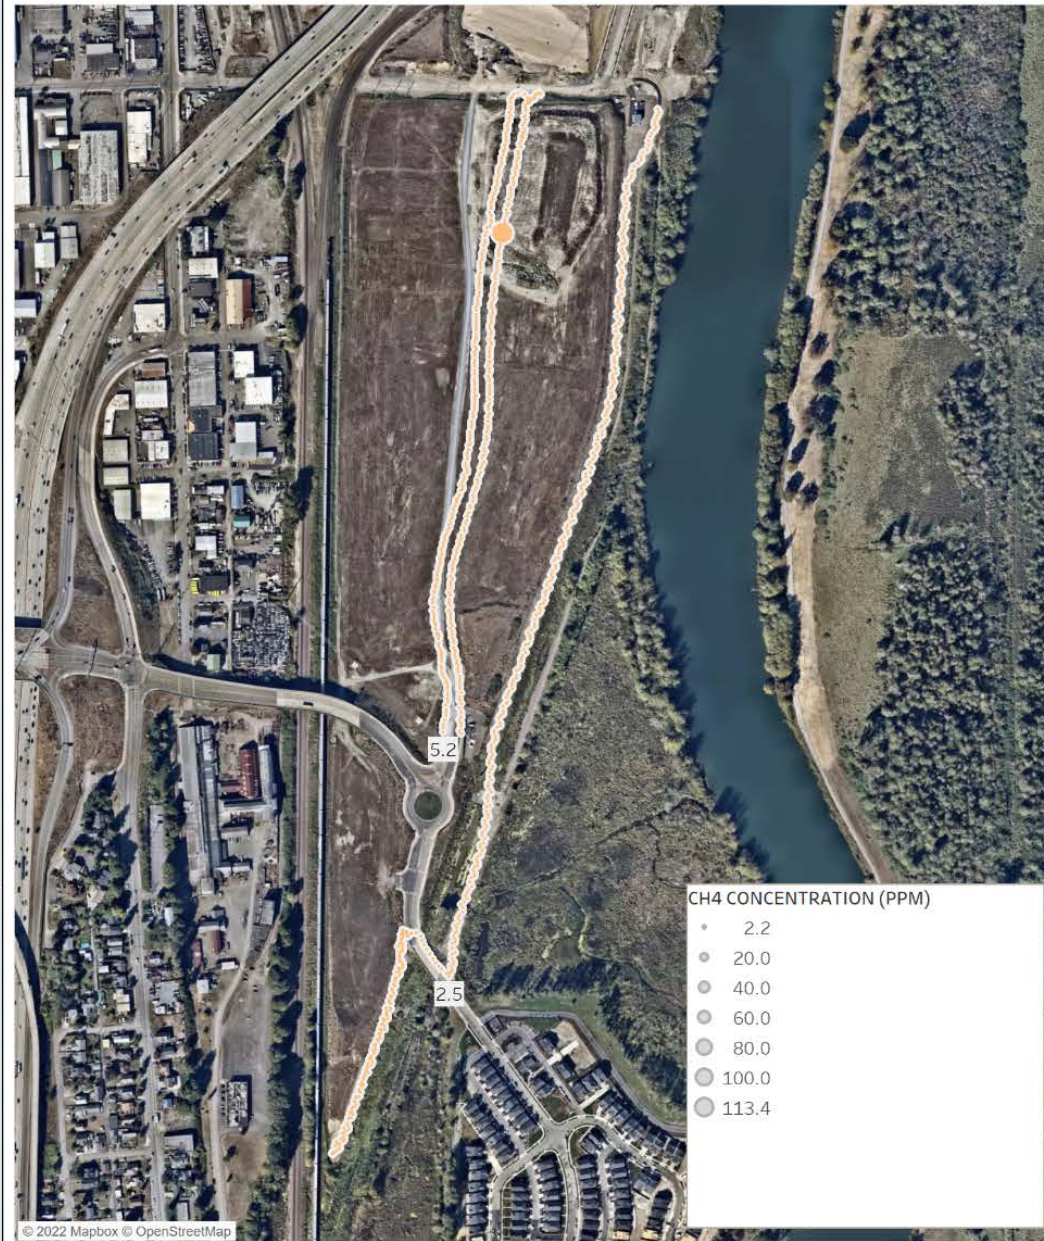
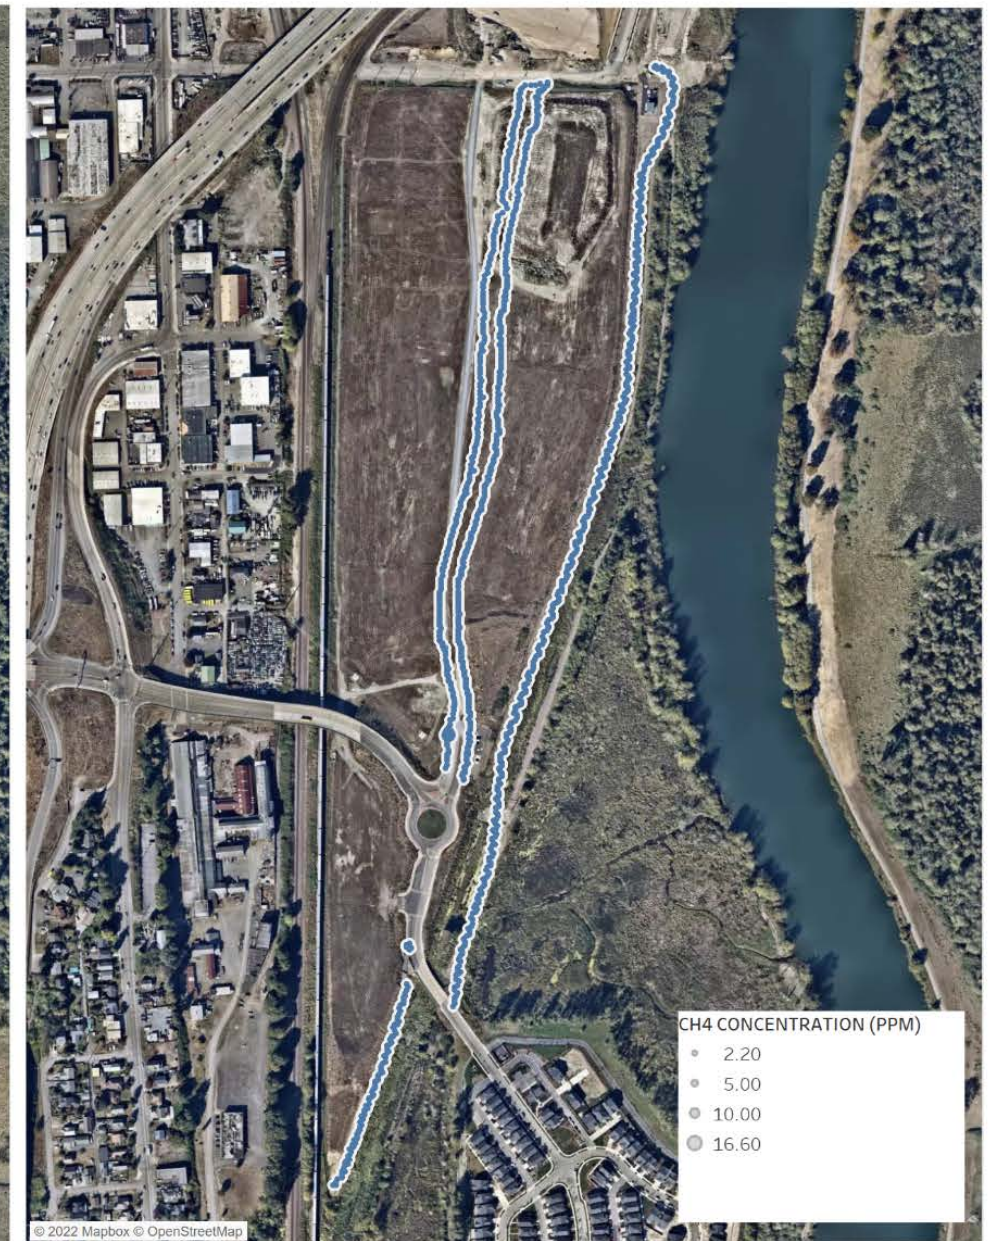
Figure 3. Quarterly Serpentine Monitoring Results

The regulatory threshold for the on-site monitoring elements is 500 ppm. None of the quarterly monitoring events that took place during 2021 had any regulatory exceedances. Serpentine monitoring was not conducted at the Riverfront Boulevard in March as it had not been dedicated to the City of Everett for public access. Serpentine data is not displayed for the June monitoring event as the data was lost during return of the SEM 5000 from the rental company. The real-time methane concentrations displayed on the SEM 5000 during the June serpentine monitoring event were observed closely and no exceedances were found. As shown in Figure 3, the landfill surface monitoring had a maximum of 113.4 ppm reading in September and a maximum of 16.60 ppm reading in December, well below the regulatory limit of 500 ppm.

*Right: Data from the September 30, 2021 and December 14, 2021 collection. *Data from the June 23, 2021 collection was lost and cannot be displayed.*

March 23, 2021: No regulatory exceedances for off-site buildings or Riverside Trail. Serpentine monitoring of Riverfront Boulevard was not conducted as it had not been dedicated to the City of Everett.

June 23, 2021: No regulatory exceedances for off-site buildings, Riverside Trail or Riverfront Boulevard.

September 30, 2021: No regulatory exceedances for off-site buildings, Riverside Trail or Riverfront Boulevard.

December 14, 2021: No regulatory exceedances for off-site buildings, Riverside Trail or Riverfront Boulevard.
