# UST DECOMMISSIONING, OVEREXCAVATION CLEANUP, & ASSOCIATED SITE ASSESSMENT

**ALCOA INTALCO WORKS**  
**4050 Mt. View Road**  
**Ferndale WA 98248**

**August 15, 2001**

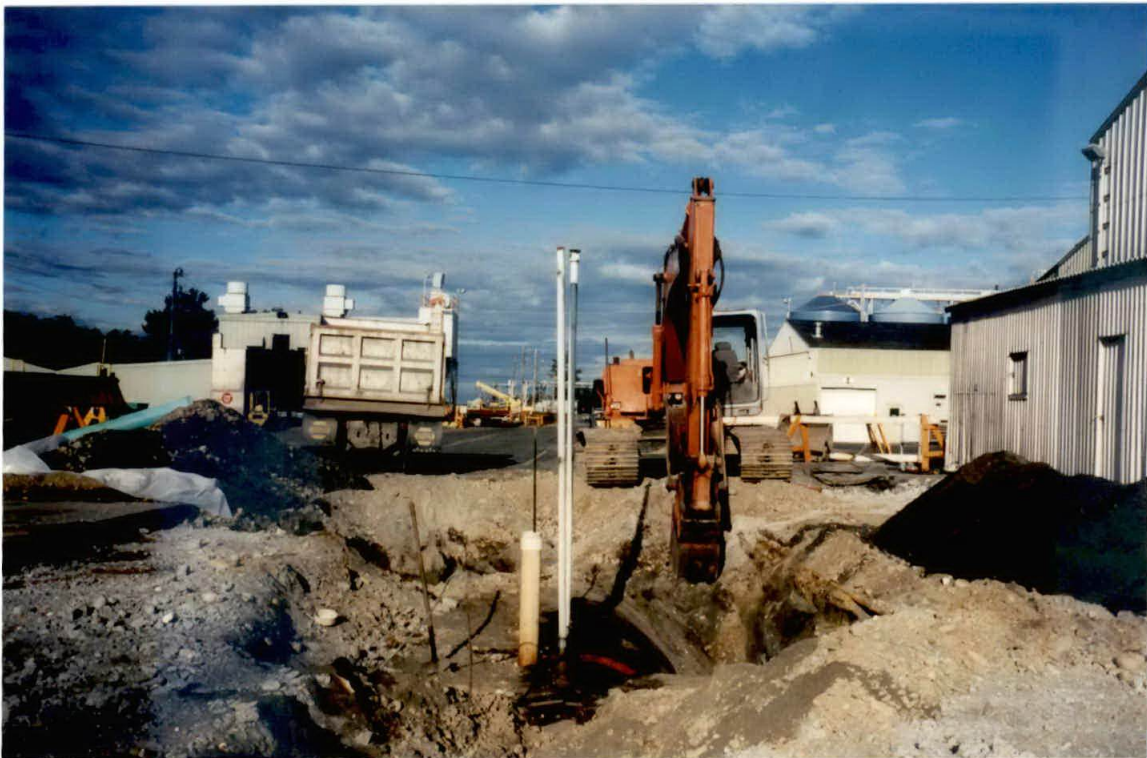
**Photo 4: Excavating  
12,000 gallon  
Diesel UST**

Upon our arrival at the Automotive Repair Shop at Alcoa Intalco Works, the soil overburden for the 12,000 gallon Diesel UST (Photo 4) and the 12,000 gallon Gasoline UST had been removed and hauled as clean soil. The fuel dispenser island which straddled one end of both USTs (Photo 3) had already been removed. Soil staining was apparent where the fuel dispenser island containing the fill pipes had stood. The monitoring well inside the fuel dispensing island remained. It had shown the water table at about 3 feet depth. The day before commencing UST removal, a hole was excavated at the south side of the Diesel UST and the excavation was dewatered using this hole and the monitoring well casing. About 4,500 gallons of water were pumped out, loaded into a tank trailer, and delivered to the onsite 1,000,000 gallon holding tank for eventual onsite treatment once enough water has accumulated. Initially, on the day of UST removal, the UST excavation was dry. But as excavation proceeded, the excavation gradually filled with one foot of groundwater by the time the Diesel UST was removed (Photo 7).

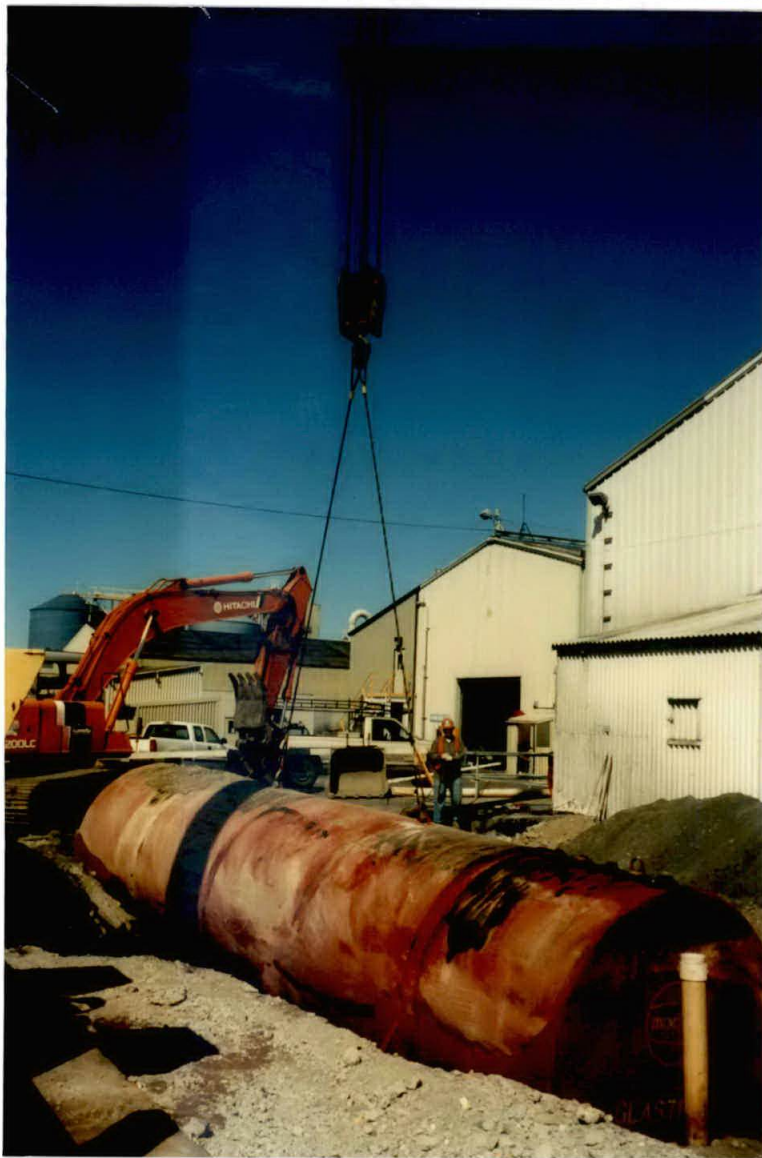
**Photo 5: Removing  
12,000 gallon  
Diesel UST**

The 12,000 gallon Diesel UST was first removed and inspected (Photos 5 & 6). It measured 8 feet in diameter by 32 feet long. It was a steel tank covered on the outside with fiberglass. This tank was in excellent condition. The shell of the UST showed no blemishes, no electrolytic pitting and no rust. There were no apparent holes in the UST. The UST had rested at a depth of 11 feet below the ground surface. This UST was loaded onto a semi-trailer to await removal from the site (Photo 6).

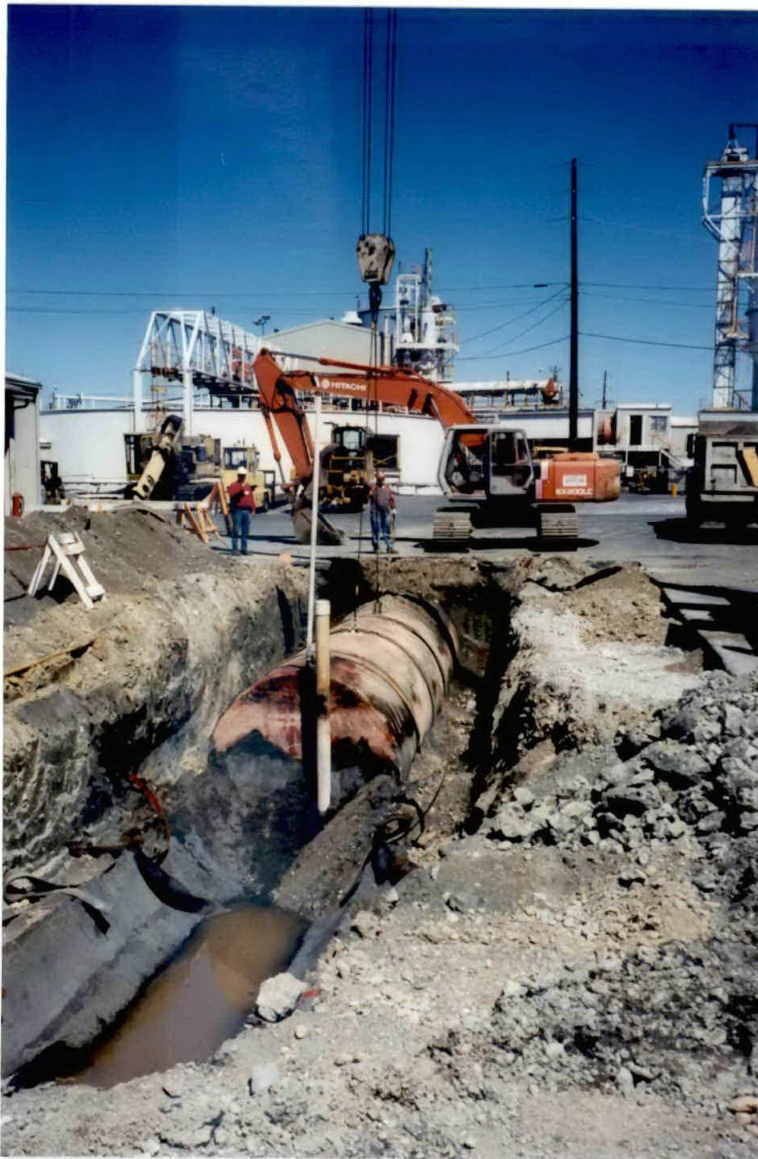
**Photo 7:**  
**Removing 12,000 gallon**  
**Gasoline UST**

Profile of the native soil at the excavation edges showed brown cobely, gravelly, sandy loam from 0 to 3 feet, then patchy grey and green tight to very tight fine silt and weathered sandstone from 3 feet to the excavated depth of 11 feet. Inside the UST excavation surrounding the USTs themselves was grey medium sand. Groundwater was observed in the excavation (Photo 7) at 10 feet depth.

Next the 12,000 gallon Gasoline UST was removed and inspected (Photos 7 & 8). It measured 8 feet in diameter by 32 feet long. It was a steel tank covered on the outside with fiberglass. This tank was in excellent condition. The shell of the UST showed no blemishes, no electrolytic pitting and no rust. There were no apparent holes in the UST. The UST had rested at a depth of 11 feet below the ground surface. This UST was also loaded onto a semi-trailer to await removal from the site (Photo 9).

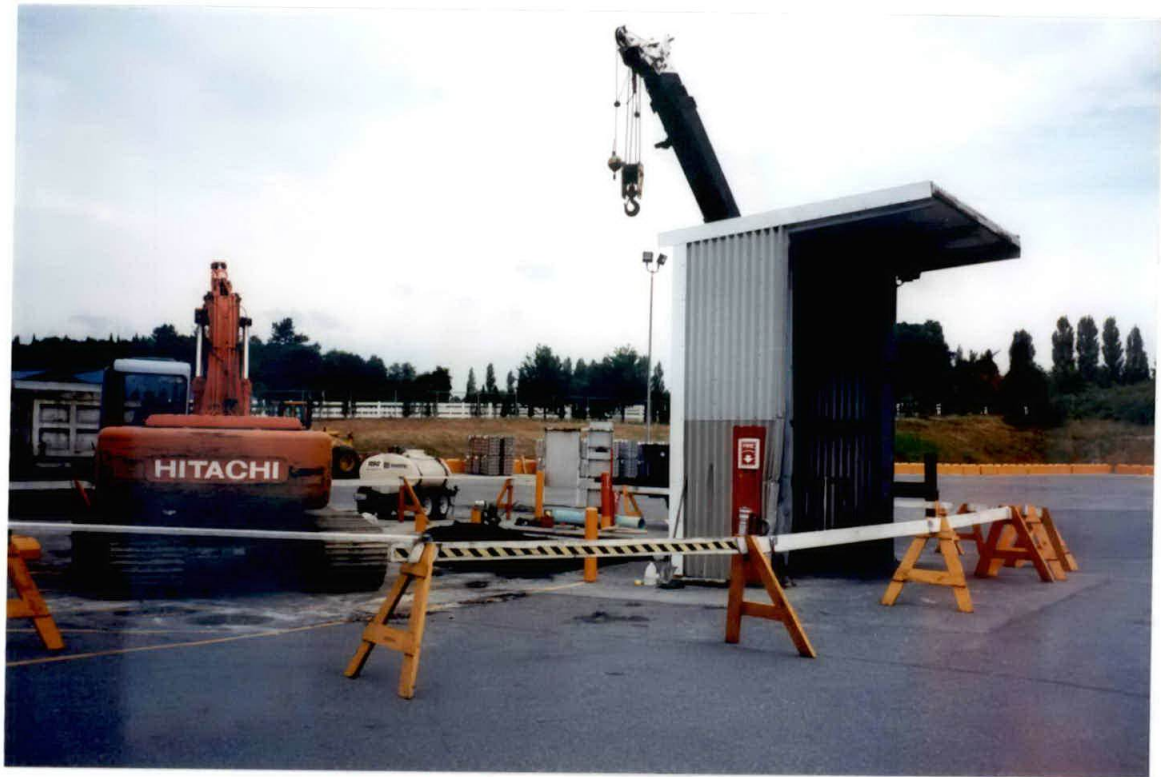
**Photo 11: Cast House Excavation Site**

Decommissioning proceeded at the Cast House location with excavation of the 6,000 gallon Diesel UST. The soil overburden had been removed (Photo 11). Dry ice was introduced into the UST to inert it. Groundwater was observed inside the excavation. 6,000 gallons of water had been pumped from the location a day earlier, loaded into a tank trailer, and hauled to the 1,000,000 holding tank for eventual treatment (Photo 13). 7,500 gallons of water was pumped the day of decommissioning and hauled likewise. The UST was further excavated to release the UST (Photo 14). Contaminated soil was loaded into a dump truck and hauled to the Alcoa Intalco Works Toxic Waste Disposal Site on the north side of the property for remediation there (Photo 16).

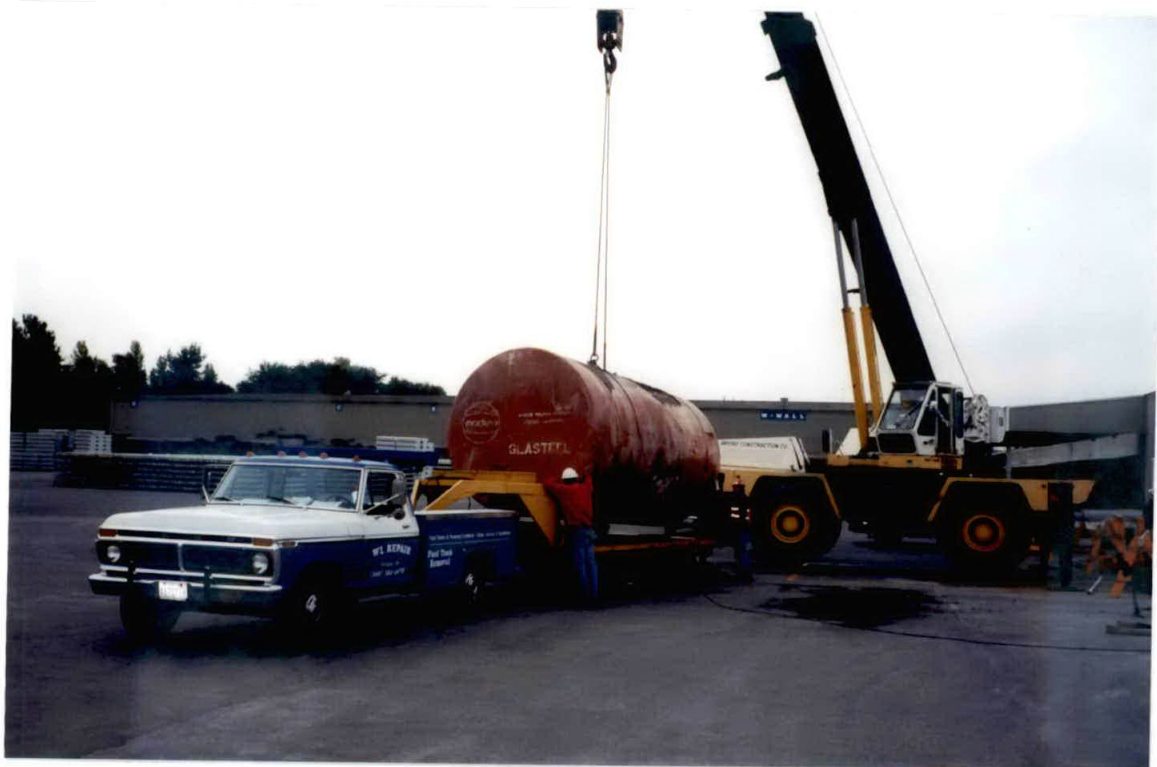
**Photo 12: Cast House 6,000 gallon Diesel UST Removed**

The 6,000 gallon Diesel UST was removed and inspected (Photo 12). It measured 8 feet in diameter by 18 feet long. It was covered with fiberglass. The shell of the UST was in excellent condition and showed no rusting. There were no apparent holes in the UST. This 6,000 gallon Diesel UST was loaded onto a trailer and hauled to the W. L. Repair Shop at 959 W. Laurel Road, Ferndale WA 98248 where it will be cleaned for eventual disposal at Z-Recyclers at 6129 Guide Meridian, Lynden WA 98264.

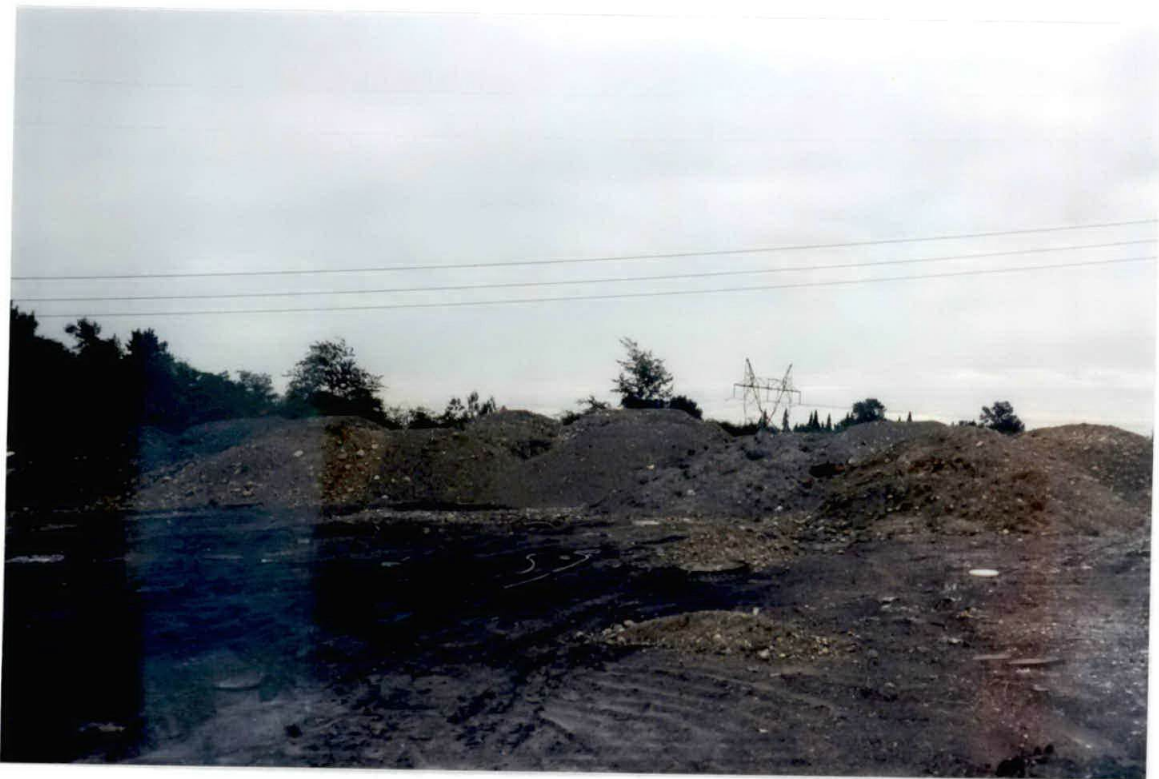
**Photo 16: Petroleum Contaminated Soil Stockpile**

A soil sample taken from the PCS stockpile to characterize contamination showed gasoline and diesel range hydrocarbons above cleanup levels. Benzene was at the cleanup level. Ethylbenzene and xylenes were below cleanup levels, and toluene was not found.

The Petroleum Contaminated Soil stockpile was sampled to characterize the contamination at the Automotive Repair Site location. This sample showed gasoline range hydrocarbon contamination 60% greater than the cleanup level of 30 ppm. Diesel range hydrocarbons in this sample were 119% greater than the 2,000 ppm cleanup level. There was no oil range contamination. The analysis for BTEX in this sample showed benzene at the cleanup level of 30 ppm, no toluene, ethylbenzene at 7.66% of the cleanup level, and xylenes at 6.88% of the cleanup
