**Re: Opinion Pursuant to WAC 173-340-515(5) on Remedial Action for the following Hazardous Waste Site:**

- **Name:** Four Corners Cleaners New Location
- **Address:** 23886 SE Kent-Kangley Road, Maple Valley, WA 98038
- **Facility/Site No.:** 5867
- **Cleanup Site ID No.:** 12513
- **VCP No.:** NW3234

## **Enclosure A**

### **Description and Diagrams of the Site**

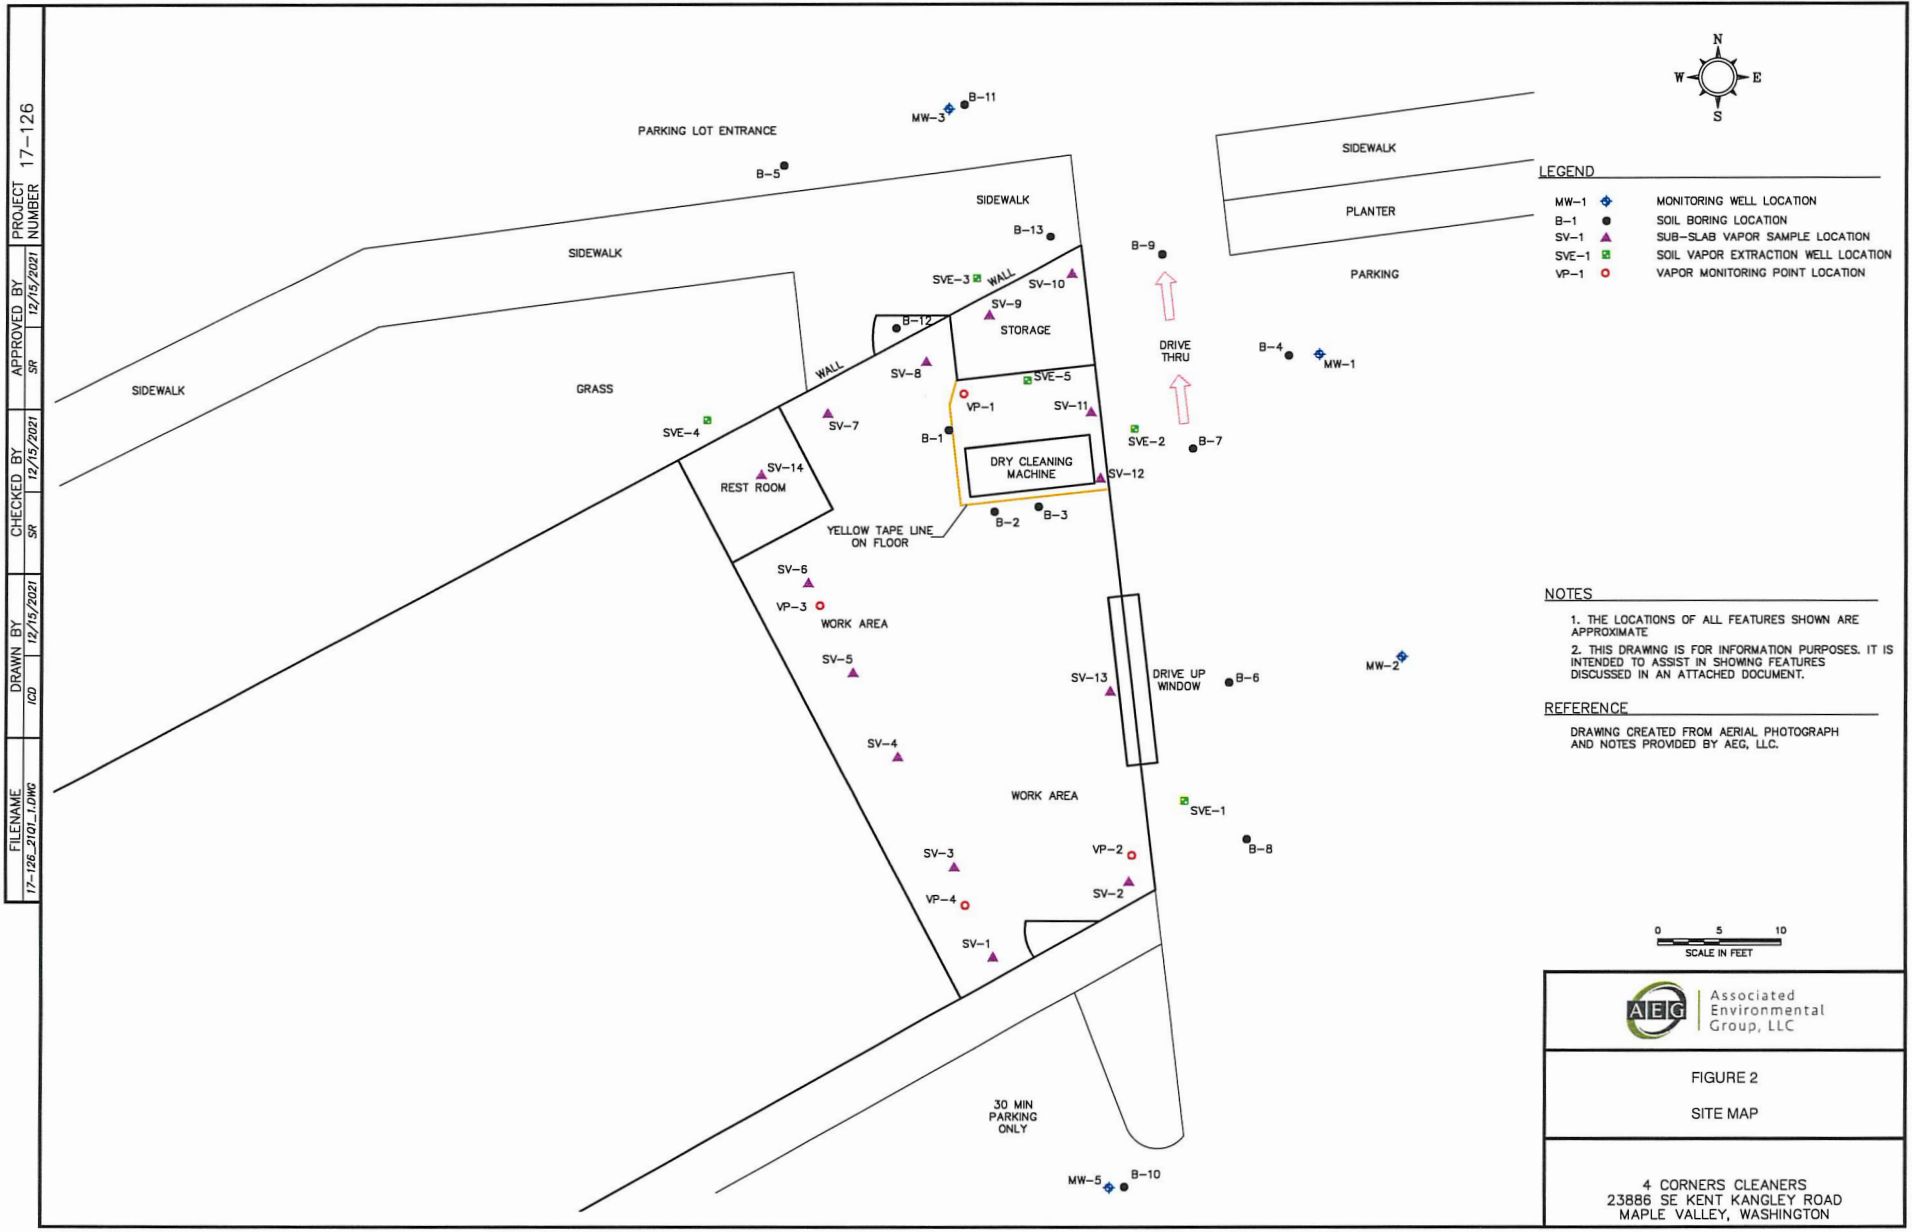
**Area and Property Description:** The Property is located in the middle of a city block, in an area of five retail buildings totaling 254,663 square feet. An "L" shaped building on the southwest portion of the Property includes the Four Corners Cleaners tenant space. The remainder of the Property not covered by buildings consists of asphalt-paved parking and driveways, and landscaped areas. The immediate vicinity of the Site is primarily commercial businesses. **(Figure 2)**

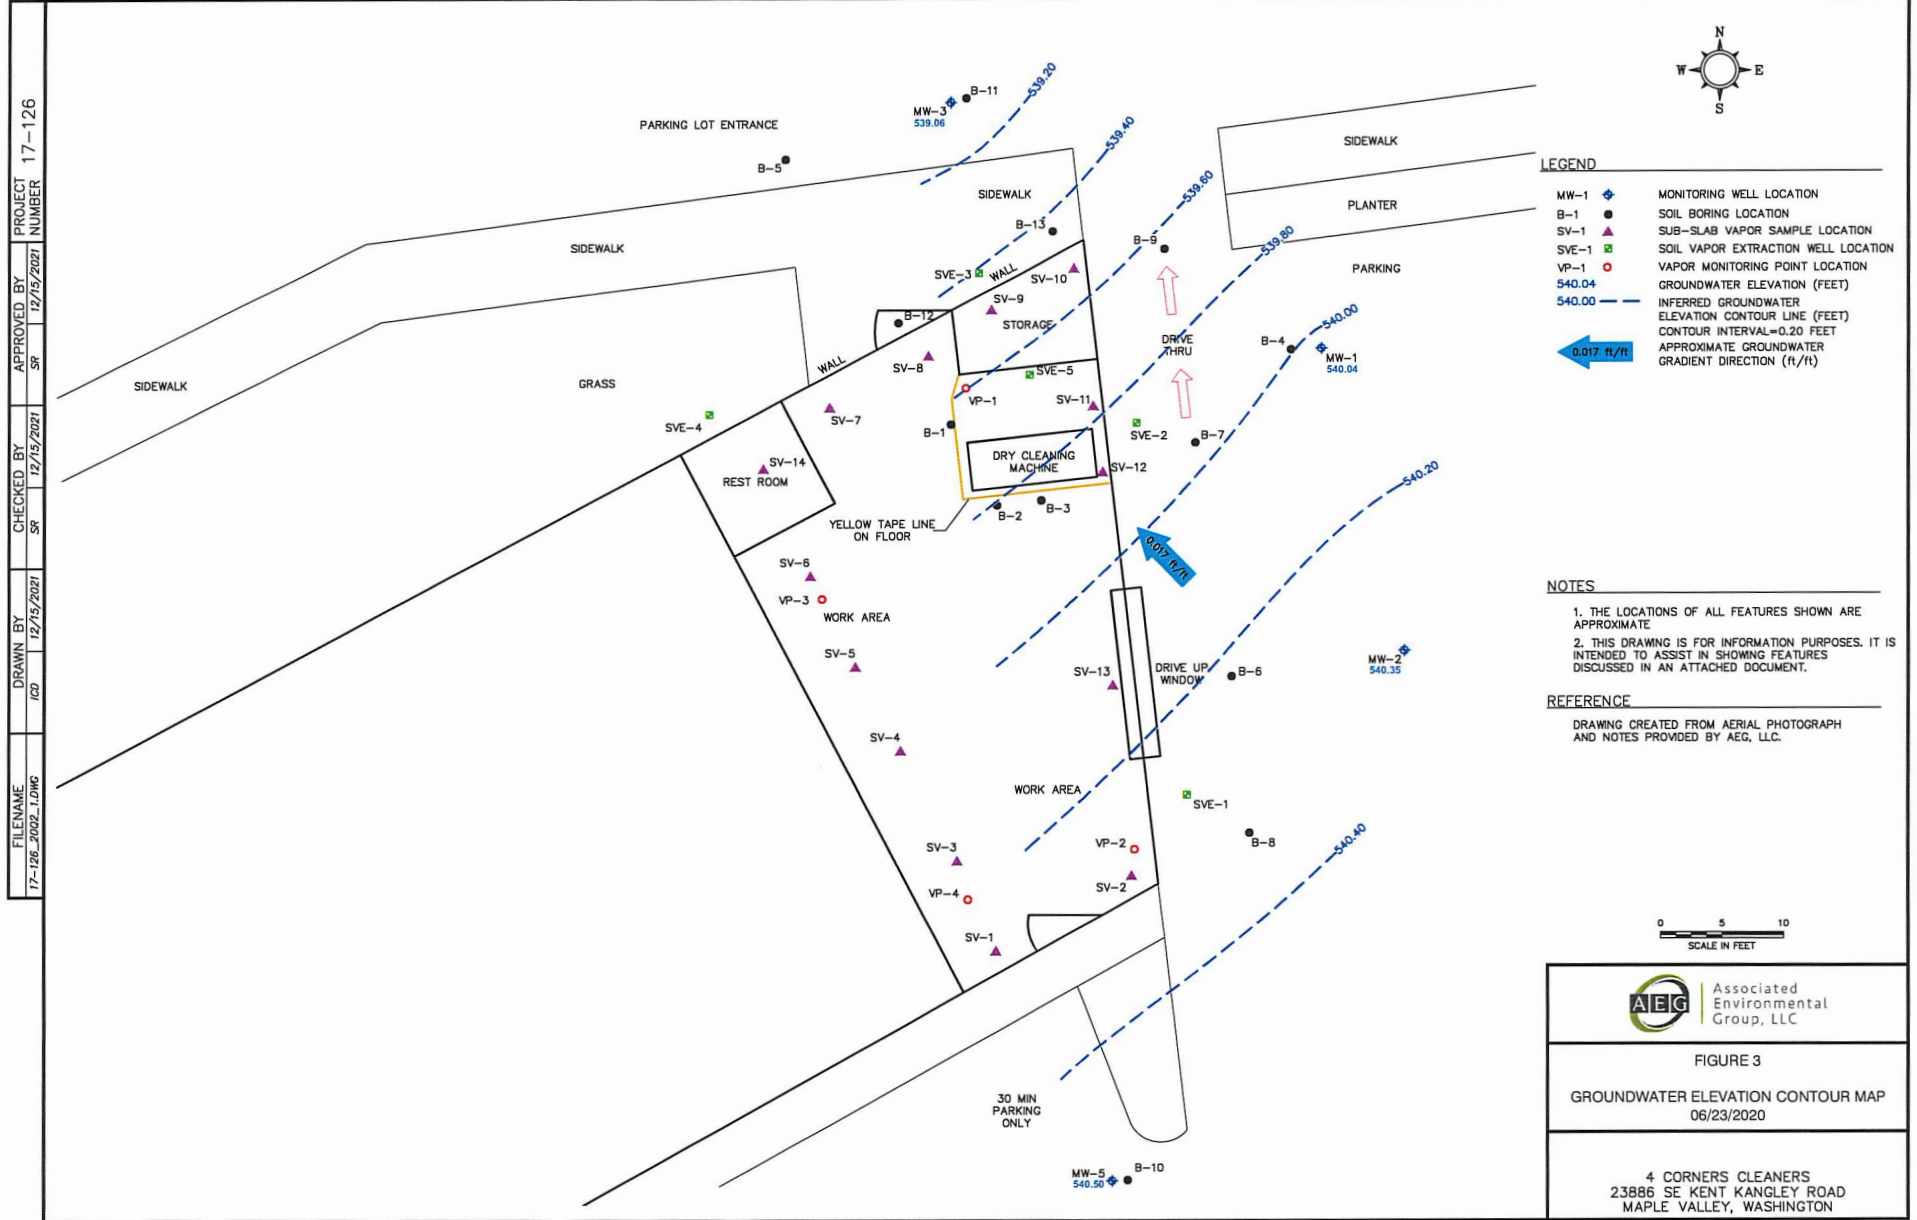
**Release and Extent of Soil, Soil gas, and Groundwater Contamination:** The source of releases of contamination to the soil, soil gas and groundwater at the Site are the use of chlorinated solvents associated with the operations of the Four Corners Dry Cleaners facility prior to process change to hydrocarbon cleaning. **(Figure 3)**
