**FINAL REMEDIAL
INVESTIGATION/FEASIBILITY STUDY
FOR THE HILLYARD DROSS SITE
EAST 3412 WELLESLEY AVENUE, SPOKANE, WA**

The Burlington Northern and Santa Fe Railway Company

**BNSF File No. WASPO-05-005
Agreed Order No. DE 98TC-E105
EMR Project 338**

August 1999

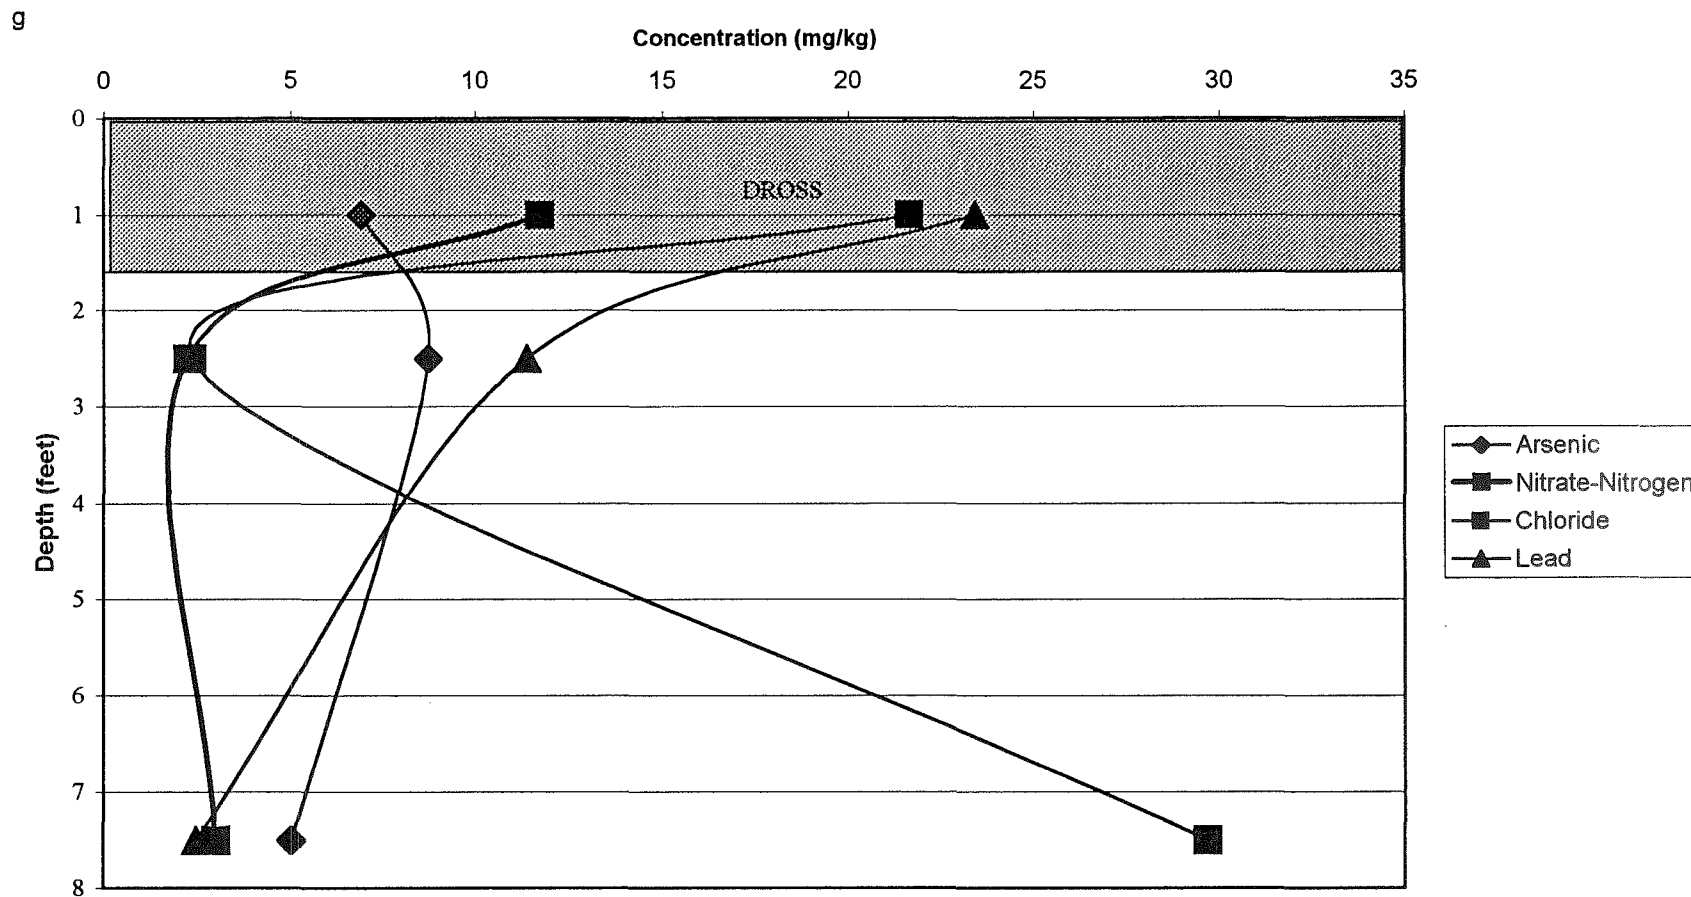
FIGURE 5-9

*Average Concentration of Selected Parameters with Depth
BNSF Hillyard Dross Site, Spokane, Washington*

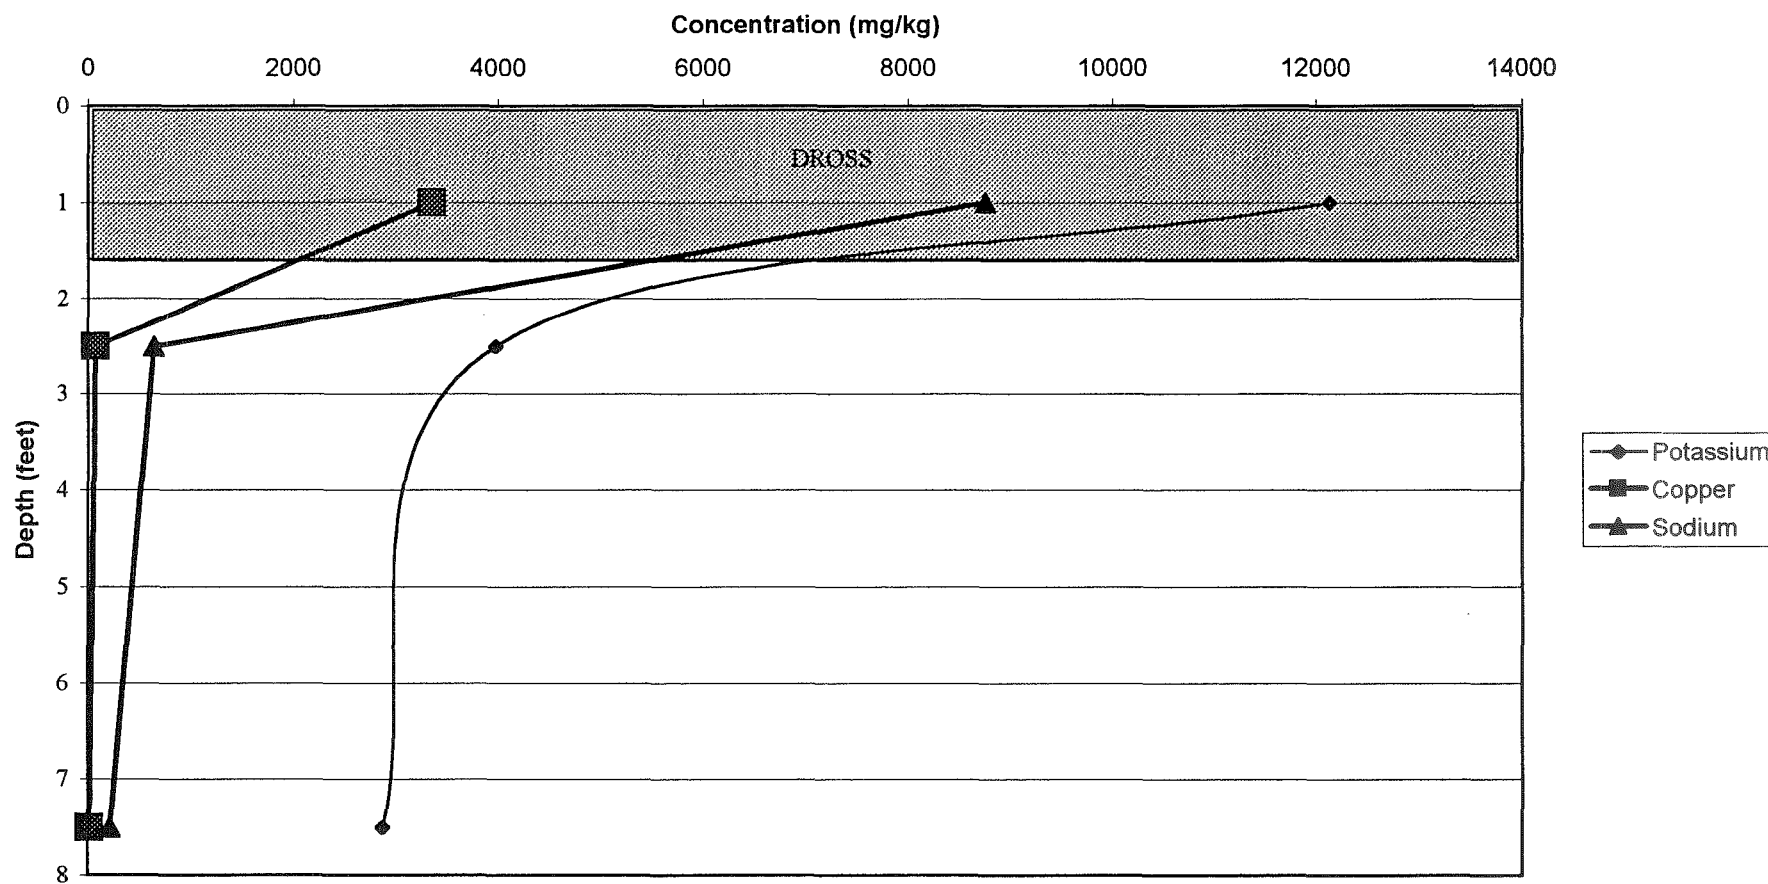
FIGURE 5-11

*Average Concentration of Selected Parameters with Depth
BNSF Hillyard Dross Site, Spokane, Washington*
