Re: Buse Timber & Sales Cleanup Discussion

Thank you for taking the time last Monday, May 2, 2022, to discuss the Buse Timber & Sales property located at 3812 28th Place NE, Everett, Washington (Buse Timber). As we discussed, the property has been the subject of regulatory oversight for more than 30 years, starting as early as 1990, and is listed with the Washington Department of Ecology (Ecology) as Facility Site ID 2786 and Cleanup Site ID 4340. In connection with their recent purchase of the property, the current owner conducted Phase I and Phase II environmental site assessments and is committed to performing additional remedial action at the property to meet current Model Toxics Control Act (MTCA) cleanup levels.

Buse Timber & Sales
3812 28th Place NE
Everett, Washington

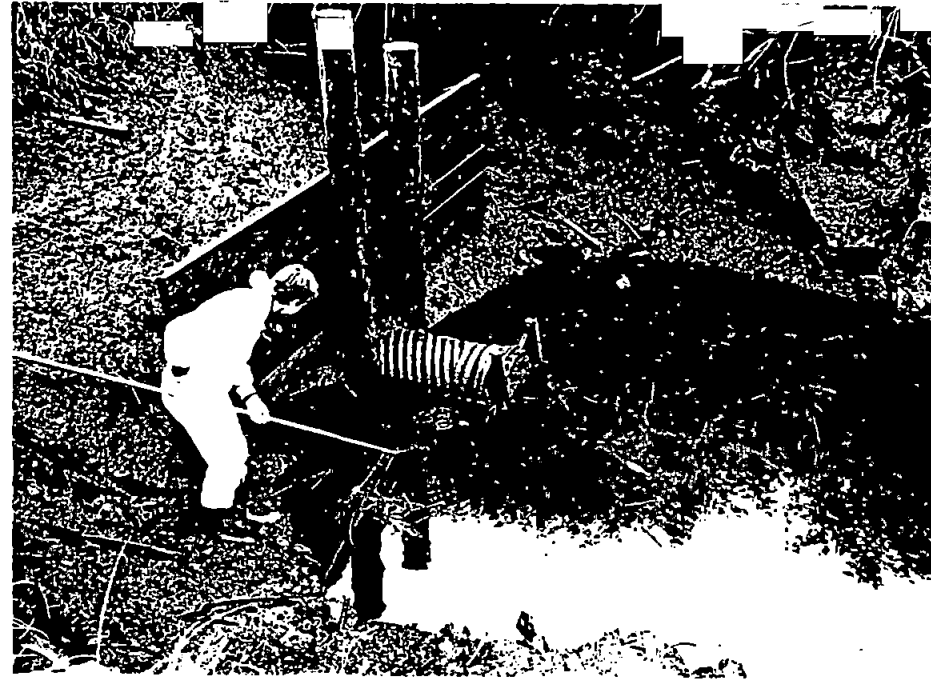
14

Collecting subaqueous tidal gate sediment sample
