**Groundwater Investigation Report  
Kitsap County North Road Shop Site  
301 Bernt Road  
Poulsbo, Washington**

May 18, 2022

Kitsap County Department of Public Works  
614 Division Street  
Port Orchard, Washington

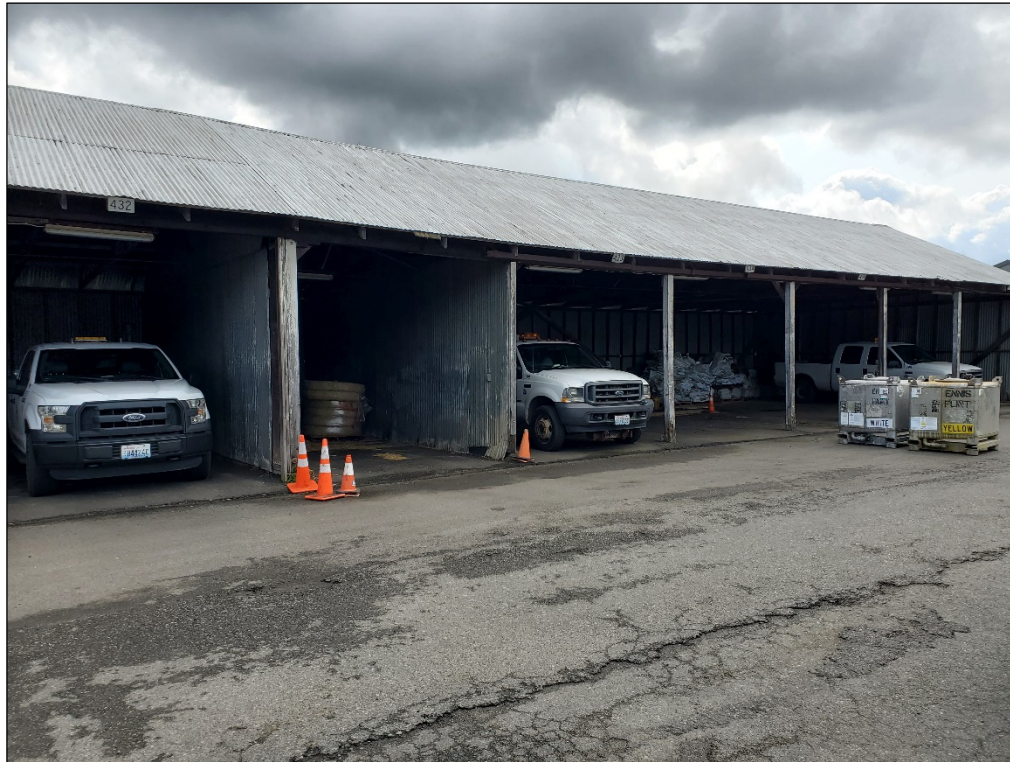
1. Capped area of east truck storage shop.

The 2017 Site Periodic Review (Ecology 2018b) included an additional recommendation to install a pavement cap on top of the dirt and/or gravel floors present in two of the buildings at the Site. The County has installed pavement in the two buildings and photographs showing the paved floors in the two buildings are provided in Appendix A.

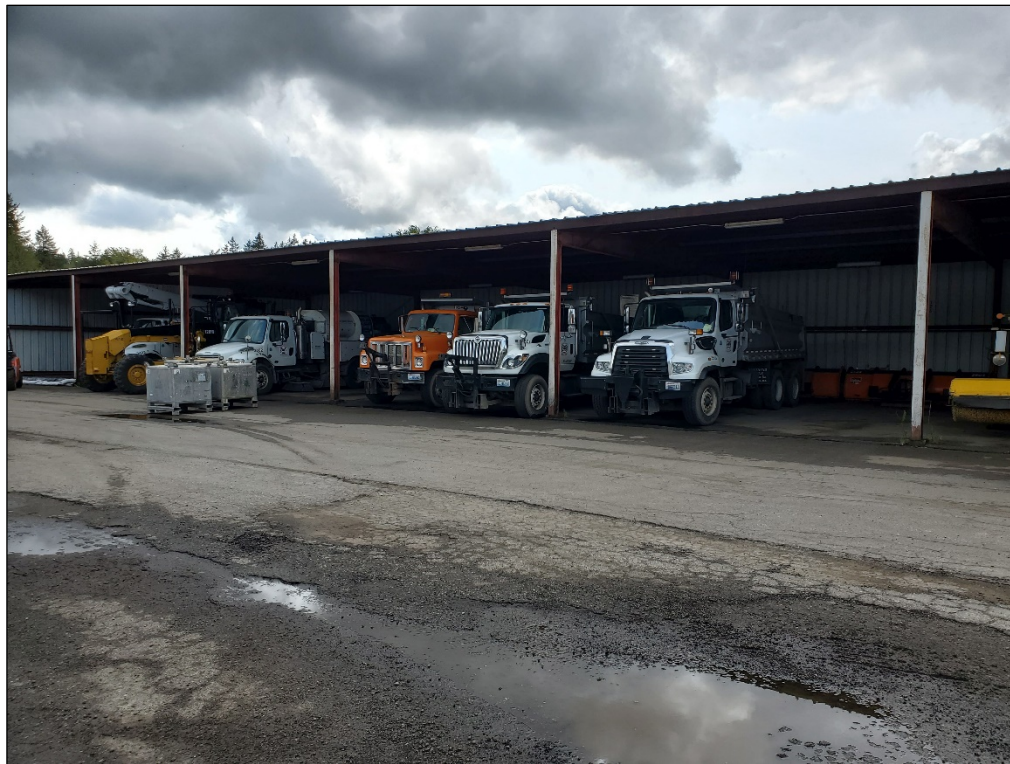
2. Capped area of south truck storage shed.

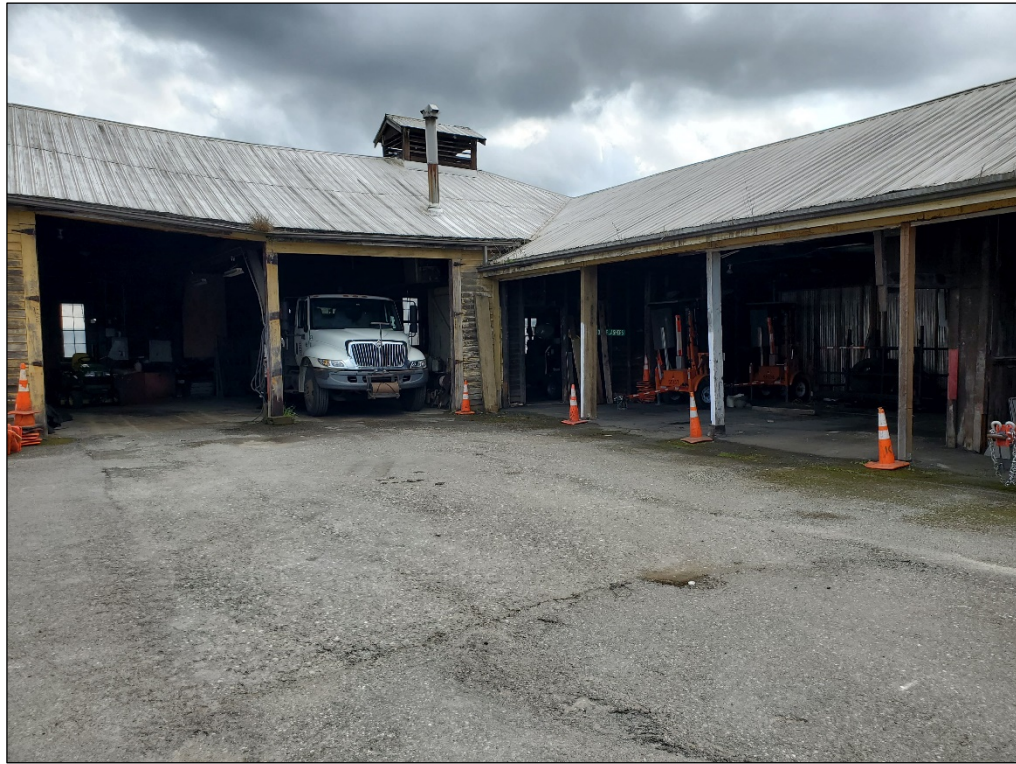
3. Capped area of Building 3.
