**Remedial Investigation/Feasibility Study and
Cleanup Action Plan**

Carpenter Road Site
Lacey, Washington

for
City of Olympia

February 2, 2022

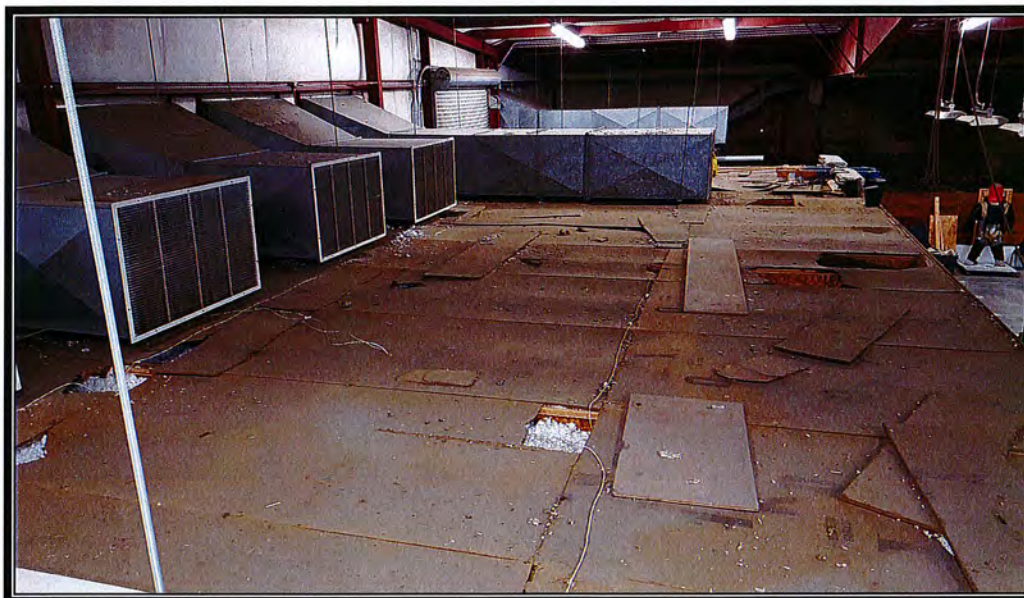
Photo #3 – Settled dust above training room

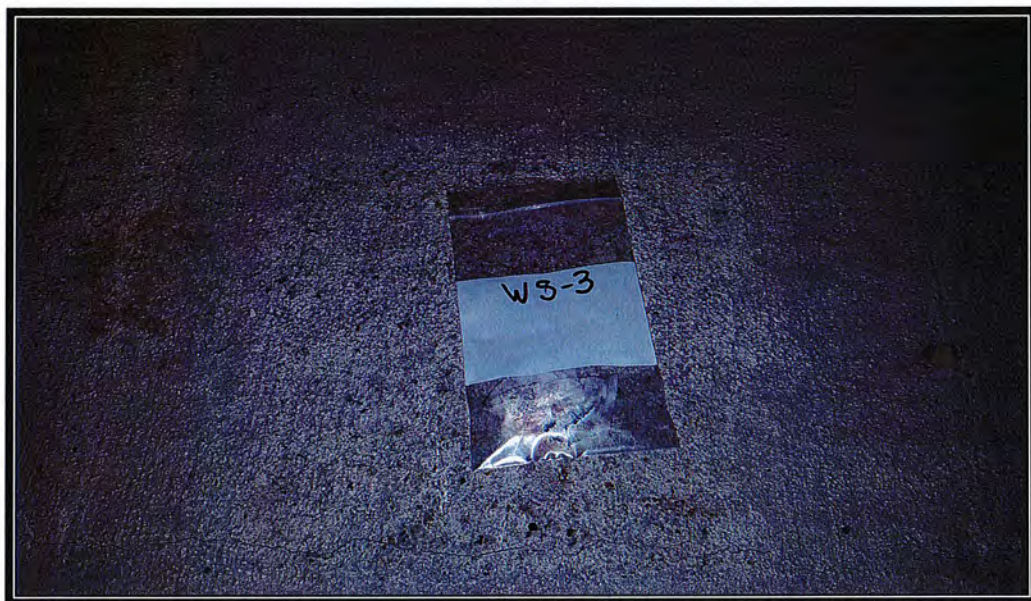
Photo #7 – Dust Sample on Eco Block

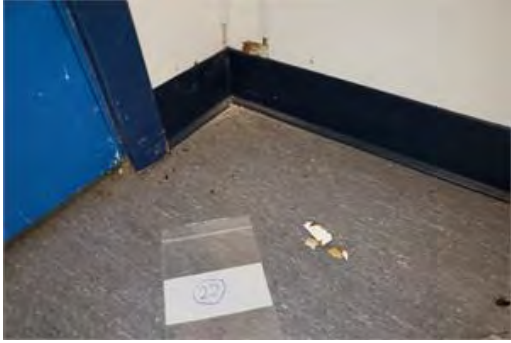
Sample		Sample Date	10-Nov-2021
Project Name	OPD Range		
Sample Type	Physical Sample	AHERA Category	Miscellaneous
Sample Number	22	Homogenous Material Number	
Material Description	Mastic under FRP.		
Homogenous Mtl Area	N/A		
Sample Location	East bathroom, on east wall.		
Quantity	250	Unit of Measure	Square Feet
Asbestos Type/%	Layer 1: (Painted fiberboard) None Detected Layer 2: (Orange/lit yellow mastic) None Detected Layer 3: (White mud) Tremolite <1% Layer 4: (Lt brown paper) None Detected		
Sample Photo

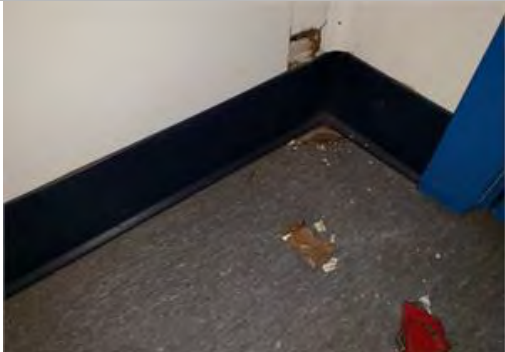
Sample		Sample Date	10-Nov-2021
Project Name	OPD Range		
Sample Type	Physical Sample	AHERA Category	Miscellaneous
Sample Number	23	Homogenous Material Number	
Material Description	Mastic under FRP.		
Homogenous Mtl Area	N/A		
Sample Location	West bathroom, west wall.		
Quantity	See 22	Unit of Measure	Square Feet
Asbestos Type/%	Layer 1: (Painted fiberboard) None Detected Layer 2: (Lt orange/yellow mastic) None Detected Layer 3: (White texture) Tremolite <1%		
Sample Photo

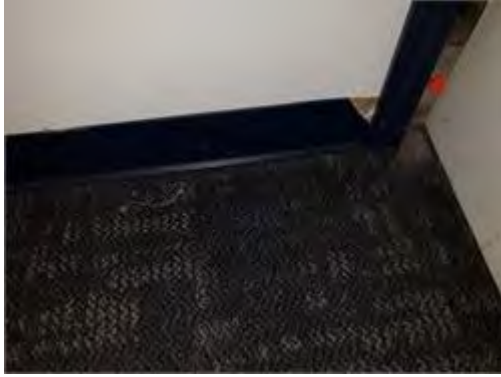
Sample		Sample Date	10-Nov-2021
Project Name	OPD Range		
Sample Type	Physical Sample	AHERA Category	Miscellaneous
Sample Number	24	Homogenous Material Number	
Material Description	Cove Base Mastic, on 4 inch blue cove base.		
Homogenous Mtl Area	The total reflects the material also seen in the North and south bathrooms.		
Sample Location	Training Classroom at Southwest corner.		
Quantity	210	Unit of Measure	Lineal Feet
Asbestos Type/%	None Detected (All Layers)		
Sample Photo
