Re: 2022 Groundwater Monitoring and Asphalt Inspection
Darling-Tacoma Facility (aka Darling Delaware Co., Inc. and Puget Sound By-Products)
Facility No.: 25455514, Cleanup Site No.: 8475, VCP Project No.: SW1317

2.0 ASPHALT INSPECTION

ASPHALT INSPECTION PHOTOGRAPH LOG
DARLING-TACOMA 2041 MARC AVENUE
February 3, 2025

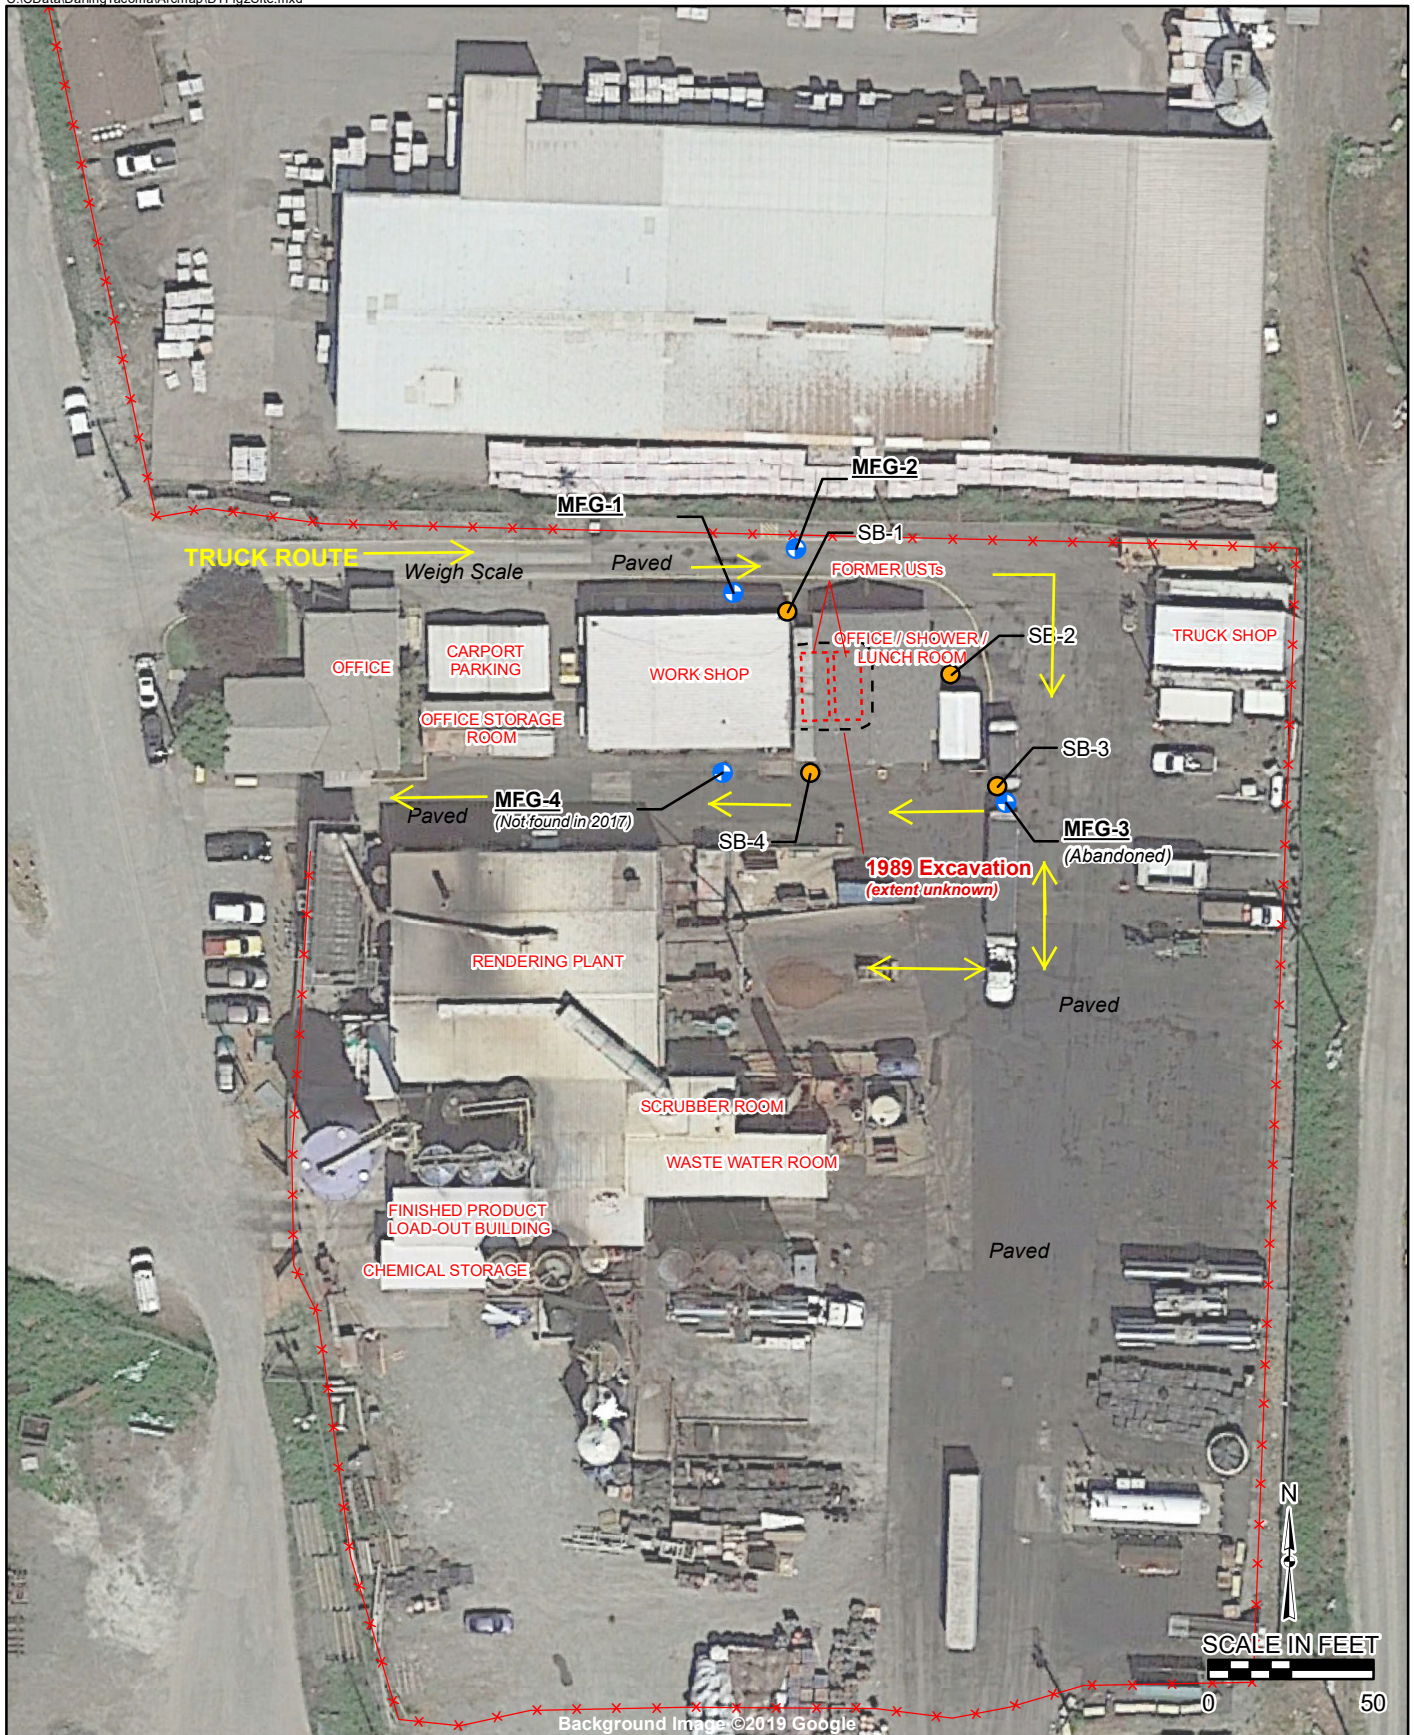
Figure 2
Site Map
Darling-Tacome
2041 Marc Avenue
Tacoma, Washington

- ← Groundwater Flow (estimated)
- + Groundwater Monitoring Well
- Soil Boring Location
- 8.99 (10.54) 2017 (2019) Water Table Elevation (feet amsl)
- x-x-x Fence
- Former USTs

recorded on March 25, 2022 were 5.12 feet in MFG-1 and 4.89 feet in MFG-2, which equate to elevations of 10.89 and 10.75 feet above mean sea level (amsl), respectively. Recorded water levels were consistent with prior sampling events and seasonal variations.

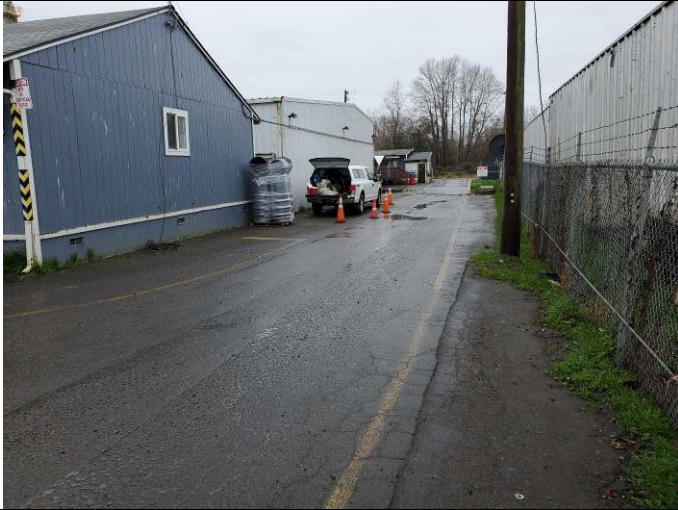
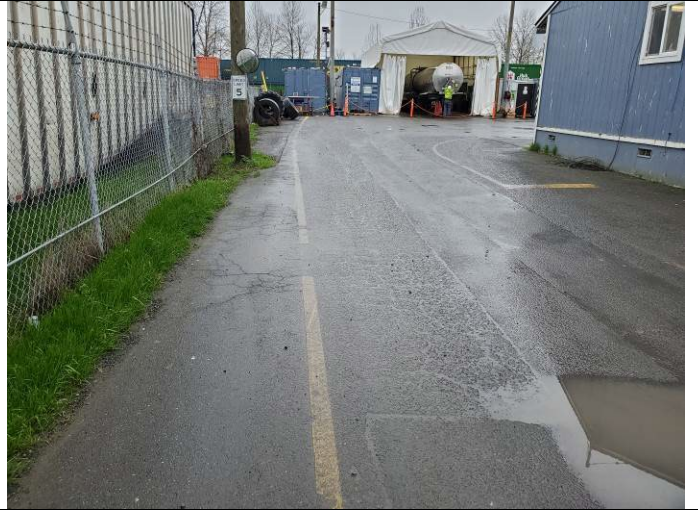
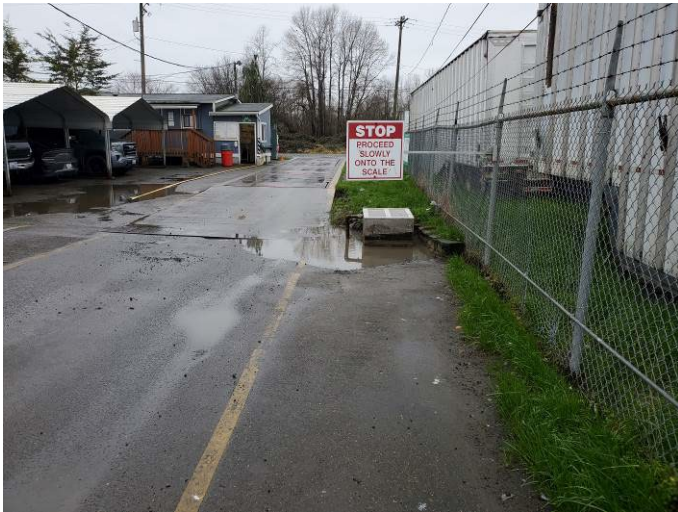
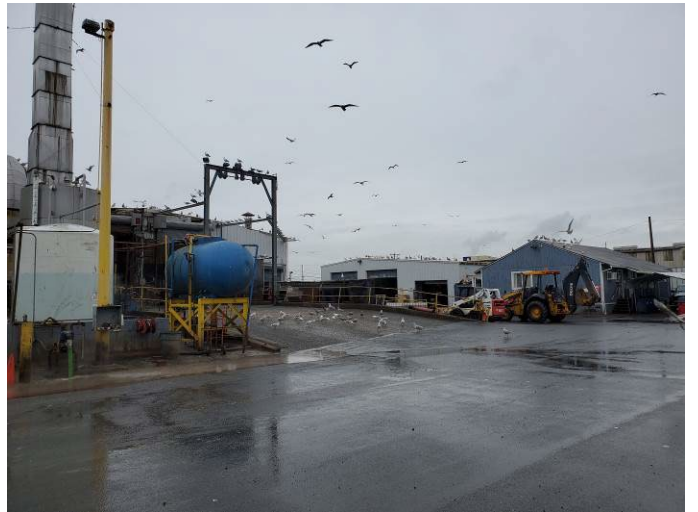
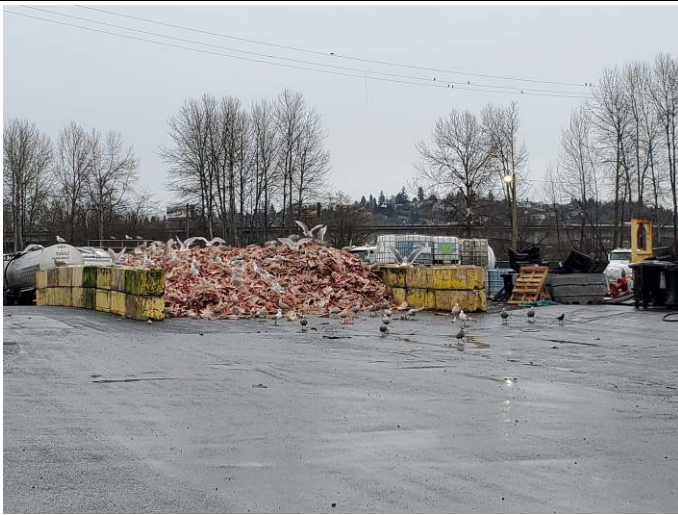
General asphalt surface conditions during the time of inspection were wet with rain falling during the asphalt inspection. Several areas were observed with pooled water from the rain but no evidence of asphalt degradation in or near those pooled areas. Slight alligator cracking was observed in an approximately 10-foot square area at a location about 40 feet north of the weigh scale. Overall condition of the asphalt was good with no ruts, cracks, or gaps observed at the time of the site visit.
