June 25, 2021

Ridgetop Golf
c/o: Halsen Frey Associates
PO Box 1447
Gig Harbor, WA 98335
(253) 307-1822

Soils Investigation and Report
Proposed Contractor Yard
xxx - 14th Avenue Northwest
Pierce County, Washington
PN: 0221213045
Doc ID: RidgetopGolf.14thAveNW.SIR

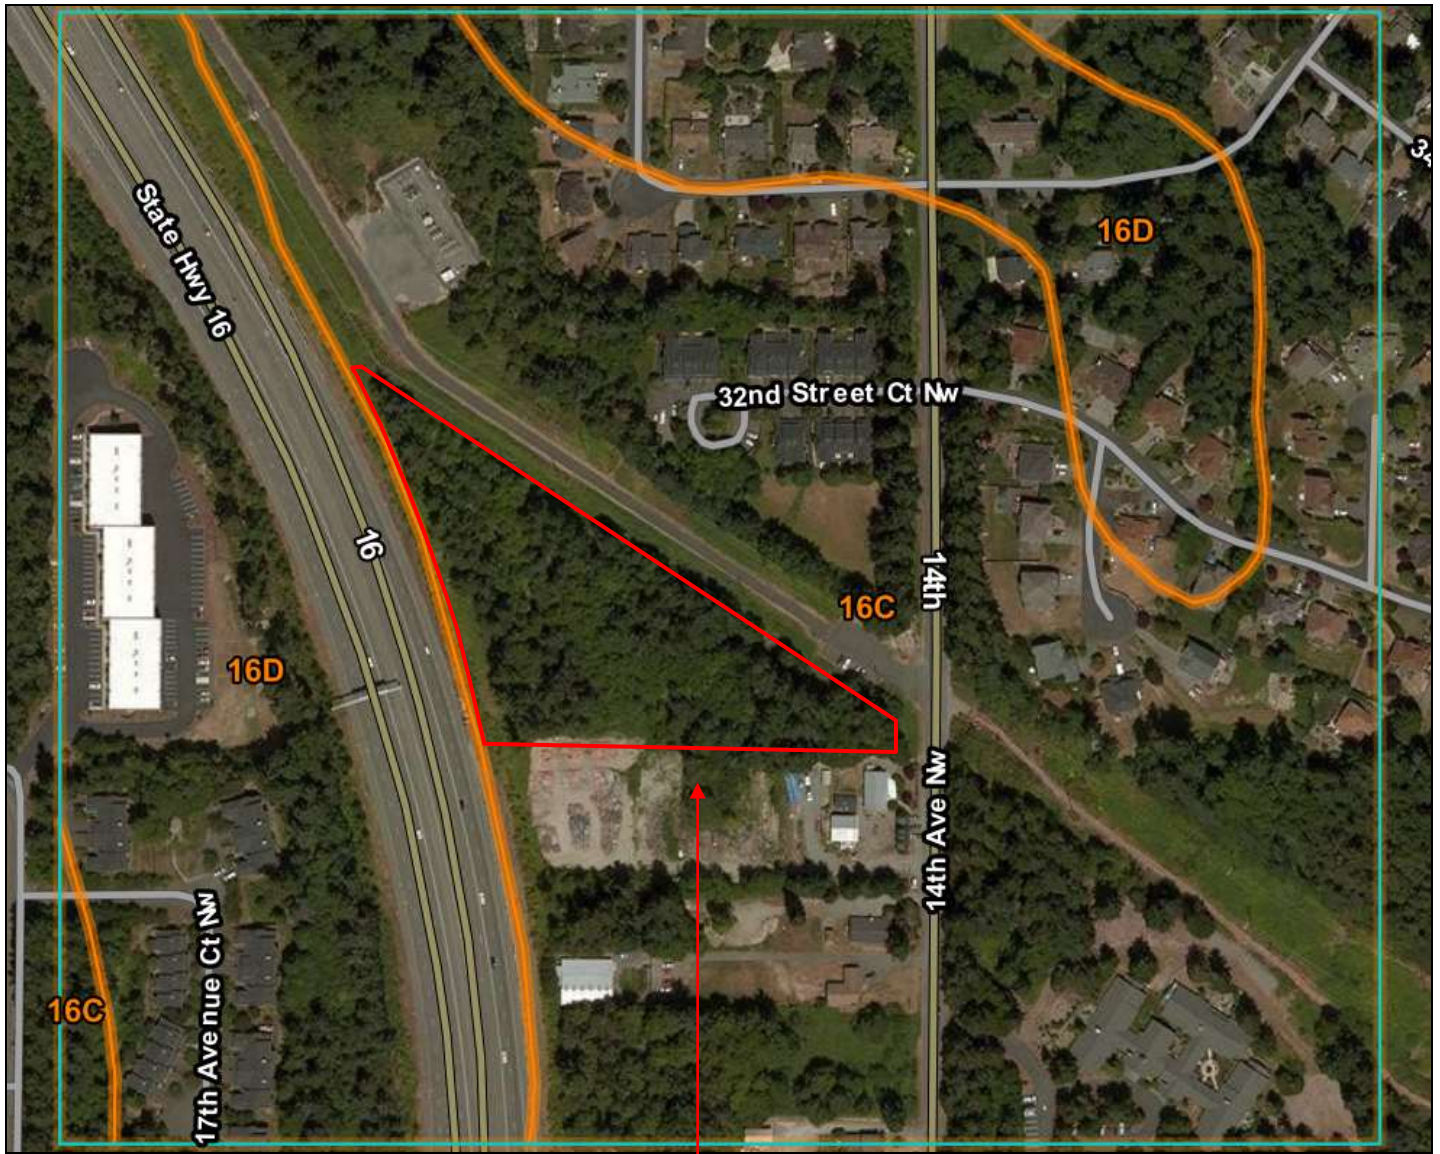
NRCS Soils Map

Soil Type	Soil Name	Parent Material	Slopes	Erosion Hazard	Hydrologic Soils Group
16C	Harstine gravelly sandy loam	Sandy glacial drift with an influence of volcanic ash over dense glaciomarine deposits	6 to 15	Moderate	C
16D			15 to 30	Moderate to severe

The USDA Natural Resource Conservation Service (NRCS) Web Soil Survey indicates that the site is underlain by Harstine gravelly ashy sandy loam (16C). The Harstine soils are derived from sandy glacial till and form on slopes of 6 to 15 percent. These soils have a “moderate” erosion hazard when exposed and are included in hydrologic soils group C. A copy of the soils map for this area is illustrated on Figure 3.
