Phase III Interim Action Summary Report – Ditch Remediation – Phase I for the Superlon Plastics Site Tacoma, Washington

The Chemours Company FC, LLC

FEBRUARY 14, 2022

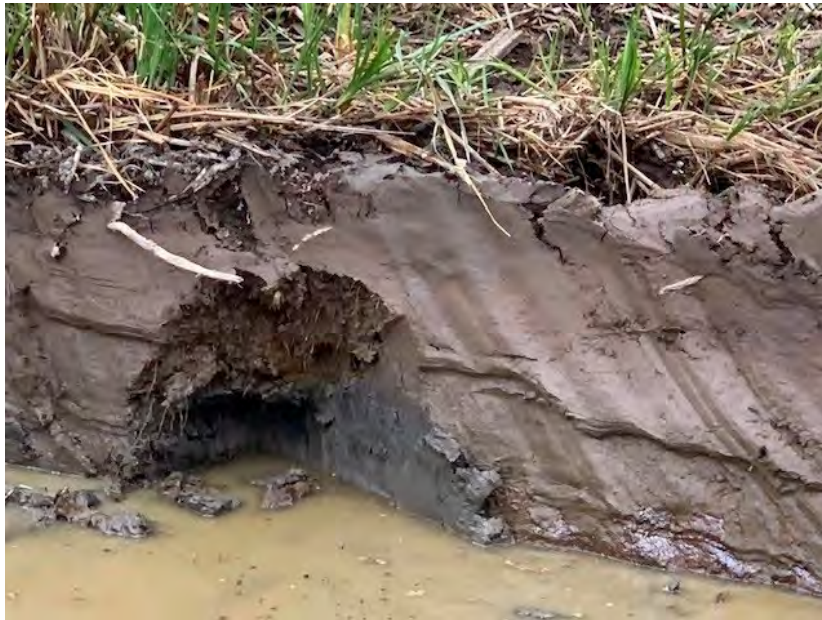
Originally the top 6 inches of material in the drainage ditch (i.e., the biologically active zone) are considered to be freshwater sediments. Throughout the remediation of ditch sediment, the biologically active zone was observed to be up to two feet thick. The ditch sediment and underlying soil consisted of up 6-inches of fine sediment overlaying clay-rich silt with a high degree of marine grass (original tide flats) to approximately 2 feet. This was judged to be the biologically action zone (Figure 6). Under the top two feet was clay-rich silt (original tide flats).

Figure 6: Cross section of sediments showing biological active zone to 2 feet

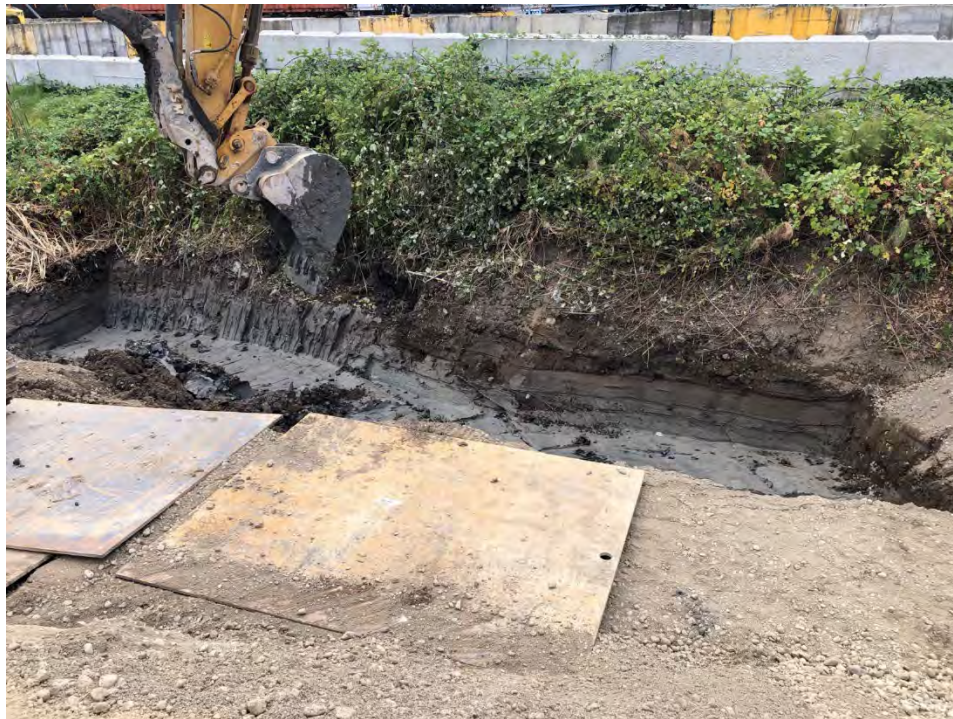
The eastern excavation boundary was limited by the presence of the Haub Log Yard retaining wall. Excavation in the eastward direction was stopped when the possibility of undermining the wall was present.

Figure 7: Eastern excavation limit

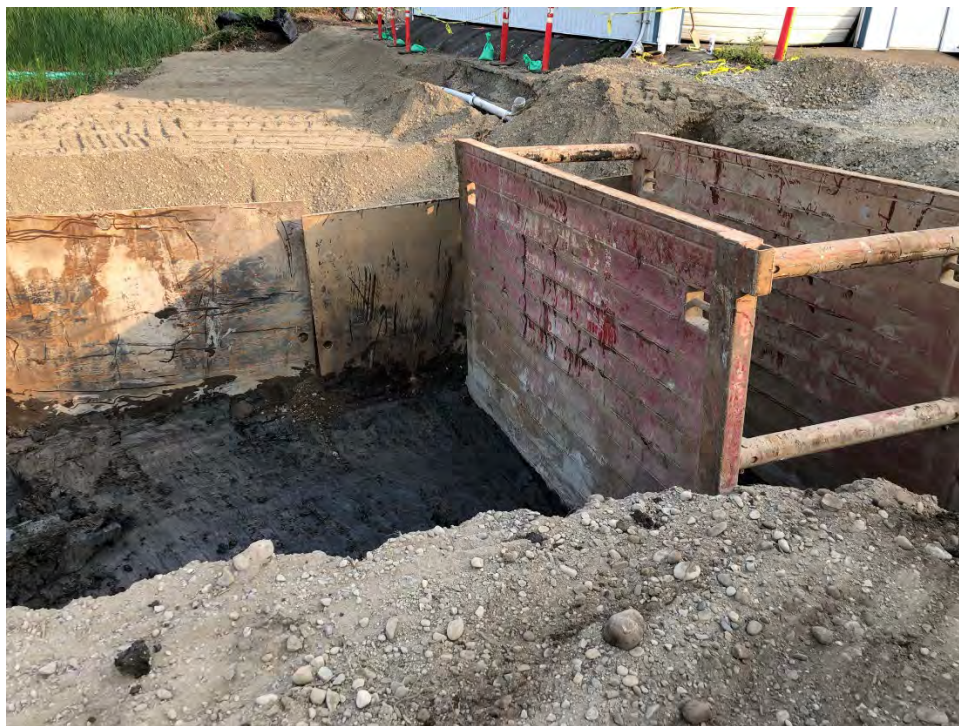
Excavation occurred within trench boxes if caving of surrounding soils was anticipated and to allow for the removal of the soil up to the limits of the previously completed remediation of on- Property soil in 2018. As a result, the excavation was successful in removing all soils containing COCs above the remediation goals listed above. This method also ensured that the excavation remained open to collect samples.

Figure 8: Use of a Trench box and steel sheeting to ensure that all impacted soils are removed and prevent caving.

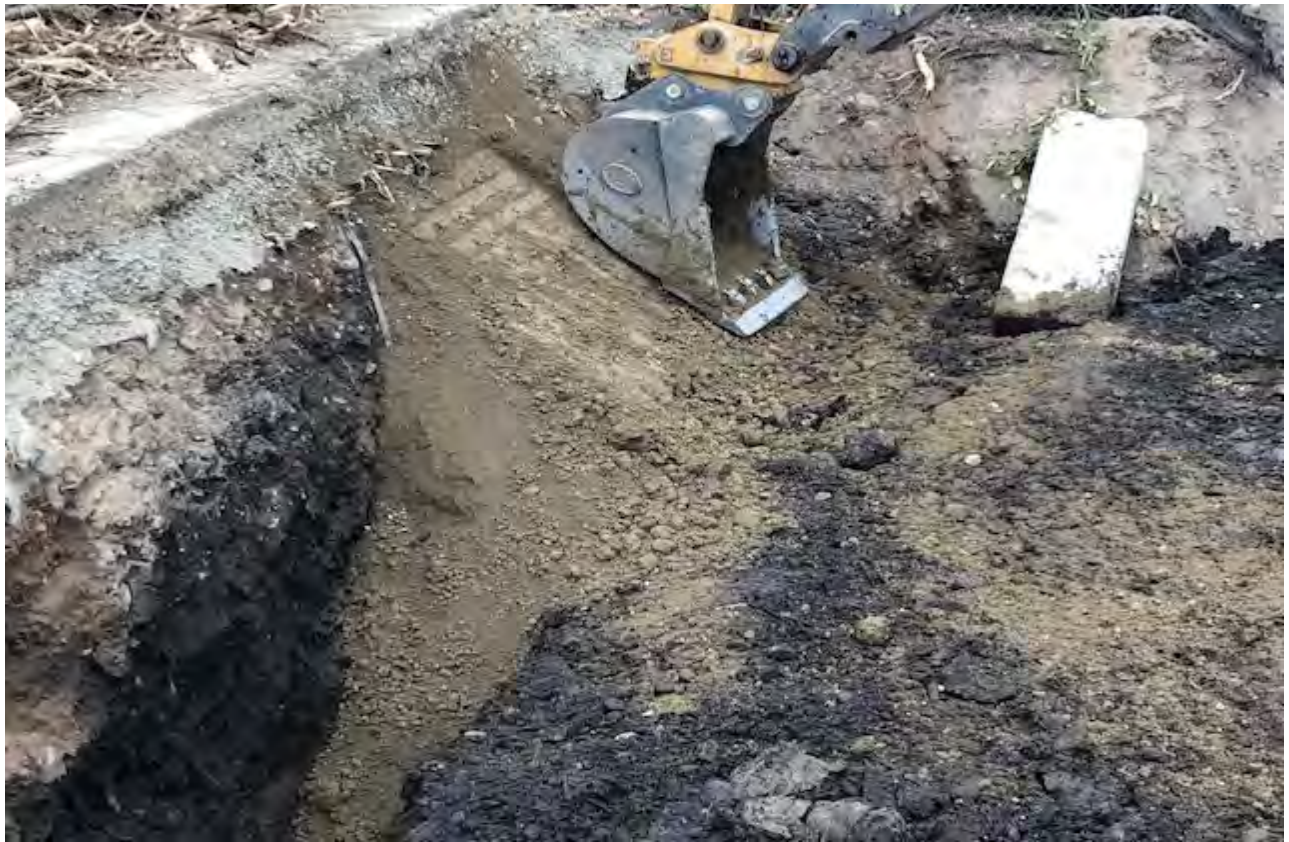
Figure 9: Construction of Clay barrier. Finished product. Note ragged edge of introduced fabric two feet bgs. The fabric was placed below the grade backfill was installed during remediation of the adjacent soils

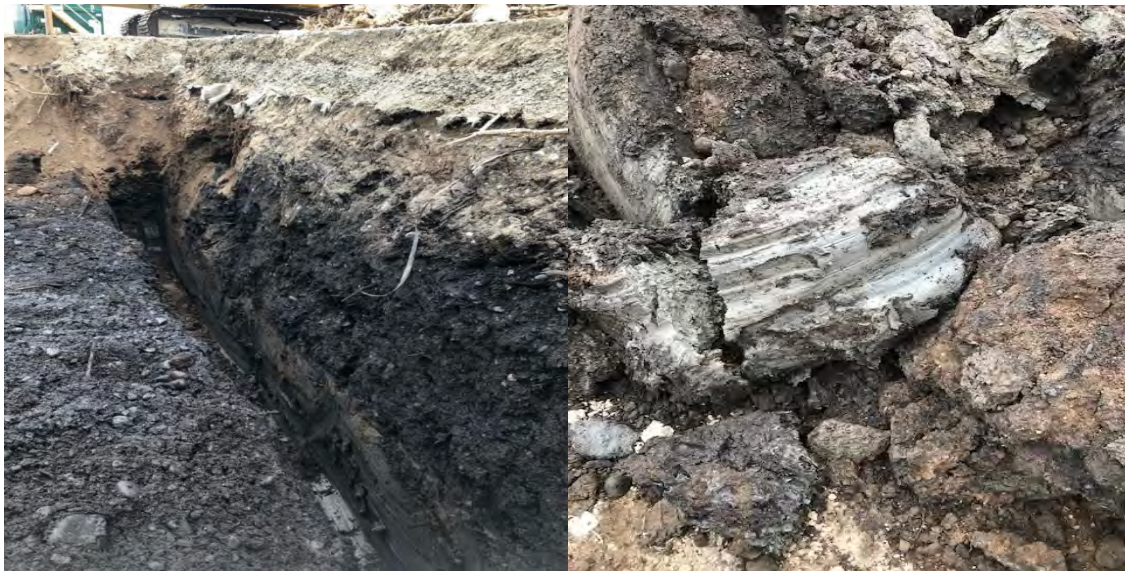
Figure 10: Trench prior to filling with Clay

Figure 11: Clay -rich Silt layer excavated at the bottom of the trench

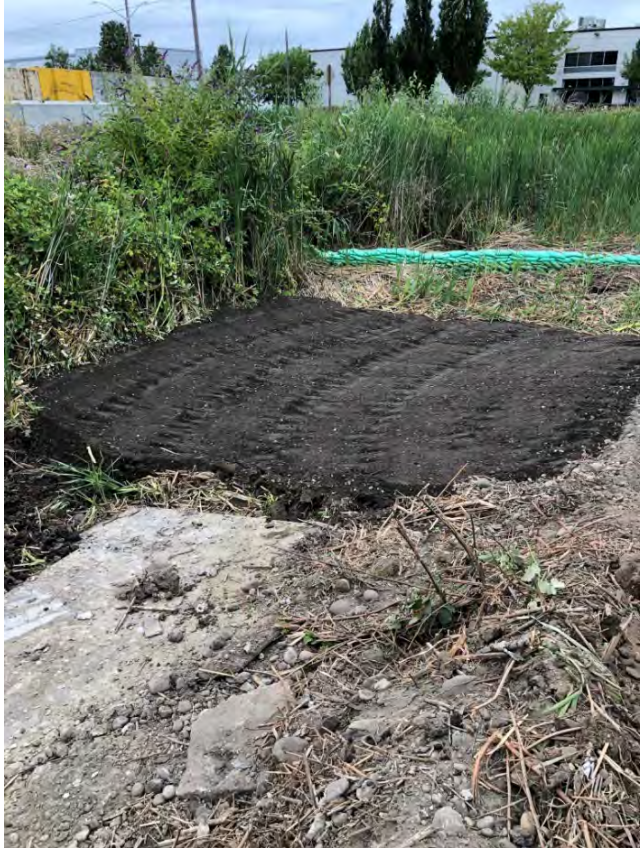
Restoration of the sediment excavation were done in two layers. If the excavation was deeper than the biological active zone (in this area 2 feet) clay was used to replace the soil excavated at greater than two feet. This was done to replace the clay-rich silt that was removed during the excavation. All sediment removed in the top two feet was replaced by a Steam bed Sediment mix obtained from Corliss Resources of Sumner, Washington (specifications included in appendix 2).

Figure 15: Typical Steam bed backfilling

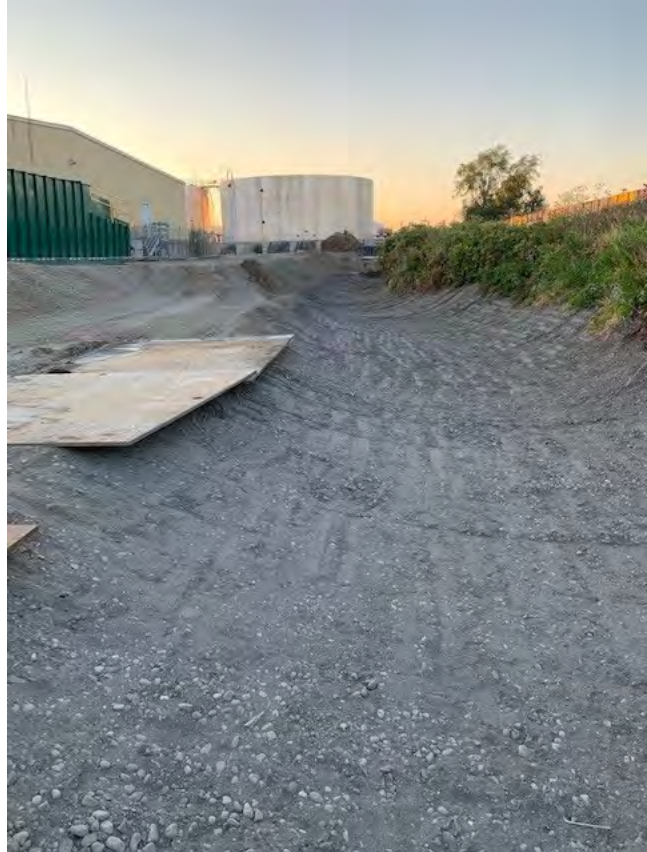
Figure 16: Completed ditch bed restoration prior to re-vegetation

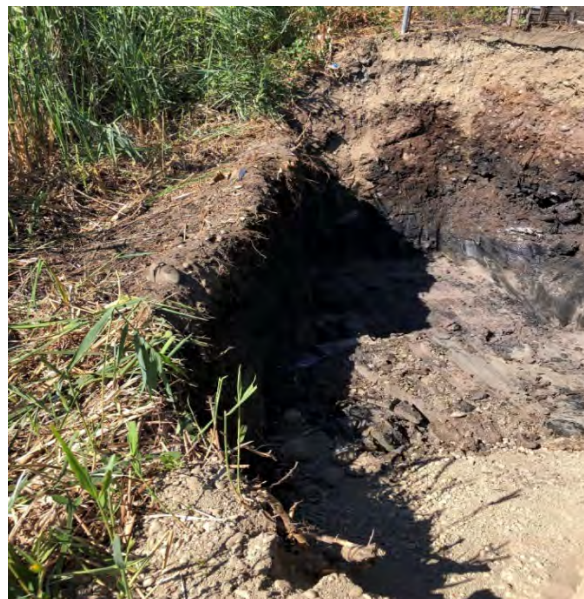
Figure 17: Bottom of RAU B1. Note oil staining in headwall

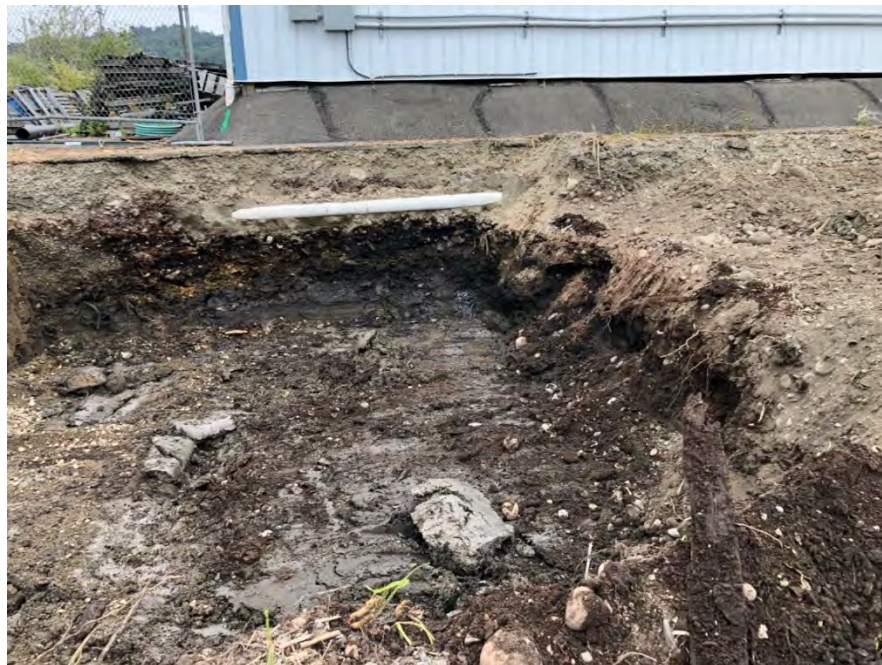
Figure 19: Bottom of RAU B3 - NOTE physical debris and black stained soil in headwall of excavation

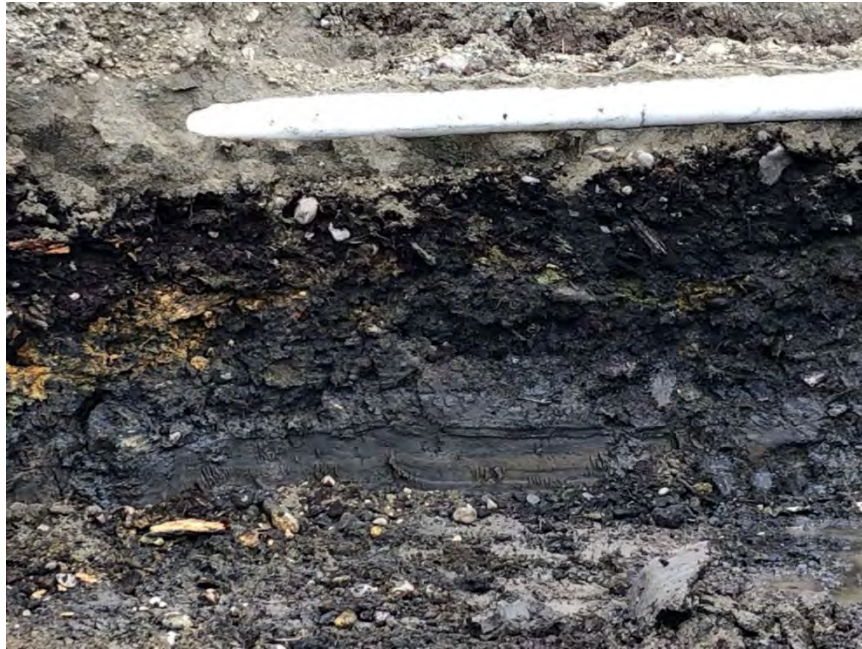
No significant differences in soil type from general description. Black stained (no visible oil products) construction debris, a small amount of shot and other mixed waste in the eastern sidewall. A white drainage line was present in eastern sidewall. Excavation limit restricted by the presence of building.

Figure 20: Eastern sidewall of RAU B3 underlying building D on the Superlon property. Note: Drainage line and presence of mixed debris and shot.

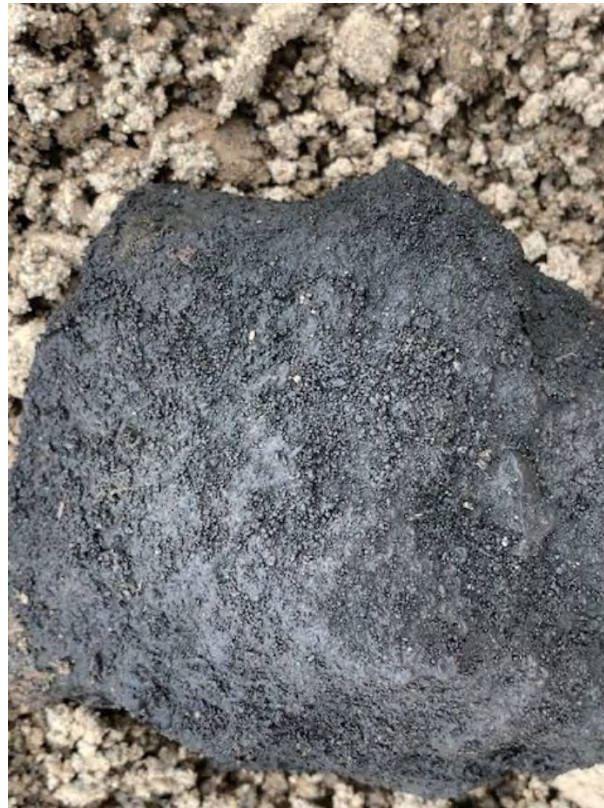
Figure 21: Shot collected from excavation headwall

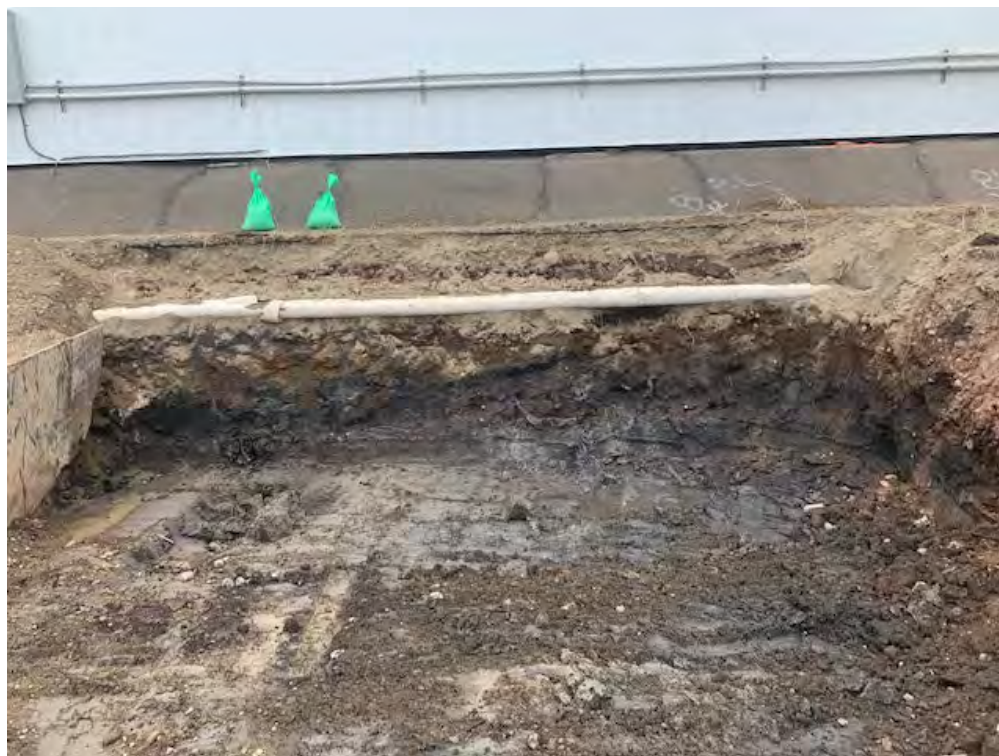
Figure 23: RAU B5: Eastern sidewall at 0-5 feet: Note shot intermixed with soil on the right end of the excavation.

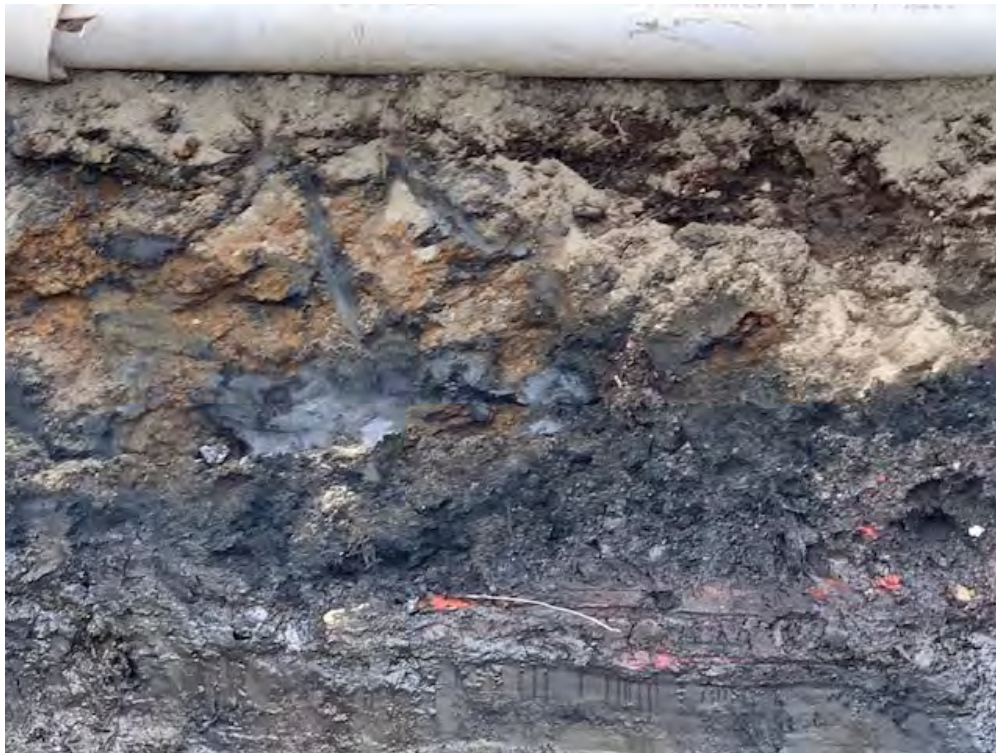
Figure 24: RAU B5: Close up Eastern sidewall at 0-5 feet – NOTE: Presence of “Shot” in center of photograph

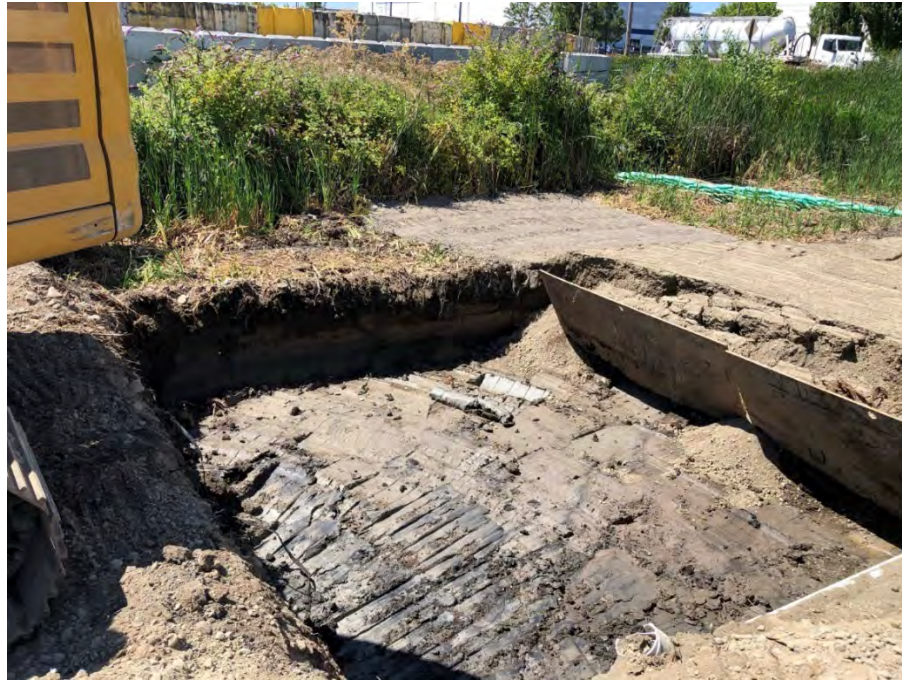
Figure 25: Bottom of RAU B6 – NOTE Steel plates used to prevent sidewall caving

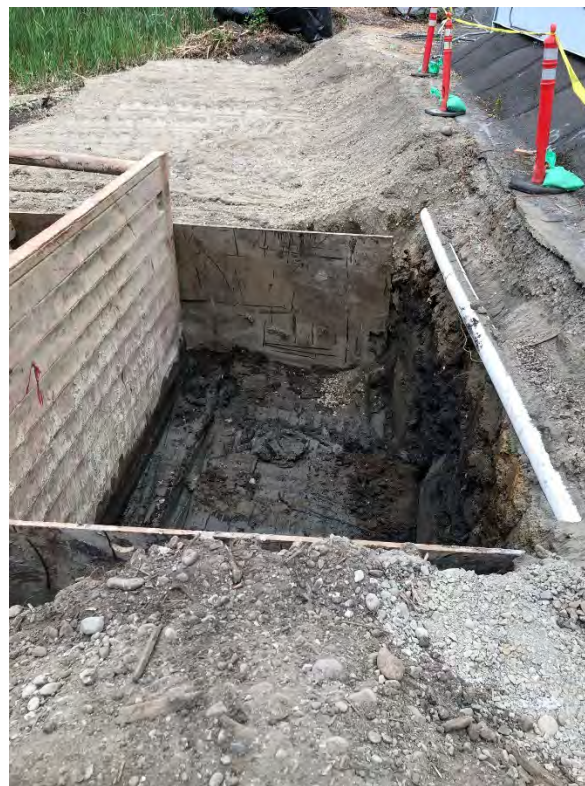
Figure 26: Use of steel plates and trench box to prevent caving

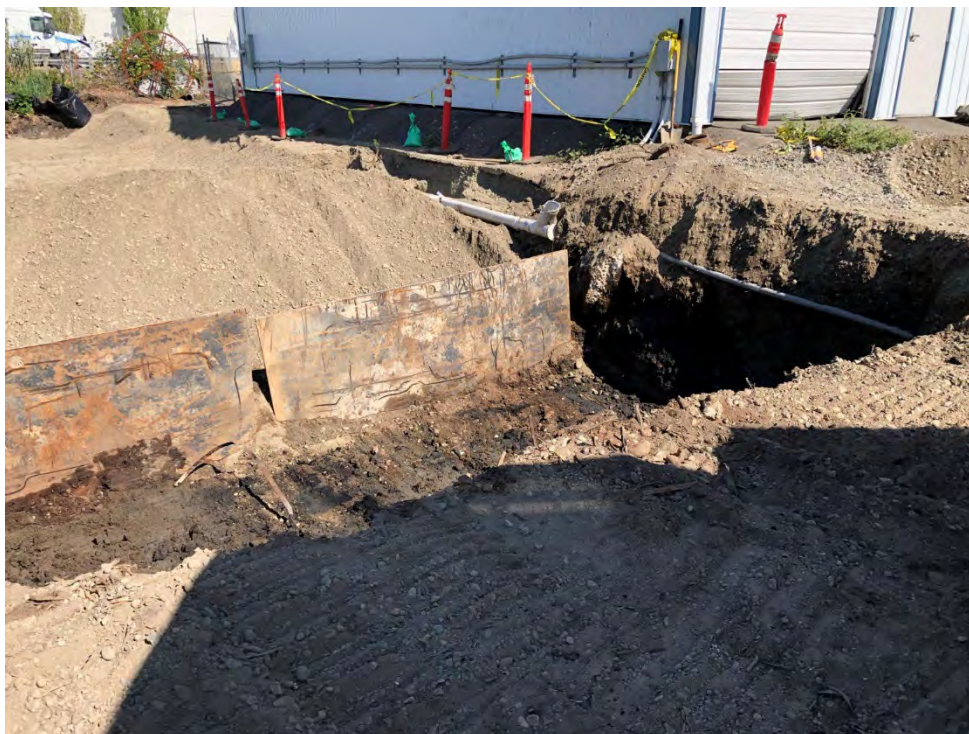
Figure 27: Bottom of RAU B7 – NOTE Steel plates used to prevent sidewall caving

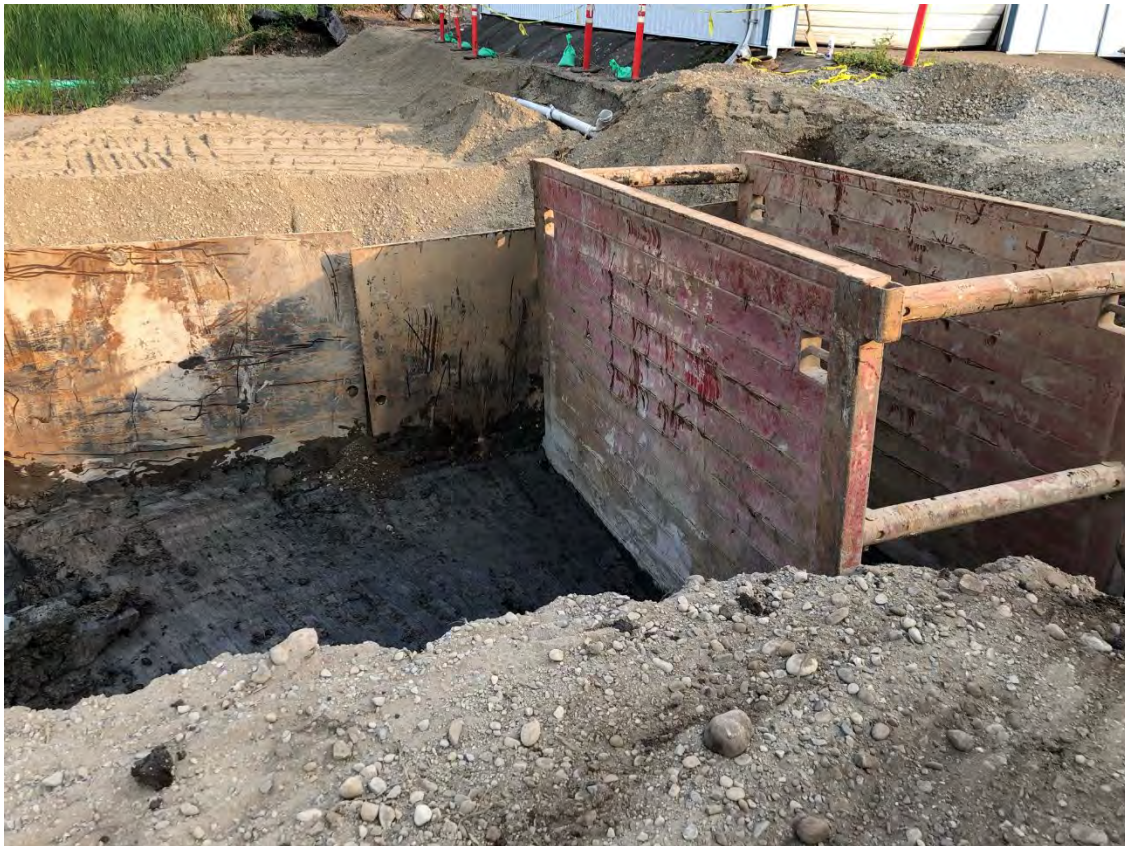
Figure 28: Bottom of RAU B8 – Note use of Trench box and steel sheets to prevent caving

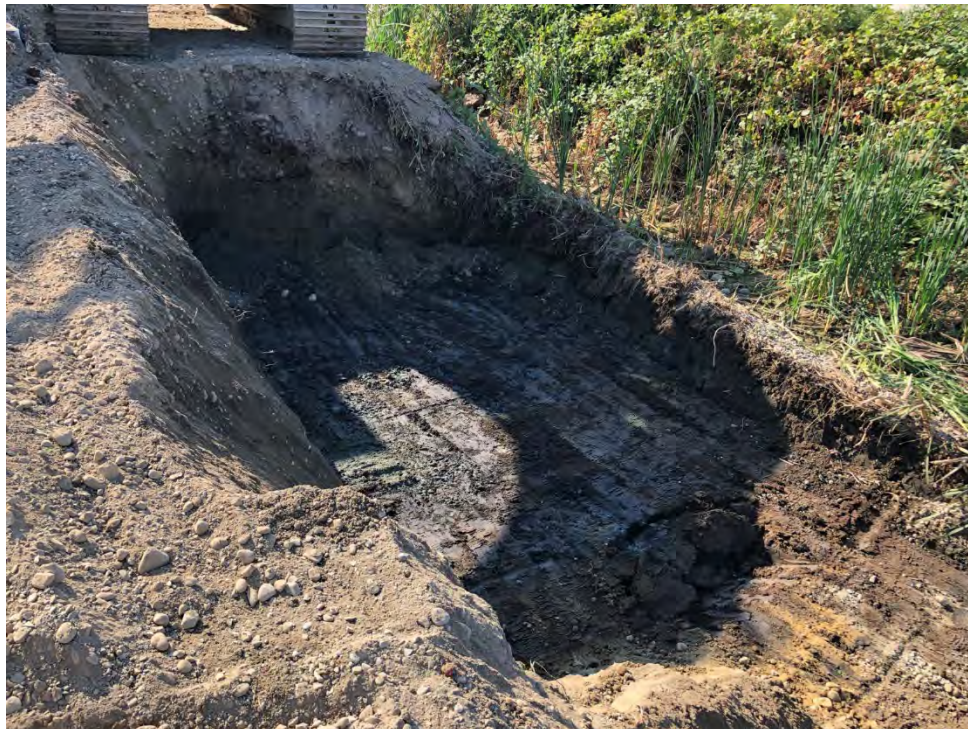
Figure 31: Bottom of RAU B11 - NOTE Narrow width of the RAU

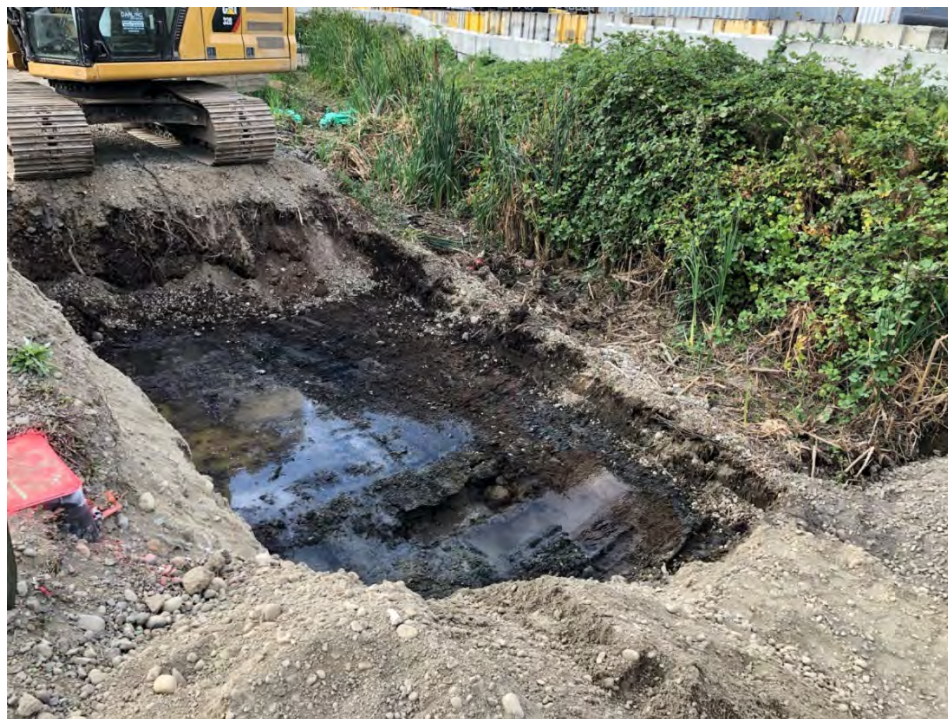
Figure 32: Bottom of RAU B12 - NOTE Narrow width the RAU and oil sheen on water

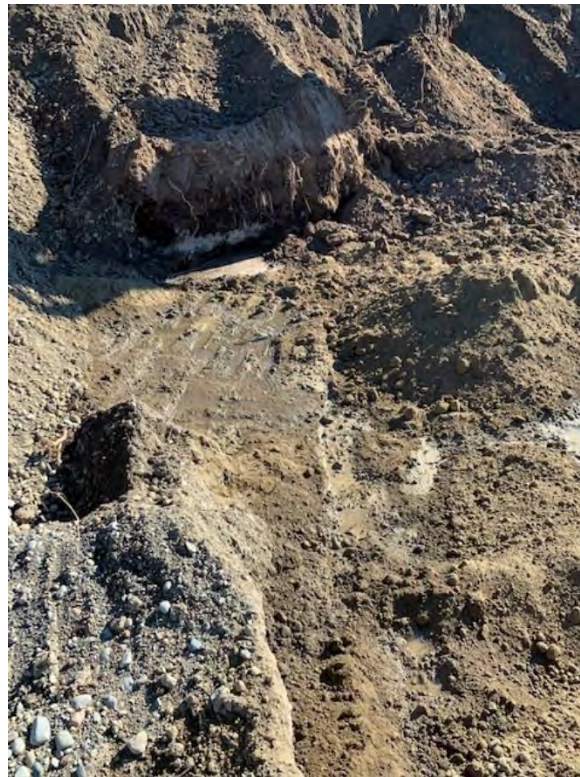
Figure 36: Excavation of RAU B14 - Note Waste water sludge as white band in sidewall

a mixture of waste water treatment sludge and soil found in RAU B14 was determined to be hazardous and was disposed of at the US Ecology Landfill in Grandview, Idaho. This process was in accordance with existing protocols for site soil management under the Ecology approved Remedial Design report (PERC/PIONEER 2017b) for the remediation of on-property soils at the Superlon Plastics Site.

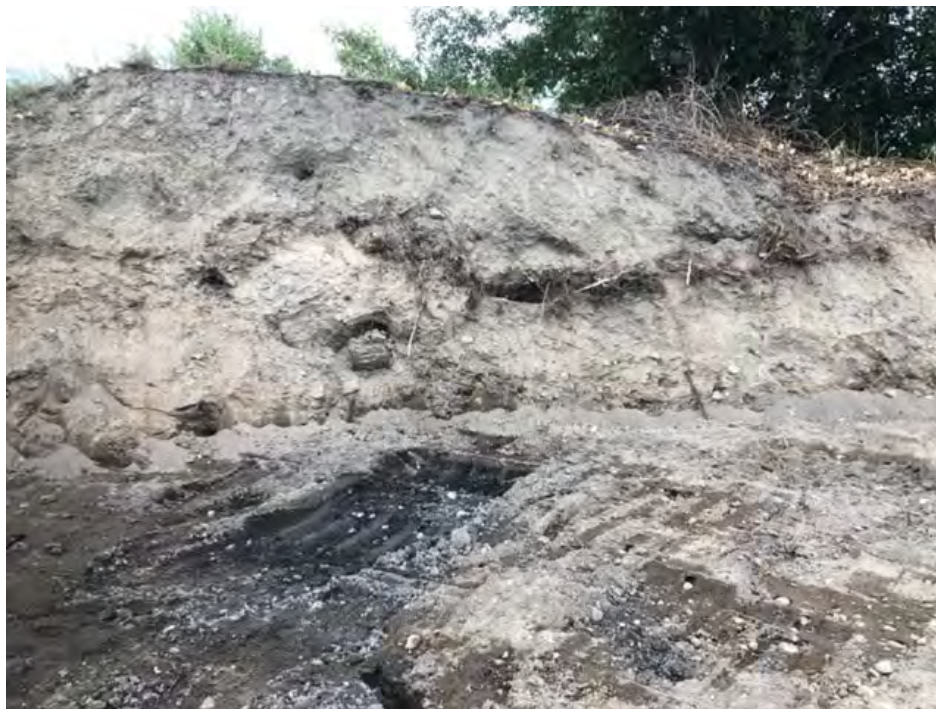
Figure 37: South wall of excavation on Port property. Sand and silt fill with rocks and concrete blocks

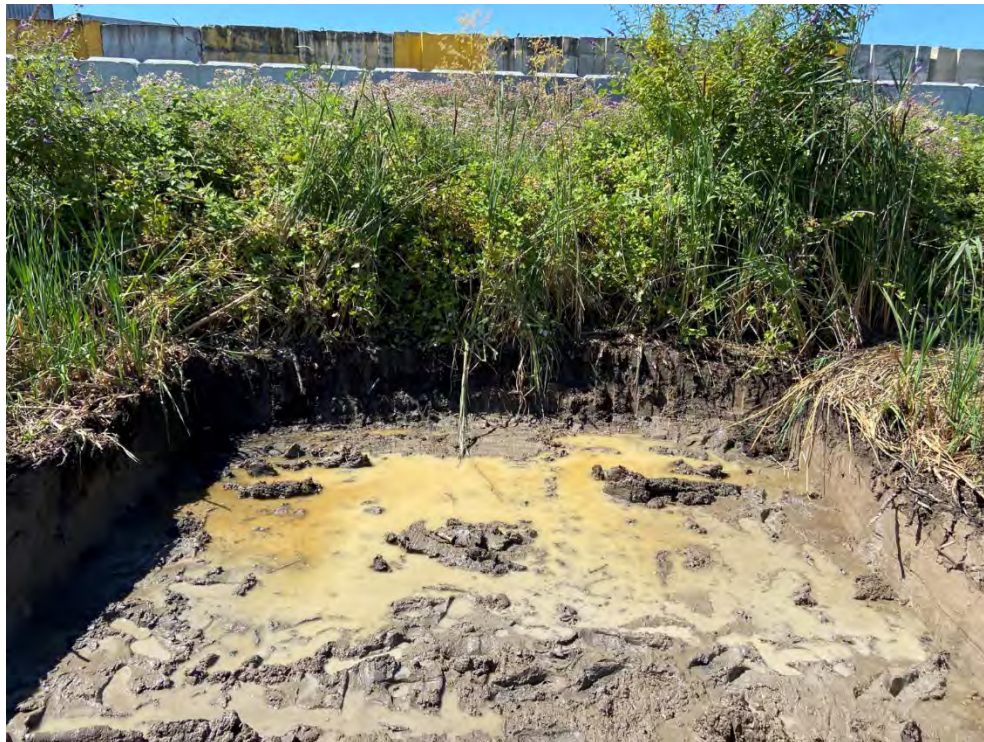
Figure 38: Bottom of RAU D1 NOTE: Clay-rich Silt bottom

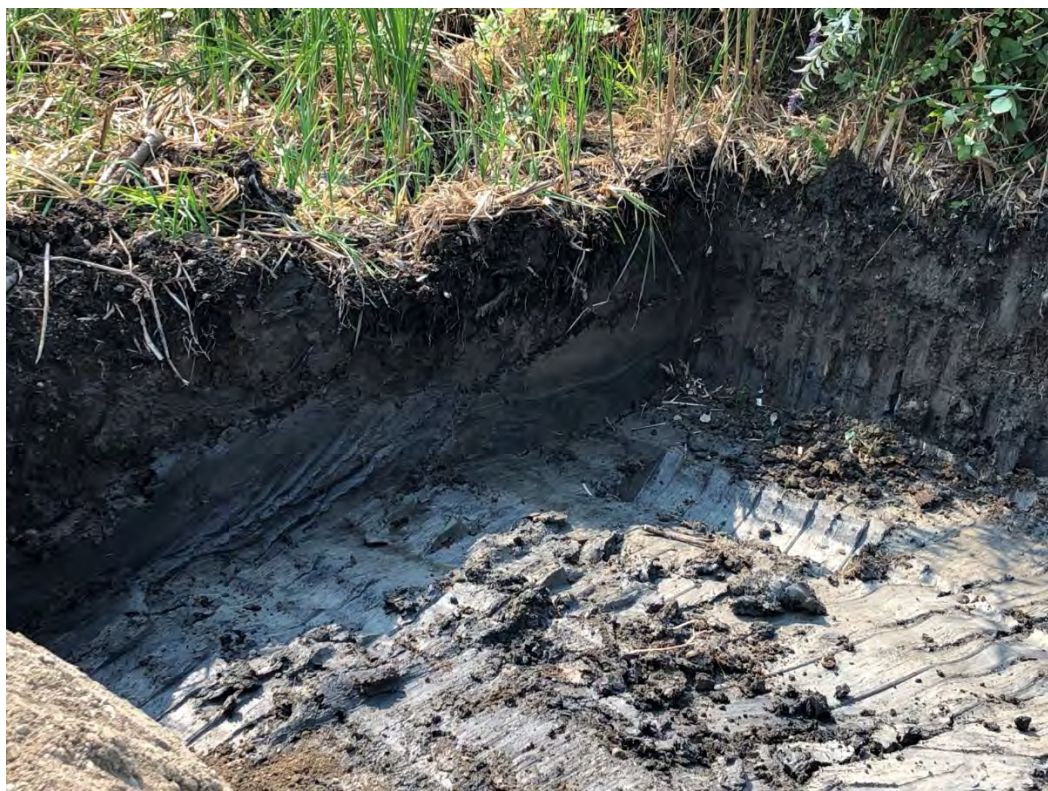
Figure 39: Bottom of RAU D2 NOTE: Three foot thickness of clay-rich silt bottom

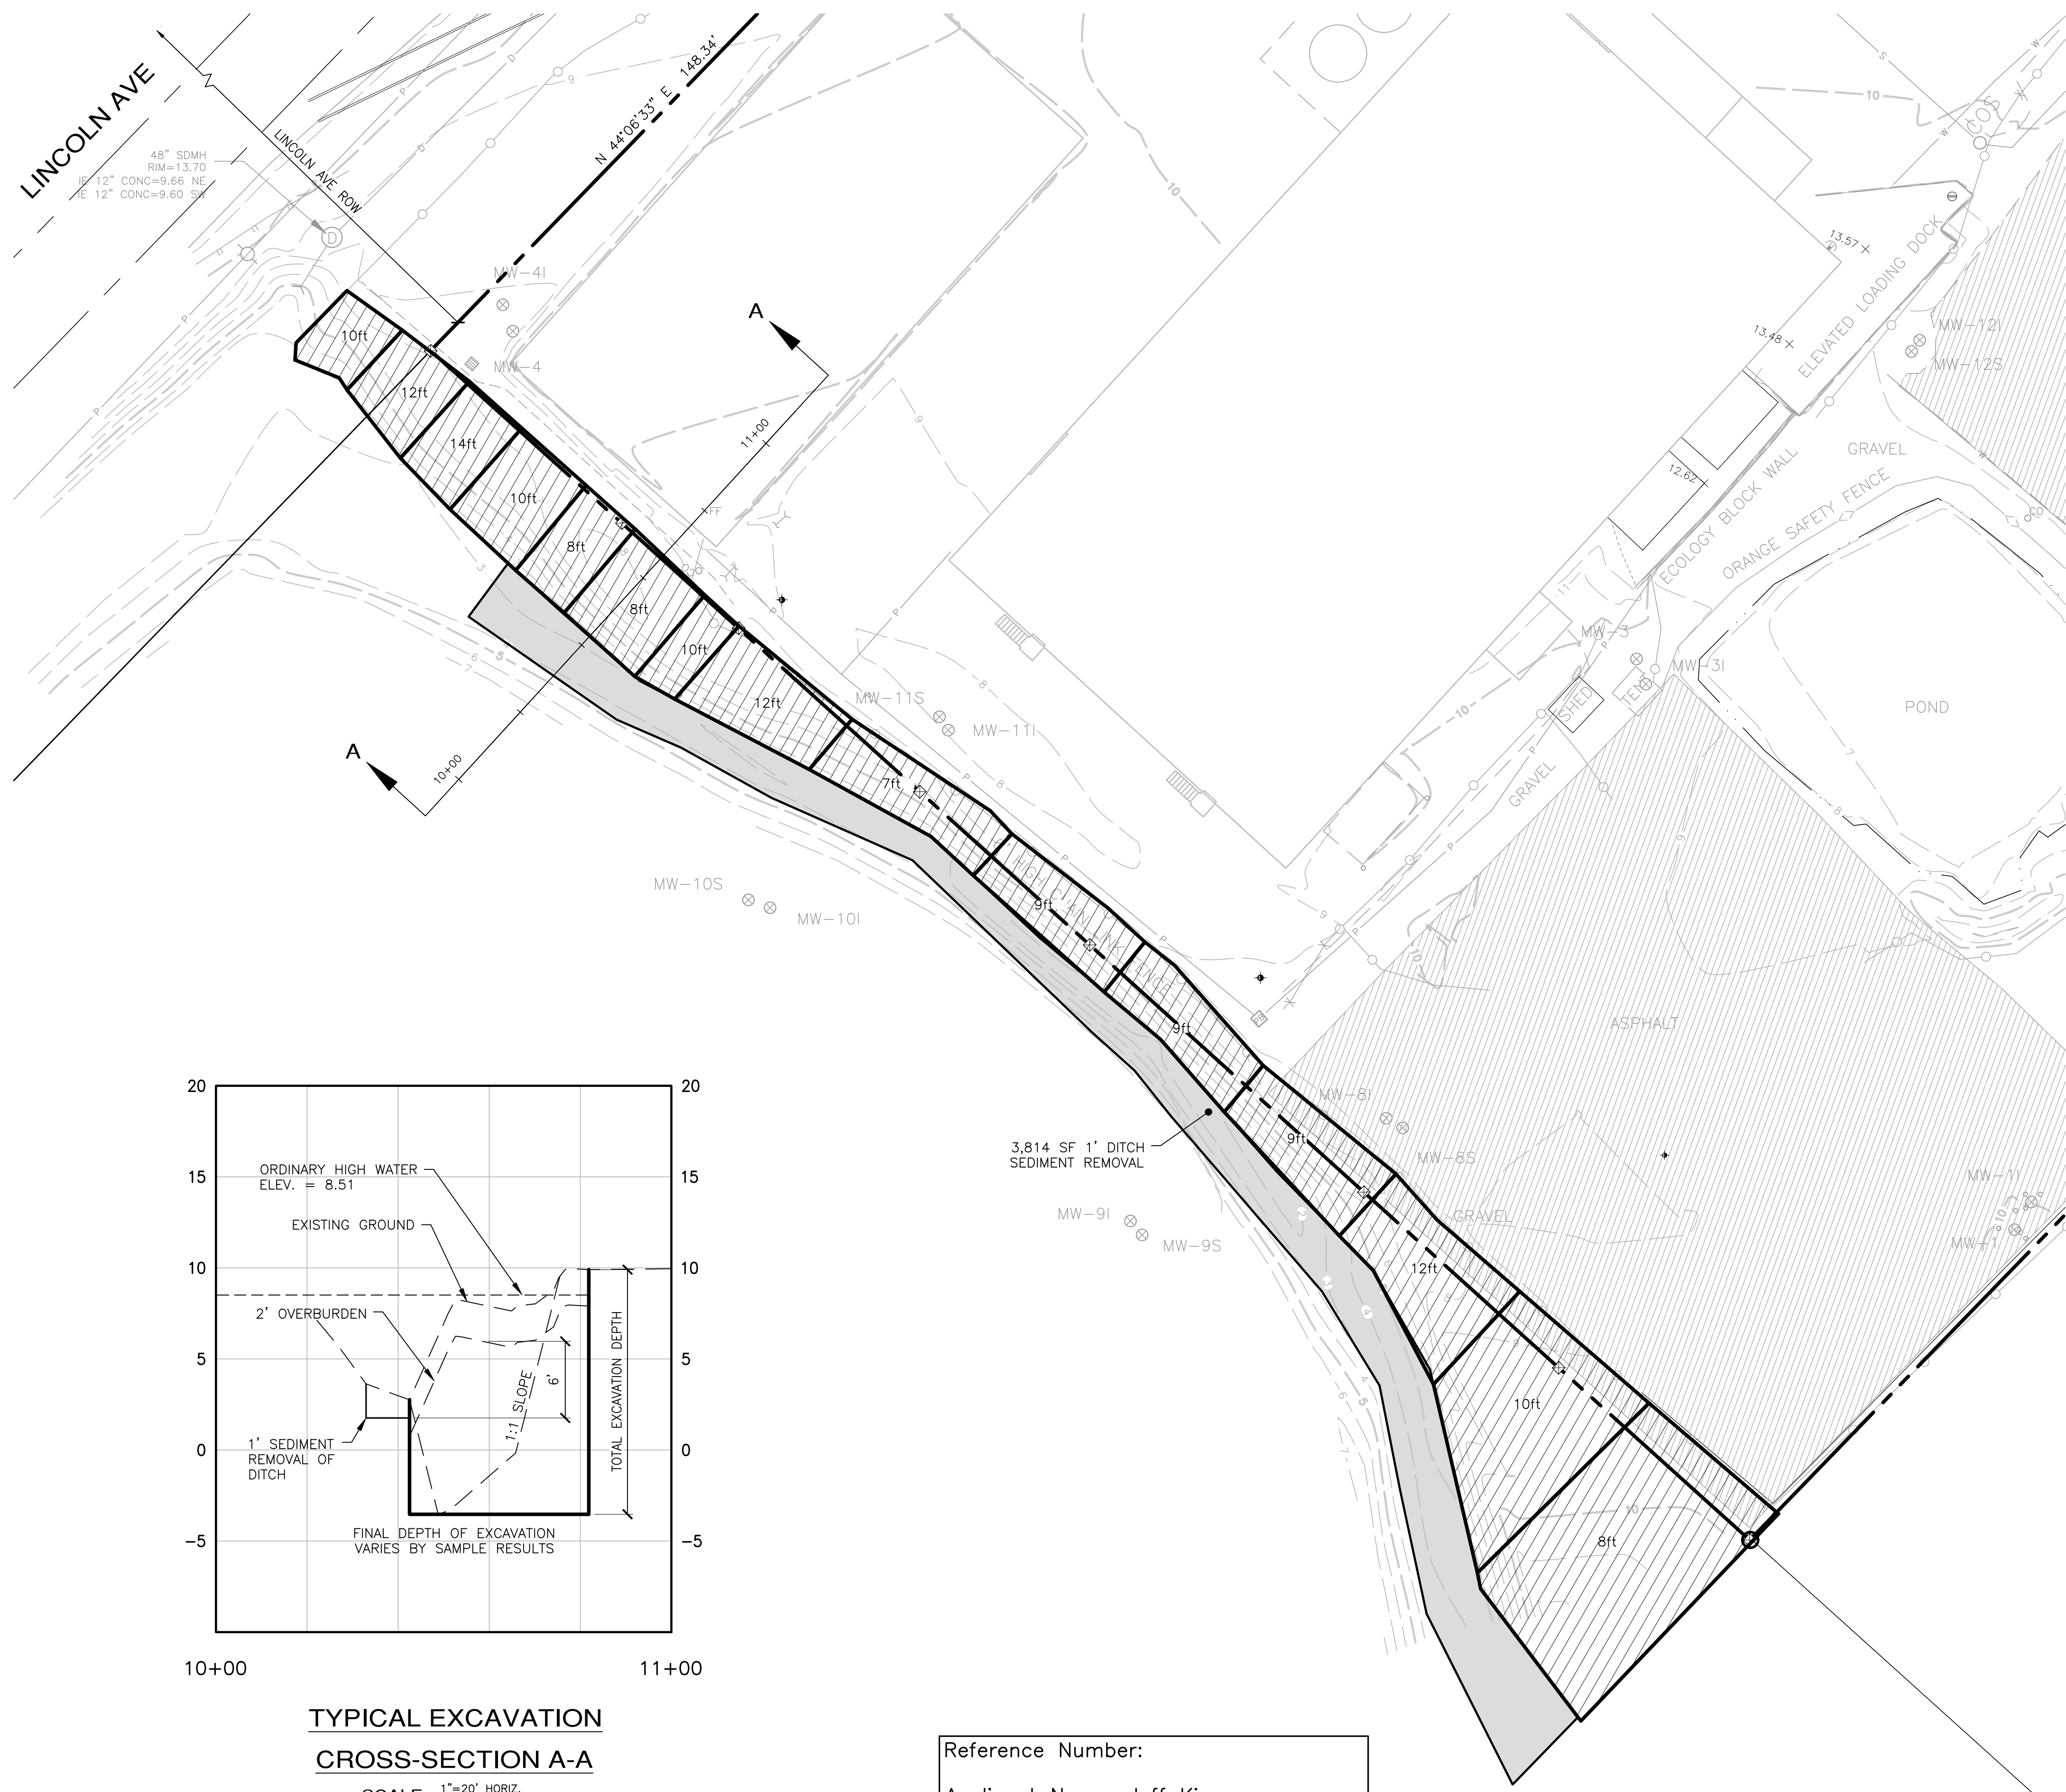
The ditch and berm were surveyed by ESM Consulting Engineers prior to the start of work to determine the existing topography of the berm and the sediment within the ditch. Figure 4 is a result of that survey. It should be noted that the topography within the ditch indicates a drainage flow to the south prior to the start of the remediation rather than toward Lincoln Avenue as expected.

SCALE: 1" = 20'
 CONTOUR INTERVAL = 1'

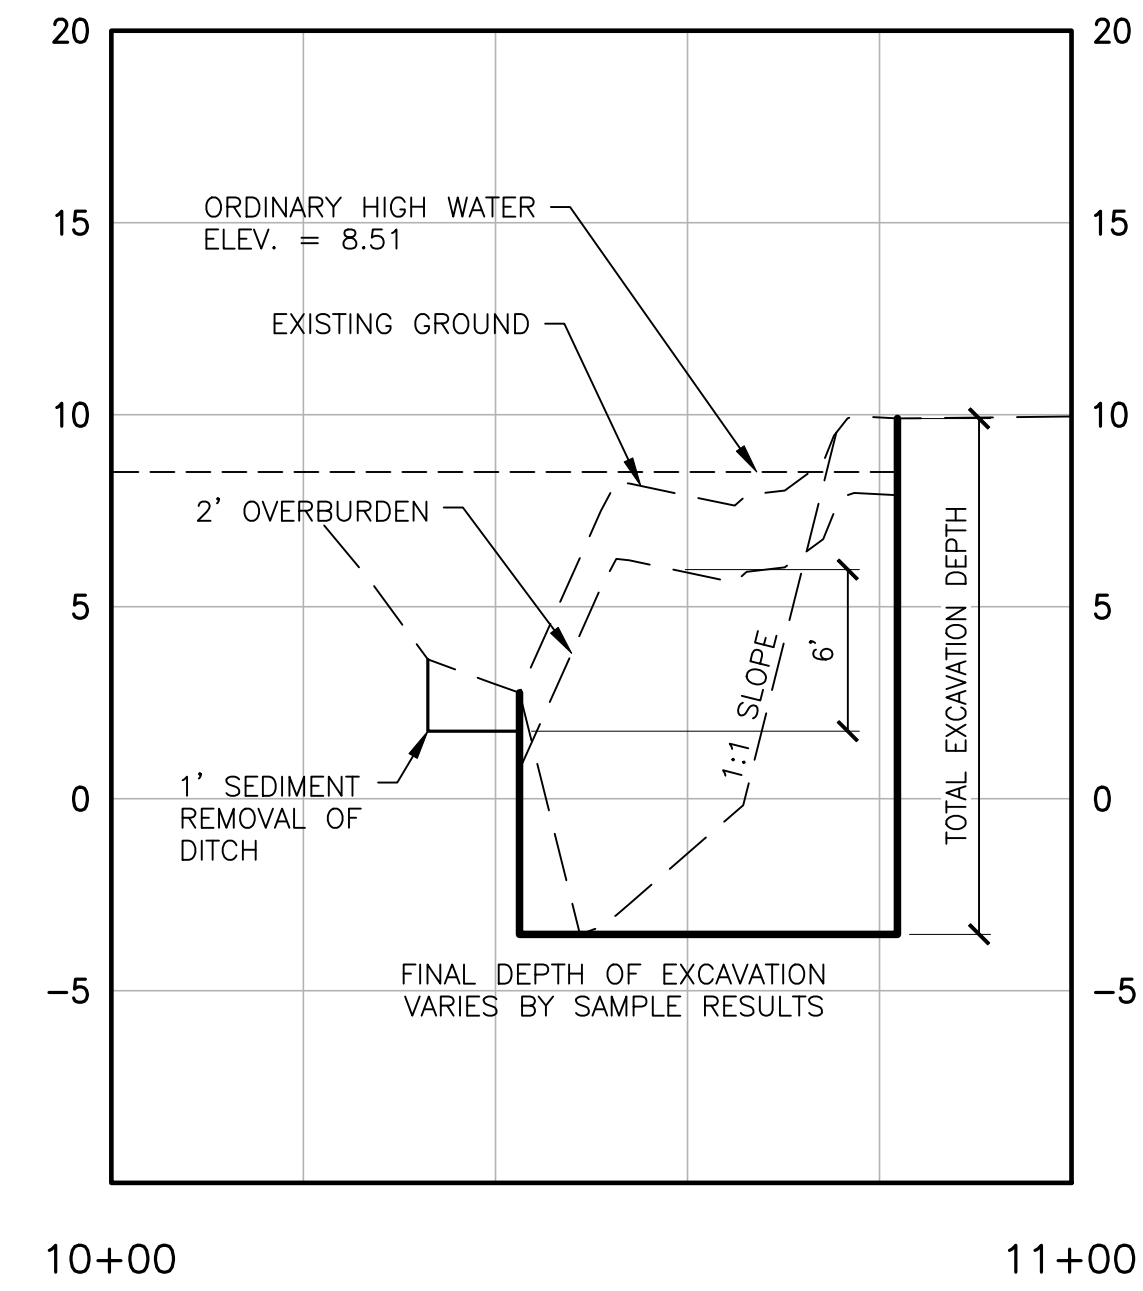
**TYPICAL EXCAVATION
 CROSS-SECTION A-A**
 SCALE: 1"=20' HORIZ.
 1"=5' VERT.

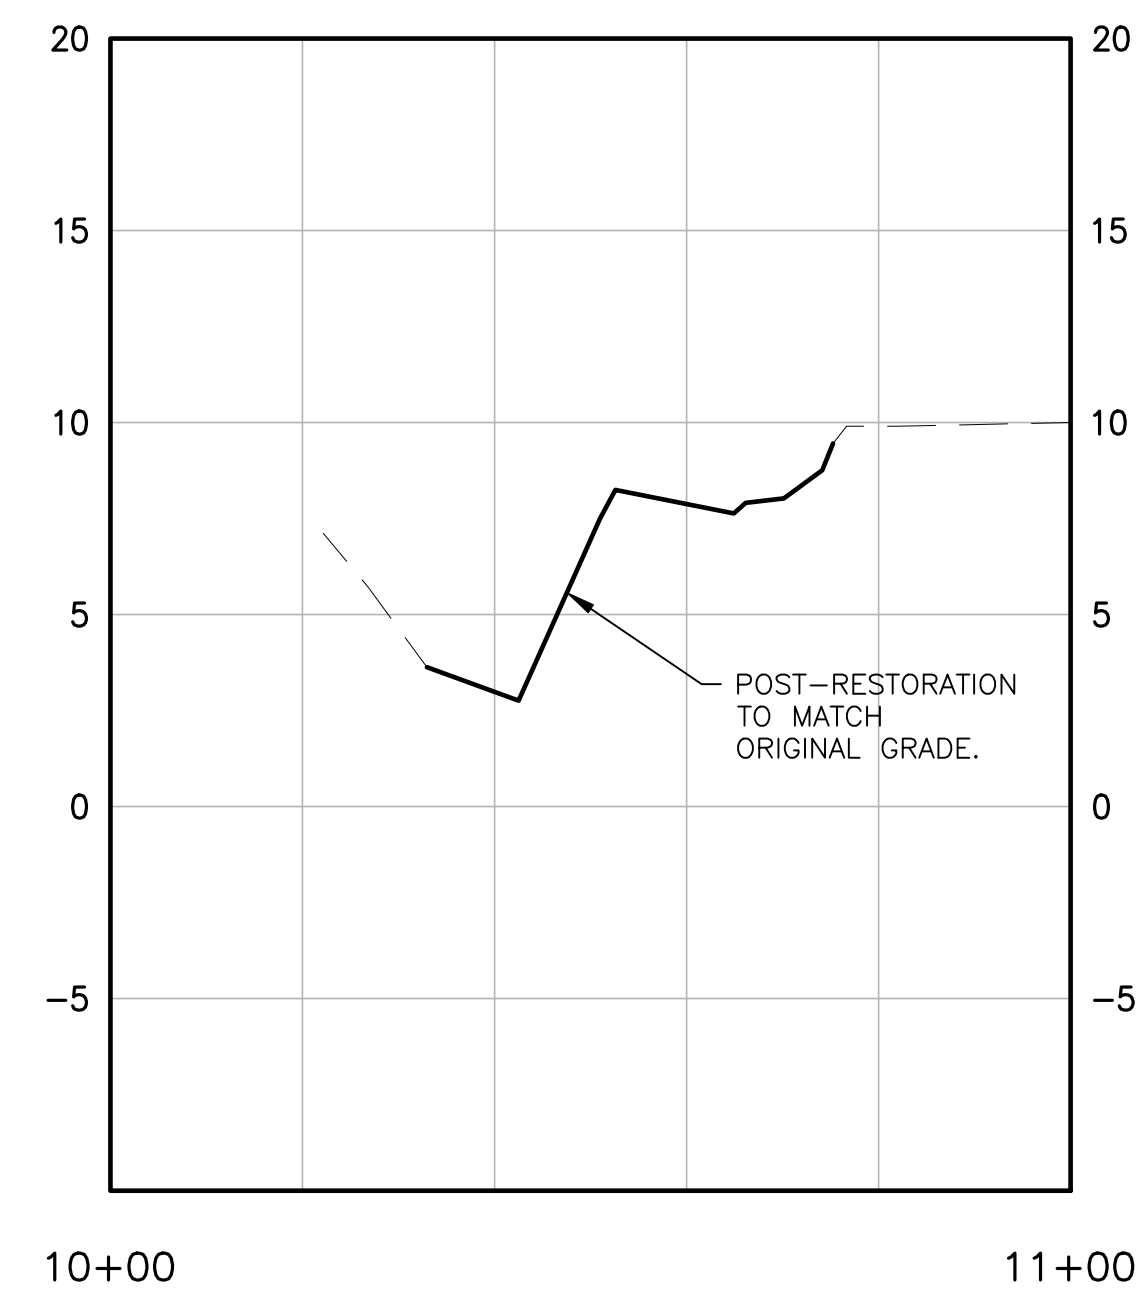
**CONCEPTUAL POST-RESTORATION
 CROSS-SECTION A-A**
 SCALE: 1"=20' HORIZ.
 1"=5' VERT.

ESTIMATED EXCAVATION VOLUMES
 DITCH 1' SEDIMENT: 141 CY
 OVERBURDEN 2': 729 CY
 OTHER SOILS: 2,750 CY
